Memorandum

Subject Targeted vegetation assessment

The Public Transport Authority of Western Australia (PTA) is proposing to develop the Morley- Ellenbrook Line (MEL) Project as part of Western Australian Government's METRONET program aimed at increasing the size of Perth's railway network. The MEL Project is a 21 kilometre railway that will connect the existing Midland line at Bayswater station to Ellenbrook in Perth's north-eastern suburbs. The MEL Project will include new stations at Morley, Noranda, Malaga, Whiteman Park and Ellenbrook, and provision for a potential future station at Bennett Springs.

The PTA is currently progressing Stage 1 of the MEL, Bayswater to Malaga Rail Works (the Project). The route follows the centre median of Tonkin Highway, heading north through the Reid Highway interchange, before leaving the median in Malaga between Marshall Road and Hepburn Avenue.

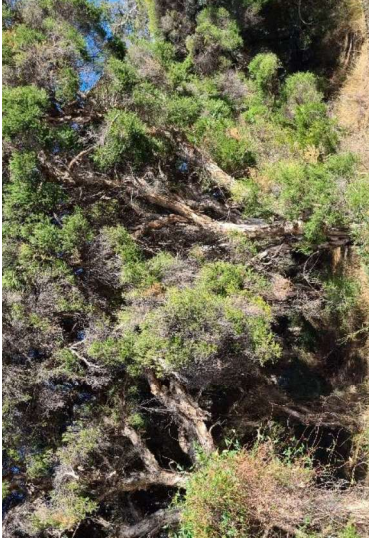
Broad vegetation type	Location	Total area (ha)	Photograph
NATIVE				
VT01	<p><i>Melaleuca preissiana</i> low woodland with scattered <i>Corymbia calophylla</i>.</p> <p>Vegetation condition: Degraded. High weed cover with edge effects.</p>	North of Marshall Road, northbound.	0.128

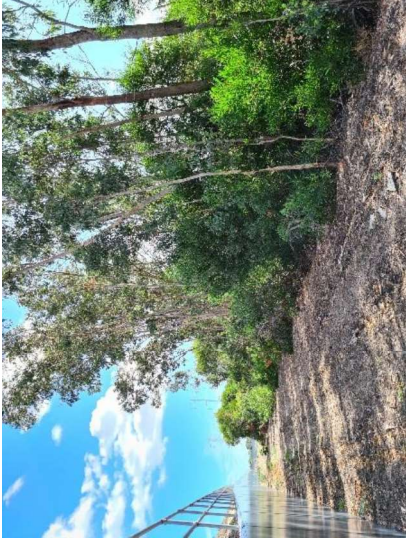
VT02	<p><i>Eucalyptus rudis</i> open woodland over *<i>Acacia longifolia</i> tall shrubland over mixed low shrubland/sedgeland.</p> <p>Vegetation condition: Degraded to completely degraded. Highly modified, mixed with some planted species. High weed cover with edge effects.</p>	<p>North of Marshall Road, southbound.</p> <p>Along Emu Swamp main drain</p>	0.169

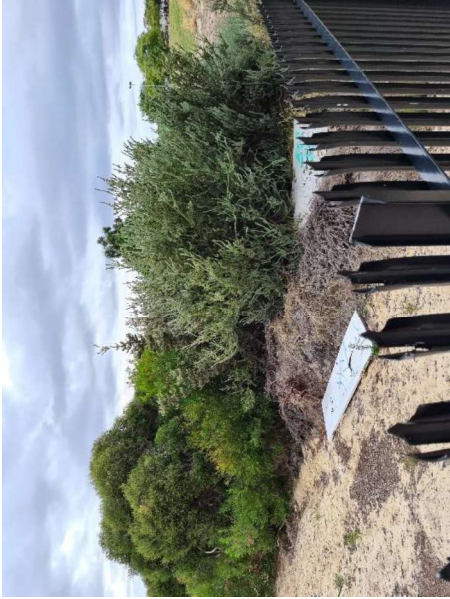
Broad vegetation type	Location	Total area (ha)	Photograph
<p>VT03</p> <p><i>Melaleuca preissiana</i> scattered trees over <i>Jacksonia furcellata</i> *<i>Acacia longifolia</i> and <i>Adenanthos cygnorum</i> open shrubland.</p> <p>Vegetation condition: Completely degraded. Highly modified, some planted species, high weed cover with edge effects.</p>	South of Reid Highway, southbound.	0.120

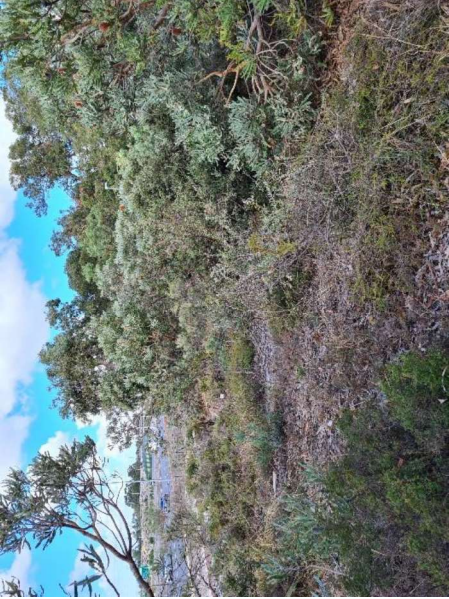
<p>VT04</p> <p><i>Banksia attenuata</i>, <i>Banksia menziesii</i> and <i>Nuytsia floribunda</i> low open woodland.</p> <p>Vegetation condition mapped as Good to Degraded with high weed cover and reduced understorey with edge effects and rubbish dumping.</p>	North of Benara Road, northbound.	0.241

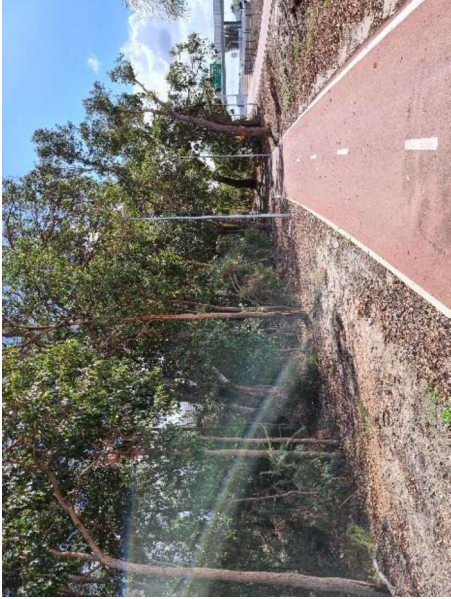
Broad vegetation type	Location	Total area (ha)	Photograph
<p>VT05</p> <p><i>Corymbia calophylla</i> open woodland over <i>Melaleuca preissiana</i> and <i>Banksia grandis</i> low open woodland.</p> <p>Vegetation condition: Good to degraded with high weed cover and limited understorey with edge effects and rubbish dumping.</p>	North of Benara Road, northbound.	0.295

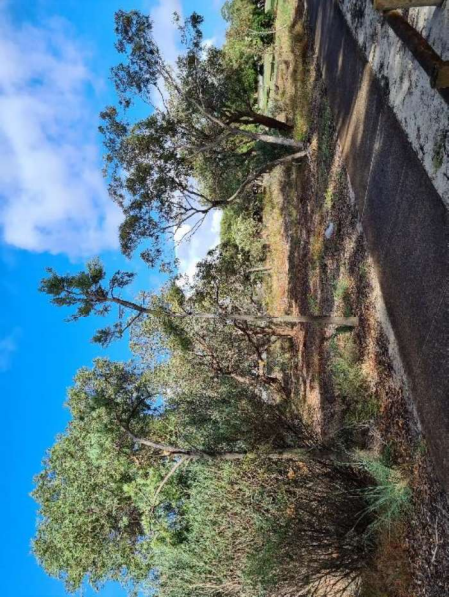
<p>VT06</p> <p><i>Eucalyptus tottiana</i>, <i>Corymbia calophylla</i>, <i>Allocasuarina fraseriana</i> and <i>Banksia menziesii</i> low open woodland.</p> <p>Vegetation condition mapped as Degraded to Completely Degraded with some planted species, high weed cover and reduced understorey with edge effects and rubbish dumping.</p>	Along the northern side of Broun Ave.	0.384

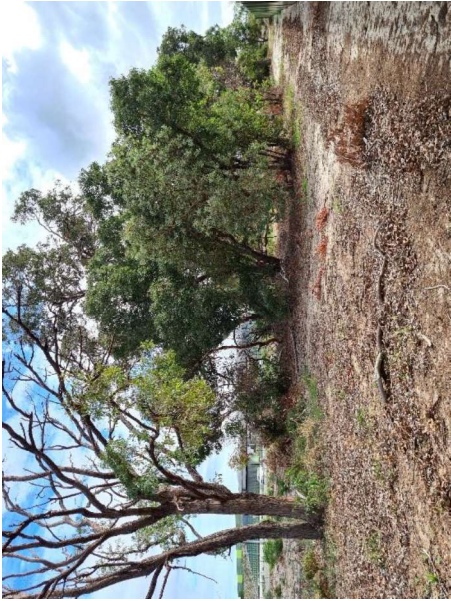
Broad vegetation type	Location	Total area (ha)	Photograph
VT09	<p>Parkland cleared. Individual trees or small patches of native <i>Eucalyptus</i> species including <i>Corymbia calophylla</i>, <i>Eucalyptus rudis</i>, and <i>Eucalyptus gomphocephala</i> over completely cleared understorey.</p> <p>Vegetation condition: Completely degraded.</p>	0.879

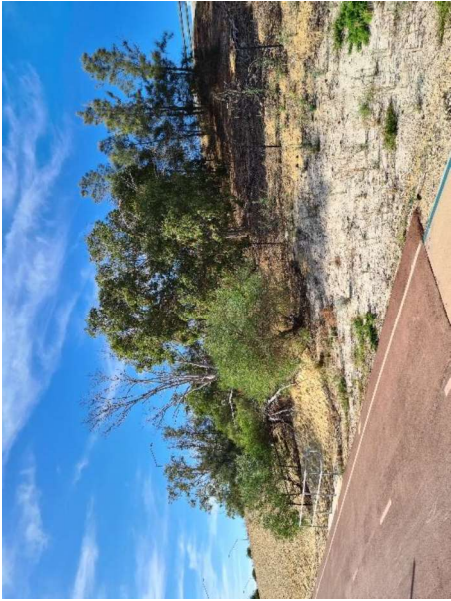
NON-NATIVE			
Planted/ non- native	<p>Areas which have previously been cleared and revegetated with a mix of introduced and native species (local and non local species). Established planted trees include <i>Eucalyptus camaldulensis</i> and <i>Melealeuca quinquenervia</i>.</p>	12.602

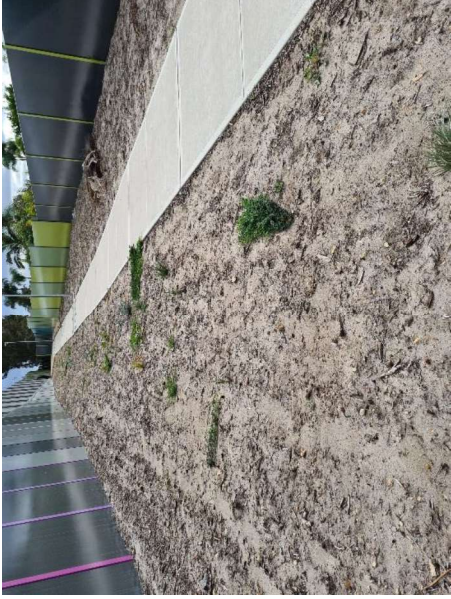
Broad vegetation type	Location	Total area (ha)	Photograph
Cleared Completely cleared or modified areas. Includes existing road network infrastructure and recently revegetated areas. Some scattered planted trees but no intact native vegetation.	Entire length of the survey area.	188.632
