RE: Rowley Road, Darling Downs – Clearing Permit Documentation

On behalf of Darling Downs Estate Pty Ltd and the City of Armadale please find attached a Clearing Permit application to clear 0.556ha of native vegetation to manage Bushfire Attack Levels (BAL) for existing and future development abutting an unmade section of the Rowley road reserve.

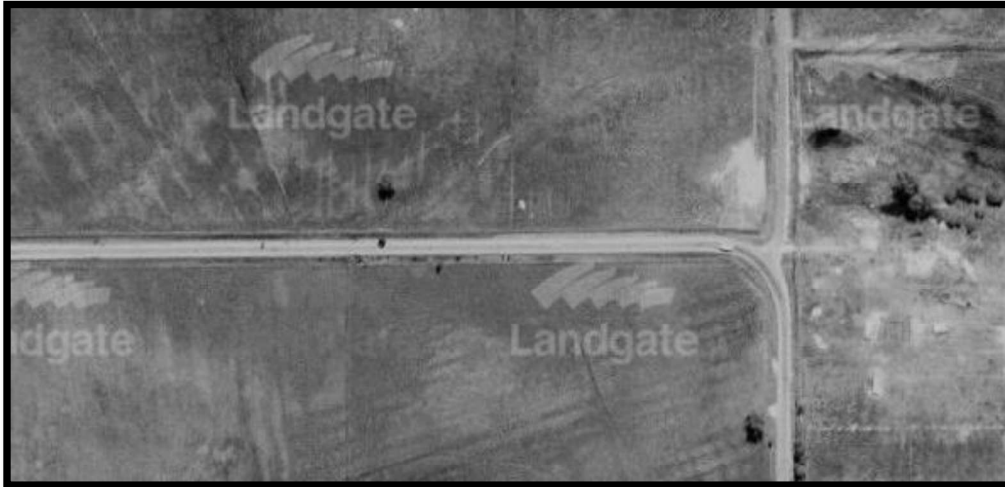
Plate 1: Historical Aerial Photography from September 1974

The section of the Rowley Road reserve relevant to the clearing permit application was completely cleared in the past as shown in historical aerial photography from 1974 (Plate 1).

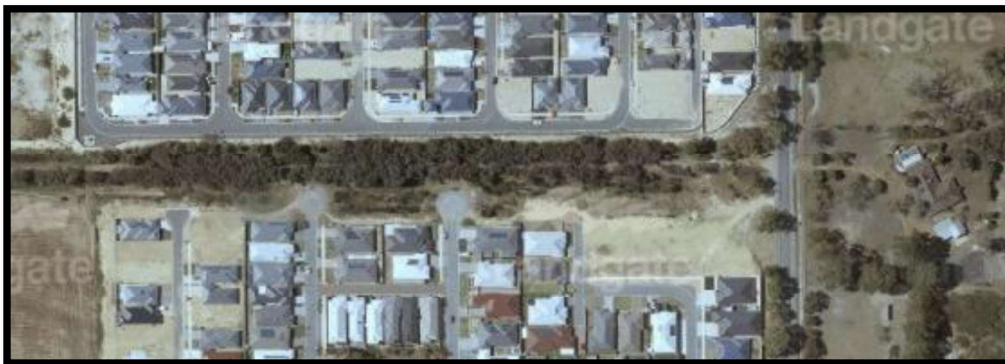
Plate 2: Historical Aerial Photography from November 2019

The vegetation has since regrown as evidenced in the 2019 aerial photograph.

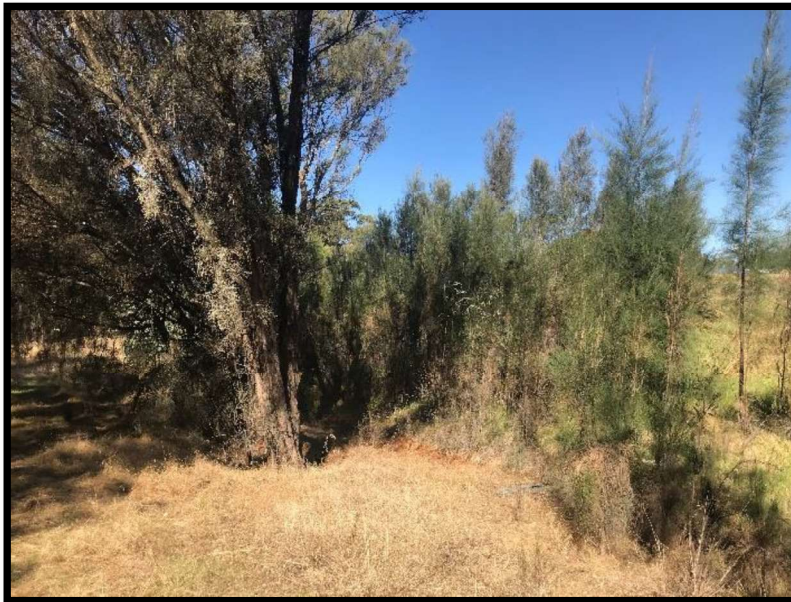
Plate 3: Different Age Native Sheoak in the Road Reserve

The native Sheoak in the road reserve is regrowth vegetation and has two noticeable different age ranges for the trees. The trees on the northern part of the road reserve, on either side of an old track, are mostly older trees up to 6m high. The trees in the southern part of the road reserve on lower ground are younger trees around 3-4m high. Plate 3 shows the two age groups.
