Project Brief

The Shire of Waroona lodged a successful application under the State Black Spot program to improve a section of Nanga Brook Road from 15.15 to 19.35 straight line kilometres (SLK). This section of road has experienced a relatively high number of crashes involving vehicles leaving the carriageway and hitting roadside objects. Current data shows one fatality plus four medical crashes, with an additional motorcycle fatality occurring in January 2019 at 19.13 SLK which is not yet showing up in the crash data available.

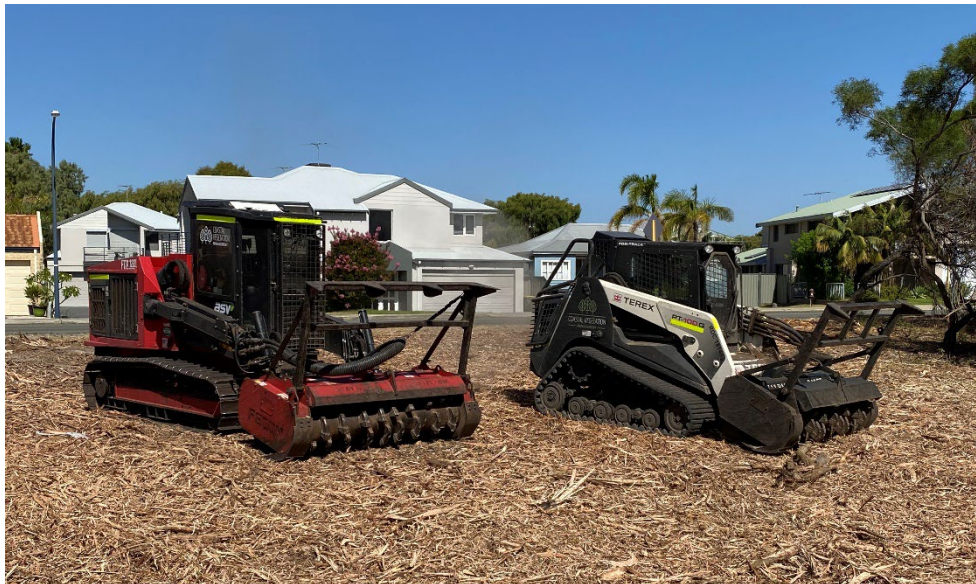
Falcon Forestry Mulching Machine – 2200mm wide

Terex Positrac with Fecon Forestry Mulcher Attachment – 1900mm wide

The mulching will leave behind a coarse mulch suitable for the verge environment.

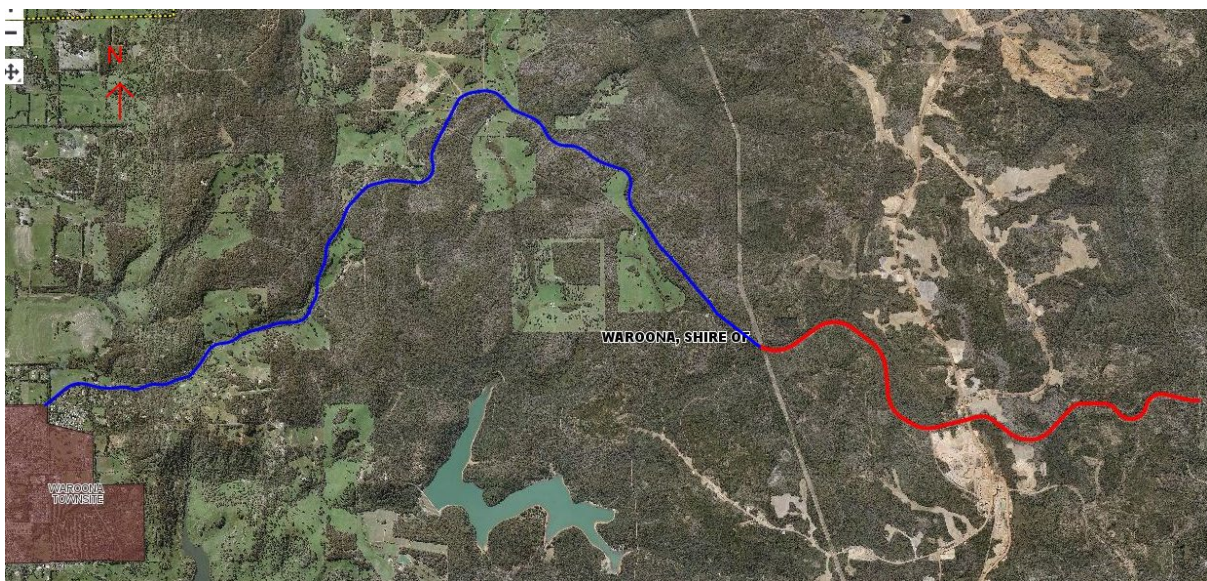
Location Plan

Nanga Brook Road runs from McDowell Street to Nanga Road and is 19.9 kilometres in length. The plan below shows a general overview of the road with the subject section shown in red.

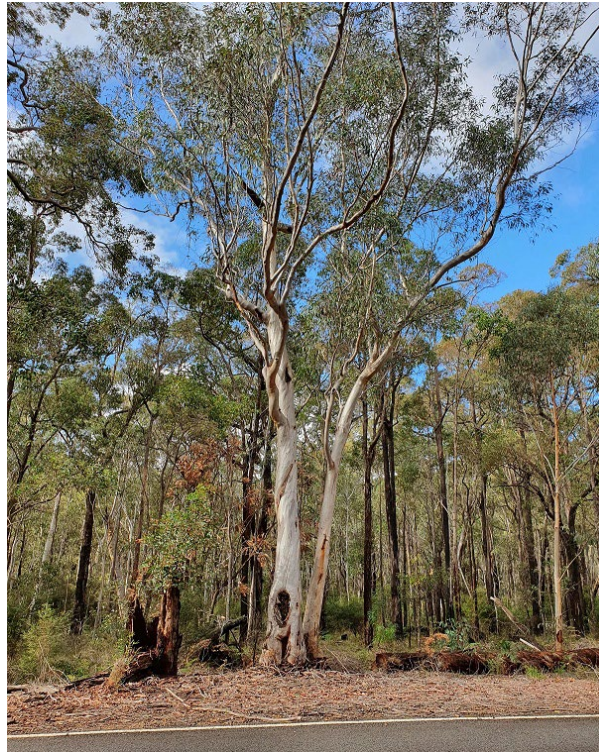
SLK	Direction	Location	Distance from Edge of Seal	Observations
15.31	East	North Side	4m	No nesting or hollow points.

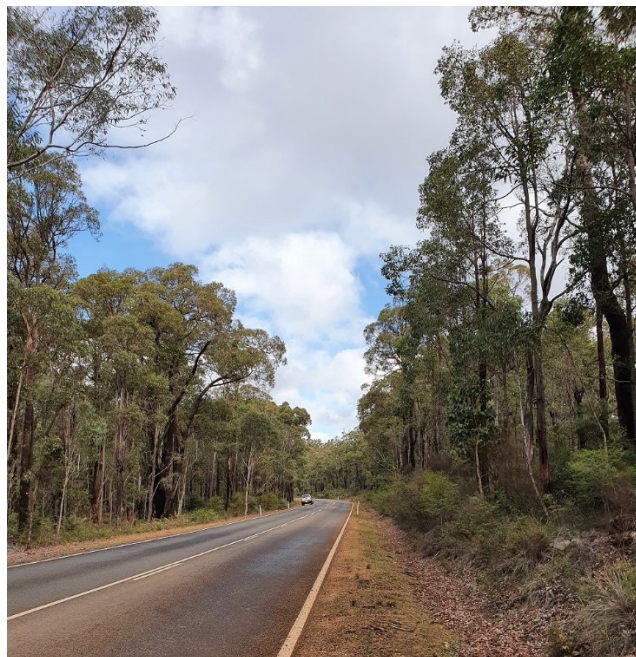
SLK	Direction	Location	Distance from Edge of Seal	Observations
15.31	East	South Side	2-5m	Native Shrubs (Variety)

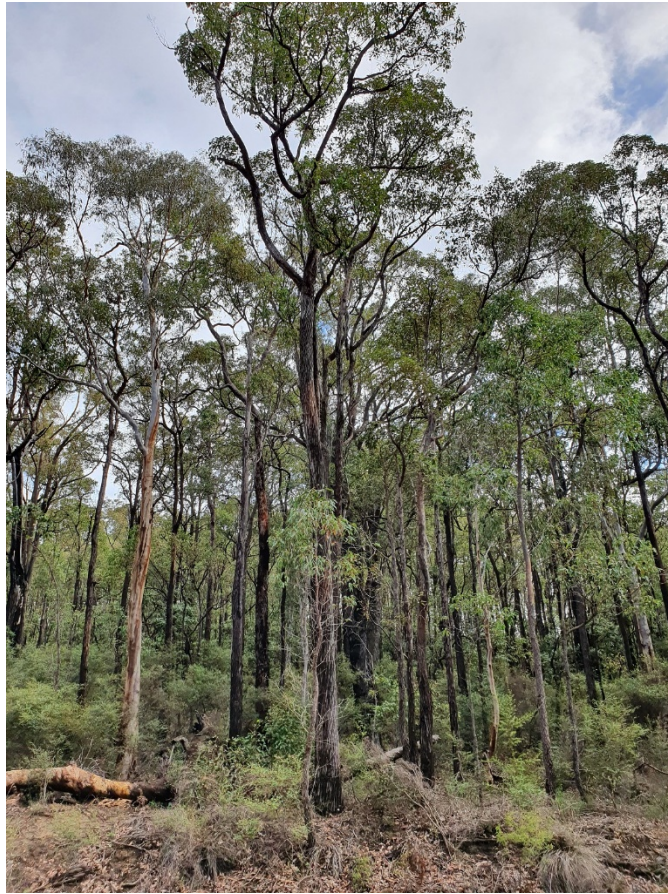
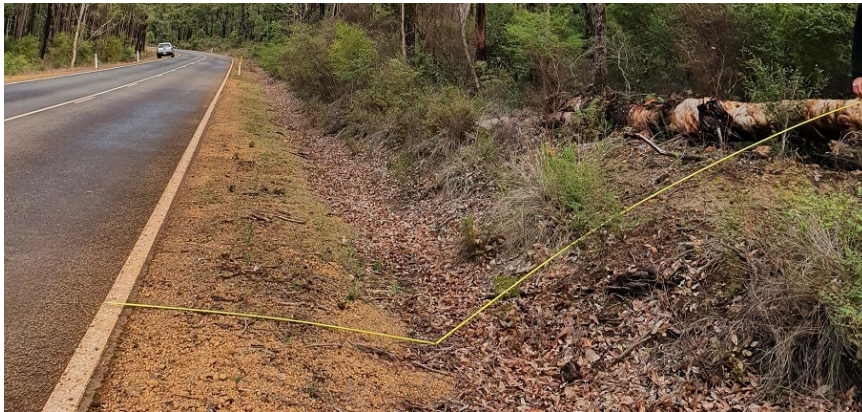
(Distance to base of tree)

SLK	Direction	Location	Distance from Edge of Seal	Observations
15.36	East	South Side	5m	No visible nesting or hollow points

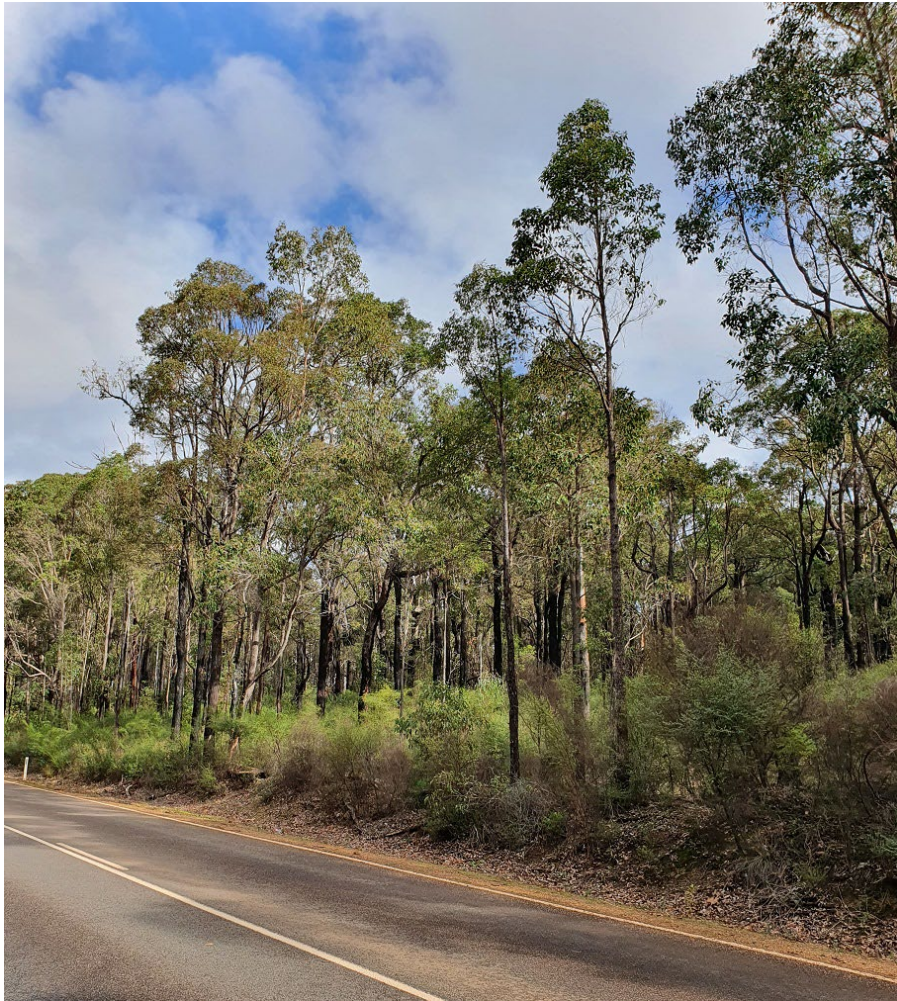
SLK	Direction	Location	Distance from Edge of Seal	Observations
15.93 – 16.04	East	South Side	5m	Native shrubs and a couple of native trees with no visible nesting or hollow points. 2-3 large thin trees may be remove pending on the batter clearance.

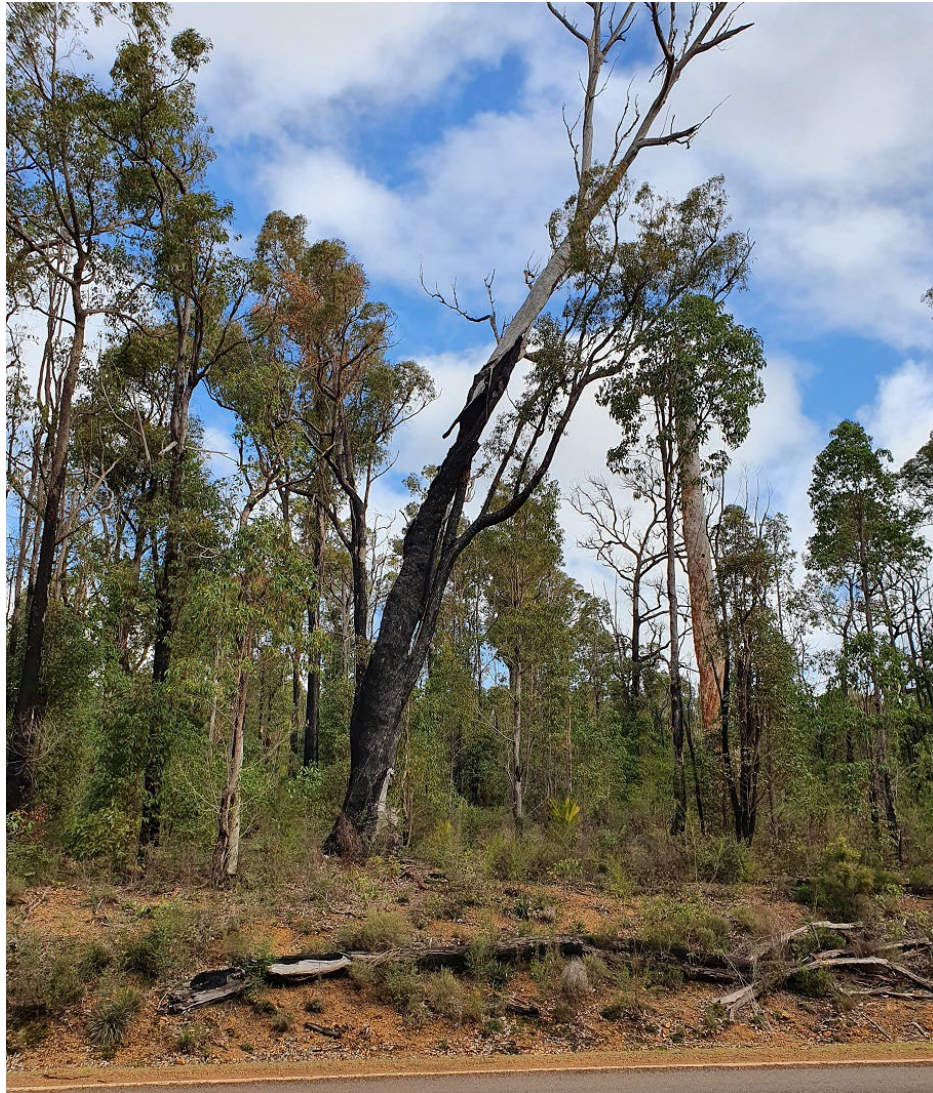
SLK	Direction	Location	Distance from Edge of Seal	Observations
16.77	East	South Side	3m	Large native fire damaged tree with no nesting points. Has a hollow point within the base but no sign of nesting. Tree is on a lean and shows signs of limbs dropping. Would be considered hazardous if left onsite.

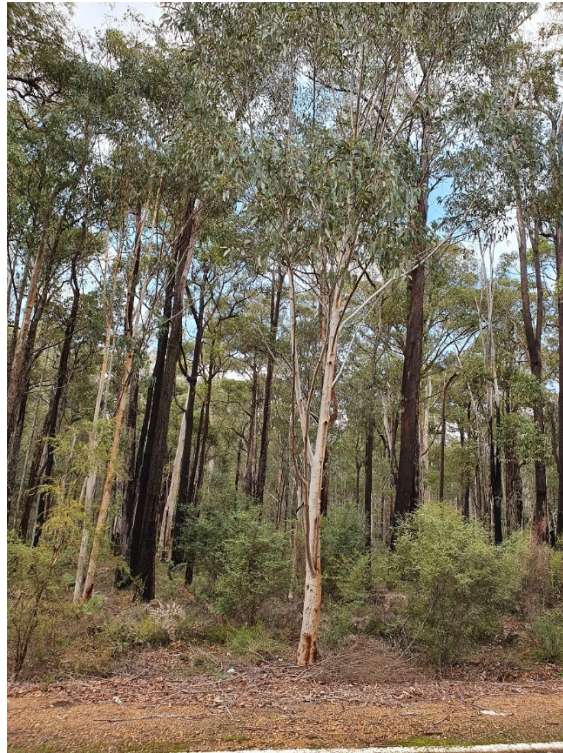
SLK	Direction	Location	Distance from Edge of Seal	Observations
16.77	East	North Side	2m	Native tree with no nesting or hollow points. Tree is within the clearance zone on the curve.

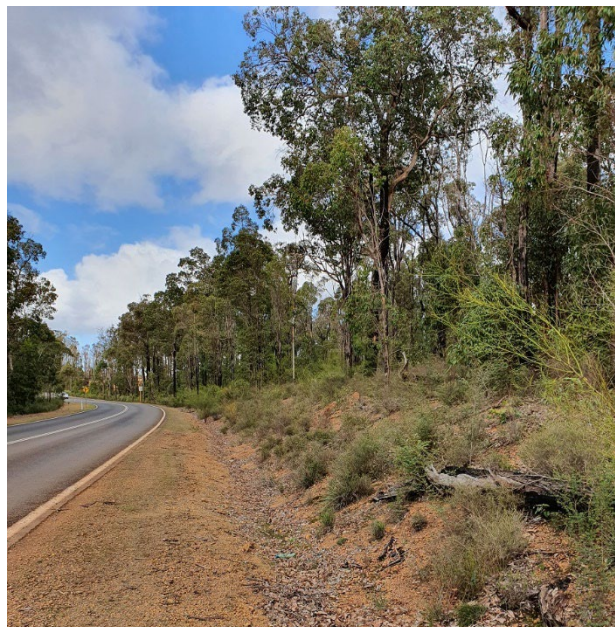
SLK	Direction	Location	Distance from Edge of Seal	Observations
16.88 – 16.93	East	North Side	1-5m	Mulching on native vegetation.

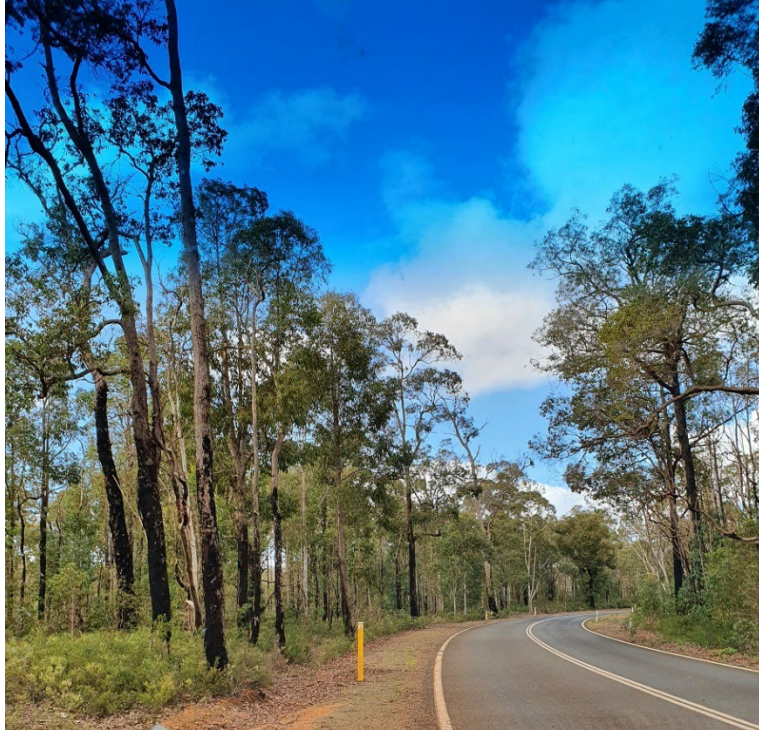
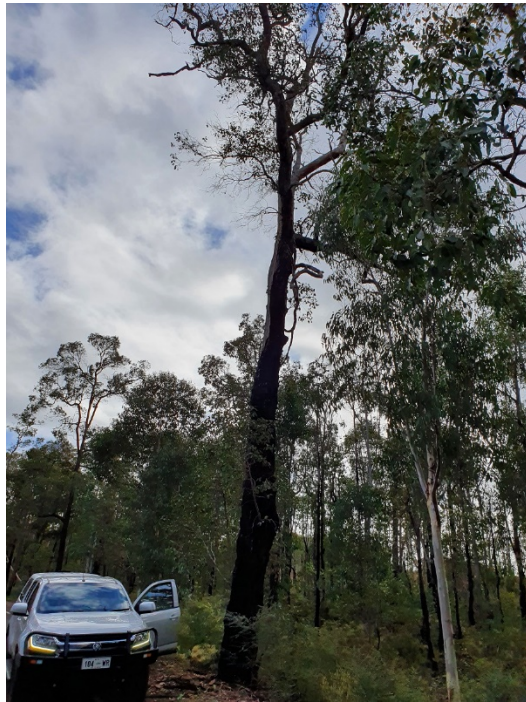
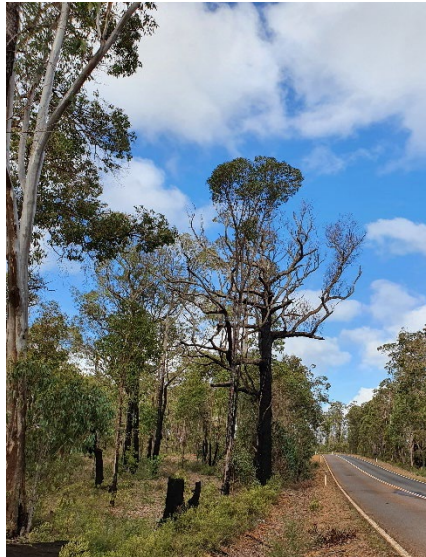
SLK	Direction	Location	Distance from Edge of Seal	Observations
16.93 – 17.15	East	North Side	2-3m	2 Large thin native tree with no visible nesting of hollow points

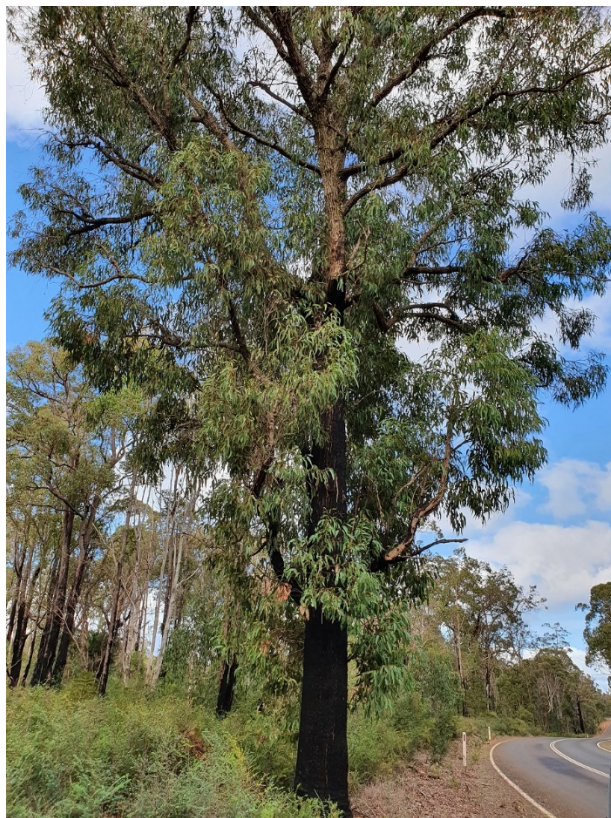
SLK	Direction	Location	Distance from Edge of Seal	Observations
17.15	East	North Side	2-3m	Large native tree no clear signs of nesting or hollow points.

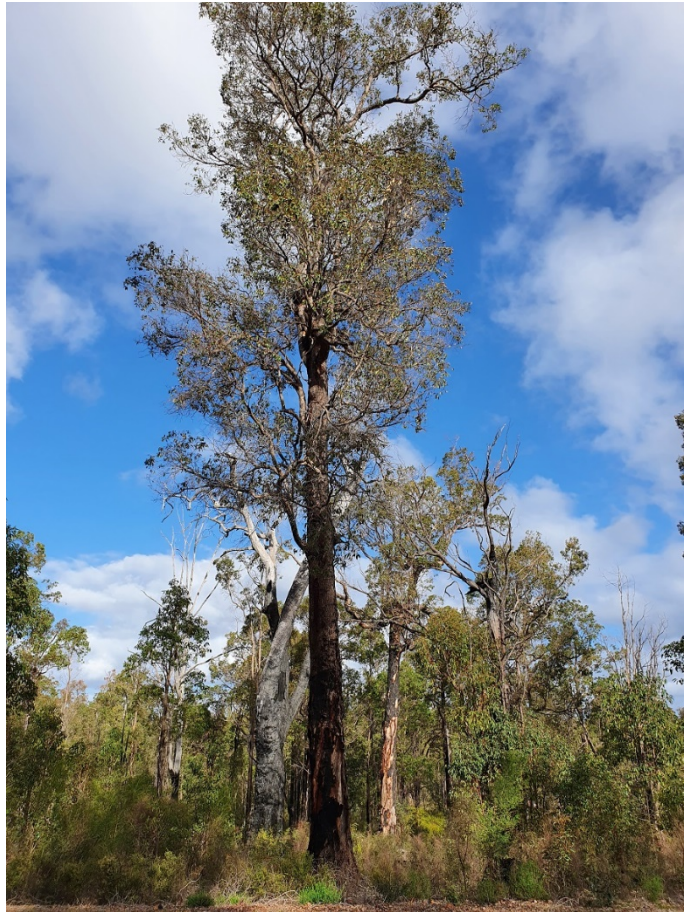
SLK	Direction	Location	Distance from Edge of Seal	Observations
17.36	East	South Side	2-3m	Large native tree no clear signs of nesting or hollow points.

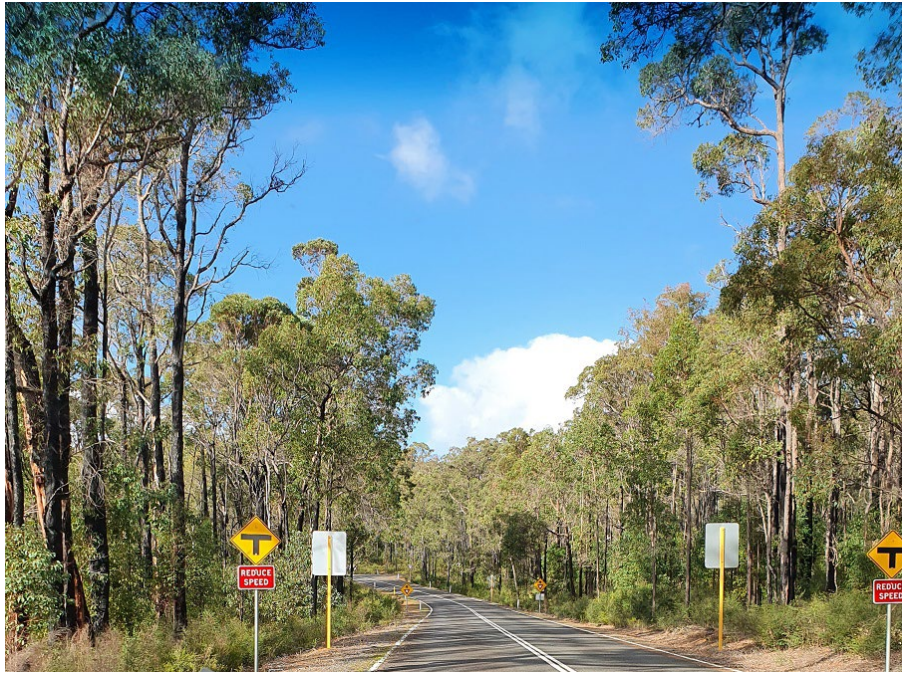
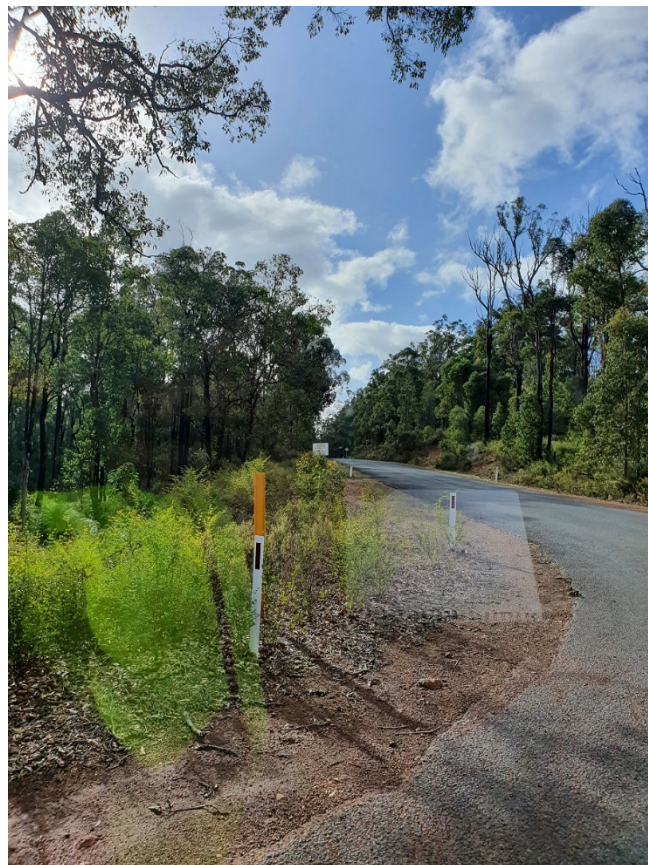
SLK	Direction	Location	Distance from Edge of Seal	Observations
18.00 – 19.35	East	North & South Side	0-5m	Native shrubs which require mulching to improve vision at the intersection of Nanga Brook and Nanga Road.
