## Project Brief

As part of the 2020/21 Budget funds have been allocated to some clearing works along Fawcett Road, Hamel. Fawcett Road is a main access road for local farmers, residents and produce farms. The section of Fawcett road from SLK 2000 to 4100 has a substantial amount of vegetation build-up which has resulted in the vegetation becoming overgrown and unmanageable. In some locations the vegetation has grown within the table drains which has resulted in the vegetation growing on a lean towards the road which has made it difficult to prune without compromising the tree structure.

## Calculations

The clearing permit is for the section of Fawcett Road which is from SLK 2000 to 4100 which is 2.1km.

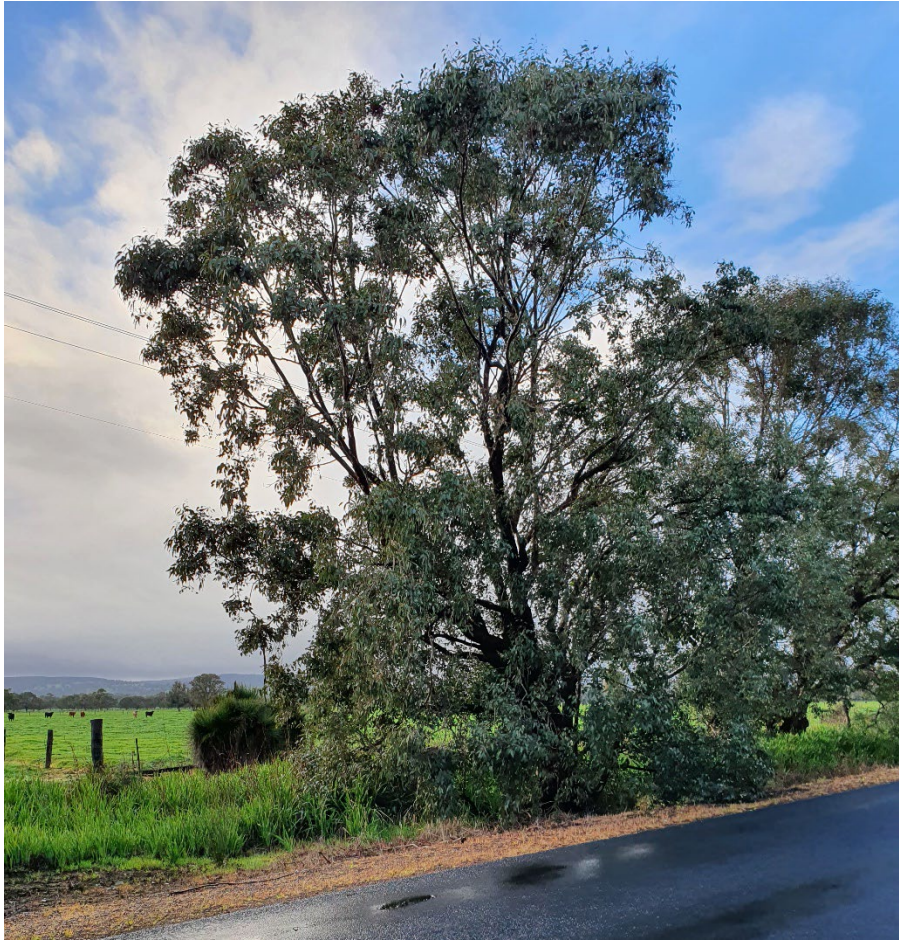
Tree ID	Direction	Location	Observations
5000	South	East Side	No visible signs of nesting or hollow points.

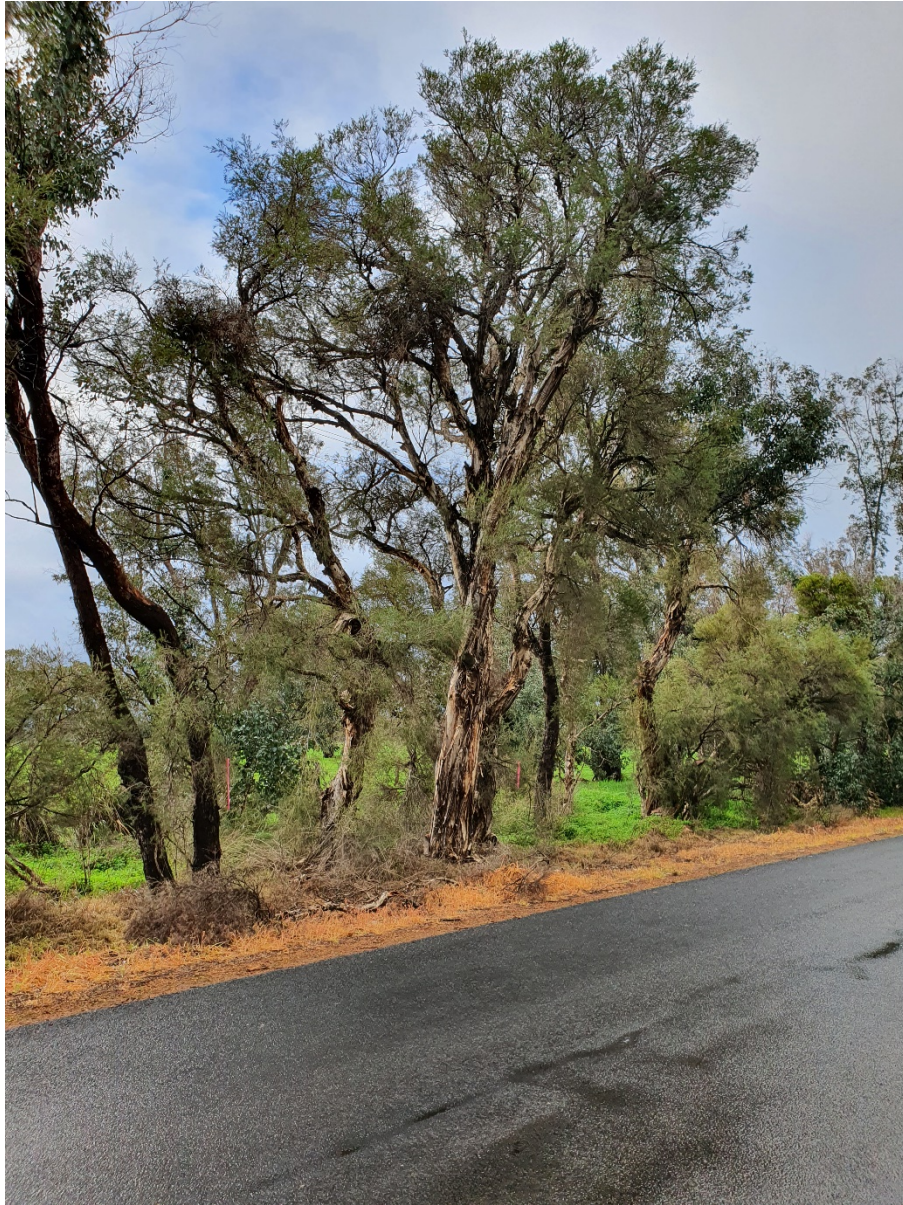
Tree ID	Direction	Location	Observations
5004	South	East Side	No visible signs of nesting or hollow points. Tree is growing within the table drain and is dropping limbs as shown in the photo above.

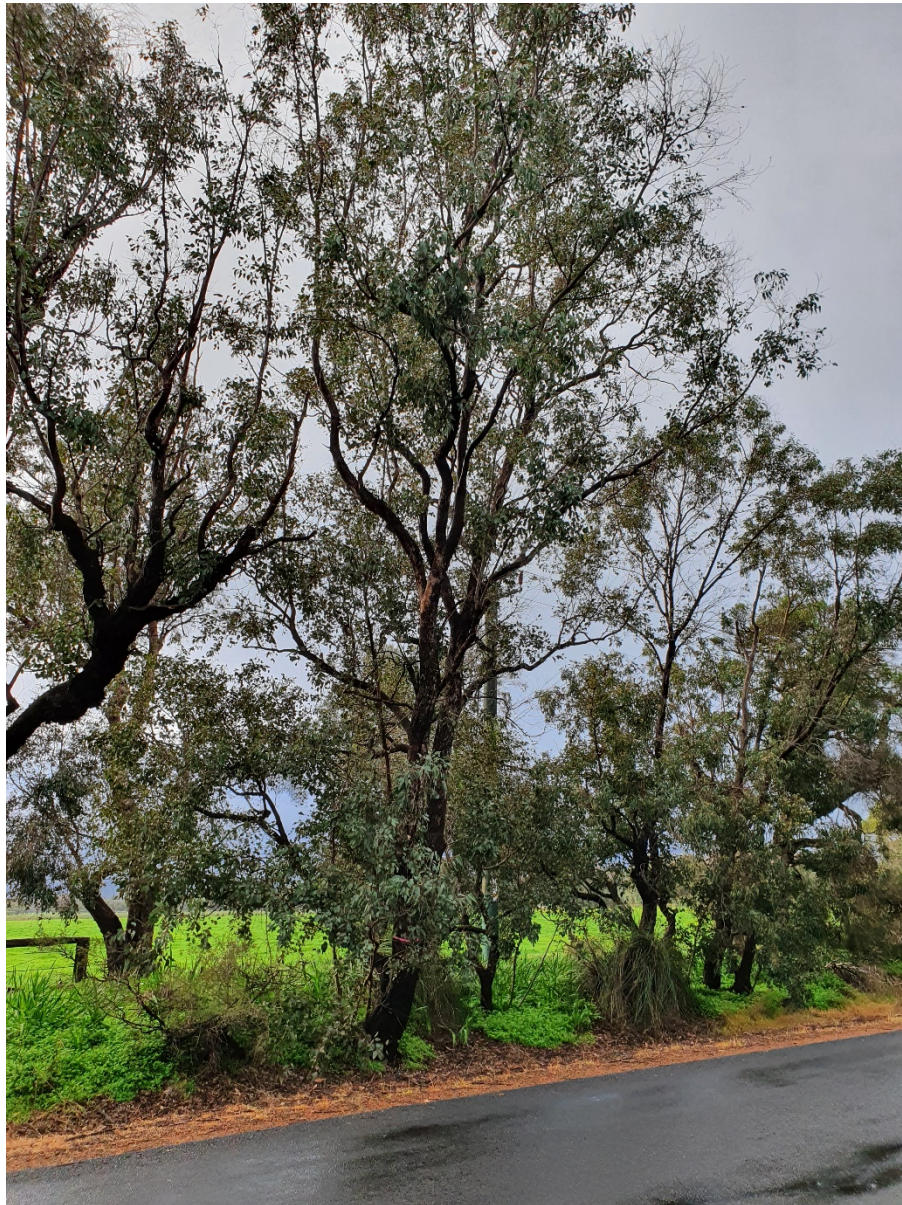
Tree ID	Direction	Location	Observations
5005	South	East Side	No visible signs of nesting or hollow points. Tree is growing within table drain which so the tree is naturally leaning towards the road.

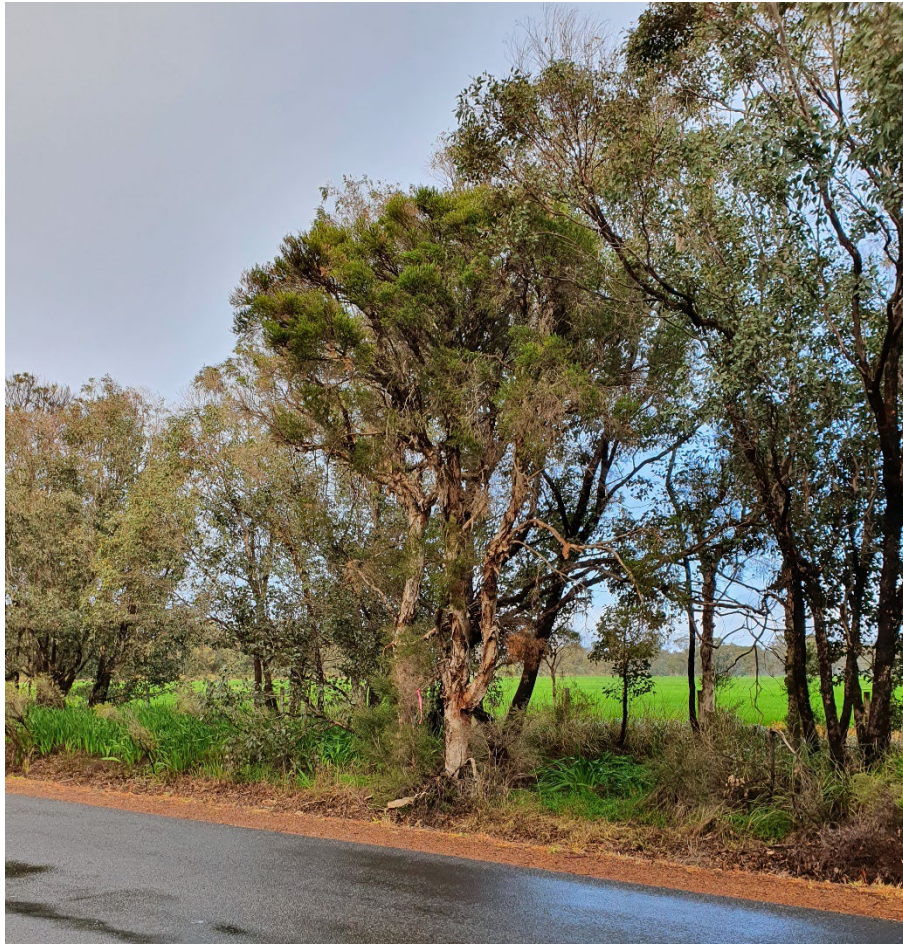
Tree ID	Direction	Location	Observations
5006	South	West Side	No visible signs of nesting or hollow points.

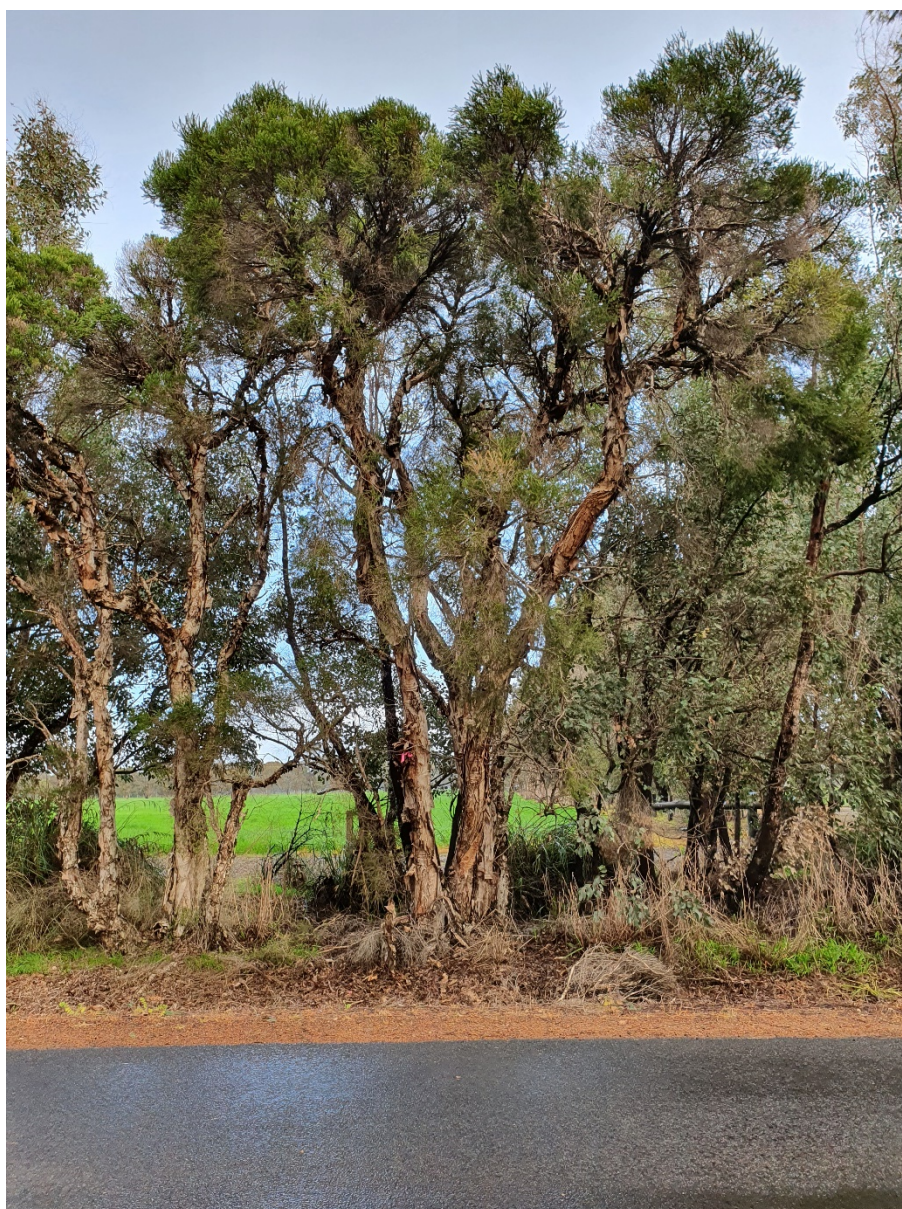
Tree ID	Direction	Location	Observations
5007	South	West Side	No visible signs of nesting or hollow points.

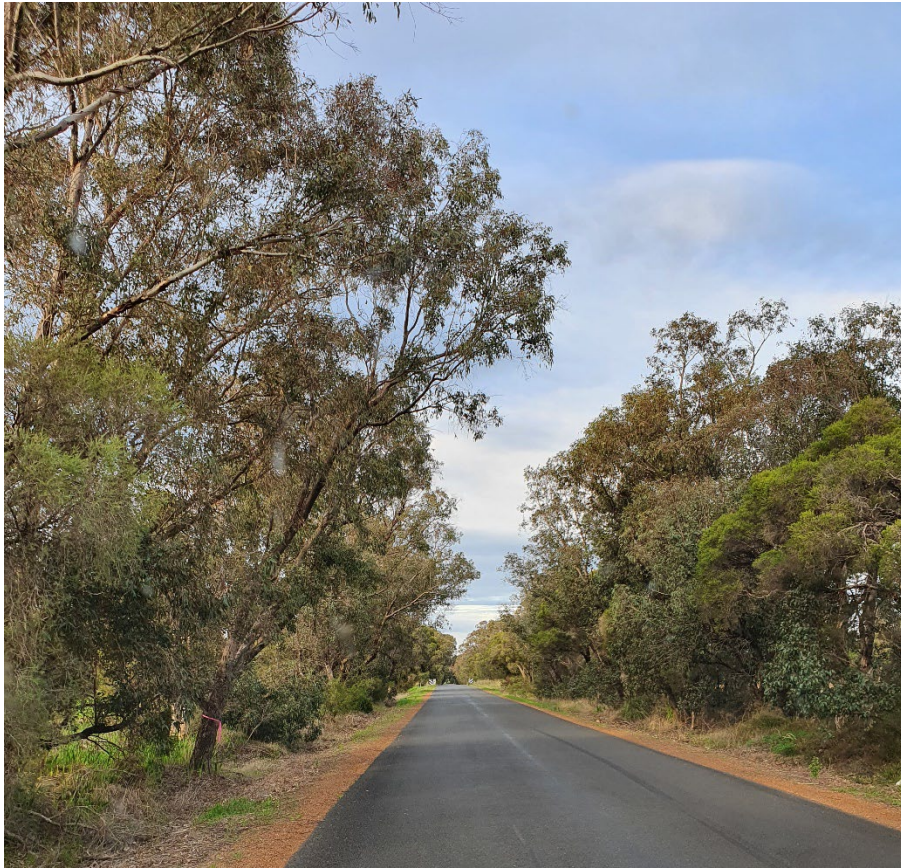
Tree ID	Direction	Location	Observations
5011	South	East Side	No visible signs of nesting or hollow points. Tree is growing within table drain which so the tree is naturally leaning towards the road.

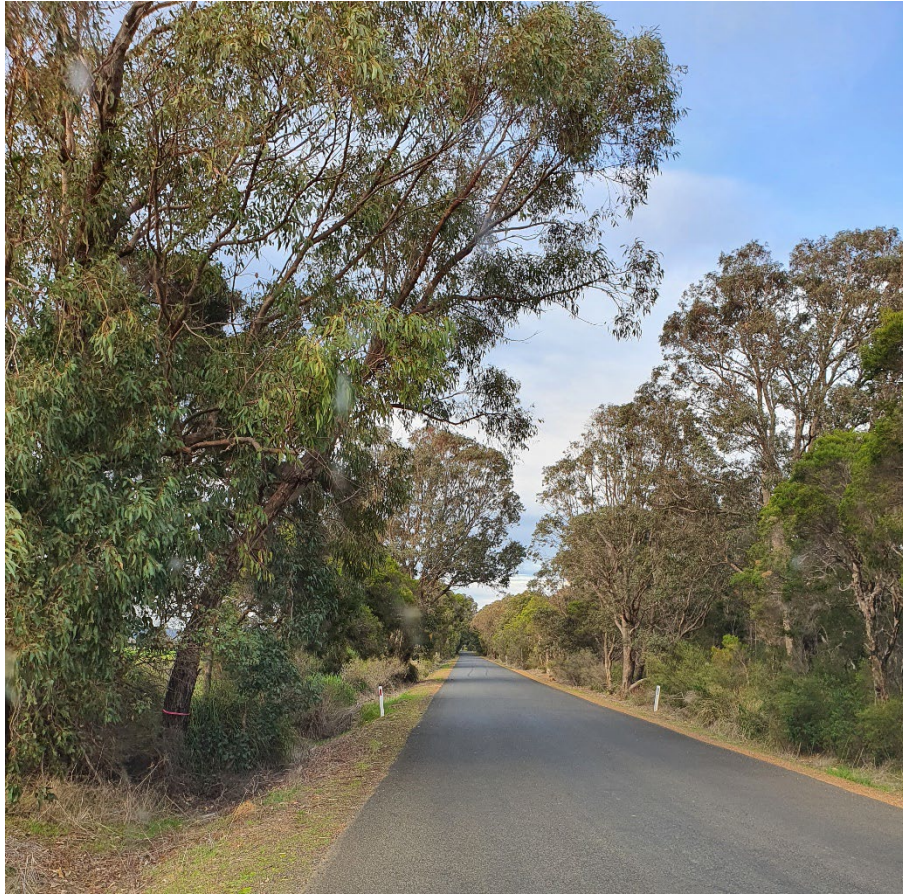
Tree ID	Direction	Location	Observations
5012	South	East Side	No visible signs of nesting or hollow points. Tree is growing within table drain which so the tree is naturally leaning towards the road.

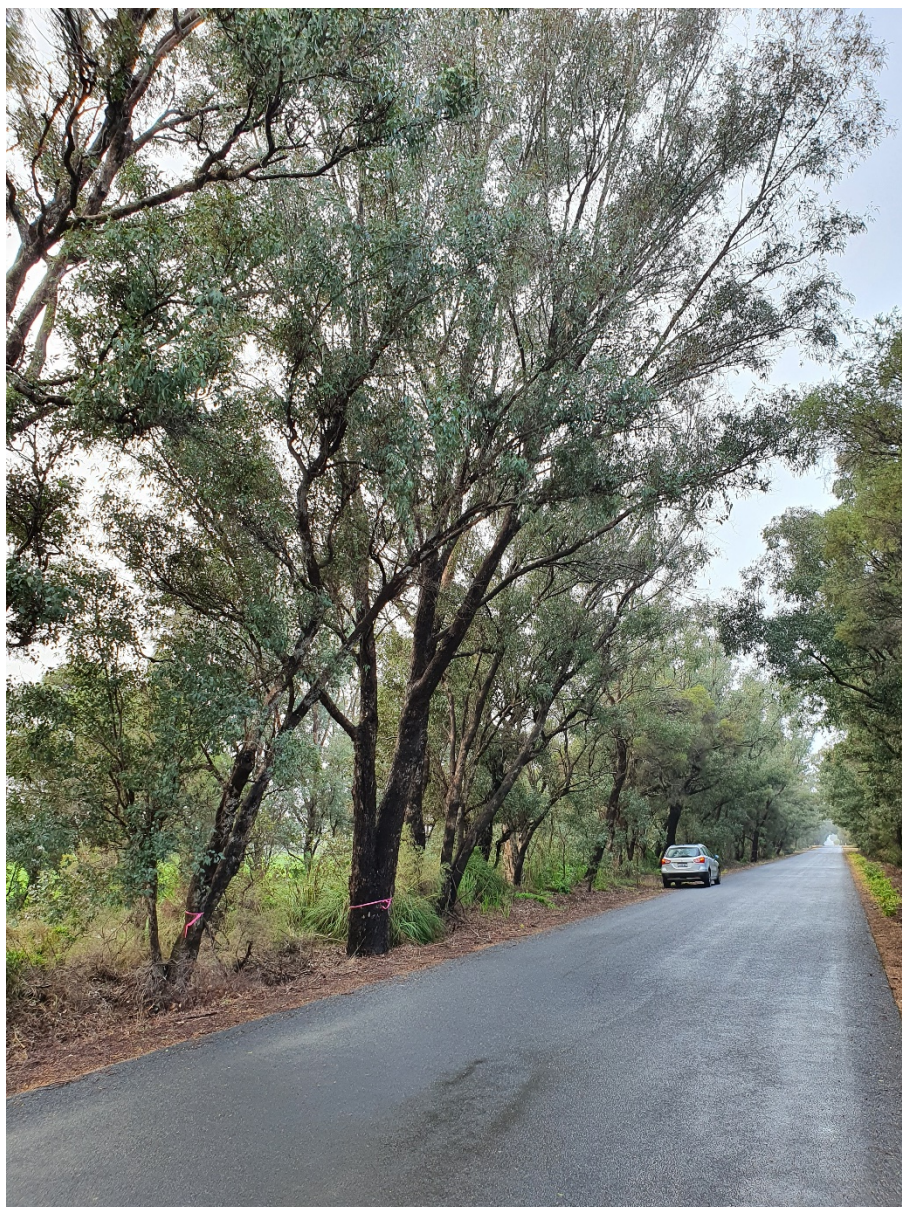
Tree ID	Direction	Location	Observations
5013-5014	South	West Side	No visible signs of nesting or hollow points. Tree is leaning towards road and is within 1m of the edge of seal.

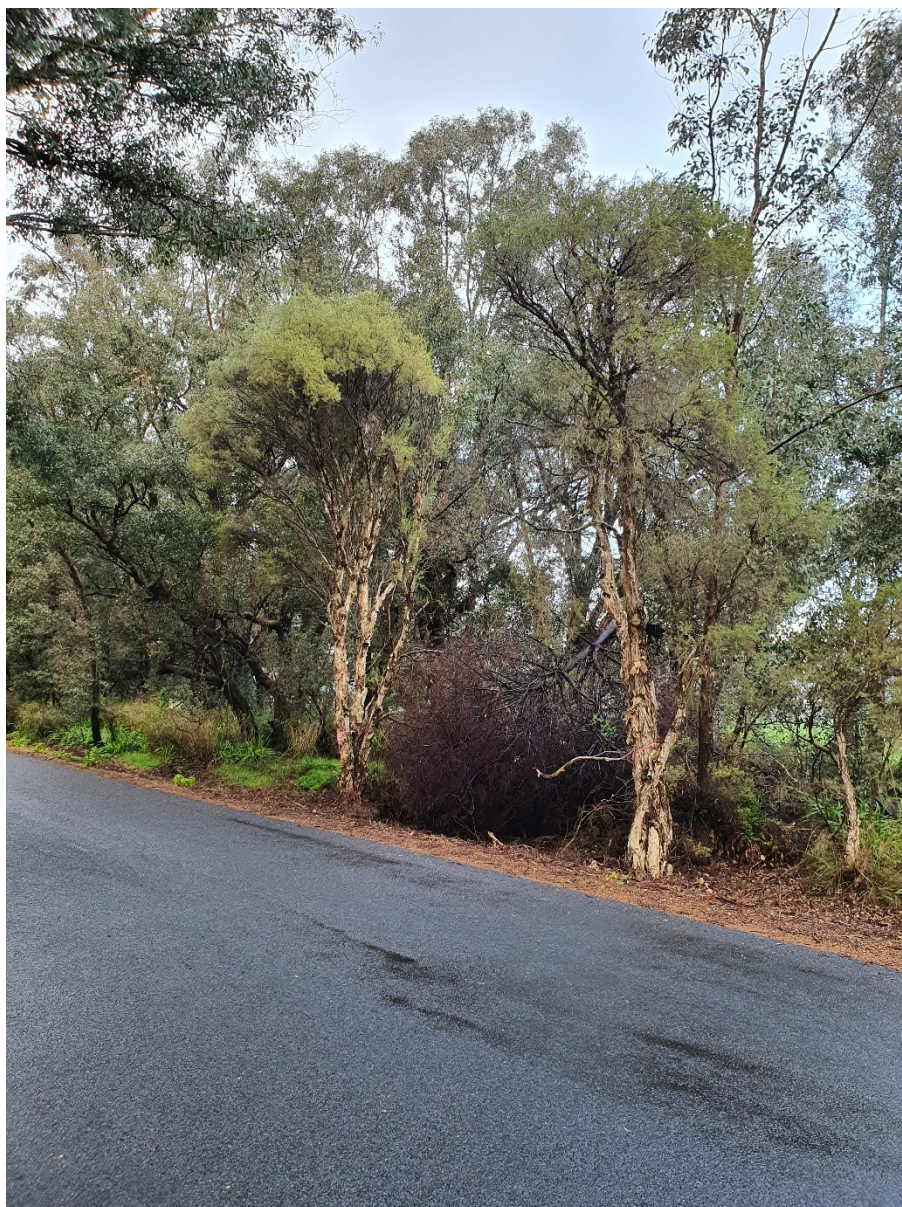
Tree ID	Direction	Location	Observations
5015 – 5016	South	West Side	No visible signs of nesting or hollow points. Trees are growing within the table drain.

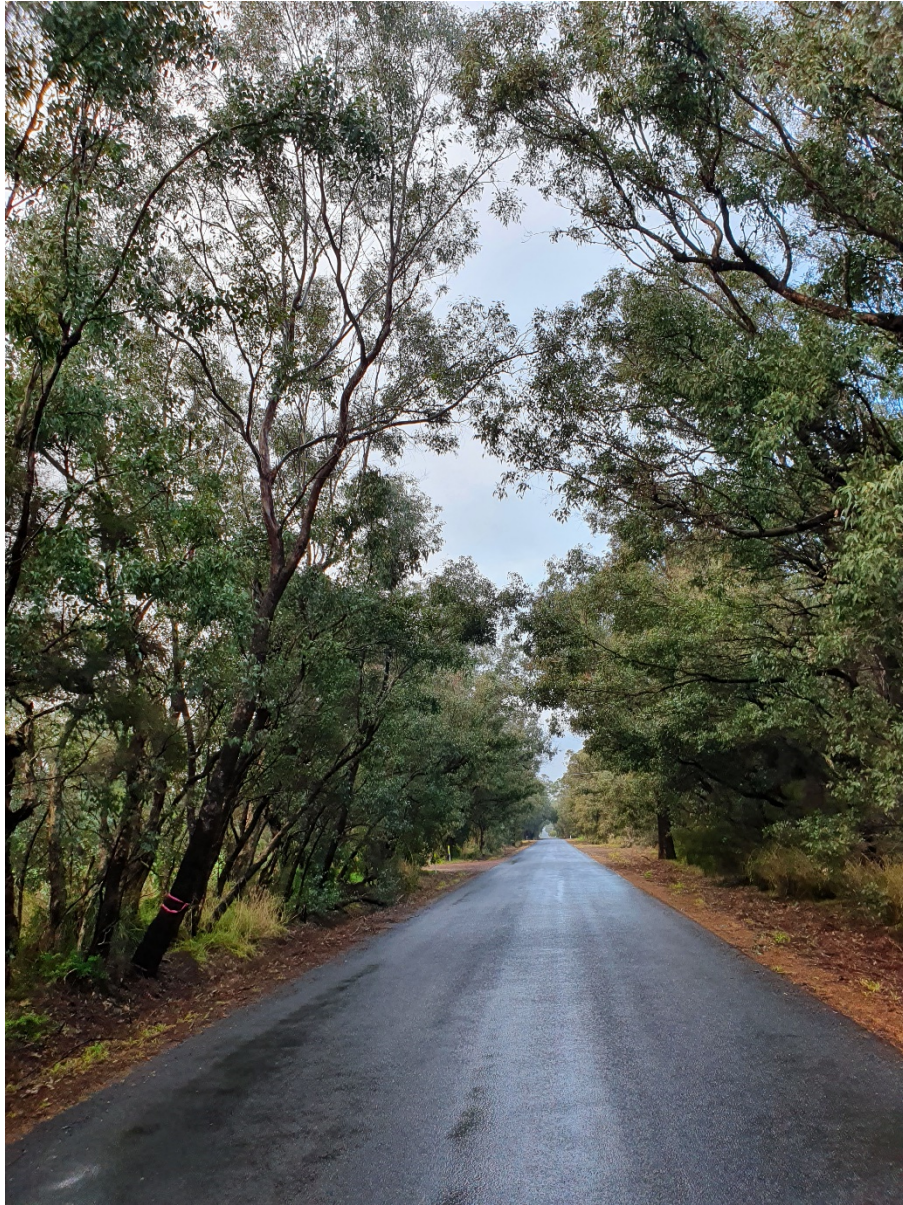
Tree ID	Direction	Location	Observations
5019	South	East Side	No visible signs of nesting or hollow points. Trees are growing within the table drain with canopy leaning towards the road.

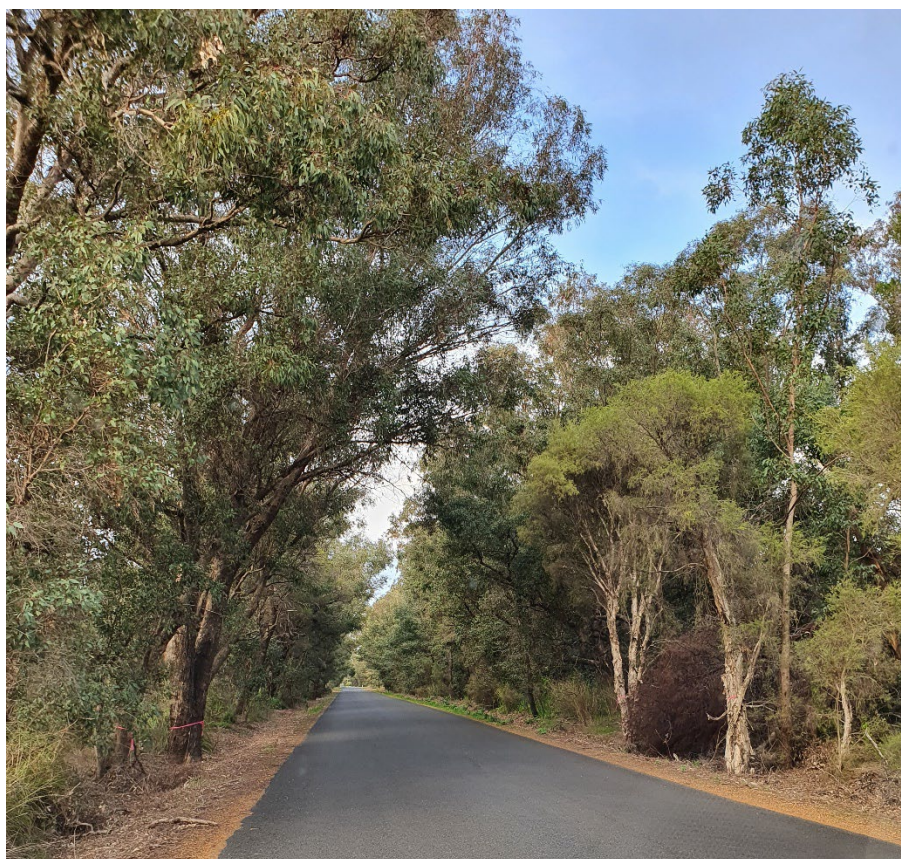
Tree ID	Direction	Location	Observations
5020 – 5021	South	East	No visible signs of nesting or hollow points. Trees are growing within the table drain with canopy leaning towards the road.

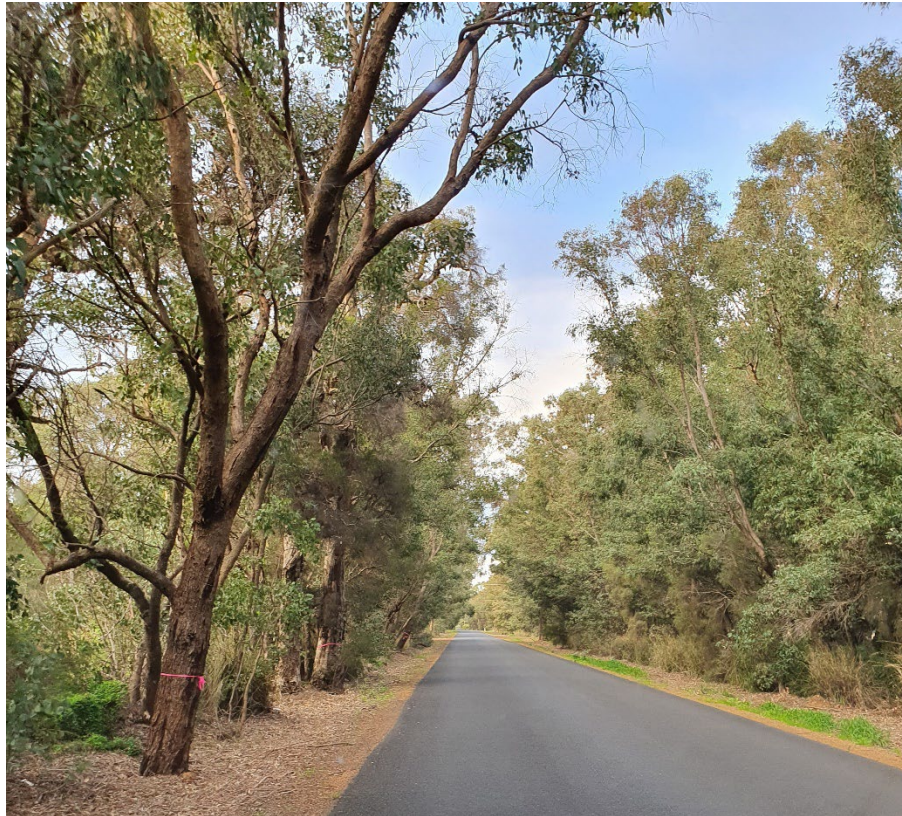
Tree ID	Direction	Location	Observations
5025 - 5026	South	East Side	No visible signs of nesting or hollow points. Trees are growing with a natural lean towards the road with substantial limbs being within the 6m height clearance.

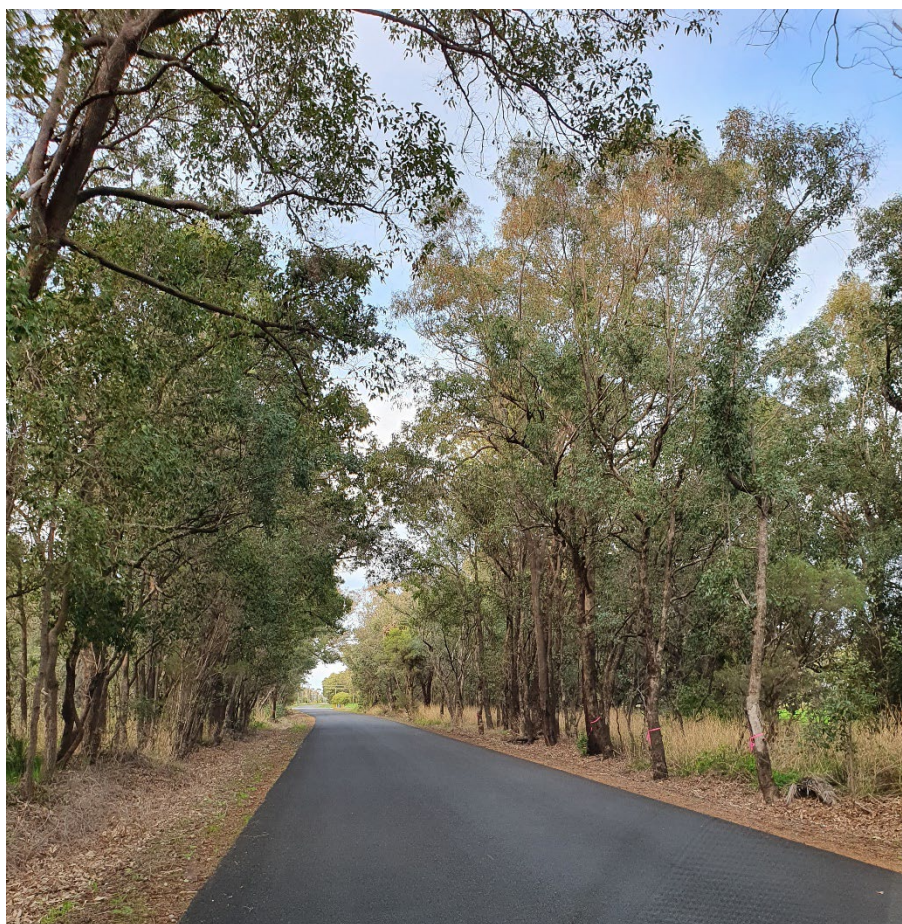
Tree ID	Direction	Location	Observations
5040 – 5044	South	West Side	No visible signs of nesting or hollow points and growing within 1m of the edge of seal.
