In 2019/20 the Shire of Waroona completed realignment works along Peppermint Grove Road between straight line kilometre (SLK) 1.7 to 3.4. The works, funded by the Australian Government Black Spot program, were designed to treat the causes of road accidents that had occurred along that section of road and focussed on the removal of road side obstacles and improvements to road geometry and carriageway width

2. Project Brief

The full report is appended. In item 2.3 of the RSA five mature *Corymbia Calophylla* trees have been identified as posing a risk in the event of a vehicle leaving the carriageway of the road. According to *Austroads Guide to Road Design Part 6 – Roadside Design Safety and Barriers (2010)*. With an estimated 85th percentile speed of 100km/h, curved alignment, flat batter slopes and less than 750 vehicles per day, the required clear zone is 5.5 metres. The trees identified in item 2.3 are less than two metres from the edge of the carriageway.

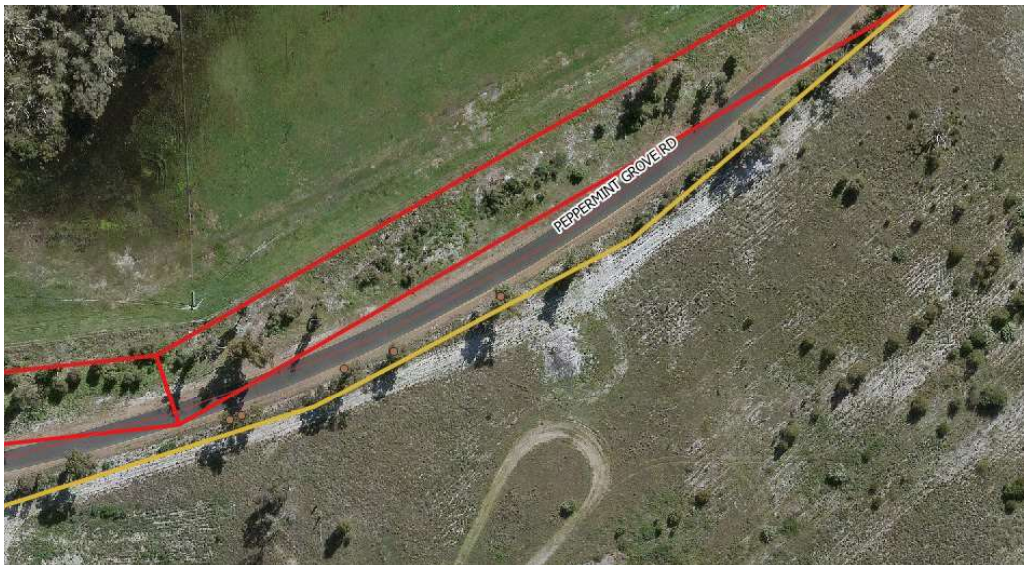
5. Aerial Map

The yellow line indicates the pending new boundary reserve boundary line.

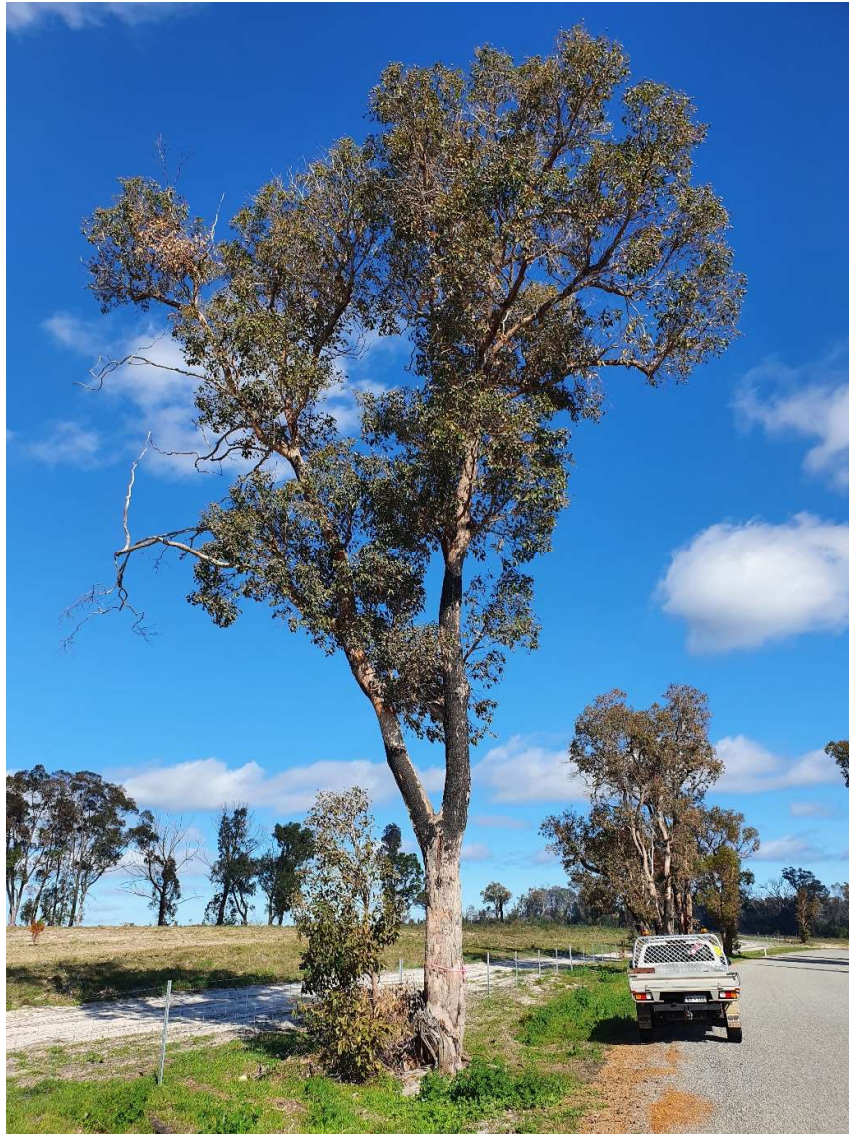
Tree ID	Description	Trunk (m)	Canopy (m)	Additional Information
5180	<i>Corymbia Calophylla</i>	0.6	12	Photo direction was taken in a western direction. No visible signs of nesting or hollow points.

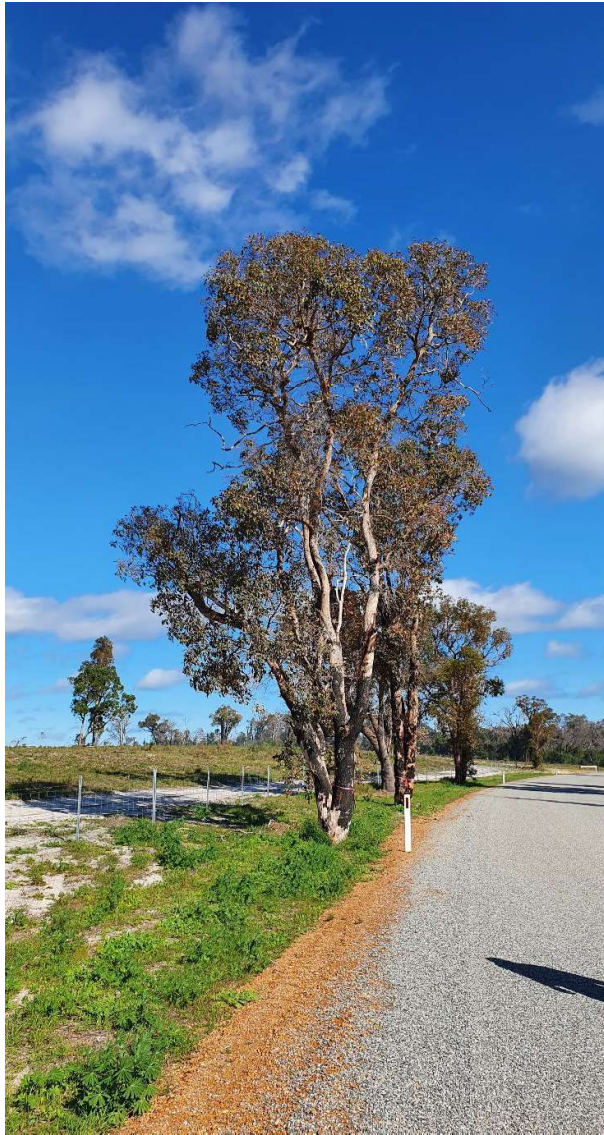
Tree ID	Description	Trunk (m)	Canopy (m)	Additional Information
5181	<i>Corymbia Calophylla</i>	0.6	12	Photo direction was taken in a western direction. No visible signs of nesting or hollow points.

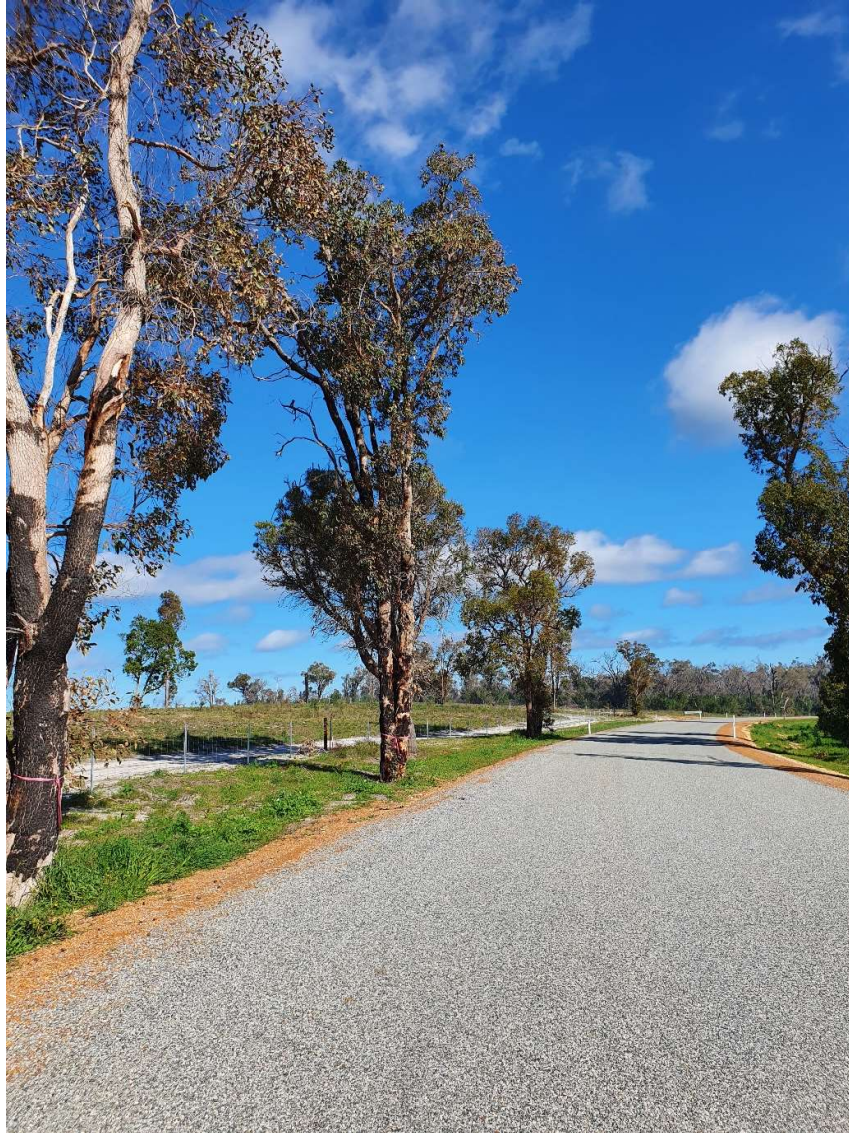
Tree ID	Description	Trunk (m)	Canopy (m)	Additional Information
5182	<i>Corymbia Calophylla</i>	0.6	12	Photo direction was taken in a western direction. No visible signs of nesting or hollow points.

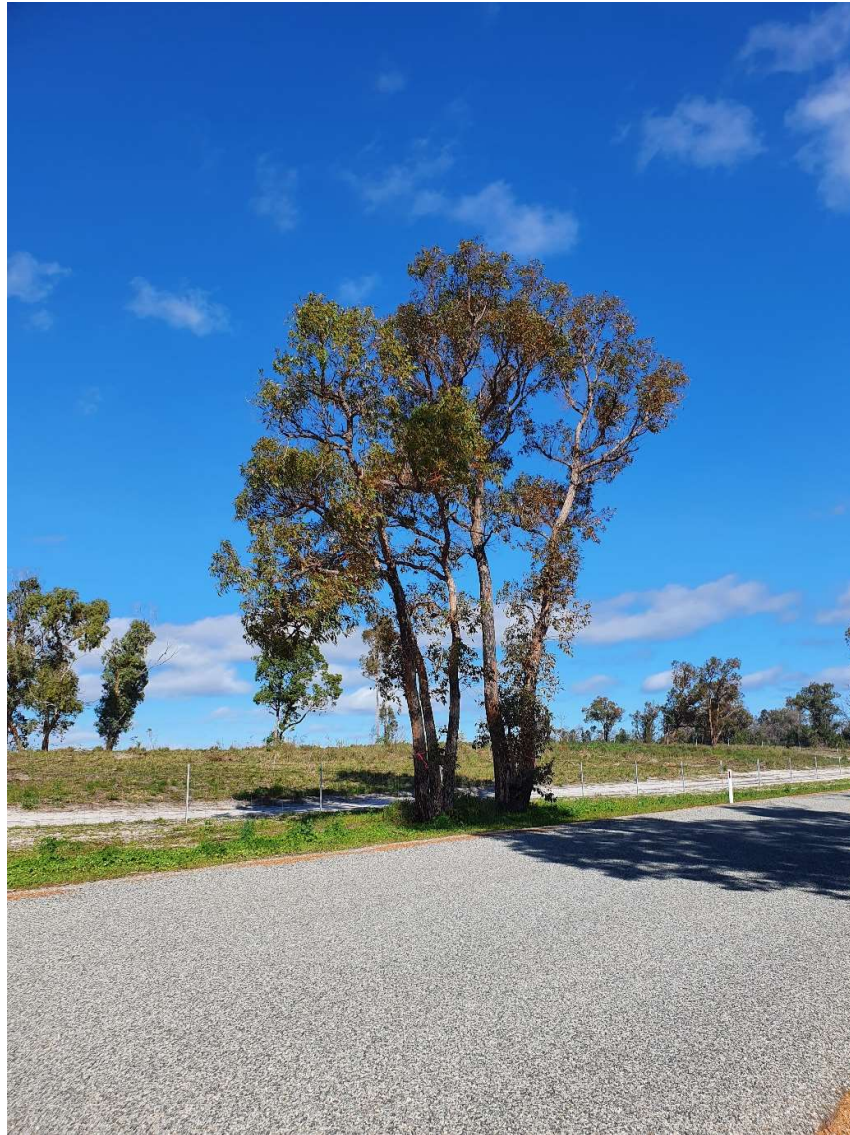
Tree ID	Description	Trunk (m)	Canopy (m)	Additional Information
5184	<i>Corymbia Calophylla</i>	0.4	8	Photo direction was taken in a south/ west direction. No visible signs of nesting or hollow points.
5185	<i>Corymbia Calophylla</i>	0.6	12	Photo taken in south/ west direction. No visible signs of nesting or hollow points.
