Application to Clear Native Vegetation – Supporting Information

Lot 56 Diagram 61012, Big Grove WA

Site Classification Report

Lot 56 Quaranup Road, Big Grove WA 6330

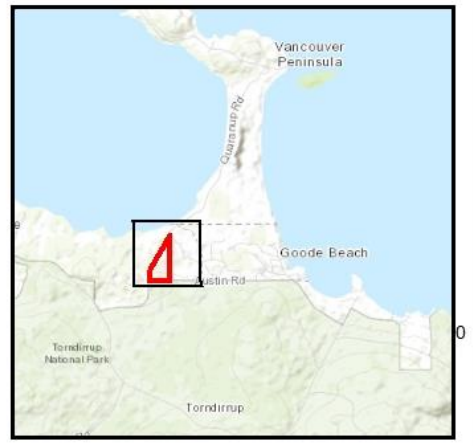
Figure 1: Site Assessment

A desktop assessment was conducted by Senior Hydrologist Chiquita Cramer to investigate the geological and hydrological conditions of the site to evaluate the potential impacts (in particular eutrophication) of the proposed clearing and land use on the surrounding environment. The Subject Site and the proposed clearing area are shown on Figure 1, attached.

Great Southern Geotechnics (GSG) conducted a geotechnical investigation on the 26th February 2021 at a proposed shed location within the Subject Site. GSG constructed three test pits to 1600mm depth, the approximate location of the three test pits is shown on Figure 1. Results of the investigation are documented in the Site Classification Report (Attachment 1), in summary the report showed that soils at the site consisted of (to slightly varying depths);

Surface water from the majority of the proposed clearing area drains in a north easterly direction towards Shoal Bay Retreat roadside drain. Shoal Bay Retreat roadside drain has been mapped by DWER as not connecting to any other waterway, roadside drainage network or Princess Royal Harbour as shown on Figure 1. This indicates that any surface water collected in the drain is likely to infiltrate, this conclusion is supported by the sandy flat nature of the area in which the drain is located.

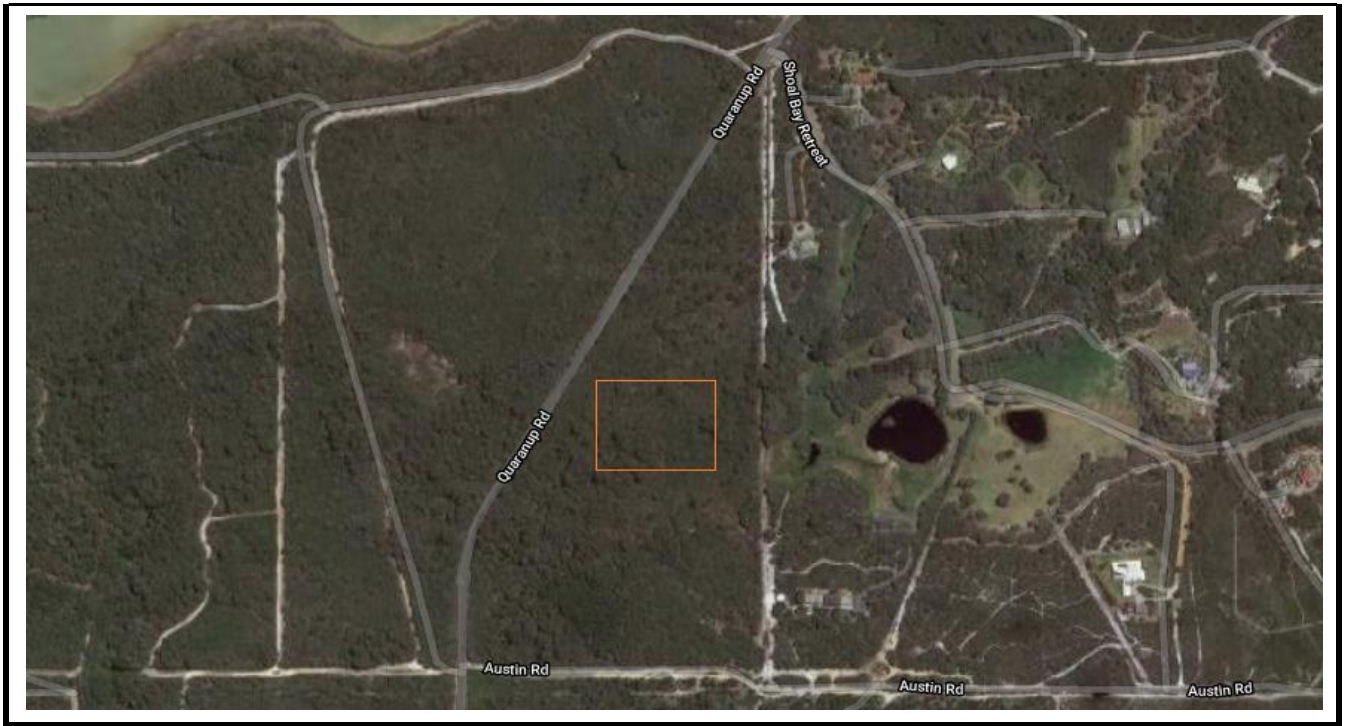
Figure 2 - Approximate Test Pit Locations

Site conditions and test pit locations were recorded and are shown in Appendix 1 .

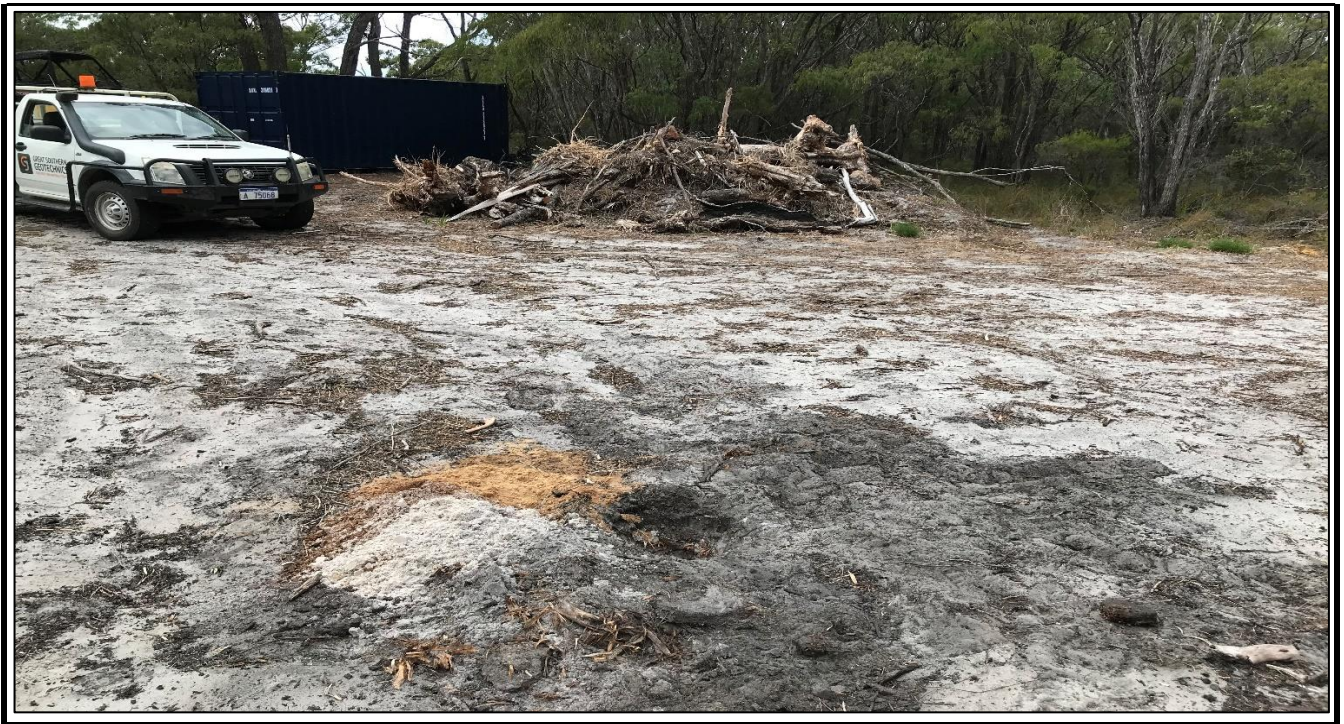
Test Pit No. 1 - Excavation

Depth Below Surface (mm)	Layer Depth (mm)	Material Description	Moist. Condition	Consistency / Strength	Cementation	Water Table	Classification Symbol	Sampler/Test
		SOIL TYPE, Plasticity, Colour, Particle characteristics, Secondary and other minor components						
0 - 250	250	(Topsoil) SAND with silt: Grey, fine to medium. Roots and root fibres.	D-M	L-M		No water table encountered.		
250 - 700	450	SAND with silt: White, fine to medium.	M	L-M				
700 - 1100	400	SAND: Brown, fine to medium.	M	L-M				
1100 - 1500	400	SAND: Yellow/cream, fine to medium.	M	L-M				
1500 - 1600	100	SAND: Light brown, fine to medium.	M	L-M

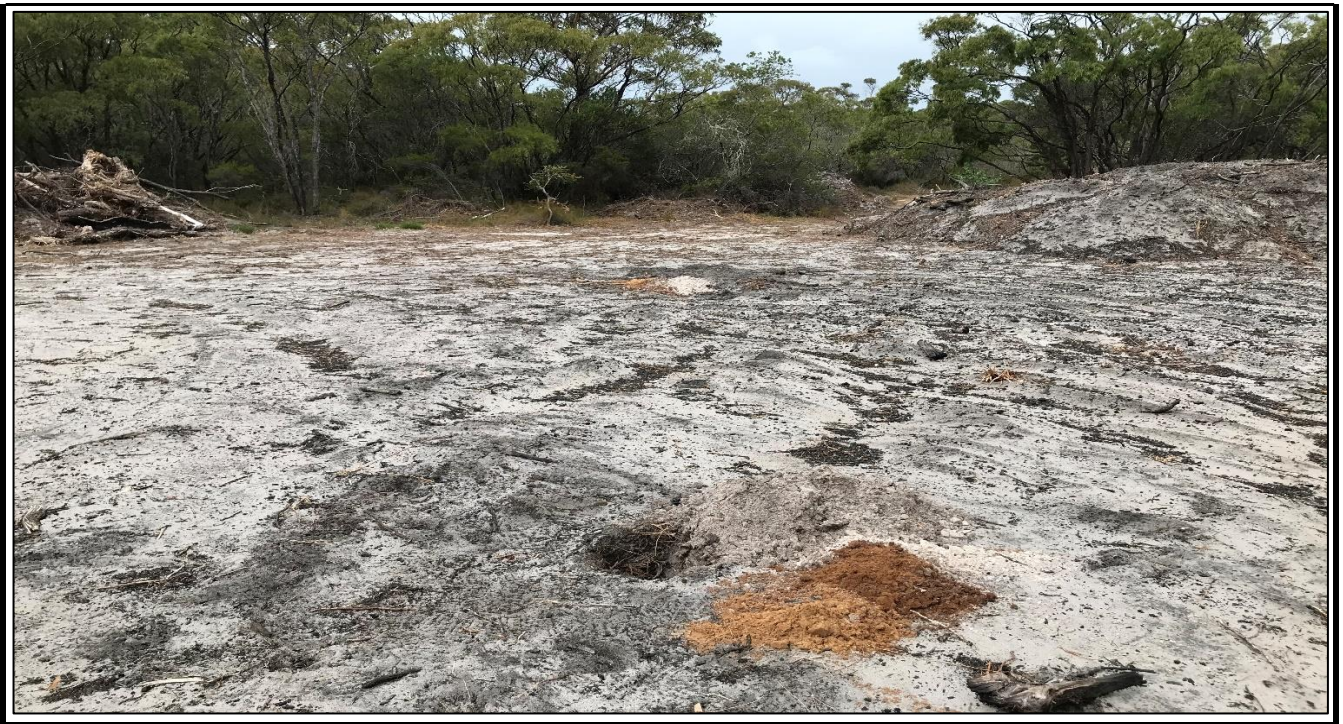
Test Pit No. 2 - Excavation

Depth Below Surface (mm)	Layer Depth (mm)	Material Description	Moist. Condition	Consistency / Strength	Cementation	Water Table	Classification Symbol	Sampler/Test
		SOIL TYPE, Plasticity, Colour, Particle characteristics, Secondary and other minor components						
0 - 400	400	(Topsoil) SAND with silt: Grey, fine to medium. Roots and root fibres.	M	L-M		No water table encountered.		
400 - 600	200	SAND with silt: Grey, fine to medium.	M	L-M				
600 - 1100	500	SAND: White, fine to medium.	M	L-M				
1100 - 1500	400	SAND: Brown, fine to medium.	M	L-M				
1500 - 1600	100	SAND: Yellow/cream, fine to medium.	M	L-M

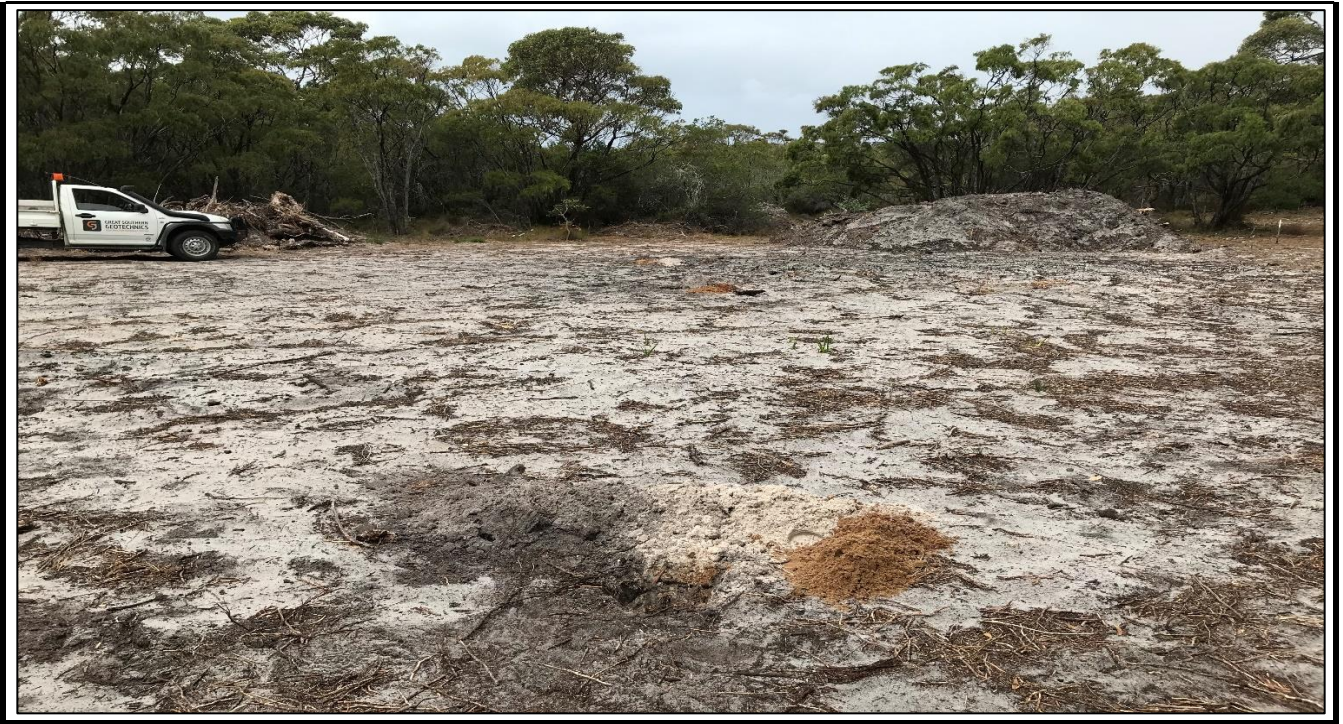
Test Pit No. 3 - Excavation

Depth Below Surface (mm)	Layer Depth (mm)	Material Description	Moist. Condition	Consistency / Strength	Cementation	Water Table	Classification Symbol	Sample/Test
		SOIL TYPE, Plasticity, Colour, Particle characteristics, Secondary and other minor components						
0 - 300	300	(Topsoil) SAND with silt: Grey, fine to medium. Roots and root fibres.	M	L-M		No water table encountered.		
300 - 800	500	SAND: White, fine to medium.	M	L-M				
800 - 1300	500	SAND: Brown: fine to medium.	M	L-M				
1300 - 1600	300	SAND: Yellow/cream, fine to medium.	M	L-M

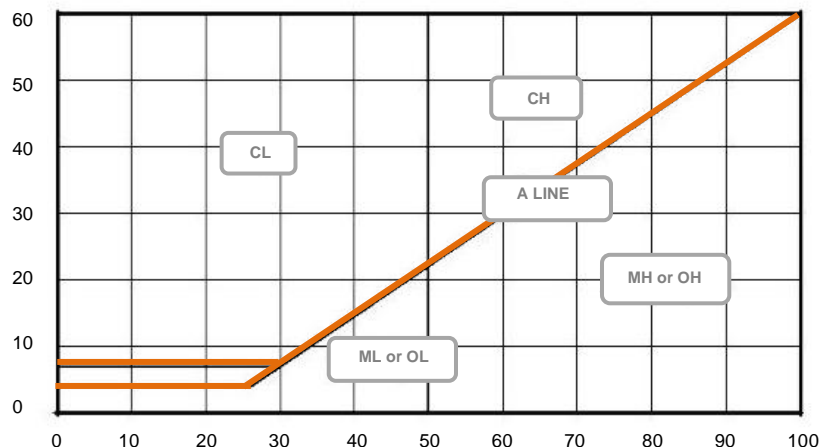
PLASTICITY CHART

For laboratory classification of fine grained soils
