NATIVE VEGETATION CLEARING PERMIT NINGALOO MARINE RESEARCH CENTRE

NOVEMBER 2020

NINGALOO MARINE RESEARCH CENTRE NATIVE VEGETATION CLEARING PERMIT APPLICATION

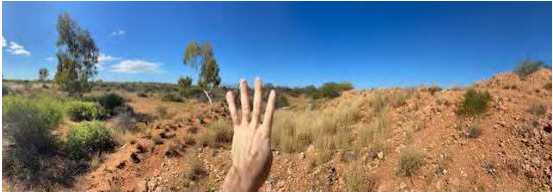
| Location | Photographs |
|--|--|
| Pipeline Easement (where alignment turns east away from Truscott Crescent) (right side of photo shows topsoil stockpile associated with development of Lot 848) | |

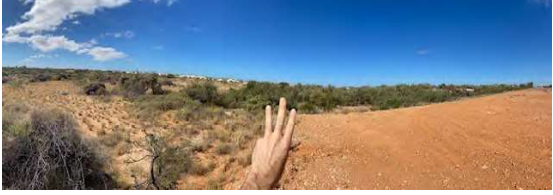
| Location | Photographs |
|--|--|
| Pipeline Easement (mid-point between Truscott Crescent and southern bore) (right side of photo shows topsoil stockpile associated with development of Lot 848) | |
