# COASTAL PLANNING AND ADAPTATION – CONCEPTUAL DESIGN REPORT

for Shire of Augusta Margaret River

**February 2020**

**Final Report**

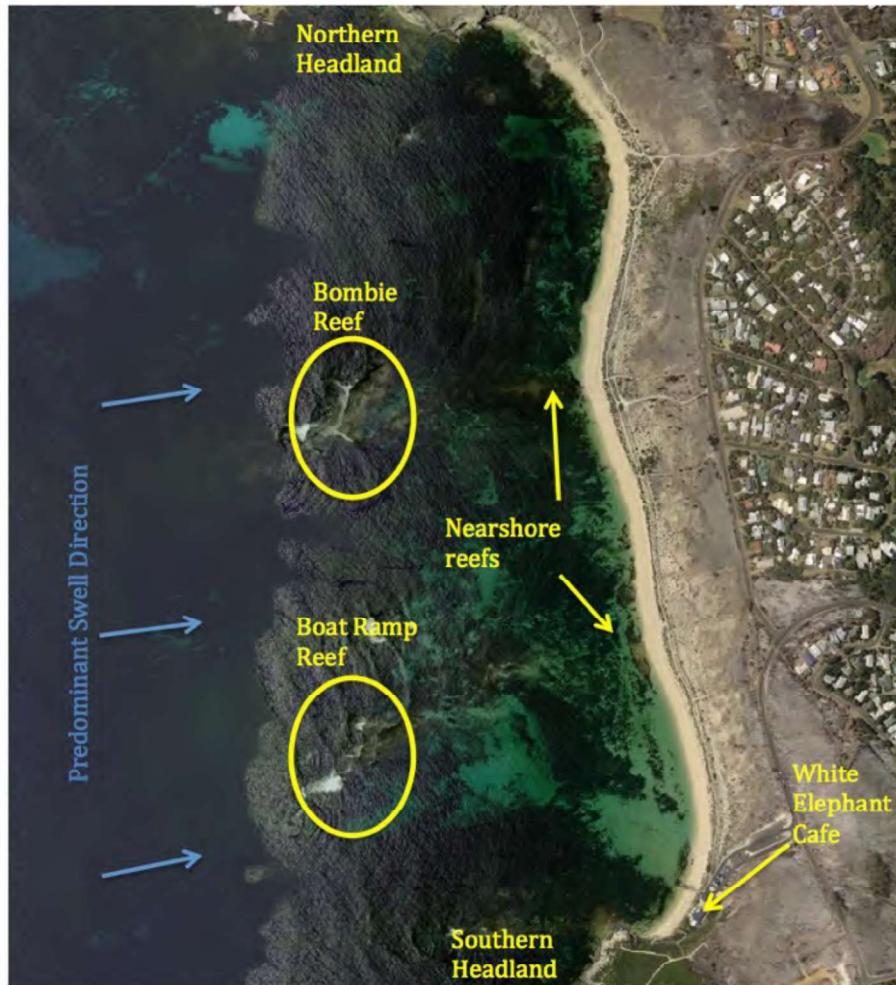
**Figure 2.1 Overview of Gnarabup Coastal Features**

Gnarabup and Prevelly Beaches are lagoon beaches, with local salient behind the Boaties and Bombies reefs (Figure 2.1). Three distinct bay beaches are evident.

As illustrated in Figure 2.1, there are a series of offshore and nearshore reefs and headlands that control the size and direction of the nearshore wave climate and any incident wave energy reaching the beach. UWA undertook a detailed monitoring campaign (1) of the wave climate inside and outside of the lagoon for a 15 month period in 2015/16 to understand the influence of the coastal features on coastal processes.

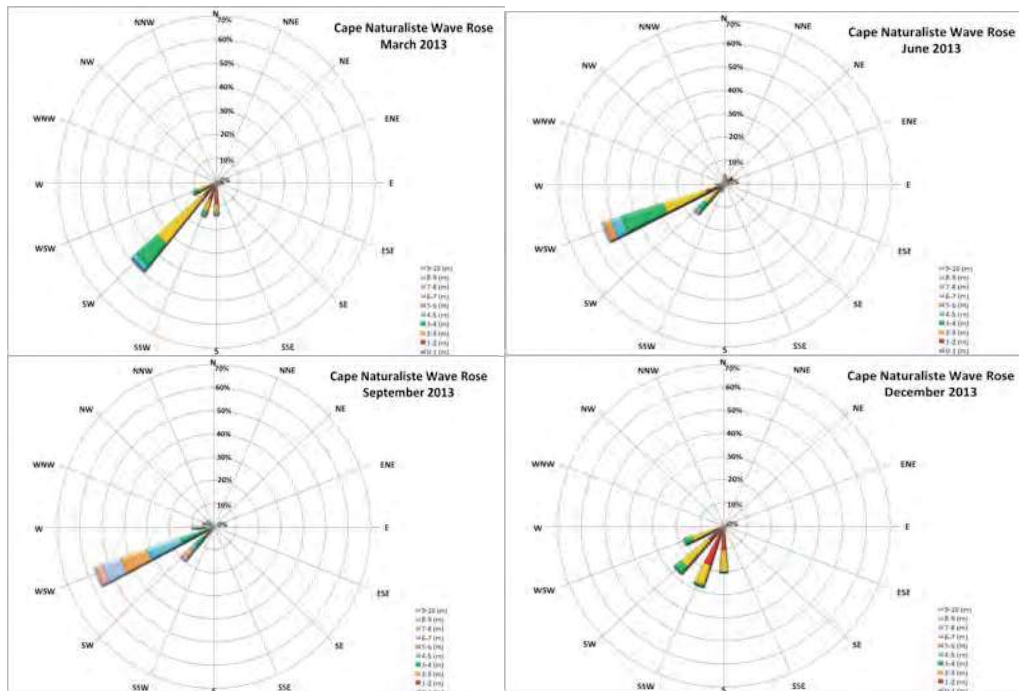
Figure 2.2 Seasonal Variability in Wave Conditions at Cape Naturaliste

Directional wave climate has been recorded offshore of Cape Naturaliste since 2010. Figure 2.2 illustrates how the wave climate varies seasonally; with southwesterly swells in autumn, larger west south westerly swells in winter and spring, and lower wave heights in summer.

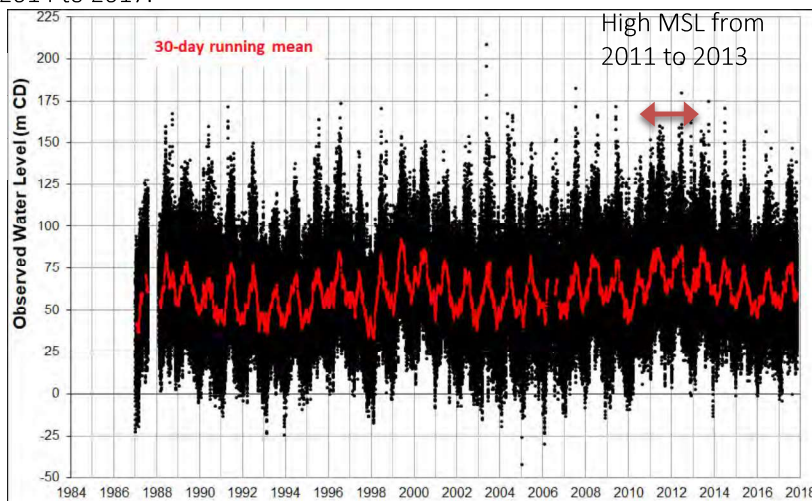
Figure 2.3 Time Series of Water Level from Bunbury Tide Gauge (1986-2017)

UWA undertook an analysis of the water levels at the site compared to incident wave height and wave heights within the lagoon. They outlined a strong correlation between wave heights in the lagoon and water levels. This showed that with higher water levels, more wave energy penetrated into the lagoon across the reefs. A time series of water level from Bunbury is shown in Figure 2.3. In particular it shows the high water levels from 2011 to 2013 associated with La Nina that suggests the beach may have been in a relatively depleted state prior to the September 2013 storms. There have been relatively typical water levels in recent years from 2014 to 2017.

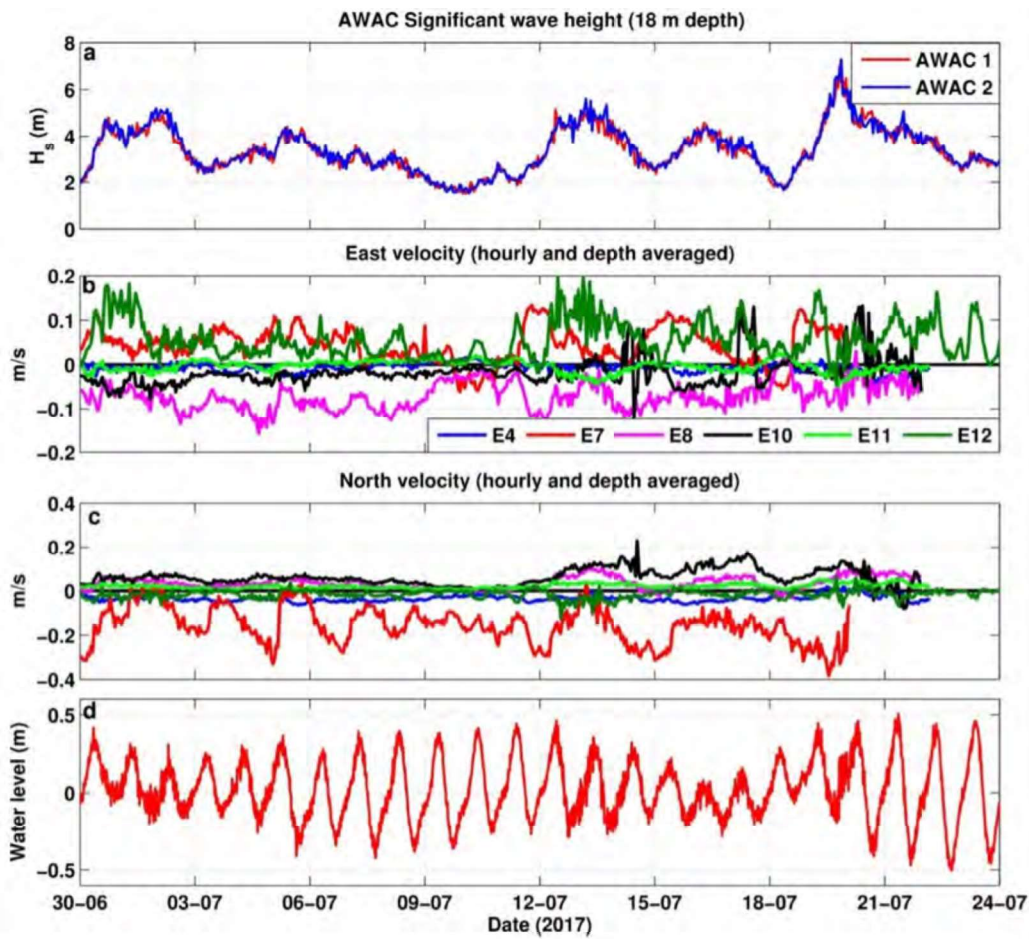
Figure 2.4 Gnarabup Lagoon - Nearshore Wave Heights, Current Velocities and Water Level in July 2017 (UWA)

Current direction was also measured and, for this deployment, showed that the onshore offshore current (east/west) was dominant and that there is only a small alongshore (north/south) component to the current in the nearshore. The strongest alongshore currents were measured inshore of the Boaties reef with up to 0.3m/s in a southerly direction. The strongest northerly current was measured in the vicinity of the removed access stairs, but was much lower at only 0.1m/s.

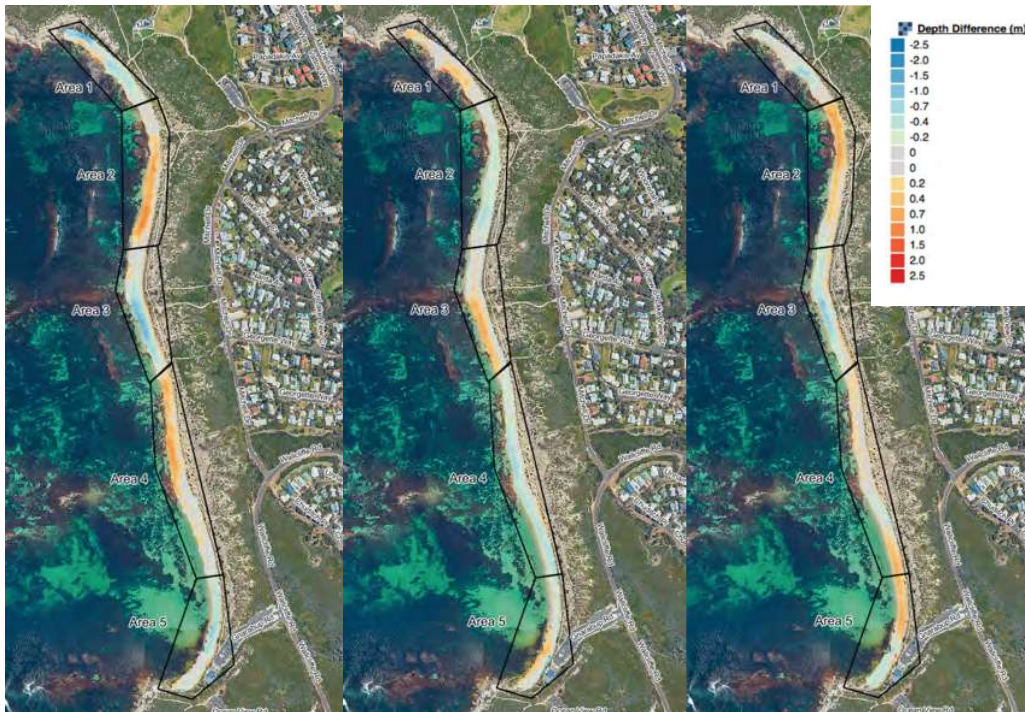
**Figure 2.6 Comparison of UWA Surveys February 2016 to September 2016 (left) September 2016 to February 2017 (middle) and February 2017 to August 2017 (right)**

The assessment split the bay into 5 areas to determine volumes of material moving along the coast. The splits in the areas were based on approximate boundaries between observed erosion and accretion in each difference plot.

The volumes of erosion and accretion observed are small (maximum 3,000m<sup>3</sup>) and generally balanced, suggesting either a closed system or a balance in material entering and leaving the system during the period surveyed. The last period assessed does show an imbalance with net erosion from the system, which may be a result of material moved offshore or alongshore to the north, providing a supply of sand to the perched beach at Surfers Point and the Rivermouth. It should be noted that only a very short period has been assessed so this pattern may only be representative of this period and assessment of a longer period would be needed to establish if a persistent seasonal pattern is present.

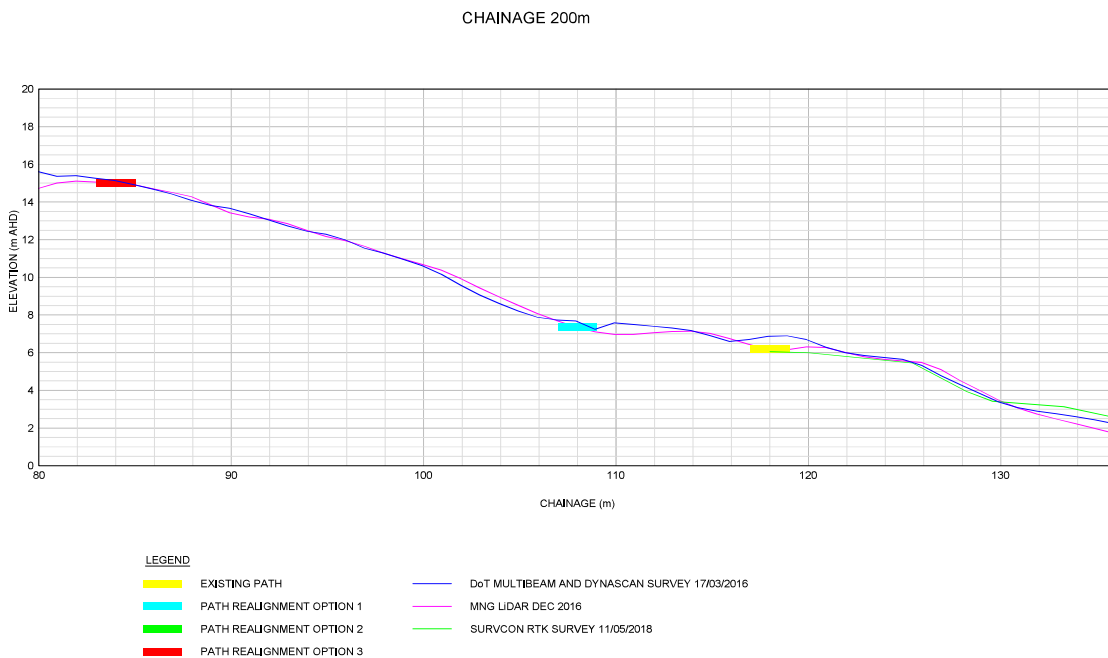
Figure 2.7 Cross-section at Chainage 200m Showing Comparisons of Recent and Historic Hydrographical and Beach Surveys.

In May 2018 a beach and hydrographical survey was undertaken to provide a comparison to historic surveys. This survey took cross-sections of the beach and nearshore to approximately 150m offshore of the Gnarabup and Prevelly Beaches (where there is coverage from the DoT March 2016 survey). Figure 2.7 shows a comparison of the recent surveys at chainage 200m along the path.

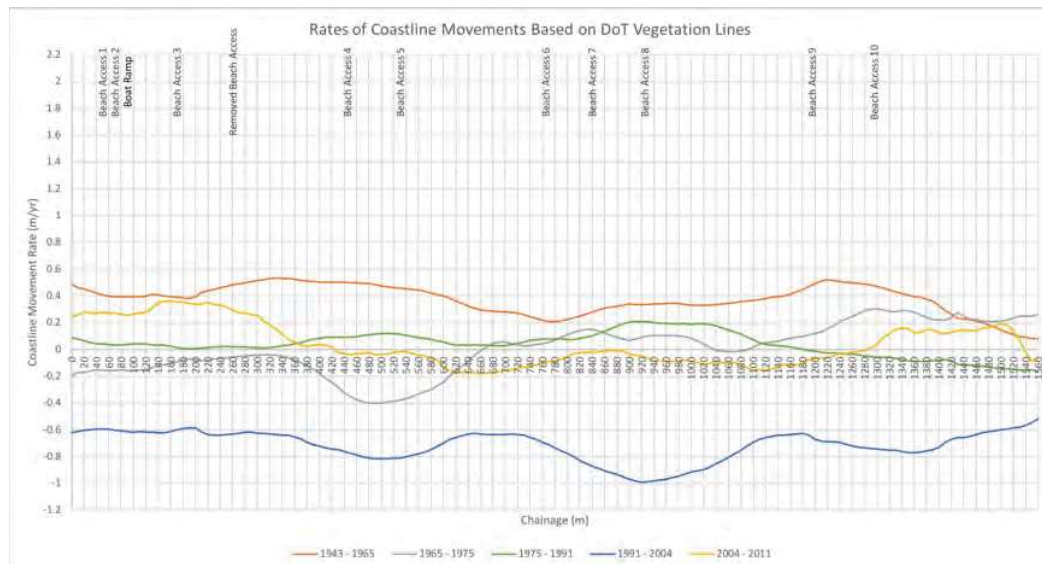
Figure 2.8 Rates of Coastline movement Based on DoT Vegetation Lines

The coastal demarcation lines have been assessed to determine rates of coastline movement over the period between the years when aerial imagery was available. The plot showing rates of coastline movement have been separated into the lines interpreted by DoT (Figure 2.8) and those interpreted by Shore Coastal (Figure 2.9). This is to reduce the potential for errors in the assessment due to different methods for interpreting the vegetation lines.

From interpretation of the DoT vegetation lines, between 1943 and 1965 there appears to have been a period of accretion of on average 0.4m/yr. Between 1965 and 1991 (over 25 years) there appears to have been a period of relative stability with coastline movements generally less than 0.2m/yr on average. Between 1991 and 2004 there appears to have been a period of relatively rapid erosion over the whole bay with erosion rates of between 0.6m/yr and 1m/yr.

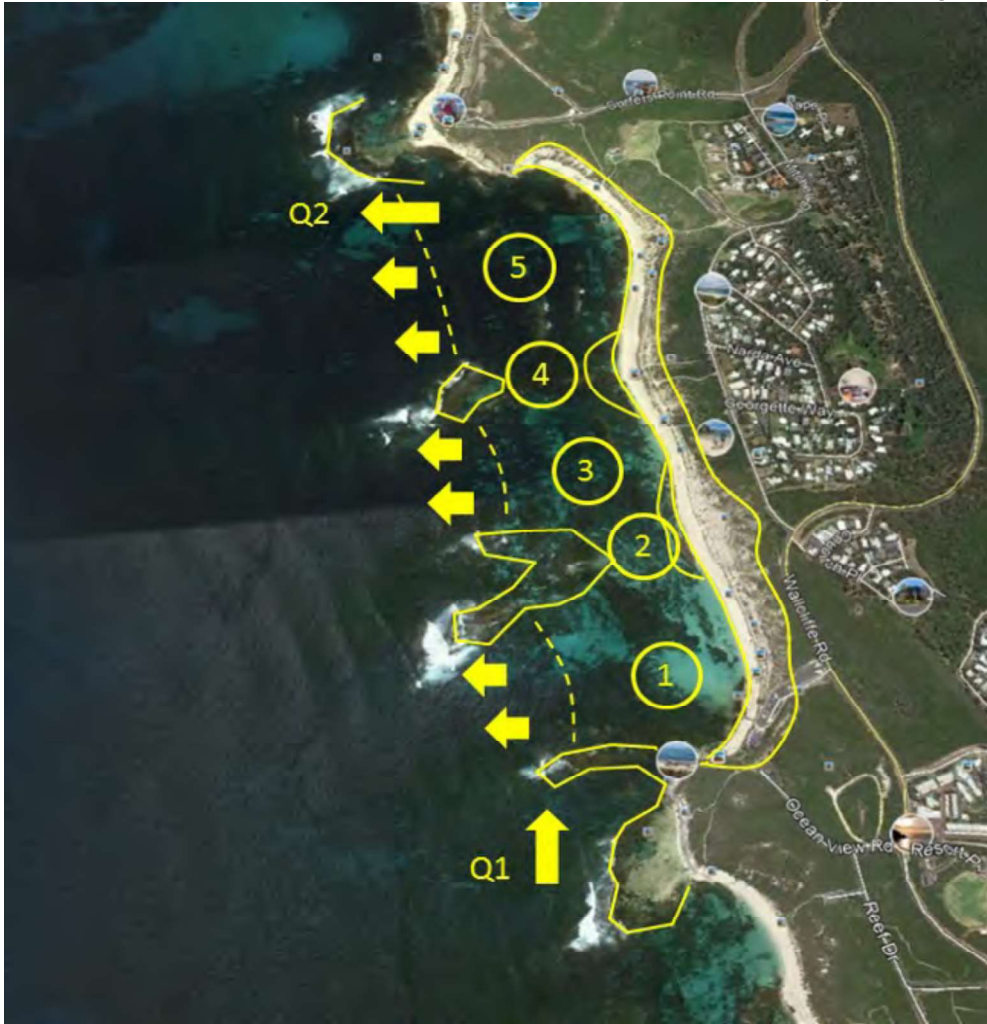
Figure 2.11 Conceptual Model of Gnarabup Beach

A conceptual model of coastal processes is provided in Figure 2.11, which identifies key landforms including Gnarabup Beach (1), Boaties Salient (2), Prevelly Beach (3), Bombie Salient (4) and Riflebutts Beach (5), with Q1 representing incoming sand and Q2 loss of sand from the local sediment cell, smaller arrows represent loss of sand through offshore transport due to currents between the reefs.

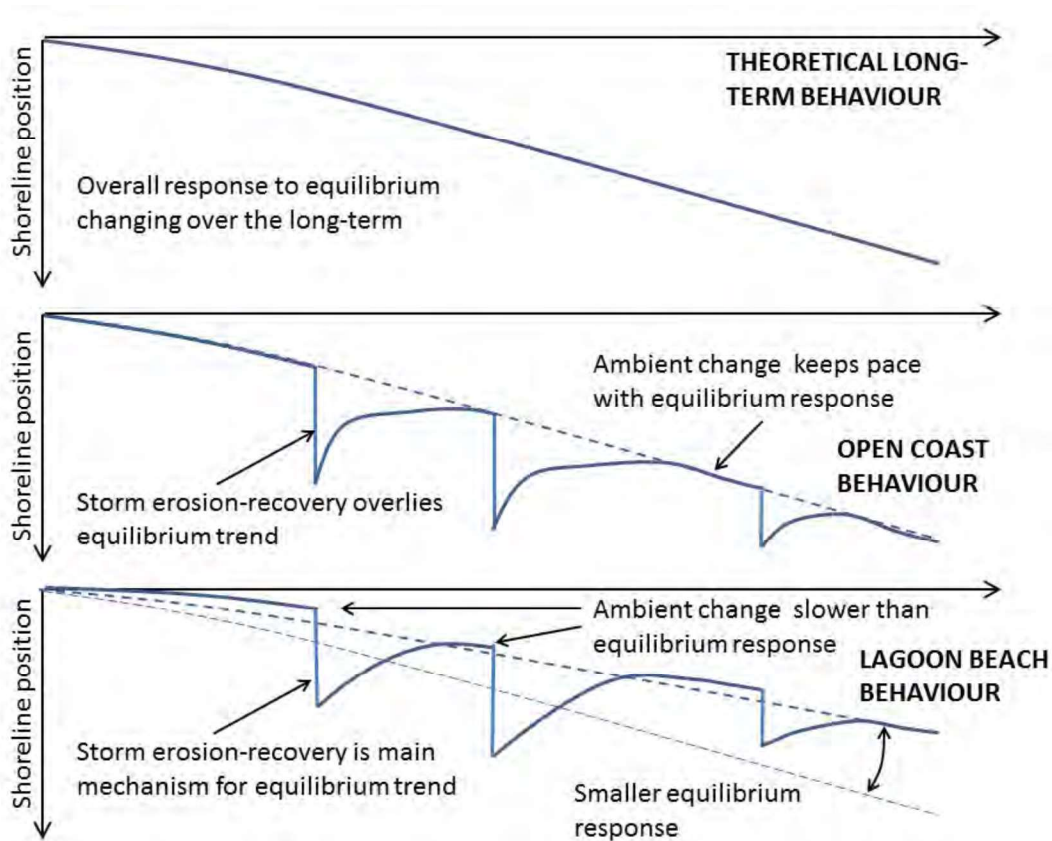
Figure 2.14 Long-term Response to SLR

Long-term behaviour of the lagoon beach differs from the theoretical response to sea level rise due to both the smaller ratio of response and the greater importance of storm-events to provide permanent cross-shore sediment transfer. This means that storms act as the main mechanism to drive change towards an ‘equilibrium’ position, rather than providing short-term cycles of erosion-recovery overlying a long-term trend.

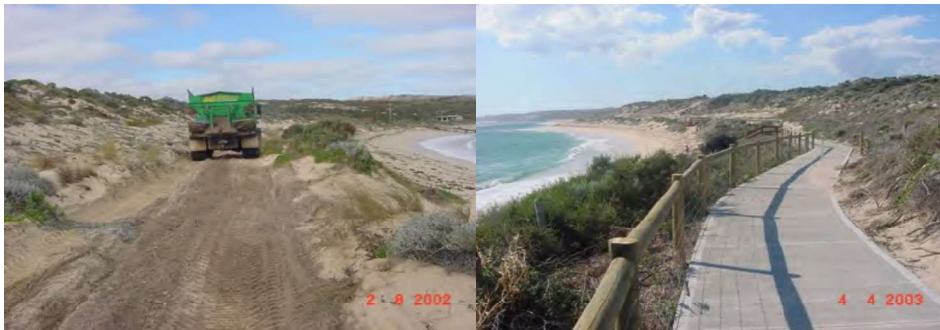
**Figure 3.1 Coastal Walkway during construction in 2002 (L) and following installation of concrete path and fencing in 2003 (R).**

In the 16 years since the construction of the walkway, erosion of the beach, incipient dunes and the front face of the foredunes has occurred. The crest of the eroded and steep foredune is now immediately adjacent to the coastal walkway in some locations along the southern section of the path.

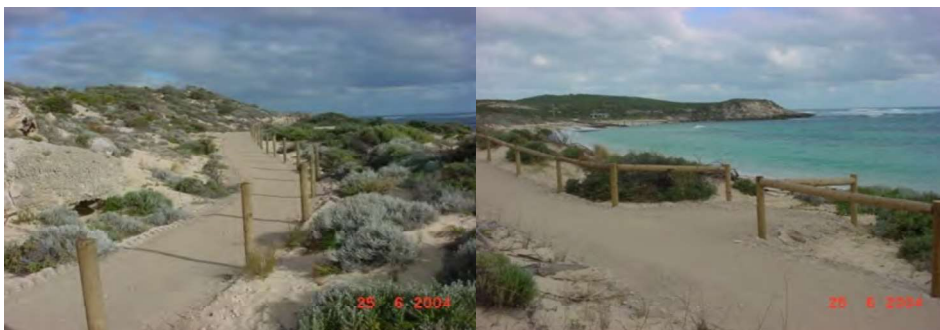
**Figure 3.2 Coastal Walkway Stage 2 & 3 Constructed in 2004.**

Subsequent stages of the coastal walkway construction north towards Rifflebutts Reserve were constructed as compacted limestone further from the coast, with short sections of path providing a number of beach access points along the path. This northern section of the path requires maintenance of wind blows sand across the path but does not have the same issues with coastal erosion due to increased setback and the relative stability of the adjacent beach in recent years.

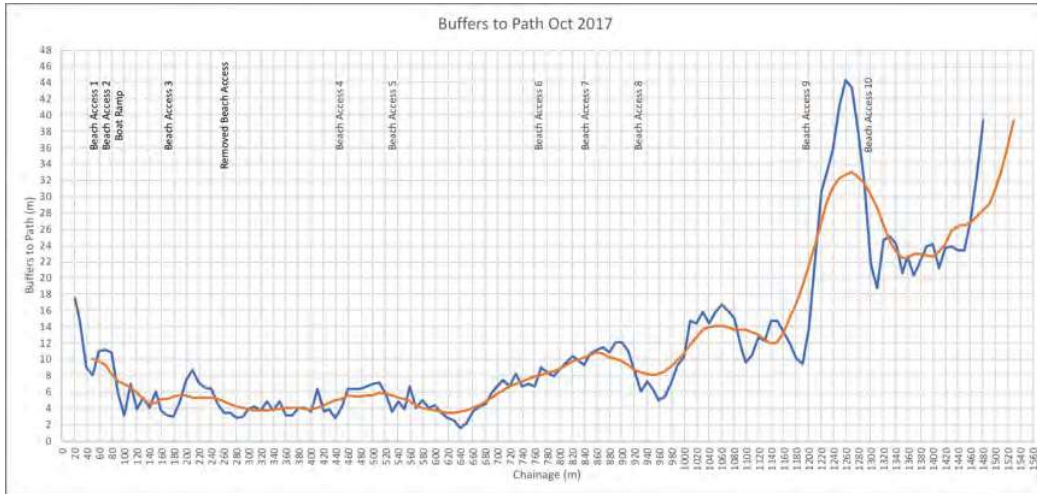
Figure 3.3 Distance Between October 2017 Vegetation line and Path

Assessment of the latest aerial image shows how the buffers between the vegetation line and the path vary between the White Elephant and Riflebutts (Figure 3.3).

The proximity of the vegetation line to the coastal walkway was outlined in Figure 3.3. As discussed previously, the observed coastal behaviour is complex with an underlying historic erosion rate in the order of 0.15 to 0.30m/yr. However, aerial photographs suggest foredune erosion of 4 meters can occur in a stormy year, with variable rates of recovery. Sections of the southern end of the path remain vulnerable to immediate storm damage from year to year, in particularly from Ch100-700m, a 600m section of the path from the Gnarabup carpark north to Prevelly.

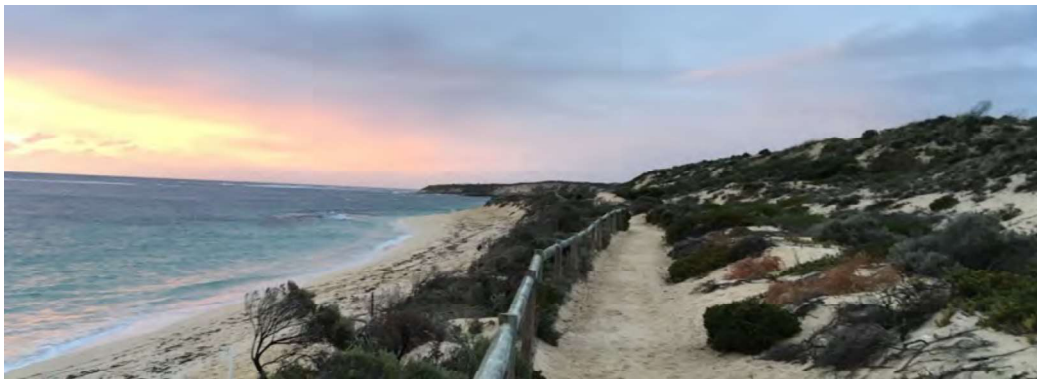
Figure 3.4 Photo Illustrating Narrow Buffer to Path

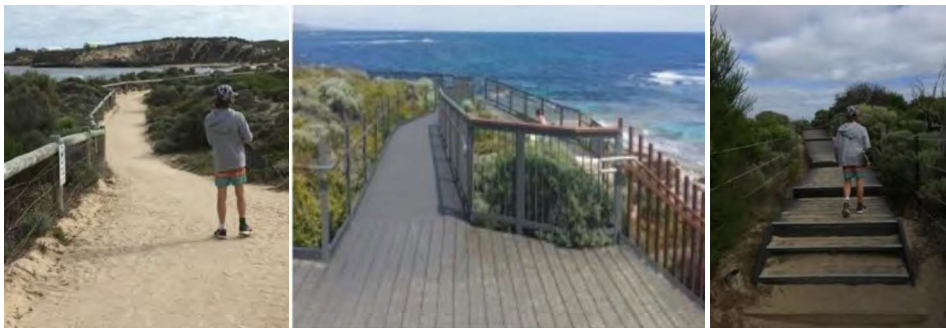
Figure 3.6 Walkways types including compacted limestone, boardwalks and boardwalks over dunes incorporating stairs.

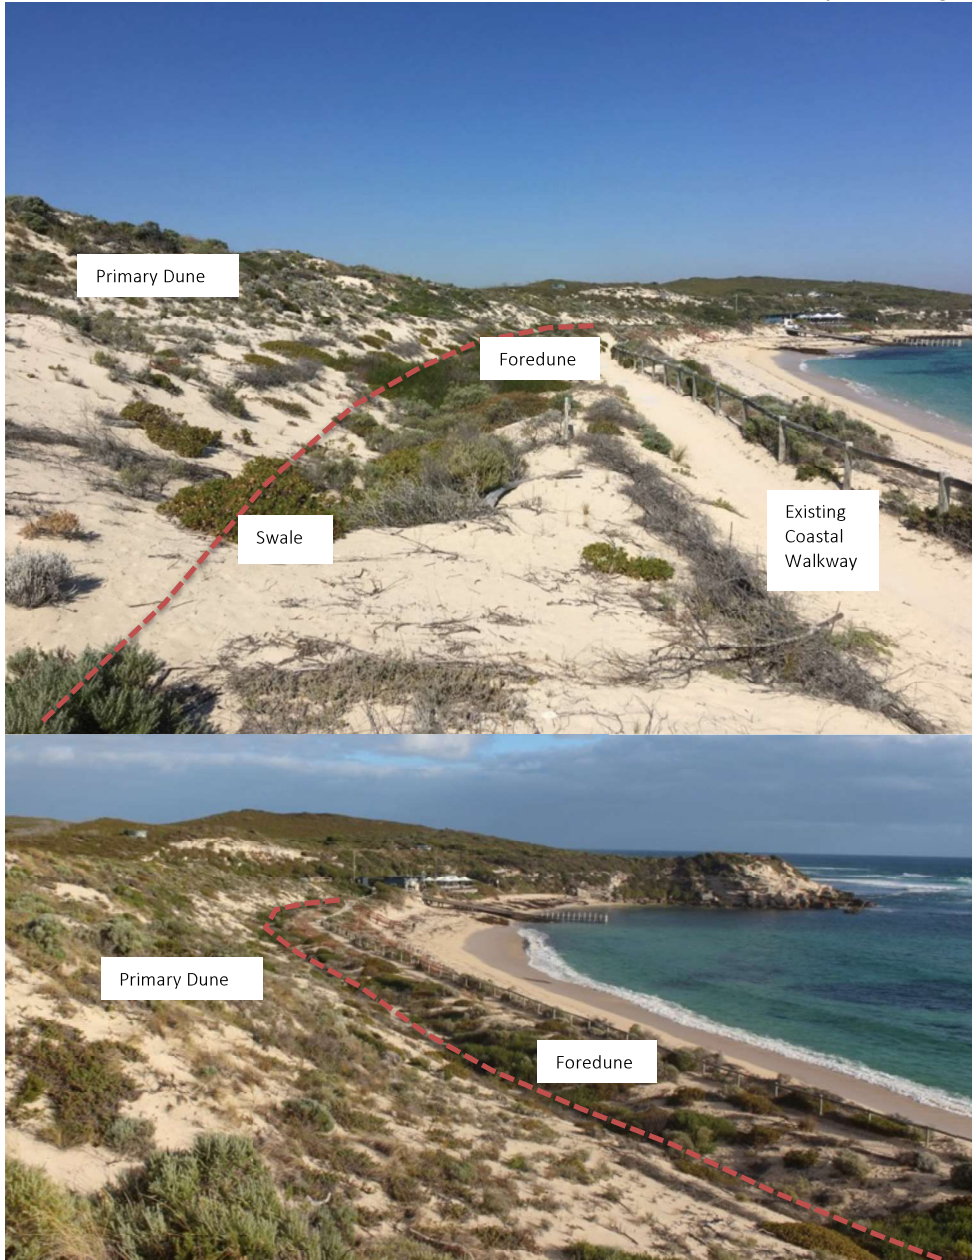
Figure 3.8 Limestone Path Alignment (Option 1) along Back of Swale

- g) Existing path to Riflebutts. There are no proposed changes to the path alignment north of Georgette Way to Riflebutts Reserve. However, the foredune 100m north of the Narda Ave access track should be monitored and the path re-aligned in this section in the future if required.

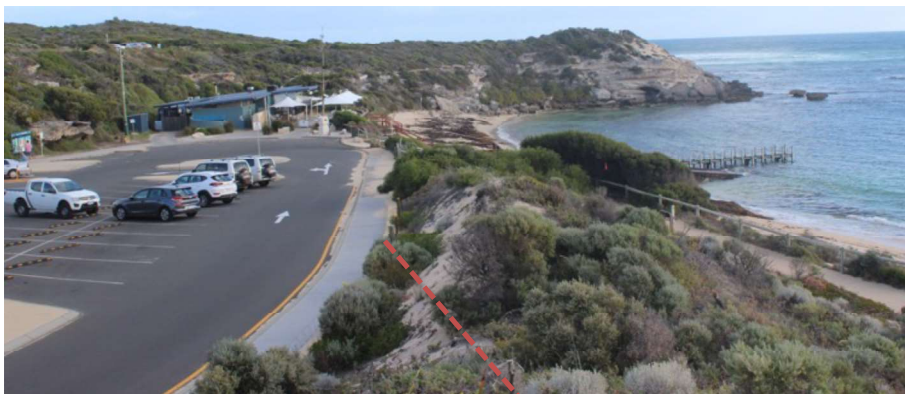
Figure 3.10 Options 1a and 2a cross the Dune Ridge adjacent to the Carpark

From chainage 200 onwards this option is the same as option 1.

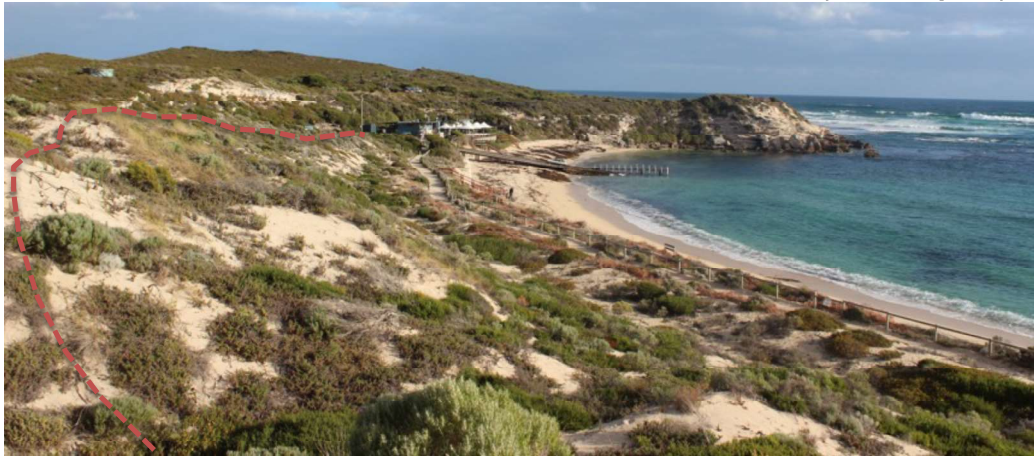
Figure 3.12 Option 3 - Nominal Alignment of Dune Ridge Path for Option 3

This option assumes the existing coastal walkway is removed and replaced with a boardwalk along the ridge of the primary dune. Beach access would be limited to the southern end of the Gnarabup beach and north of the Wallcliffe Rd access track.

From chainage ~440m northwards, the proposed path would be the same as Options 1 & 2.

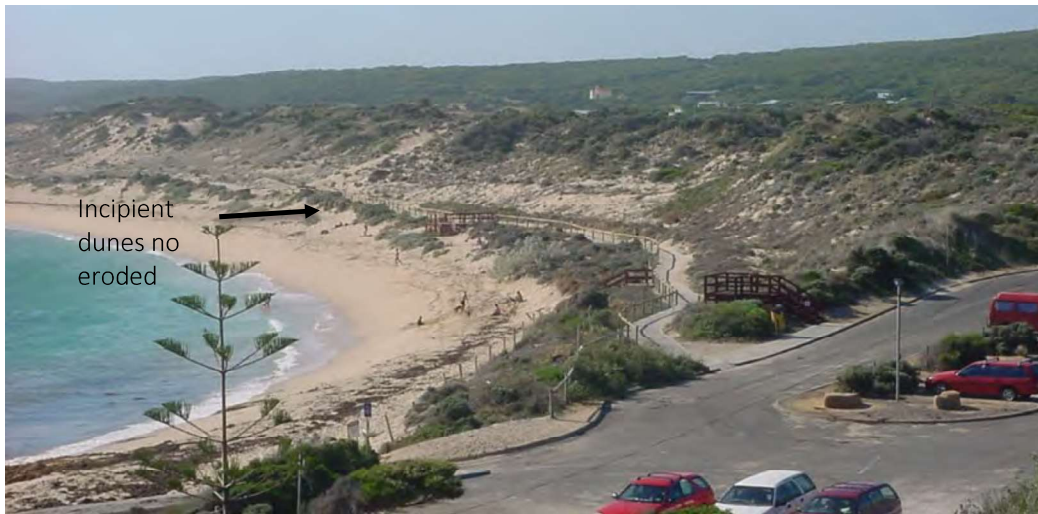
Figure 3.13 Gnarabup Beach April 2013. Note Incipient Dunes in front of recently removed Beach Access.

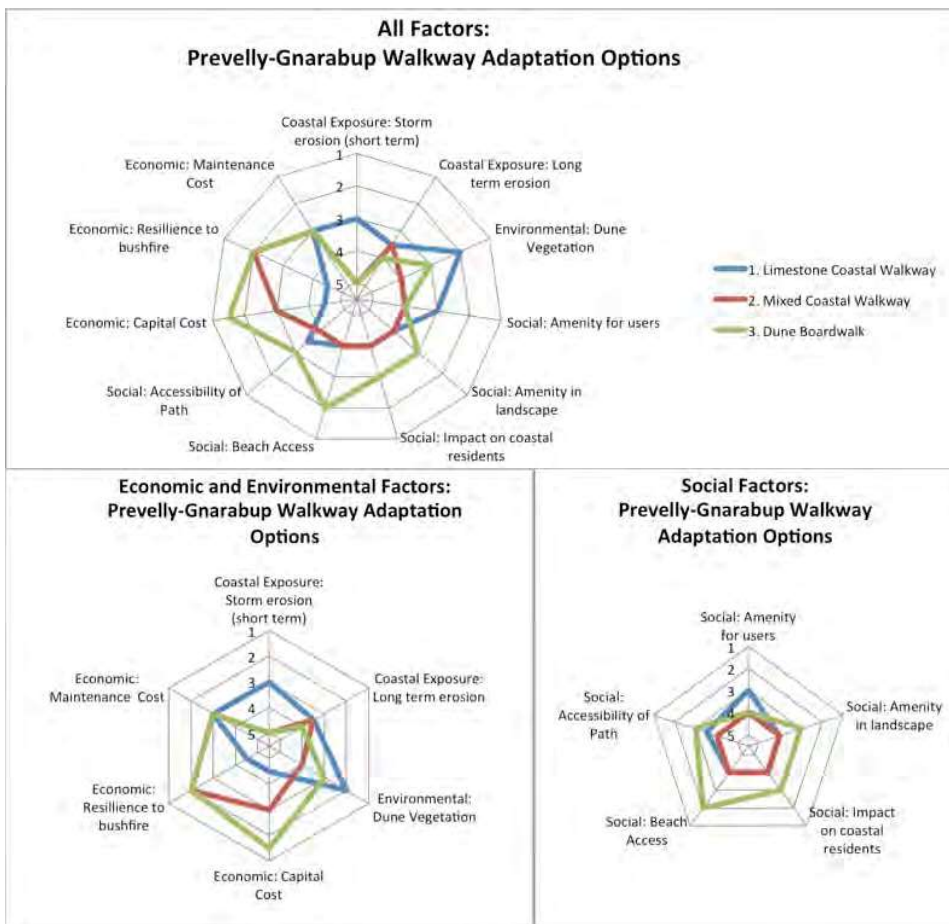
Figure 3.15 Multi-Criteria Assessment of Path Options

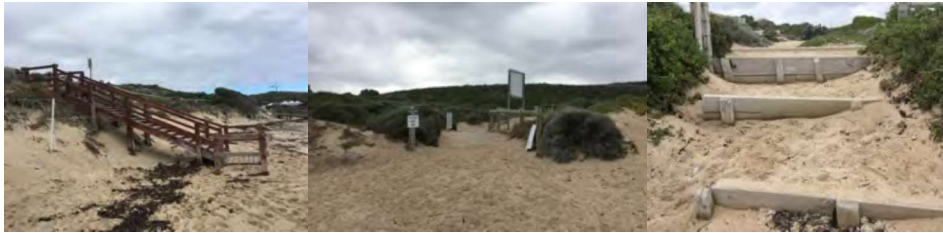
**Figure 4.1 Beach Access Types including Timber Stairs (L), Retained Timber (C) and Sand Access (R).**

- Timber stairs at the southern end of Gnarabup Beach. These provide access across a relatively steep, eroding foredune to the beach.
- Retained timber stairs at Prevelly Beach. These provide access across a wider, flatter and lower foredune to the beach
- Sand access through dunes at Riflebutts. These provide access though the foredune to the beach.

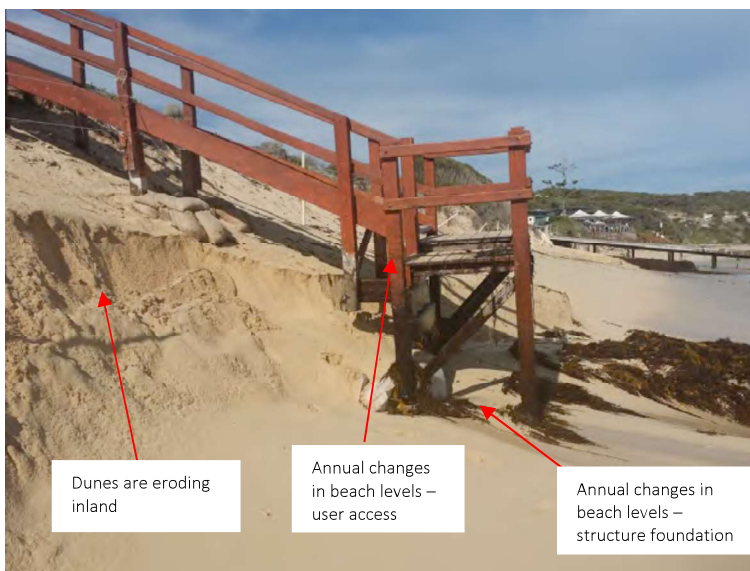
### STAIRS

Stairs require a stable foundation in order to remain structurally sound. In other words, the base of the stairs needs to remain unchanged. This can be achieved either through:

- “Protection”, i.e. provide a system to ensure the foundation is protected from the effects of wave erosion (this system was used for some years for the stairs at “Removed Access chainage 260”, but eventual demolition was necessary) or
- “Accommodation” which is the more common method, generally in the form of lengthening the support members so that they are founded BELOW a level where the beach level erodes to (the “design level”).

Design must accommodate BOTH the annual beach levels AND the movement of the primary dune inland, for beach access as well as for the structural foundation. Selection of levels will be affected by the design life for which the stairs are to be serviceable (five years, ten years etc).

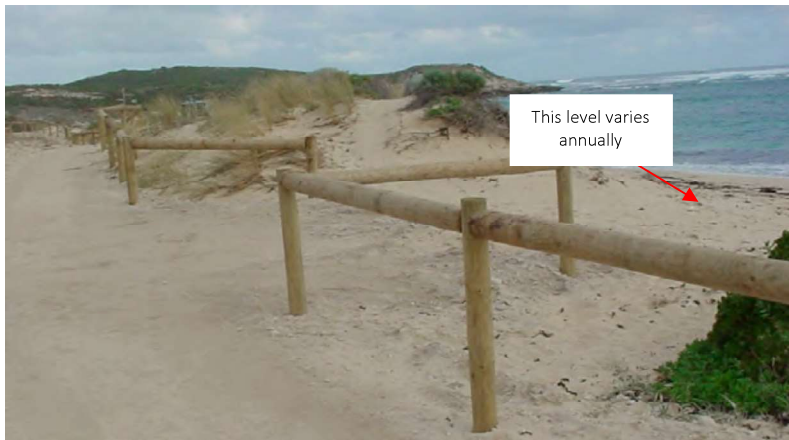
#### WALK THROUGH BEACH ACCESS

The portion of the access path that is founded where beach levels are subject to annual level changes (as much as 1.5m per year) requires consideration and a maintenance plan/program. There are several options available for this area where people step from the beach access path unaffected by level changes, onto the beach, such as:

Each option has advantages/disadvantages, it becomes a choice between capital costs/maintenance costs/serviceability under varying conditions.

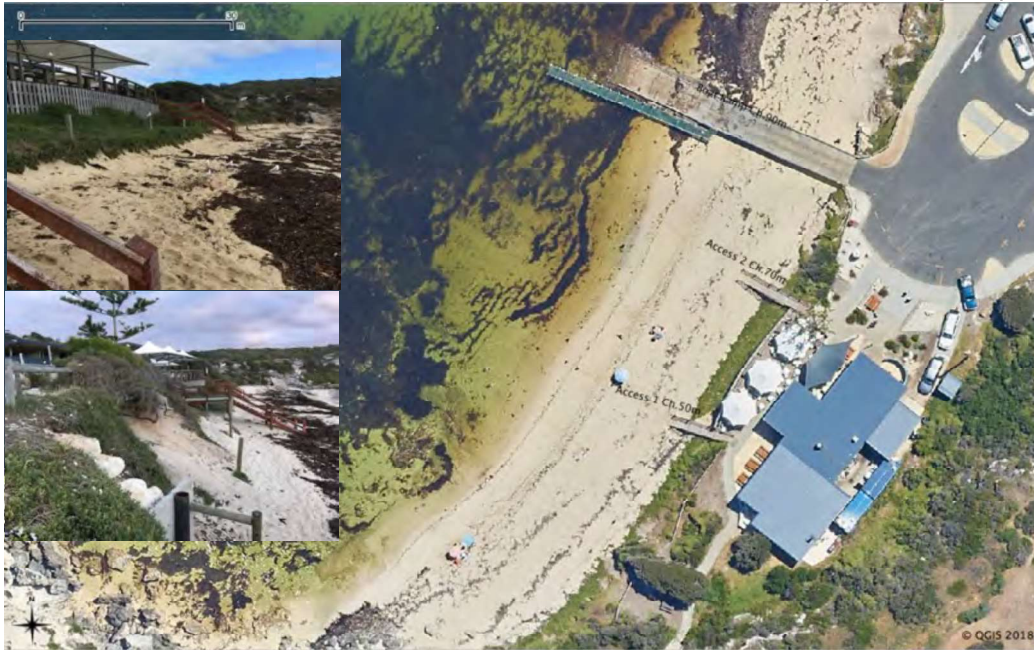
Figure 5.1 Gnarabup Beach South of Boat Ramp (Ch0-90m)

The boat ramp abutment (Ch90m) includes two 'wing wall' constructed from boat ramp slabs supported by steel piles, and some additional limestone rock armour. Variable beach levels are exacerbated by wave reflection from the vertical walls of the abutment. Scour and erosion in front of the ramp abutment has caused undermining in recent years. Installation of lower cost coir logs and monitoring of beach levels have successfully managed this in the short term.

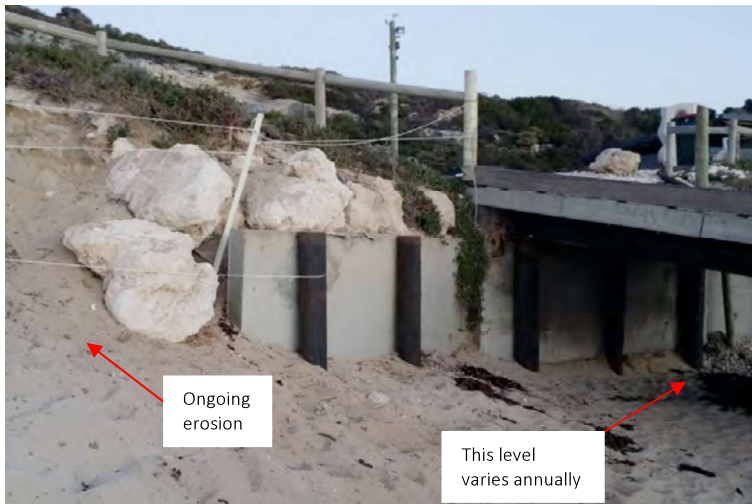
The Gnarabup boat ramp abutment is constructed from concrete panels held in place by steel piles.

Figure 5.3 Gnarabup Boat Ramp Abutment

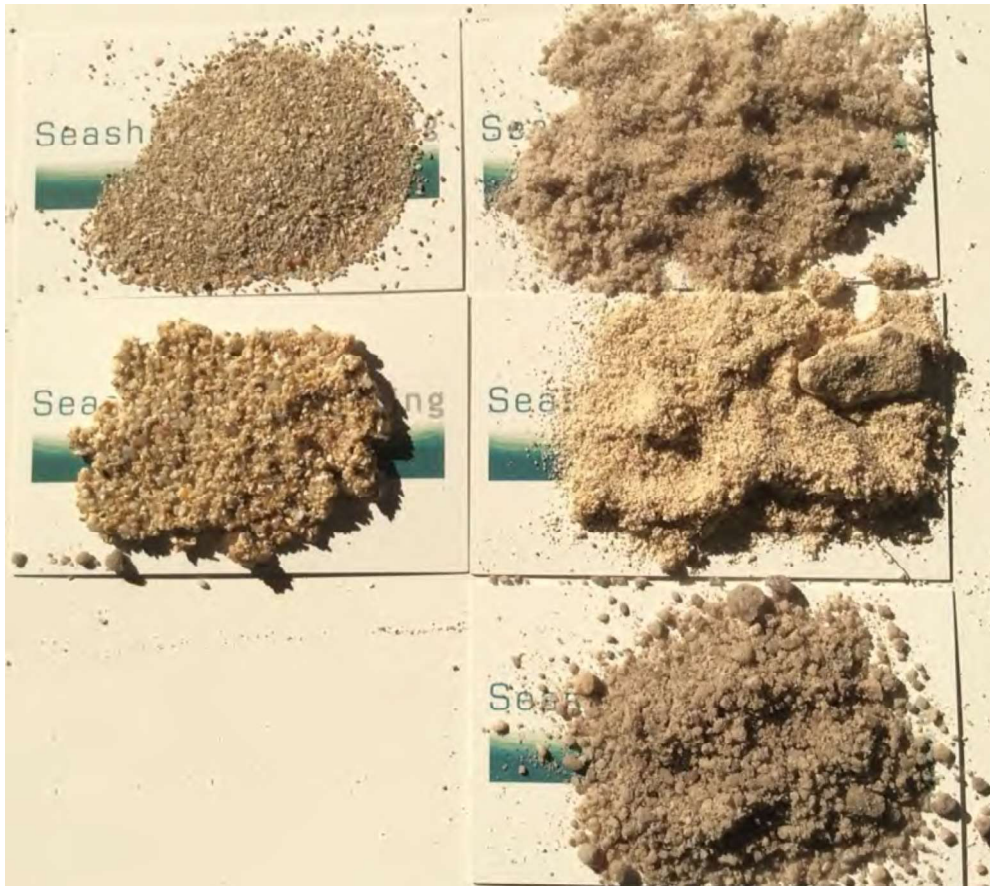
Figure 5.6 Sand Sources for Beach Nourishment

Sand sources for beach renourishment have been briefly reviewed. This included two Shire pits at Forest Grove and Redgate Rd, and a commercial pit from Kaloorup in the City of Bunbury. The following is noted:

In summary, it is likely to be difficult to find material that is a close match for grain size, composition and colour to the existing dune sand. However, sources are available that could be considered for dune nourishment provided the colour is acceptable to the Shire and quantities allow for potential higher rates of erosion of imported material.
