# COASTAL PLANNING AND ADAPTATION – CONCEPTUAL DESIGN REPORT

for Shire of Augusta Margaret River

**February 2020**

**Final Report**

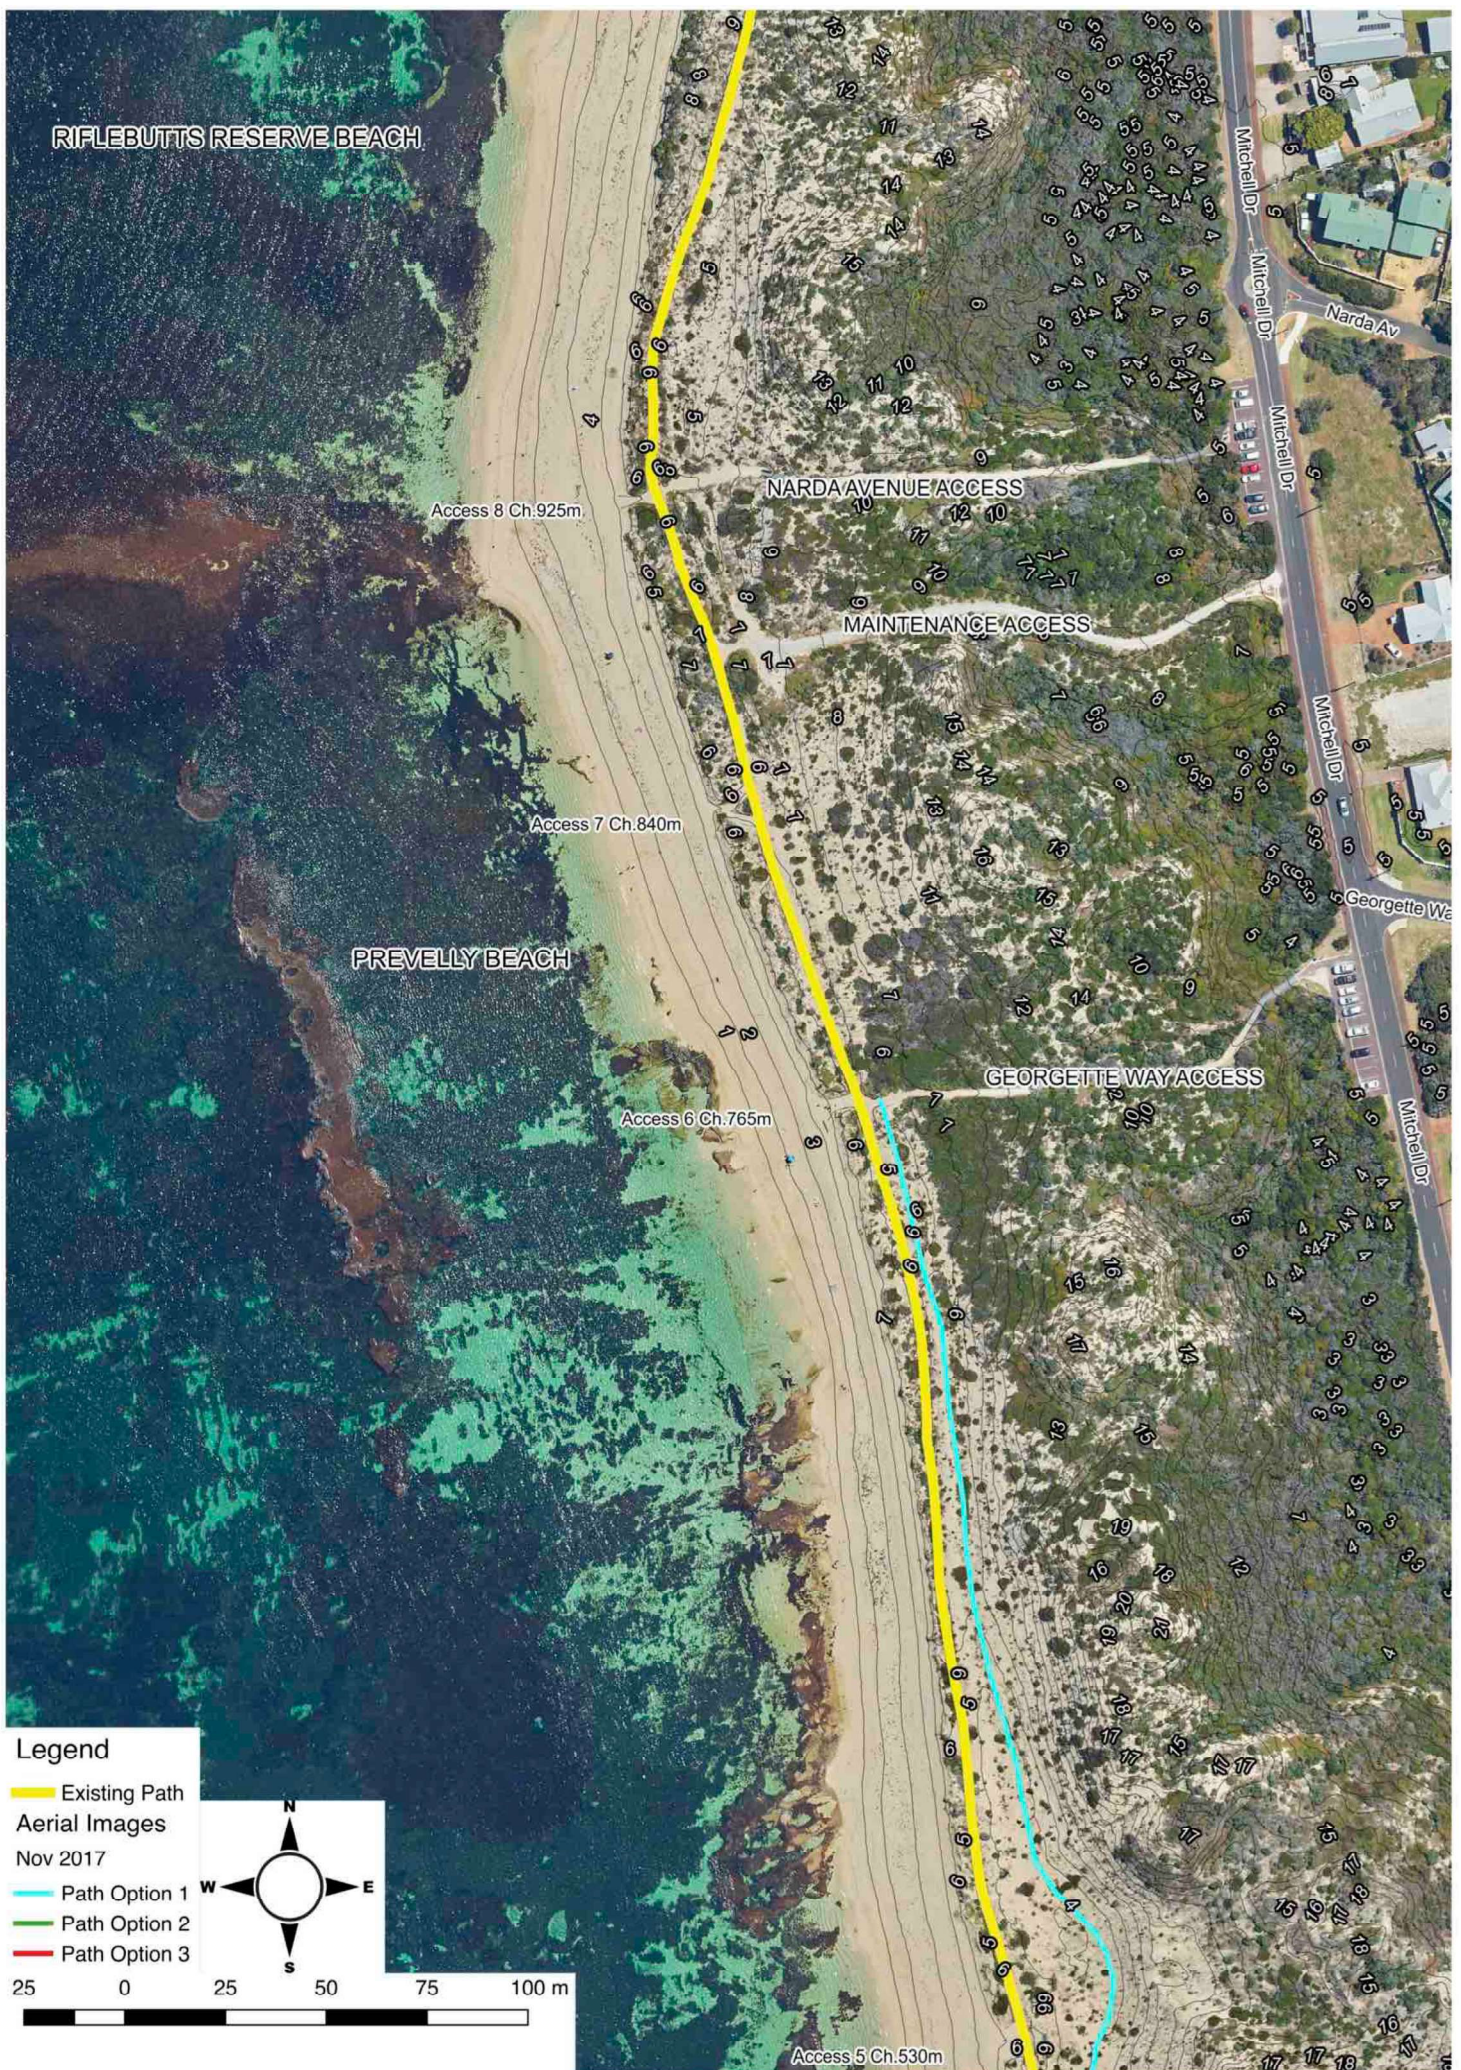
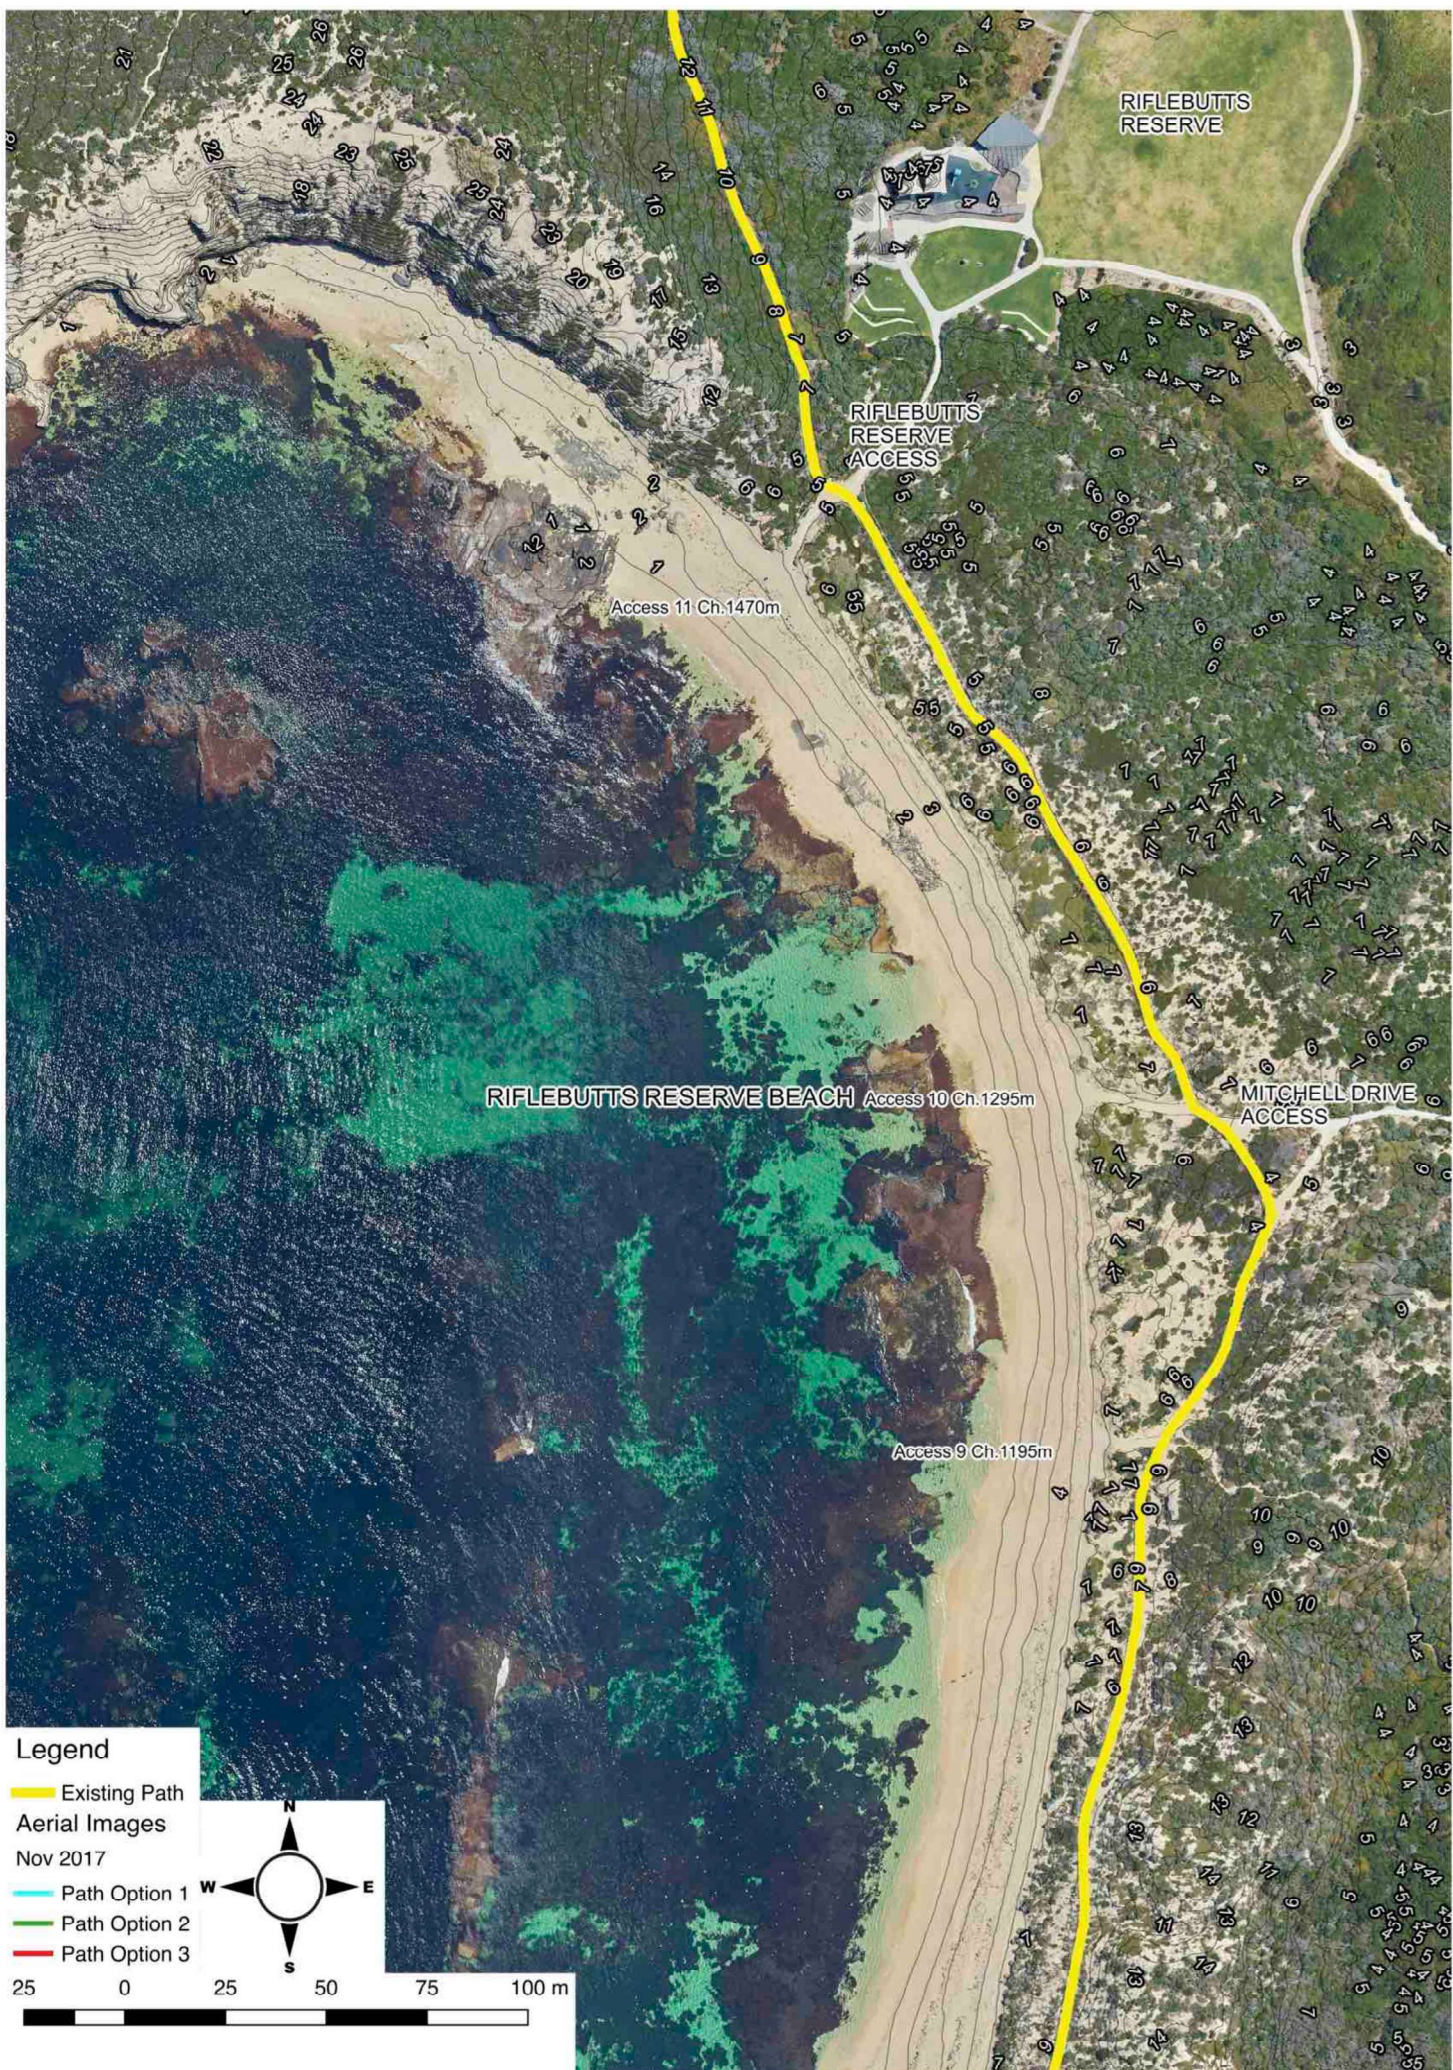
## Attachment 1 Concept Options for Coastal Walkway

- Legend**
- Existing Path
  - Aerial Images
  - Nov 2017
  - Path Option 1
  - Path Option 2
  - Path Option 3
