Clearing Permit CPA 9163/1 – Additional information

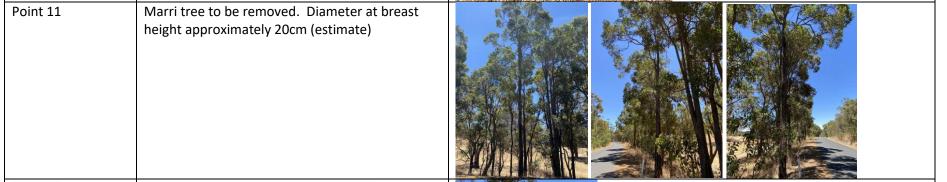
Point 8	Regrowth Eucalyptus – 2 small trees. Multi stem	
Point 9	Regrowth Eucalyptus – 2 small multi stem trees. Plus some small undergrowth

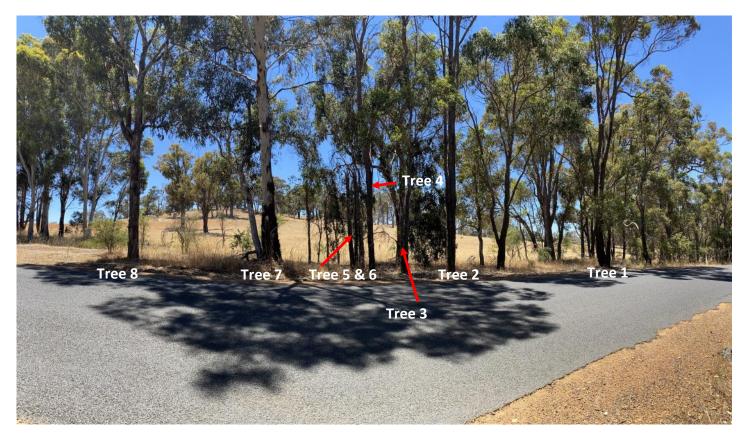
Point 13	Trees to be removed in this area. Additional details in map document. Tree 1 – Marri – DBH<30cm Tree 2 – Marri – DBH possibly between 20-30cm Tree 3 – Marri – 2 stems – both stems <30cm DBH (but combined probably over 30cm) Tree 4 – Marri – regrowth marri but probably more than 10 years old. DBH between 20-30cm Tree 5 – dead previously pruned Tree 6 – 4 stems 3 of which are dead and one small resprout – approx. 20cm DBH Tree 7 – Wandoo – main stem DBH>30cm. Second stem <30cm DBH Tree 8 – Wandoo – DBH>30cm	
Point 14	Wandoo tree here needs to be removed within the safe zone
