# Targeted Fauna Survey

## Bussell Highway – Hutton to Sabina Section (31.25 – 43.67 SLK)

MARCH 2018

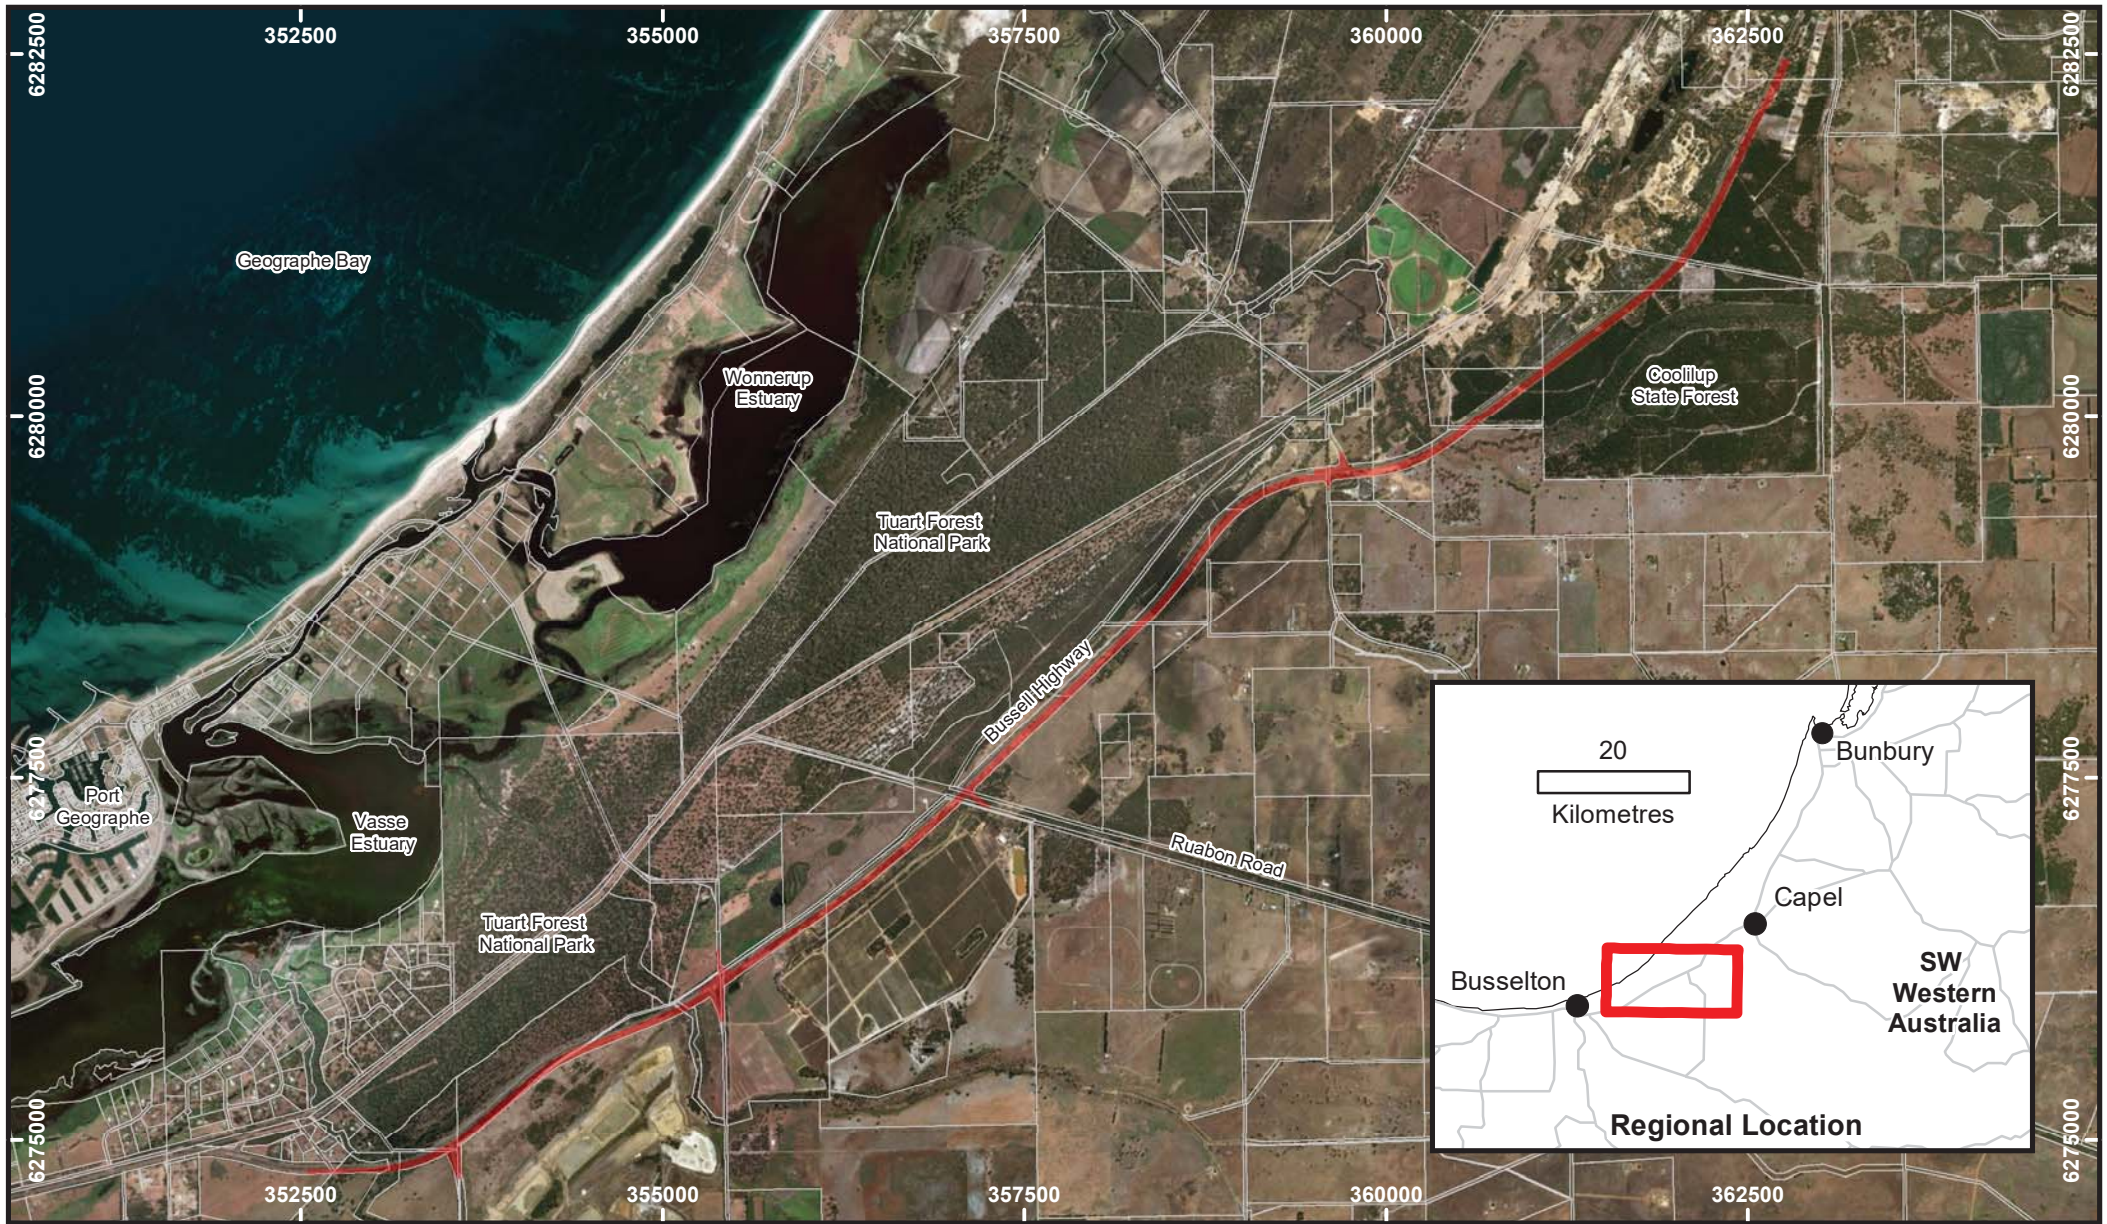
Figure: 1

**Bussell Highway**  
 Hutton to Sabina Section  
 (31.25 – 43.67 SLK)  
**Project Area**  
 and  
**Surrounds**

It is understood that MRWA are proposing to duplicate sections of the highway to improve traffic flow and safety. The Project area has a total length of about 12 kilometres (km) and covers approximately 72.42 hectares (ha), of which ~28 ha will require clearing for proposed road works (Figure 1).

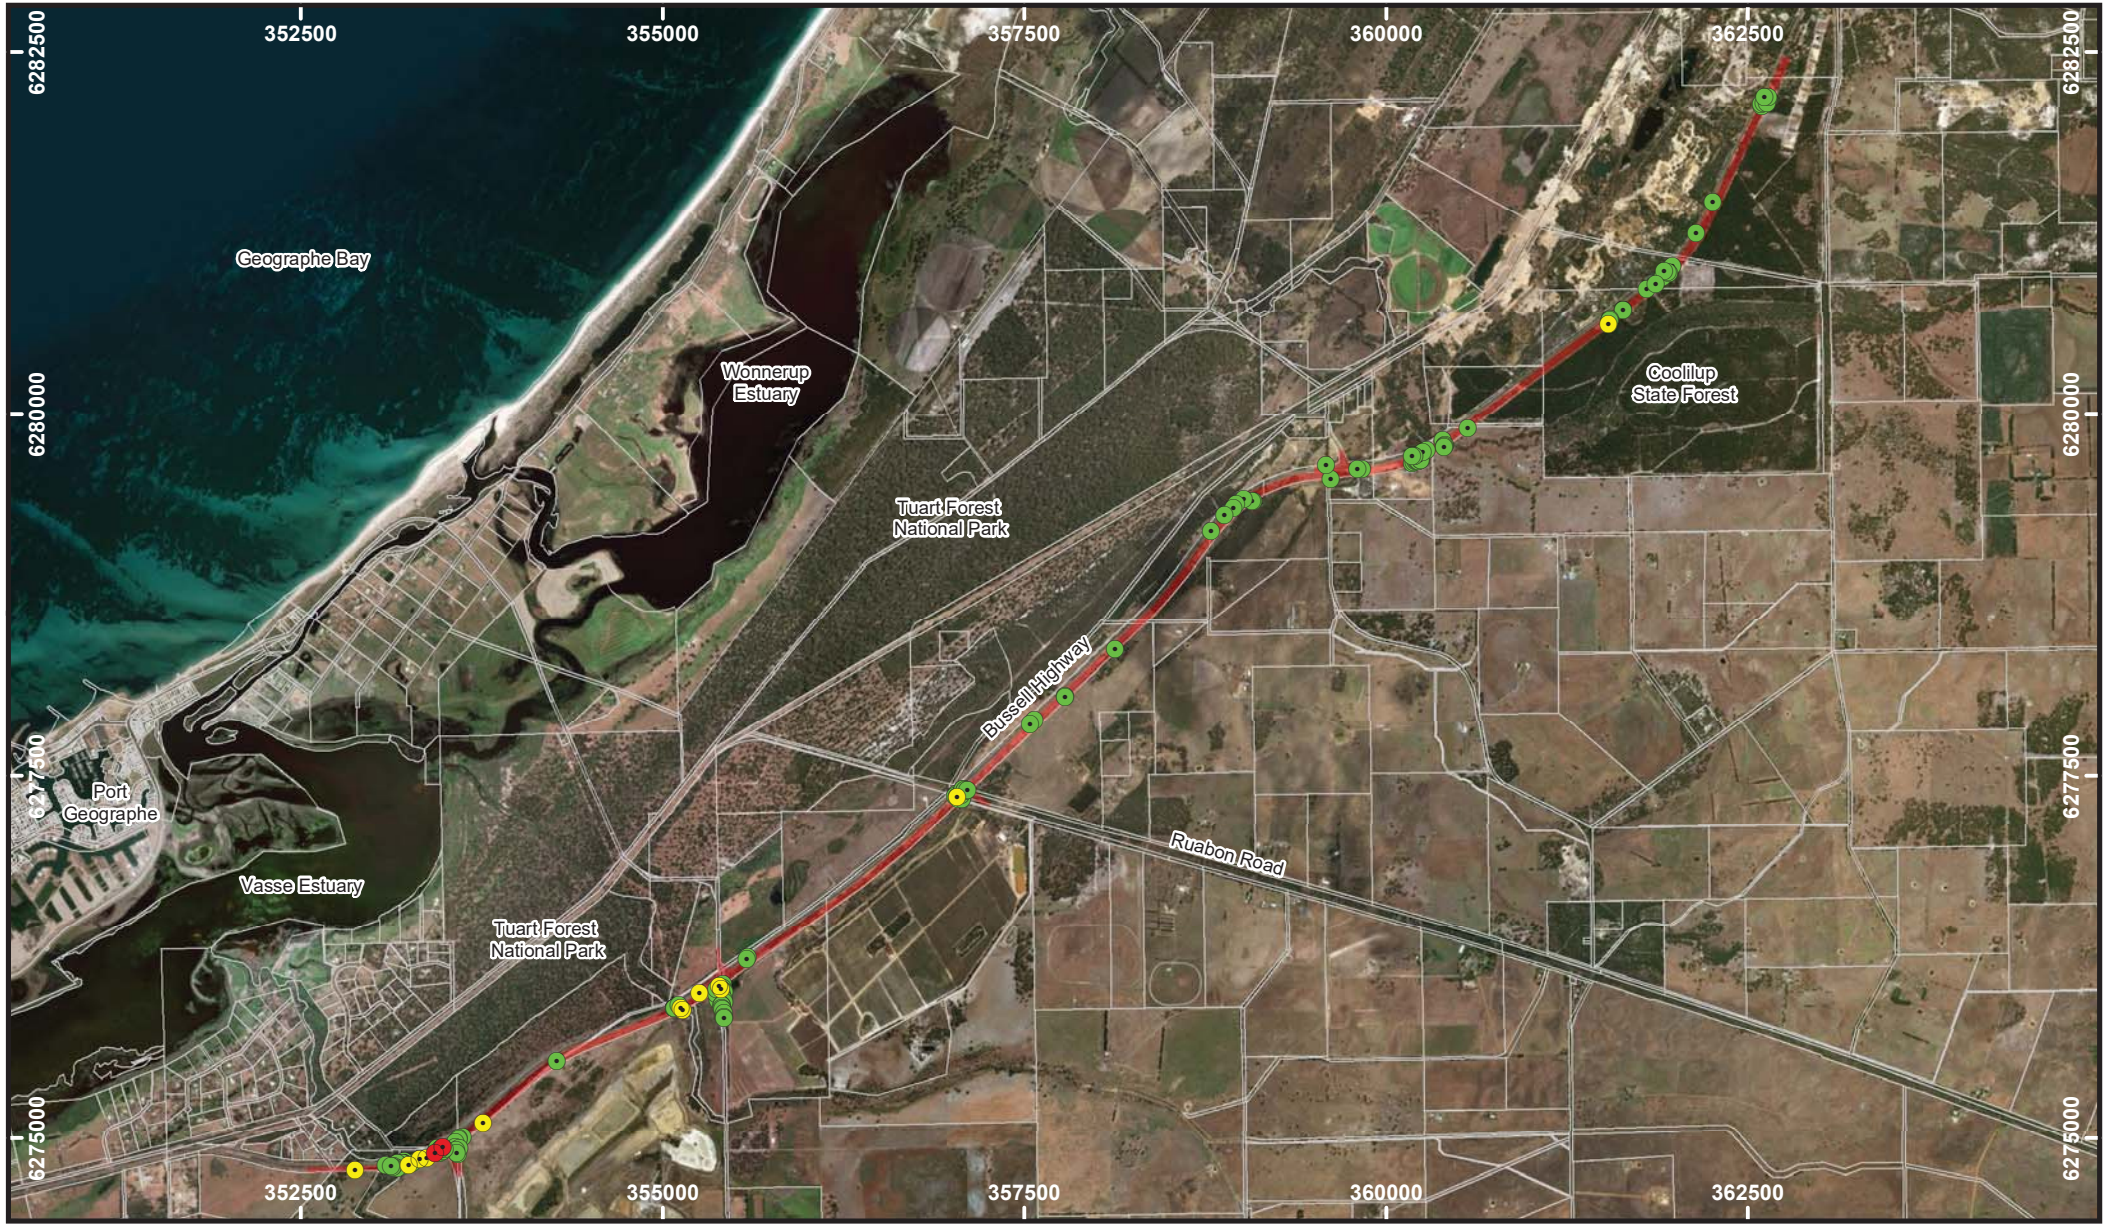
**Habitat Trees  
(DBH >50cm)**

- Habitat Tree - One or more large hollows possibly suitable for black cockatoos
- Habitat Tree - One or more possible small/medium hollows
- Habitat Tree - No hollows seen

A summary of the potential black cockatoo breeding trees (using DotEE criteria i.e. any suitable tree species with a DBH  $\geq$  50cm (Commonwealth of Australian 2012)) observed within the subject site (combined results of both surveys) is provided in Table 1 below and their location shown in Figure 2.

The assessment identified a total of 156 trees with a DBH of  $\geq$ 50cms within the subject site. The majority (142, ~91.1%) of the trees were not observed to contain hollows of any size. Twelve (12, ~7.6%) of the trees contained one or more possible hollows considered by the Author not to be suitable for black cockatoos to use for nesting purposes.

Two (2, ~1.3%) trees were identified as potentially containing hollows that appeared possibly big enough to allow the entry of a black cockatoo into a suitably sized and orientated branch/trunk though no evidence of actual use by black cockatoos (e.g. significant chew marks around hollow entrance) was seen in either case.

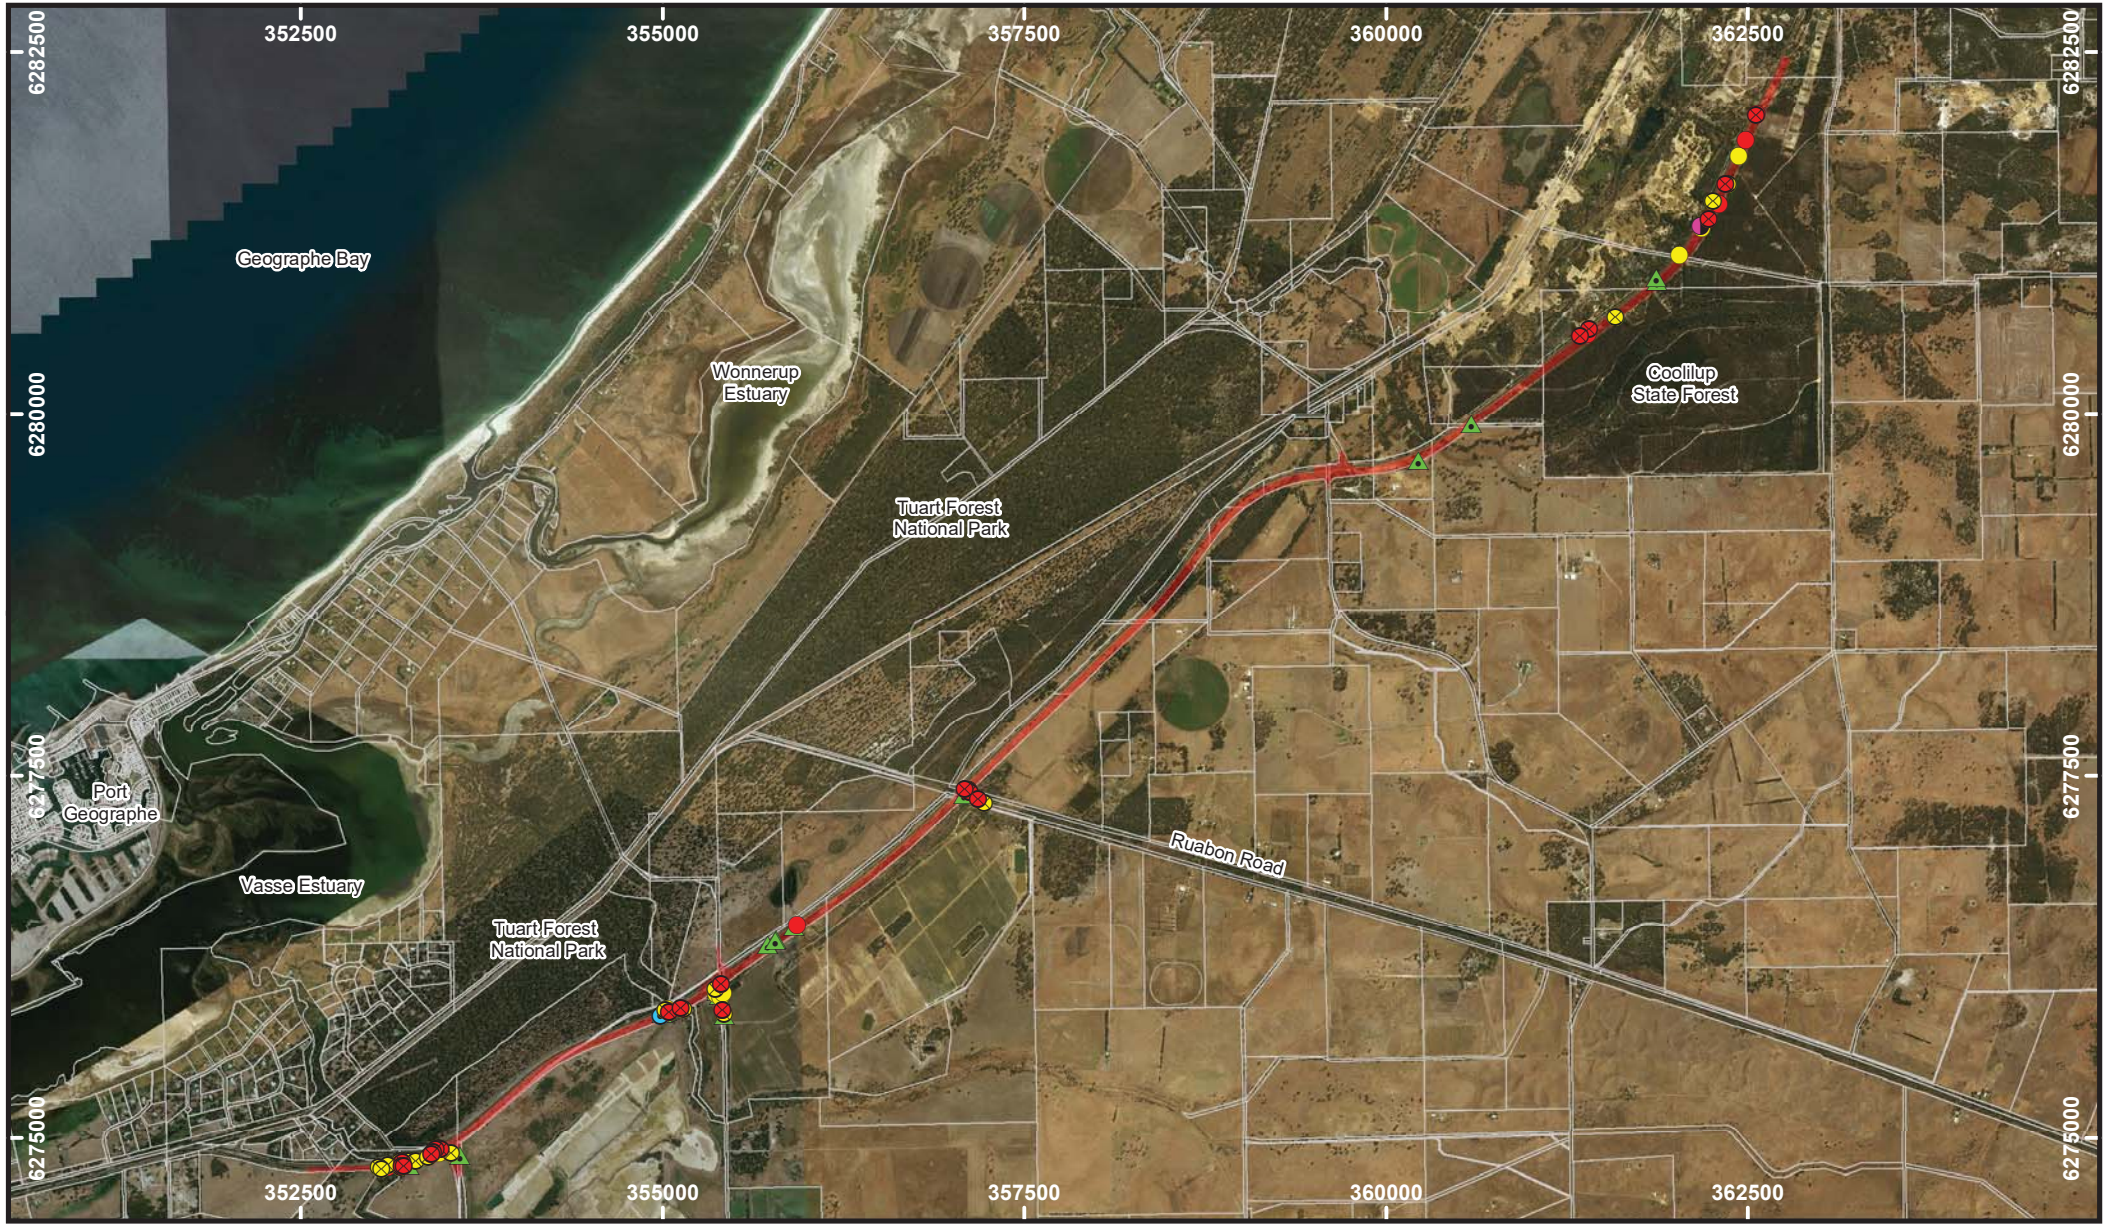
**Possum Survey  
Results**

**Night 1 (18/01/2018)**

**Night 2 (23/01/2018)**

- +
 Western Ringtail Possum
- x
 Common Brushtailed Possum
- +
 SW Brush-tailed Phascogale
- +
 Quenda

The locations of various possum observations made during the survey period are shown in Figure 3.

Twenty WRP dreys were observed during the day survey. Fourteen trees were observed to contain possible hollows, some of which may be suitable for WRPs to use for daytime refuge.

Fourteen WRPs were observed during the first nocturnal survey. Eight common brushtail possums were also recorded.

Twenty two WRPs were observed during the second nocturnal survey. Twenty one common brushtail possums were also recorded.

Two other fauna species of conservation significance were recorded during the survey period, this being the quenda (southern brown bandicoot) and the south western brush-tailed phascogale. The location of these observations is shown in Figure 3.
