## Assessing impacts of recreational use of mountain bike trails on Mounts Clarence and Adelaide, Albany 2017 - 2019.

**Report No CENRM154**

Centre of Excellence in Natural Resource Management,  
University of Western Australia

**PRODUCED FOR** **City of Albany**

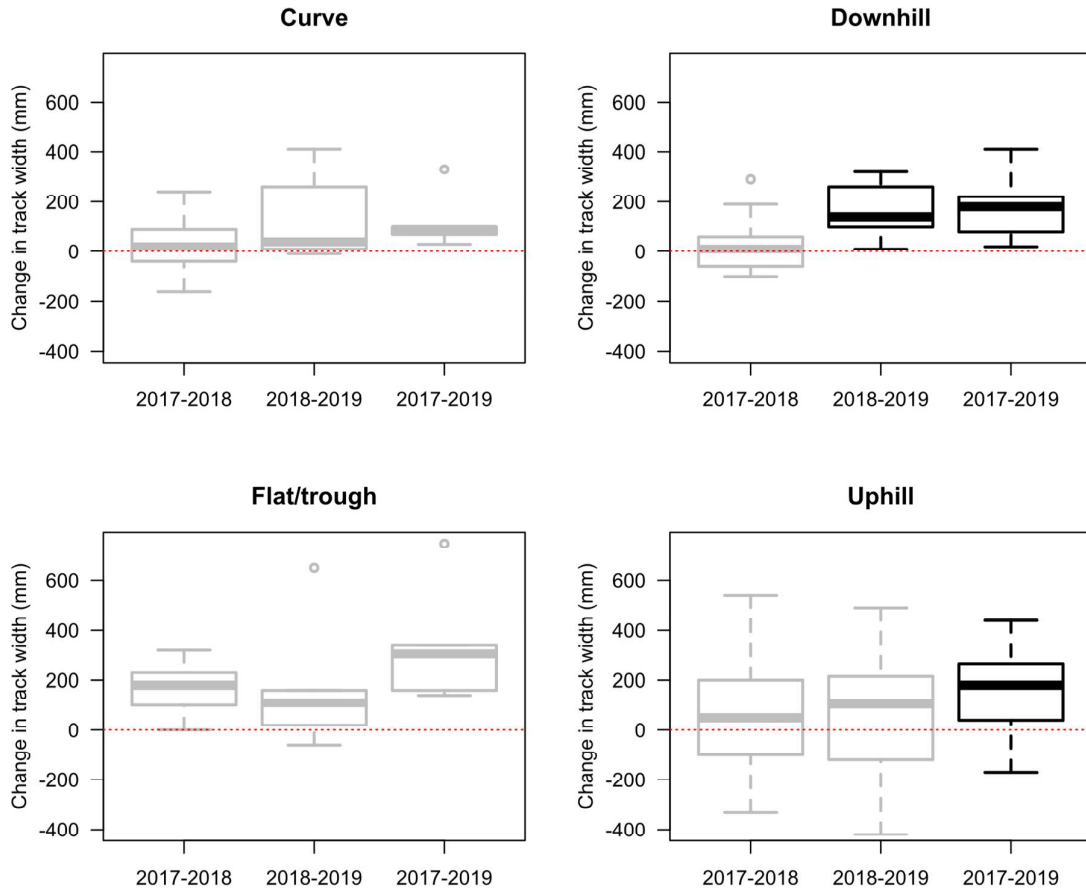
In general, trail width demonstrated an increase over time, although not always statistically significant. For “Downhill” regions, trail width increased from 2018 to 2019, and from 2017 to 2019, indicating that the greatest change from 2017 to 2019 occurred between 2018 and 2019. Trail width also increased in “Uphill” regions from 2017 to 2019 (Figure 3).

Figure 3. Changes in trail width over time and among trail feature categories. Black boxes indicate significant changes between years compared, Positive values indicate an increase in width between years.

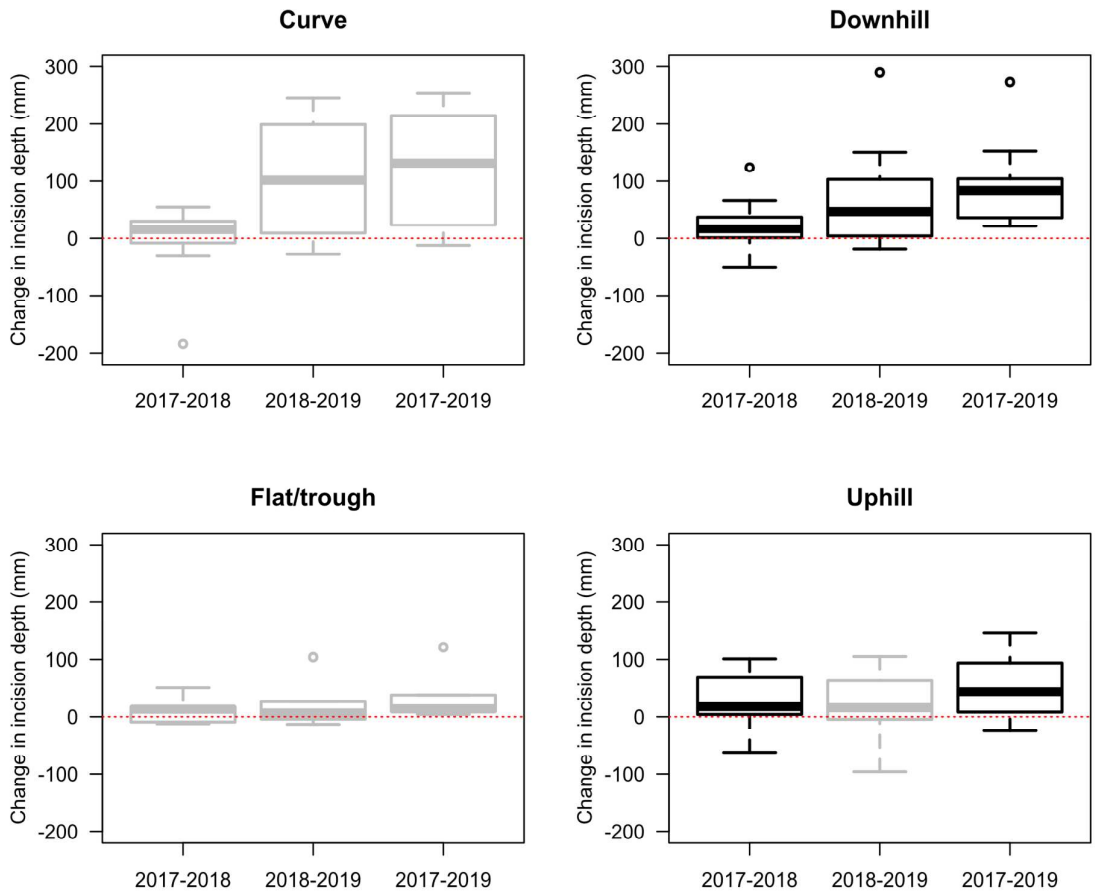
Trail maximum incision depth also showed a general trend of increasing over time, with the greatest changes occurring in the “Downhill” feature category. The maximum incision depth for the “Uphill” category appears to have increased from 2017 to 2018, and then stabilised. No differences were found for the “Curve” and “Flat/trough” categories (Figure 7).

Figure 7. Changes in incision depth over time and among trail feature categories. Black boxes indicate significant changes between years compared, Positive values indicate an increase in depth between years.

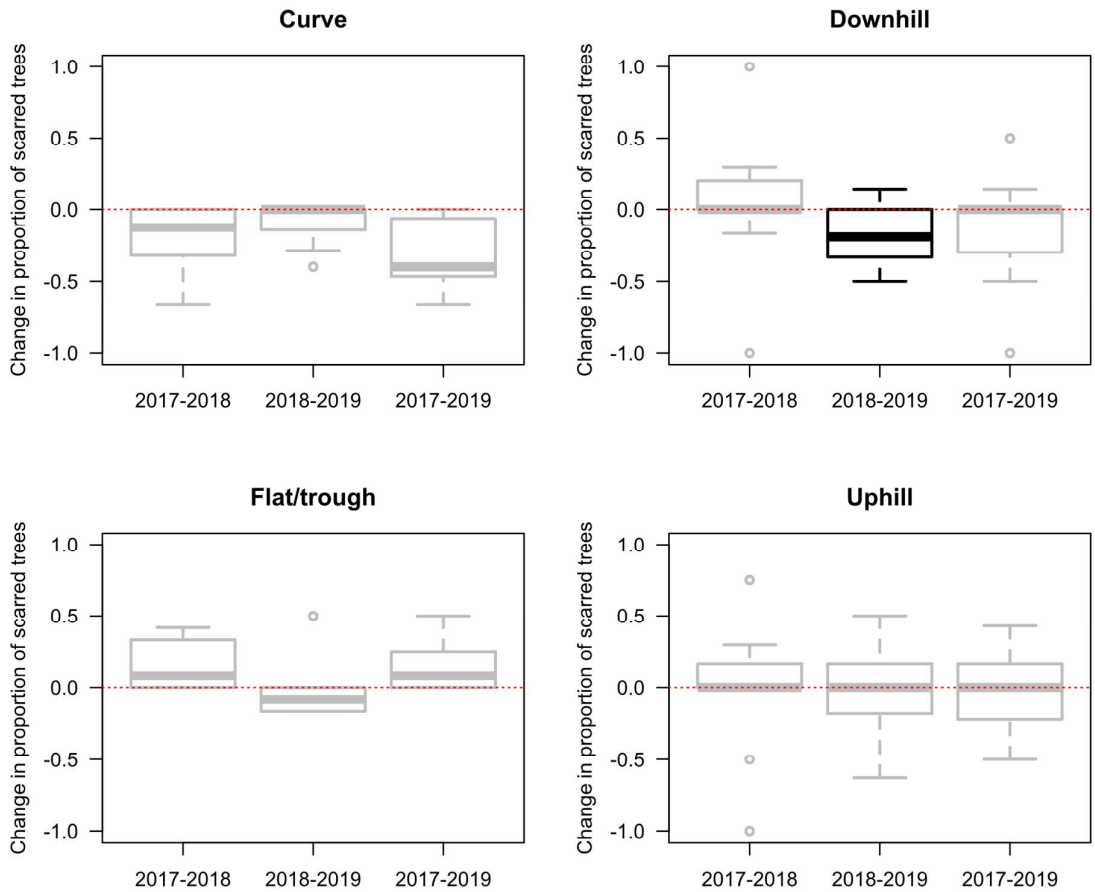
Very few trail features appear to influence the changes in number of scars on trees over time, with only the “Downhill” category significantly decreasing between 2018 and 2019 (Figure 12).

Figure 12. Changes in proportion of scarred trees over time and among trail feature categories. Black boxes indicate significant changes between years compared, Positive values indicate an increase in proportion of scarred trees between years.
