Targeted fauna survey for Leeuwin Road upgrade works – Cape Leeuwin Freshwater Snail *Austroassiminea lethae*.

Report to Shire of Augusta-Margaret River

Ottelia Ecology

January 2021

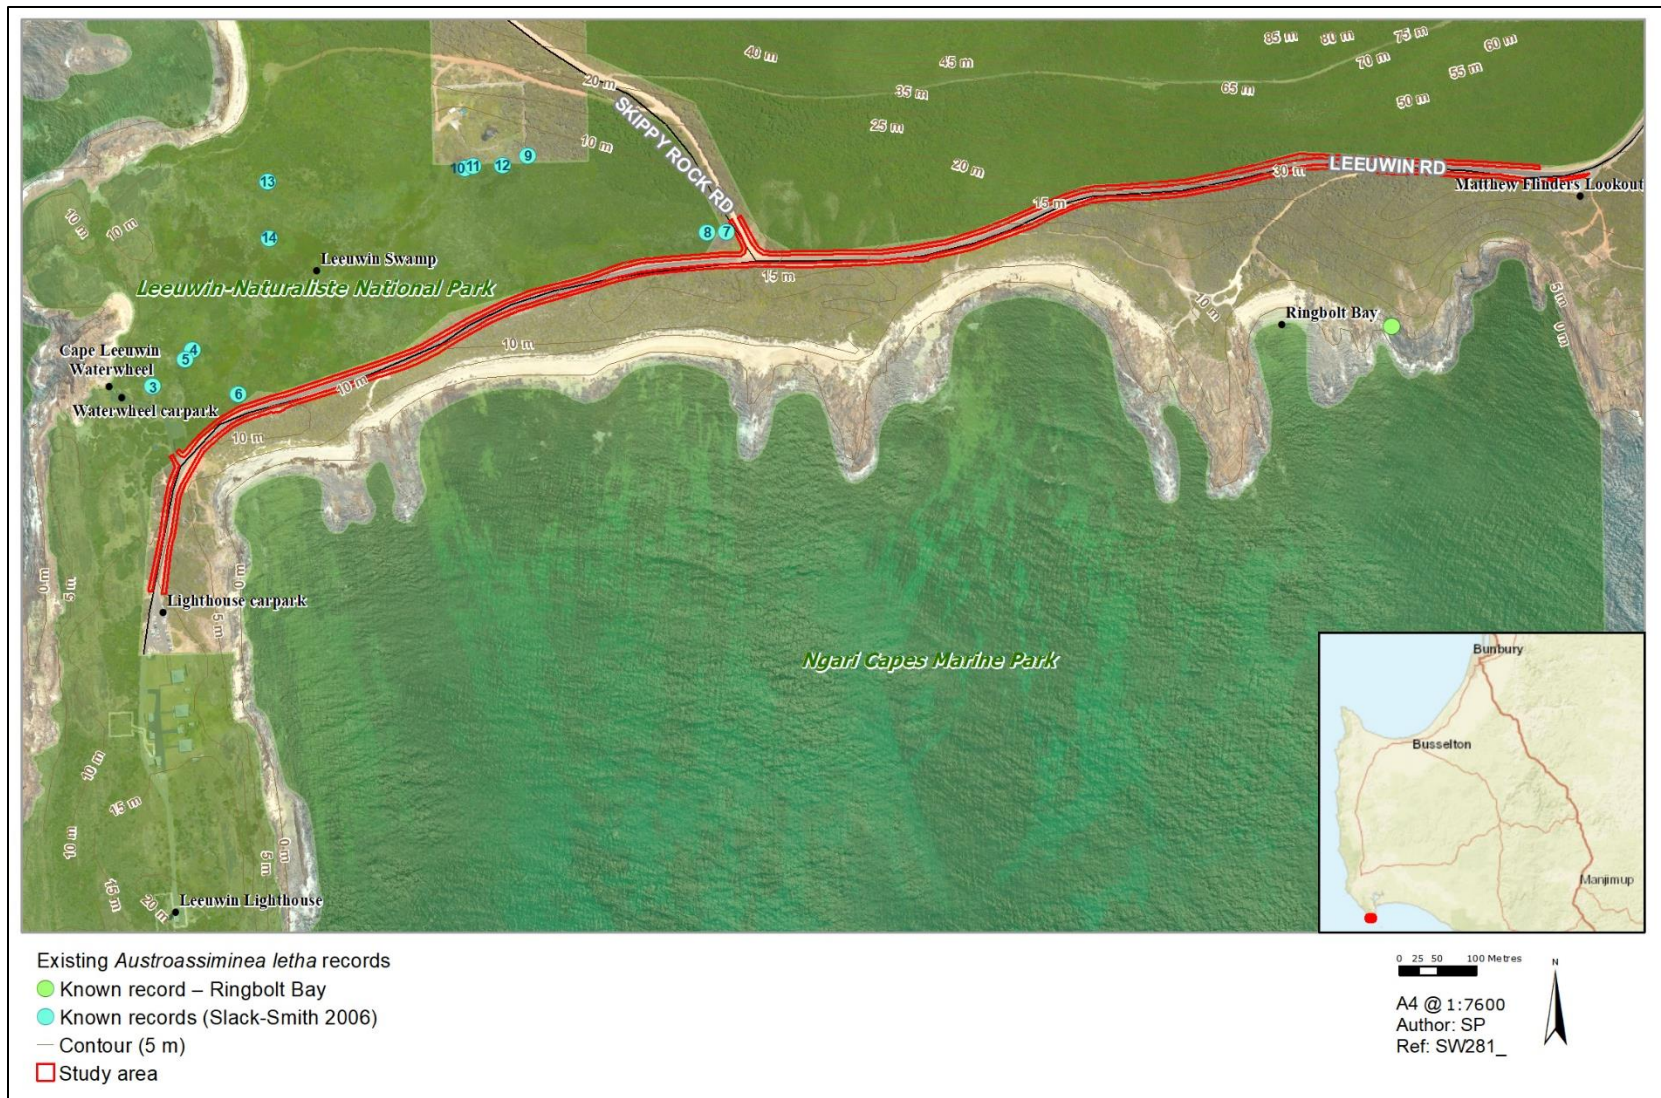
Figure 1. Study area for habitat assessment and targeted survey showing known locations of *Austroassiminea letha*.

The proposed road works are located along a 2km section of Leeuwin Road between the Cape Leeuwin lighthouse carpark and Mathew Flinders Lookout (Figure 1). DBCA Blackwood district conservation officers have previously advised the impact zone of road works (east of Skippy Rock Road) was unlikely to contain *A. lethae* but only an on-ground targeted search in freshwater seeps along the road would determine this with any assuredness. The Shire of Augusta-Margaret River requested that the targeted survey include a general search for suitable habitat within the entire 2km section of Leeuwin Road; and a targeted search for *A. lethae* individuals within suitable habitat and proposed clearing areas. This wider scope was considered appropriate to enable the Shire to plan for future road upgrades in a way that minimizes risks to potential locations of *A. lethae* populations.

Distribution of *A. letha* is restricted to seven (known) isolated populations from Cape Naturaliste to Cape Leeuwin (Onton 2009, Litoria Ecoservices 2019). All known occurrences are associated with freshwater seeps and springs draining from limestone formations near the coast and are generally located beyond the influence of tides or salt spray (Solem et al. 1982, Onton 2009). Previous database searches of the study area by Litoria Ecoservices (2019) identified *A. letha* within 10km of the project site and two known populations occur in the vicinity of the site (Figure 1):

Leeuwin Swamp was sampled by the Western Australian Museum for the Water Corporation 2005 (Slack-Smith 2006; sample sites are shown on Figure 1). The *A. letha* population associated with Leeuwin Swamp is considered the largest remaining. It has declined over the years by a contraction in moist habitats due to drying of the swamp, although in 2005 was still considered to support reasonable numbers at most sampled sites (Slack-Smith 2006). A fire in April 2019 is likely to have had a substantial impact on the population, however the extent of this is not known (data from survey work since then has been requested).

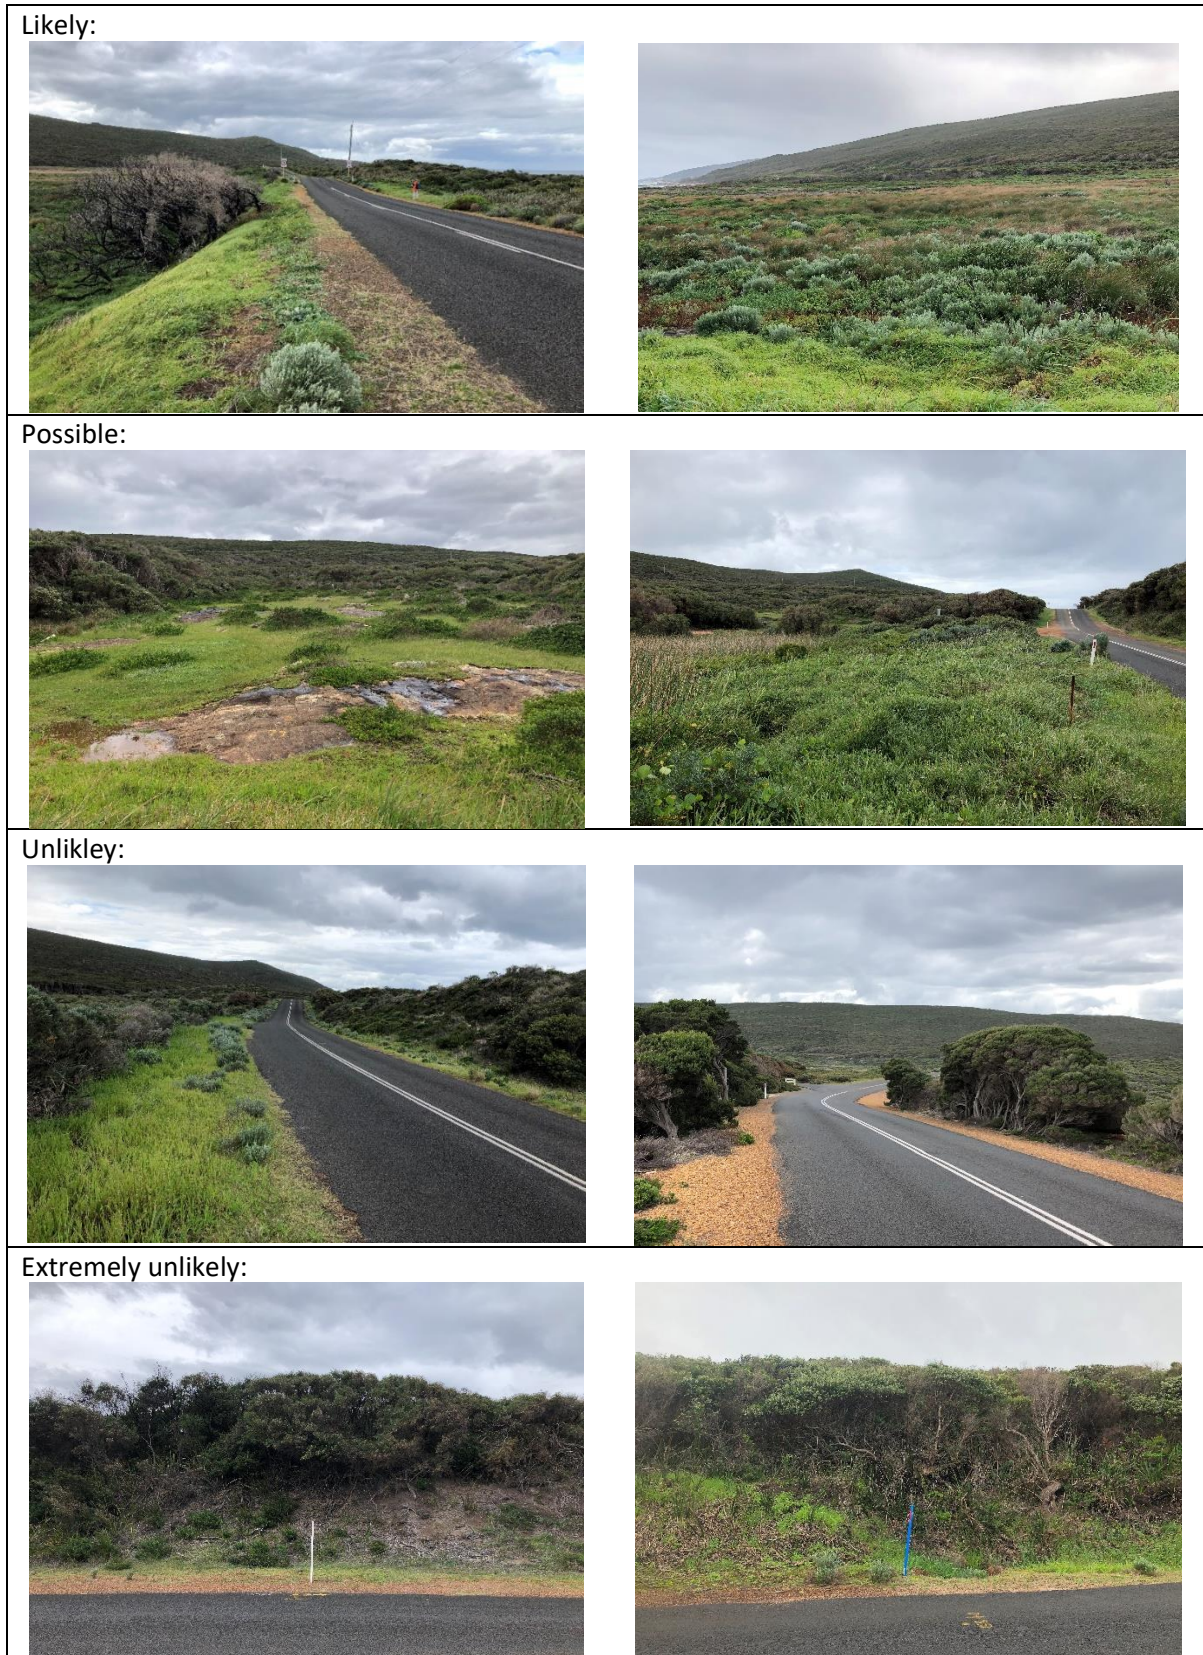
Figure 5. Habitat type examples for likelihood of *Austroassiminea lethae* occurrence.

Habitat assessment results are presented in Figure 3 and Figure 4 and some examples are shown in Figure 5. General descriptions of the habitat types are as follows:

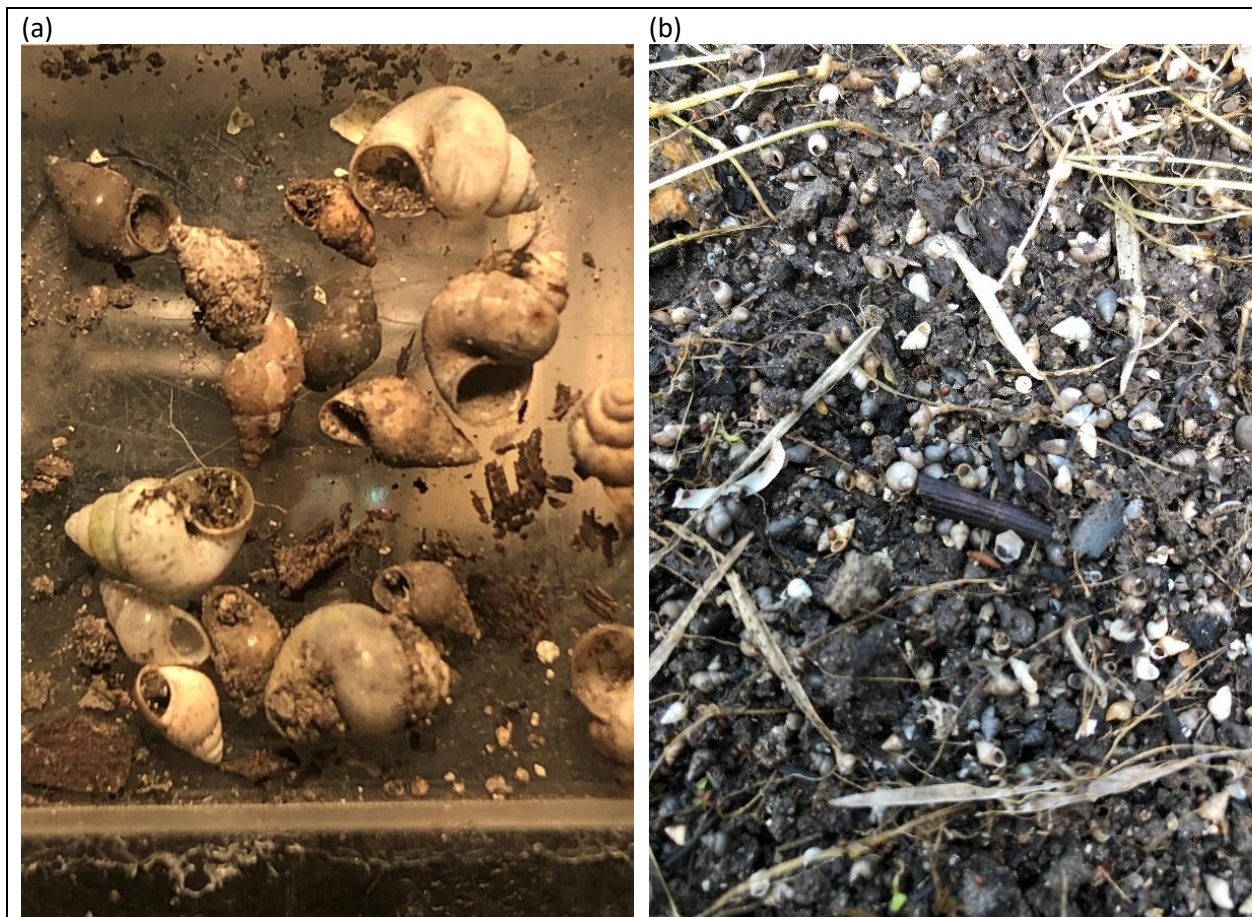
Figure 6. Images of *Austroassiminea lethta* from the targeted search, August 2020. Close-up image of dead *A. lethta* shells in varying condition (a) and an area with abundant shells on site (b).

Dead *A. lethta* shells were found at sites 2-8 between the Waterwheel carpark and Skippy Rock Road on the north side of Leeuwin Road (Figure 6). No *A. lethta* shells were located at any other survey sites. Detailed results are presented in Table 1 and 2 and site photos provided in Appendix 1. No live shells were encountered in the survey, however this does not confirm that live individuals do not occur at these sites or in close proximity. Survey scientists are confident of the identification of these shells as *A. lethta* from taxonomic descriptions by Solem et al. (1982) and Fukuda and Ponder (2003) and available imagery in literature and online. The image in Figure 6a has been identified as *A. lethta* by the Western Australian Museum's Department of Aquatic Zoology, and additional voucher specimens (dead shells only) have been forwarded for confirmation.

At sites where *A. lethta* shells were found they mostly occurred at least 6m from the edge of the bitumen and were more abundant with increasing distance toward and within Leeuwin Swamp to the north. The exceptions were sites 6 and 7, where shells were found within 1m of the edge of the bitumen. At site 6, shells were common at the east end of the proposed clearing area. At site 7, although shells were found near the road, no clearing is proposed. At site 2, shells were found close to, but not within the proposed clearing area. No shells were found at any culvert sites.

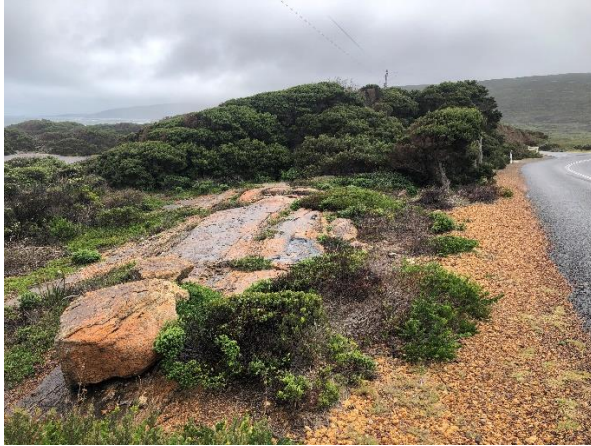
Site 1. Possible habitat close to proposed clearing area, west roadside. Shells absent.

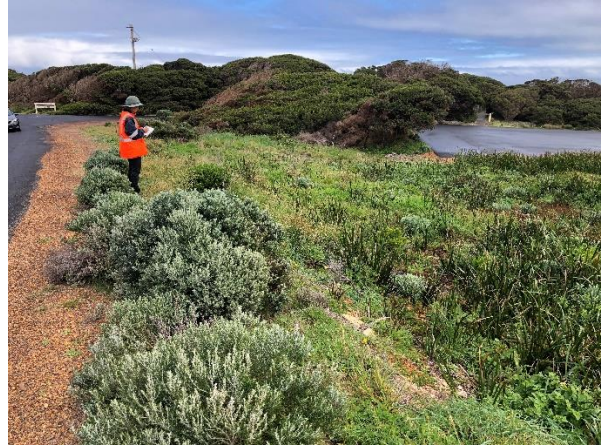
Site 2. Proposed clearing area in possible habitat, north roadside. No shells within clearing area; shells present >5.8m from roadside.

At site 2, risk to *A. lethia* during roadworks may be avoided through ensuring clearing is restricted to the proposed area and that any other disturbance associated with road works, such as unloading and storage of materials and movement of equipment, does not extend beyond the clearing polygon into any vegetated portion of the north side of Leeuwin Road.

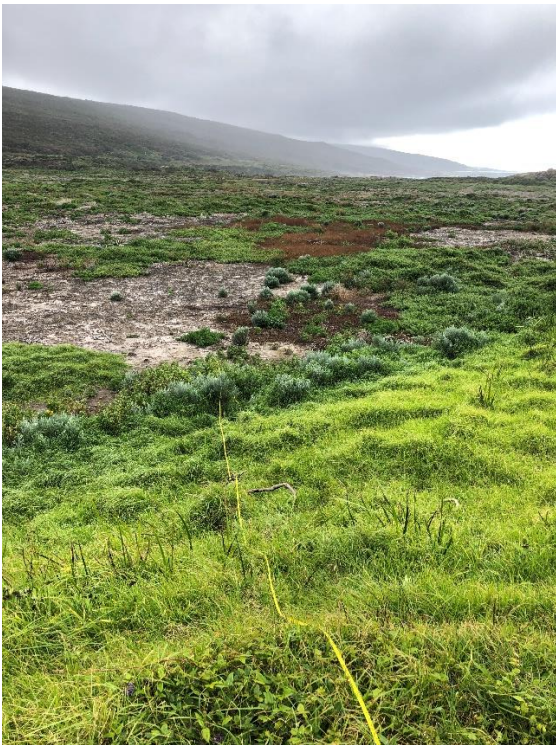
Site 3. Transect extending from proposed clearing area in possible habitat, north roadside. No shells within clearing area; shells present >6.5m from roadside.

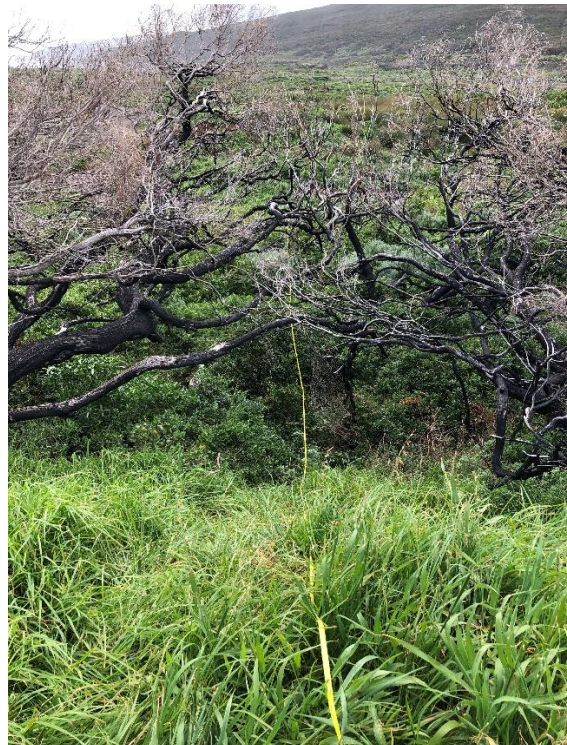
Site 4 transect. Likely habitat, no clearing proposed, north roadside; shells present >7m from roadside (Site 5 similar habitat).

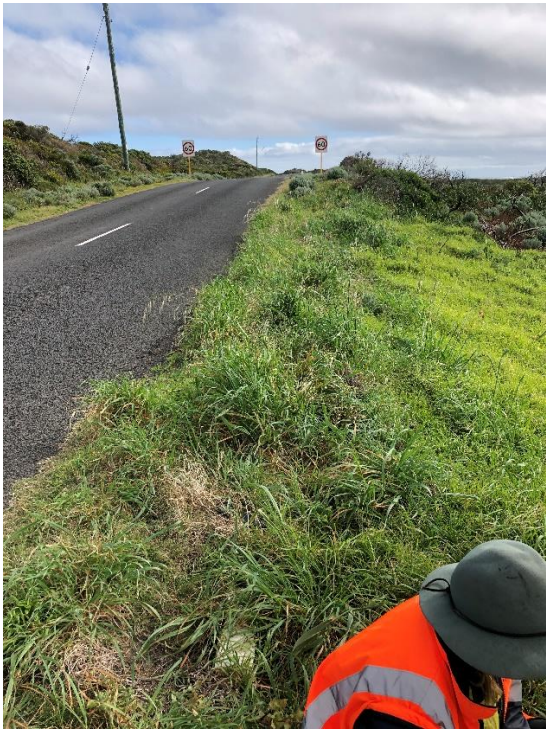
Site 6. Proposed clearing area in likely habitat close to swamp, north roadside. Shells <1m from roadside.

At site 6, the proposed 1m wide clearing will overlap identified *A. lethia* habitat, although no live individuals were encountered. However, it is possible that this habitat is no longer viable due to its position in the landscape and increasingly dry conditions of the swamp. It is also possible that no live individuals occur there due to this contraction in habitat and/or the 2019 fire.

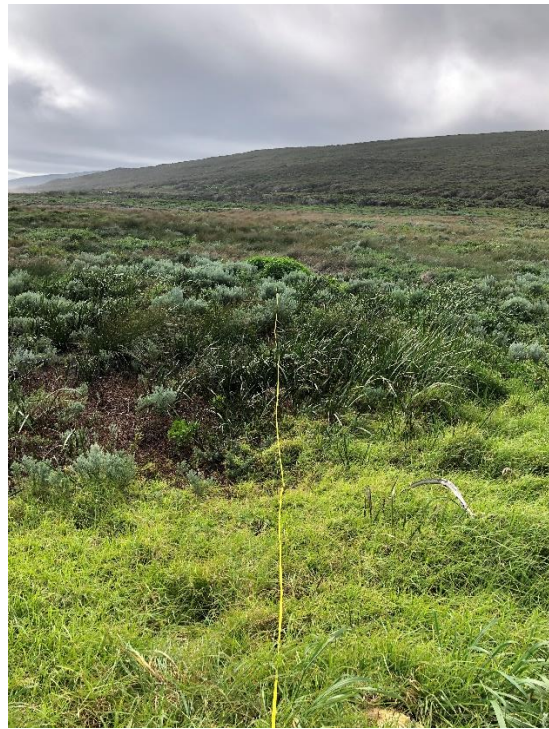
Site 6 transect. Shells throughout.

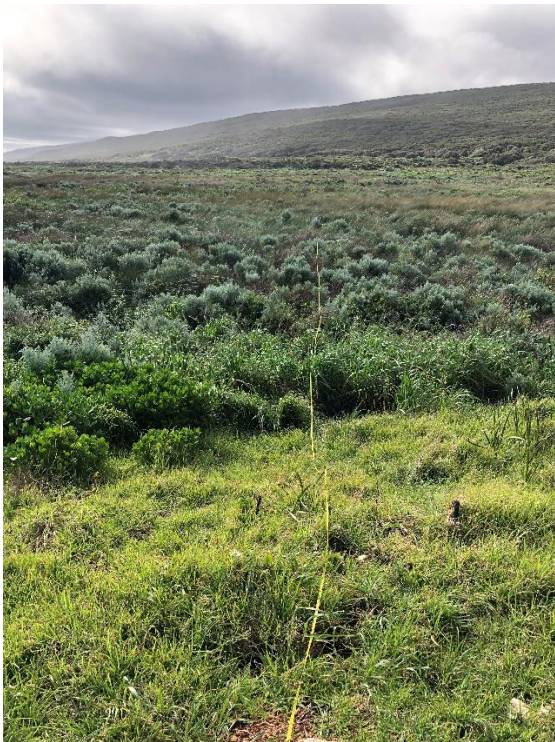
Site 7. Likely habitat, no clearing proposed. Shells present.

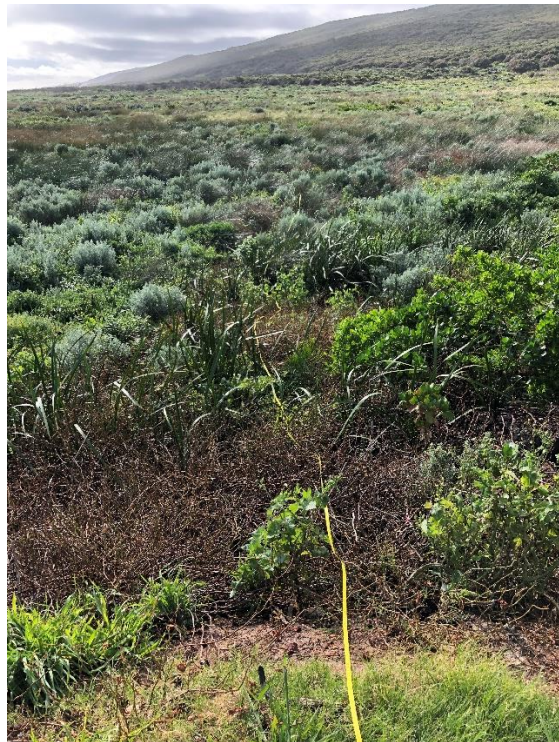
Site 8. Likely habitat, no clearing proposed. Shells present.

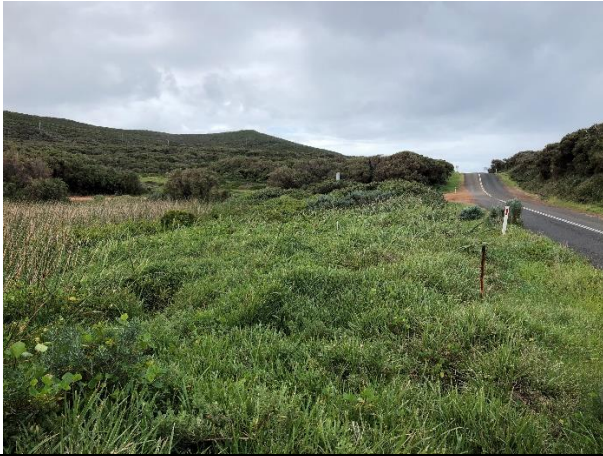
Site 9. Proposed clearing area west of Skippy Rock Road. Shells absent.

While no *A. lethia* shells were found at sites 9 and 10, these sites are close to two sites where they have been previously found by Slack-Smith (2006) and more recently in 2019 by DBCA. This known habitat is within the Leeuwin Swamp and has not been affected by fire, so is likely to be important for conservation. The surveyed roadside habitat is different to that within the swamp, with dense terrestrial vegetation and gravelly soils. The small proposed clearing area at site 9 is not considered *A. lethia* habitat, however the vegetation would provide a good buffer to the snail population and so clearing should be minimised. Skippy Rock Road is closer to the known habitat and this should be considered in any future road works.

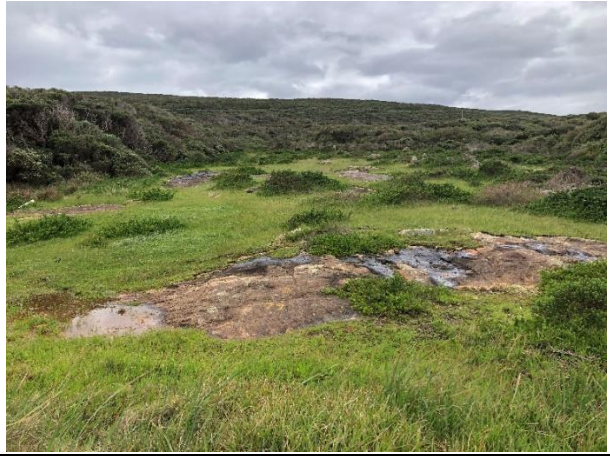
Site 11. Possible habitat area east of Skippy Rock Road. Shells absent.

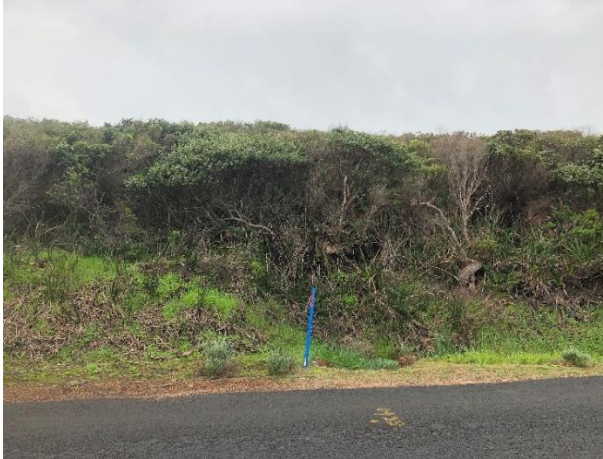
Site 13. Example extremely unlikely habitat in eastern section, culvert area, north roadside. Shells absent.

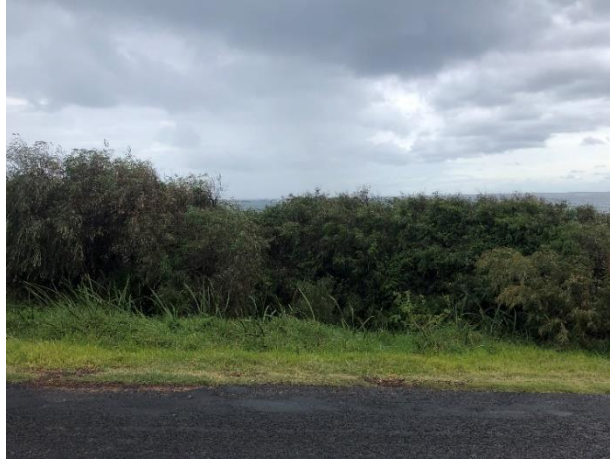
Site 13. Example unlikely habitat in eastern section, culvert area, south roadside. Shells absent.
