**Appendix 1: Ridges Iron Ore Deposit Soil Survey and Waste Characterisation (SWC 2010)**

## RIDGES IRON ORE DEPOSIT SOIL SURVEY

Prepared for: **Kimberley Metals Group**

Project No.: PN0149-1-1-KMG-001

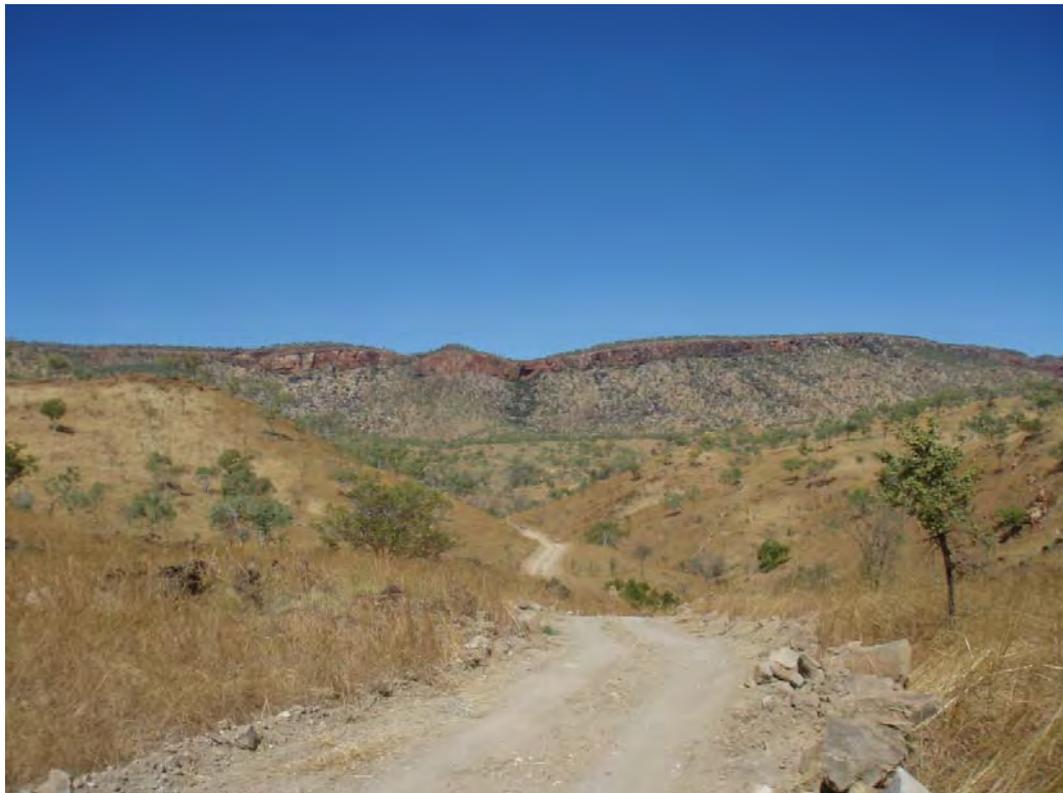
Plate 2.1: Dominant sandstone escarpment which hosts mineralised deposits.

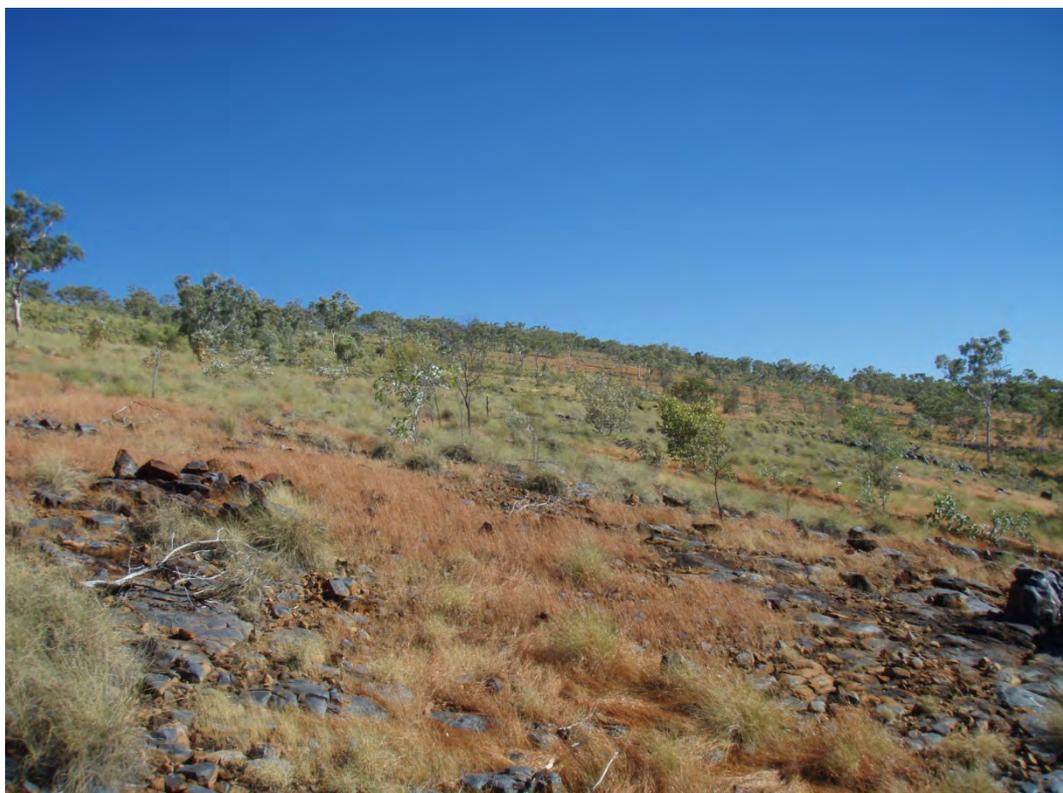
Plate 2.6: Steep linear slope within the Tony Pit area.

In the Tony Pit area the landsurface dips from 650 m west of the proposed pit to 550 m in the east (Figure 2.7). Slopes vary from 15 - 20° (Plate 2.6), and unlike in the Sam Pit area there is no broad valley at the base of the slope (Plate 2.7). At the Tony Pit the linear slope abuts the structural contact with the adjoining unweathered Hensman Sandstone and Golden Gate Siltstone (Plate 2.8). The contact between the steep slope and the unweathered basement rocks creates a defined drainage line which flows south over the edge of the escarpment.

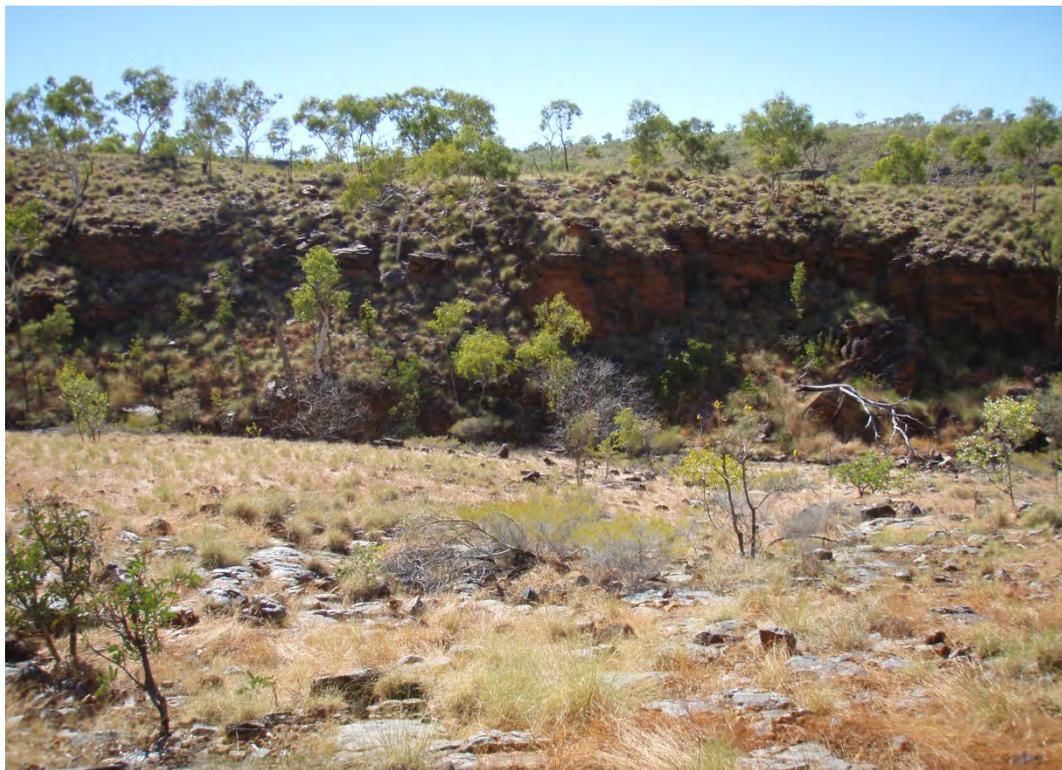
Plate 2.8: Abrupt contact between the steeply dipping landsurface of the Tony Pit area and the remnant structural surface of the Hensman Sandstone and Golden Gate Siltstone.

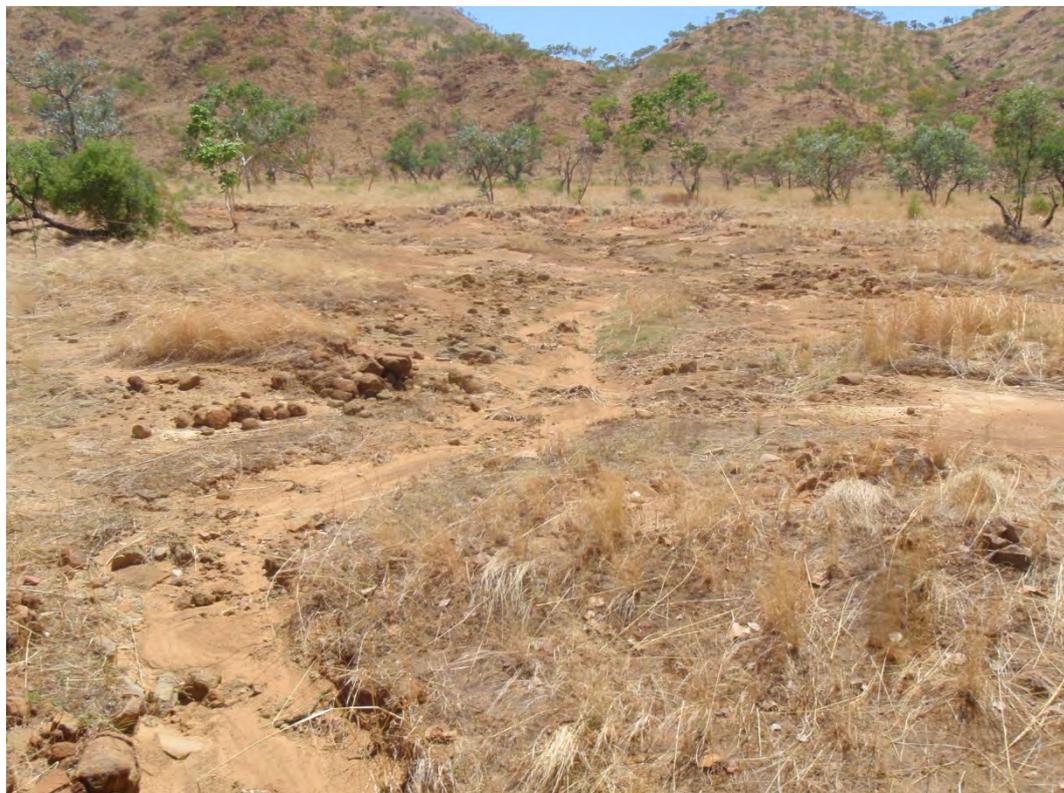
Plate 2.9: Shallow, predominately sandy soils overlying unweathered granitic bedrock within the plain surrounding the escarpment.

Soils within the surrounding plain consist of shallow granitic detritus overlying unweathered granite (Plate 2.9). Granitic outcrops are common through the area creating a gently undulation relief, with the depth of soil cover varying according to slope position. The surface soils are primarily gritty yellow sands with neutral to alkaline pH. Drainage lines within the area consist of weathered, well rounded fragments of granite in a loss sand matrix.

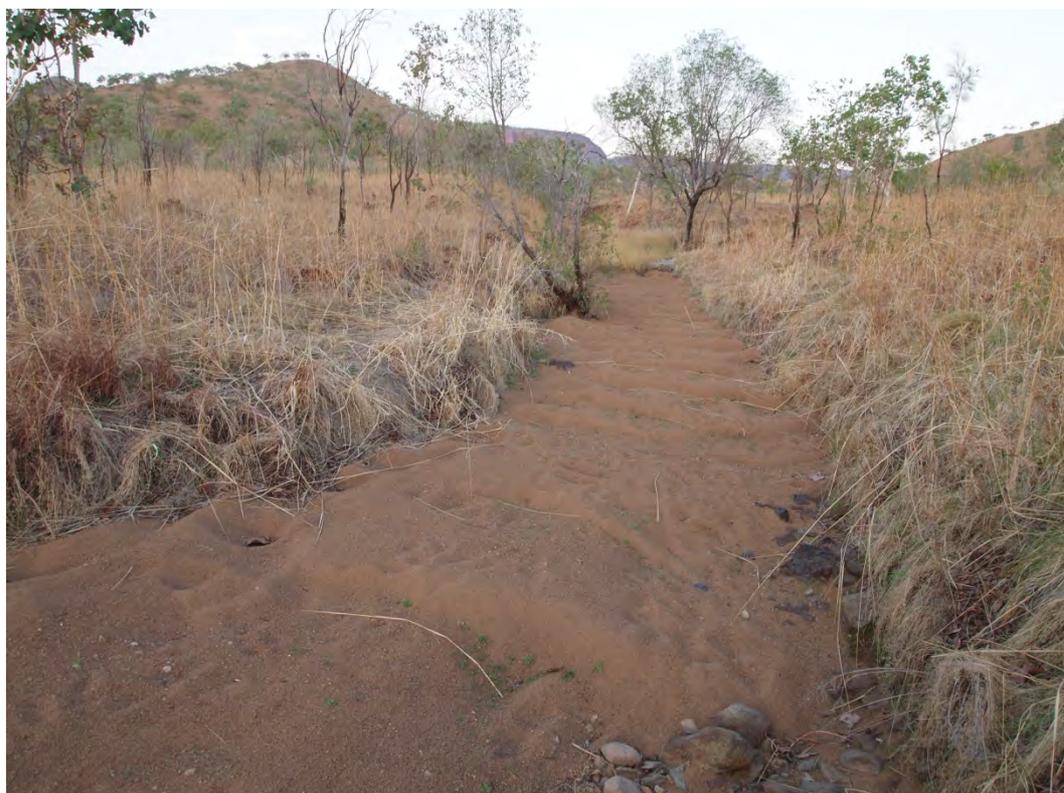
Plate 2.10: Sandy soils within drainage lines in the granite plain area surrounding the escarpment.

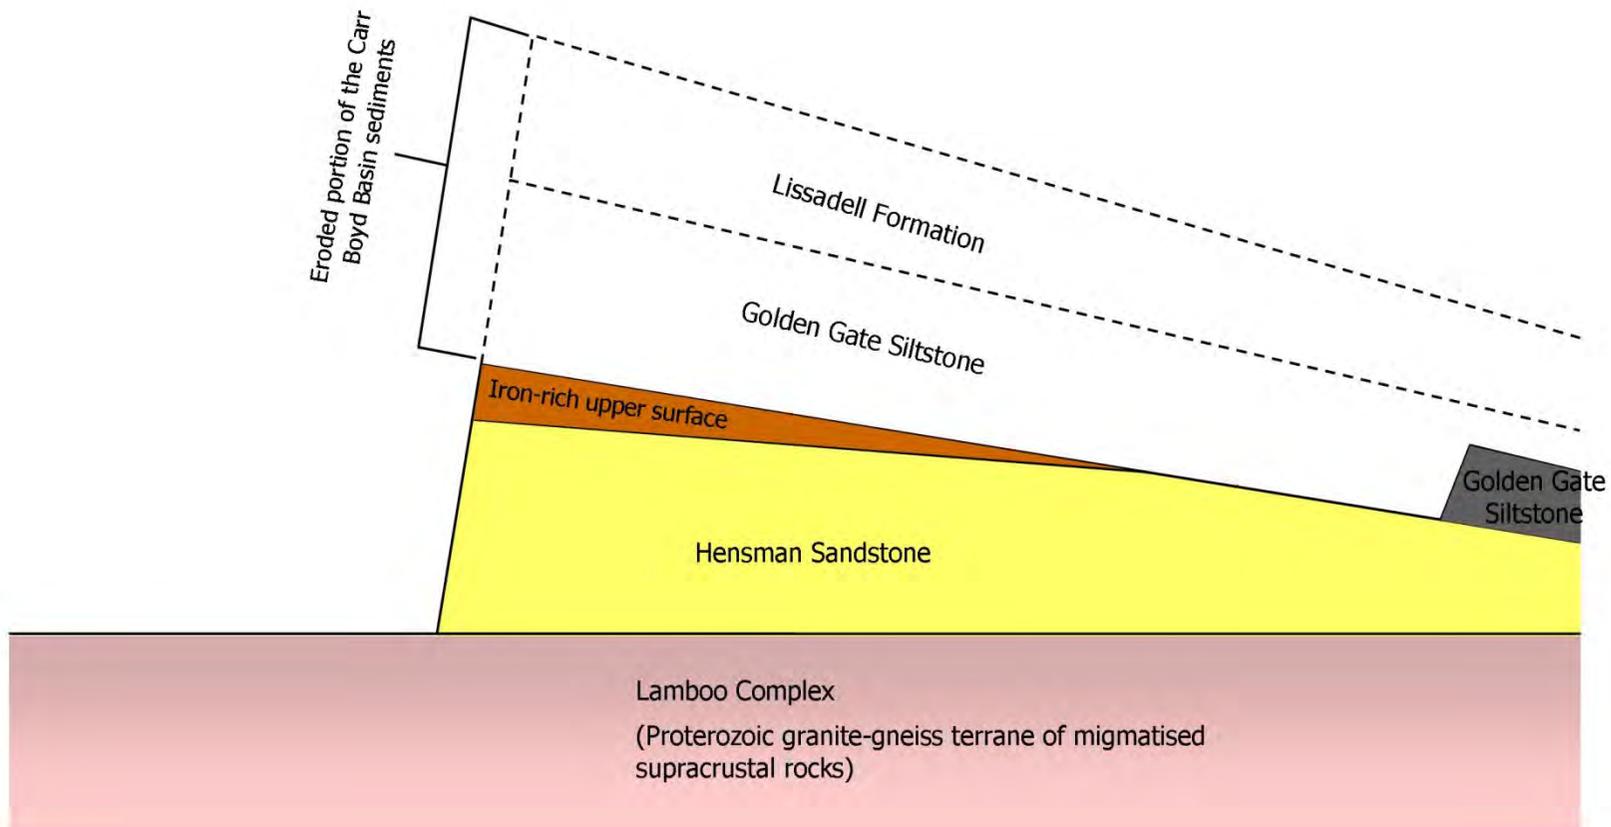
PN	PN0149-1-1-KMG-001		Kimberley Metals Group RIOP SOIL AND WASTE CHARACTERISATION <b>SCHEMATIC GEOLOGICAL CROSS SECTION</b>	<b>Figure 2.9</b>
Prep by	ASP	04/04/10		
Rev'd by	MH	04/04/10		
Revision No.	0

The regional geology covering the RIOP is shown in Figure 2.8, whilst a schematic cross-section is provided in Figure 2.9. The RIOP occurs within the metasediments of the once extensive Carr Boyd Basin, which consists of interbedded sandstone, siltstone and mudstone sequences deposited under a shallow-water environment (Xploray, 2006). These basin sediments were deposited onto the existing Proterozoic granite - gneiss terrane of the Lamboo Complex, which forms the relatively flat granitic plain area surrounding the RIOP.

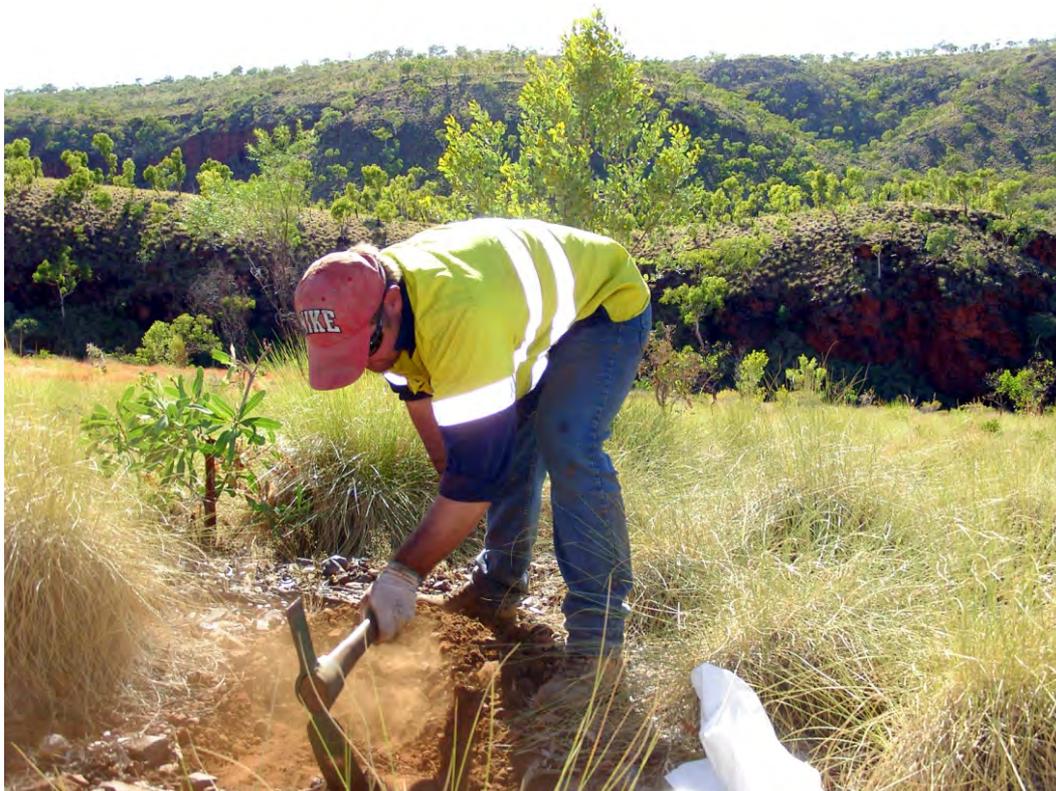
Plate 3.1: Sampling of the surficial soil materials in the proposed disturbance area

Soil samples were collected at regular intervals down the surficial profile to ensure that any pedologic organisation or horizonation was identified and that each of the major soil materials was sampled. Approximately 3 kg of soil was collected for each material for detailed laboratory analysis (Section 3.1.2).

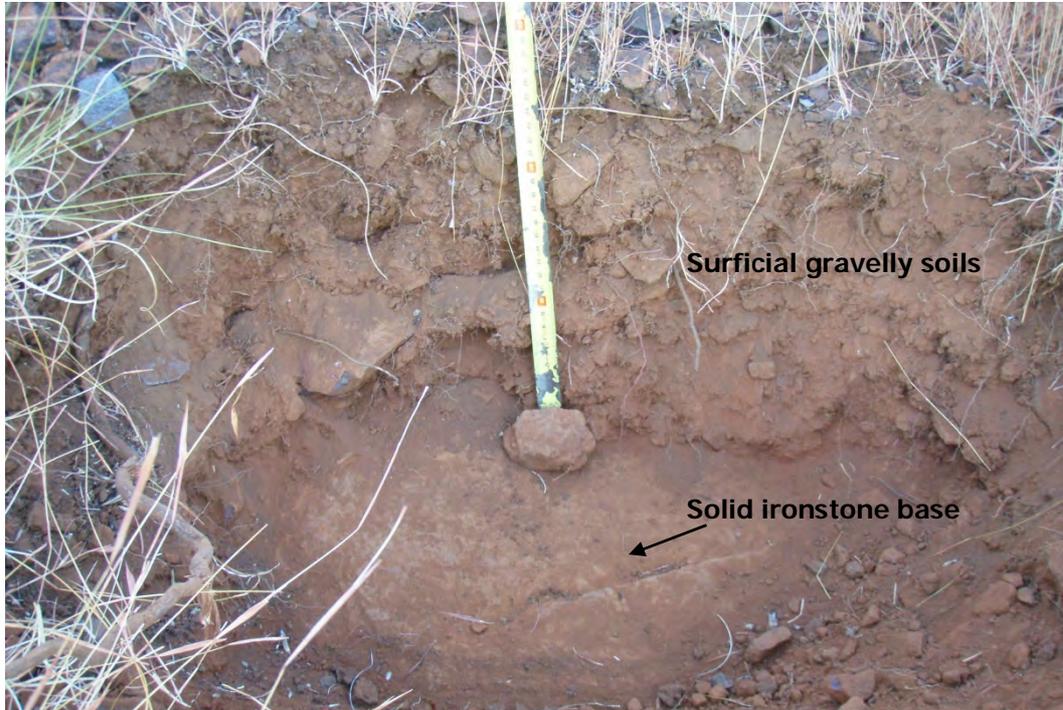
Plate 4.1: Typical soil profile in SMU 1.

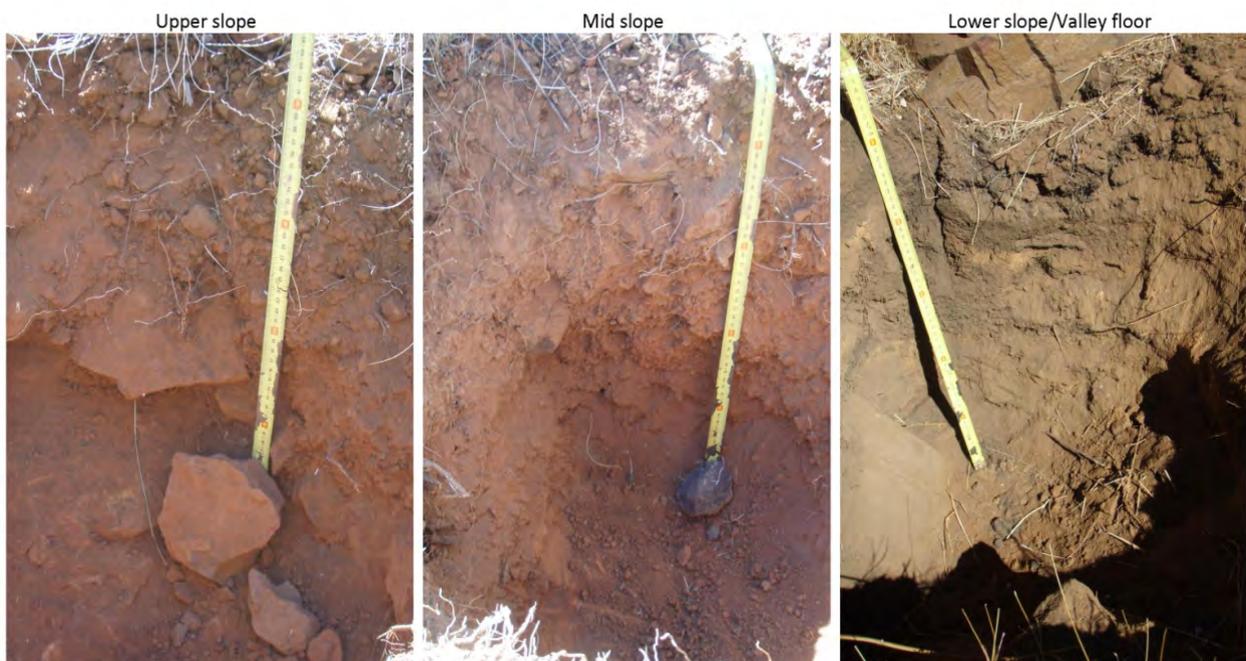
Plate 4.2: Nature of the surficial soils in SMU 1 with distance downslope.

This soil type or SMU occurs over the majority of the proposed mining disturbance area (Figure 4.1). A characteristic soil profile showing the physical and chemical properties of the soils is shown in Figure 4.2. It has negligible pedogenic organisation and consists of 30 to 60+ cm of reddish brown gravelly loamy sand to gravelly sandy loam overlying a solid siltstone or ironstone base (Plate 4.1). The surface soils typically have gravel contents > 60 %, with the gravel fraction loosely set in the finer textured matrix. The particle size distribution within SMU 1 exhibits a defined toposequence, with the gravel fraction and gravel size decreasing with distance downslope and a corresponding increase in the silt and clay content (Table 4.2). This transition in particle size distribution with distance downslope is shown in Plate 4.2.

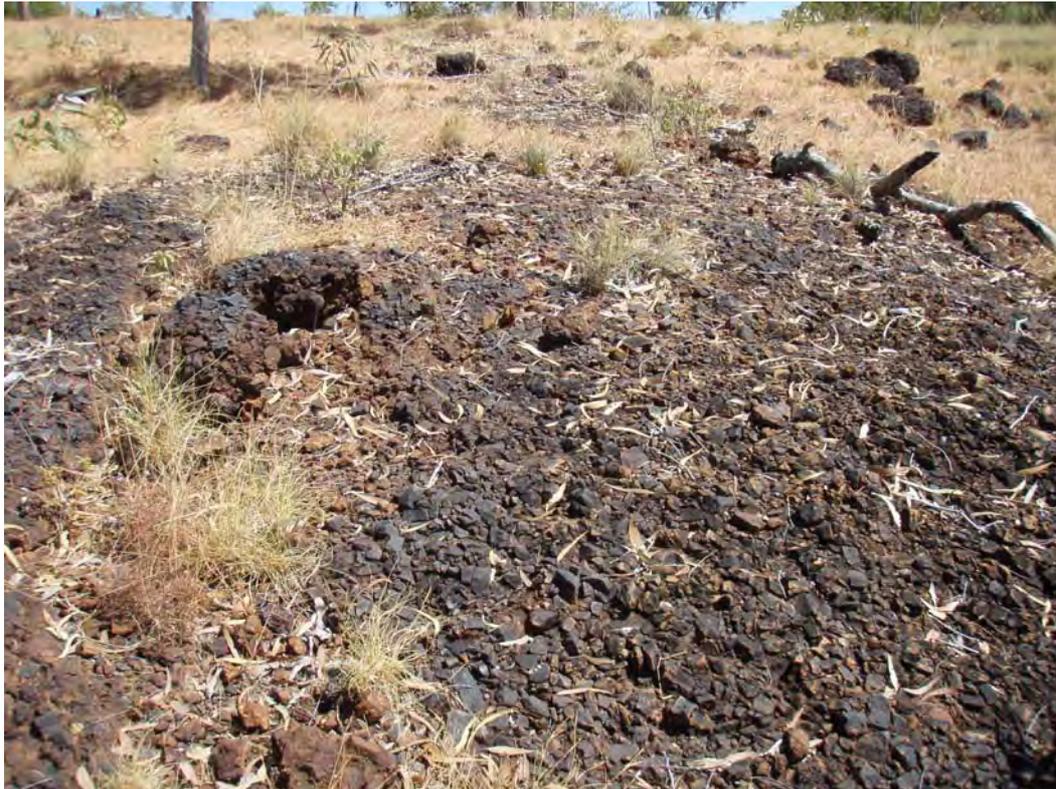
Plate 4.3: Abundance of surface gravels protecting the soils from wind and water erosion.

The high gravel fraction of the surface soils results in them having a high permeability (> 2 m/day). Subsequently, rainfall rapidly infiltrates the soil surface and recharges the soil moisture content, with minimal surface runoff. Any runoff that does occur (i.e. during high intensity storm events) is unlikely to cause significant erosion as the abundance of gravels and ironstone fragments on the surface (Plate 4.3) reduce the slope length and

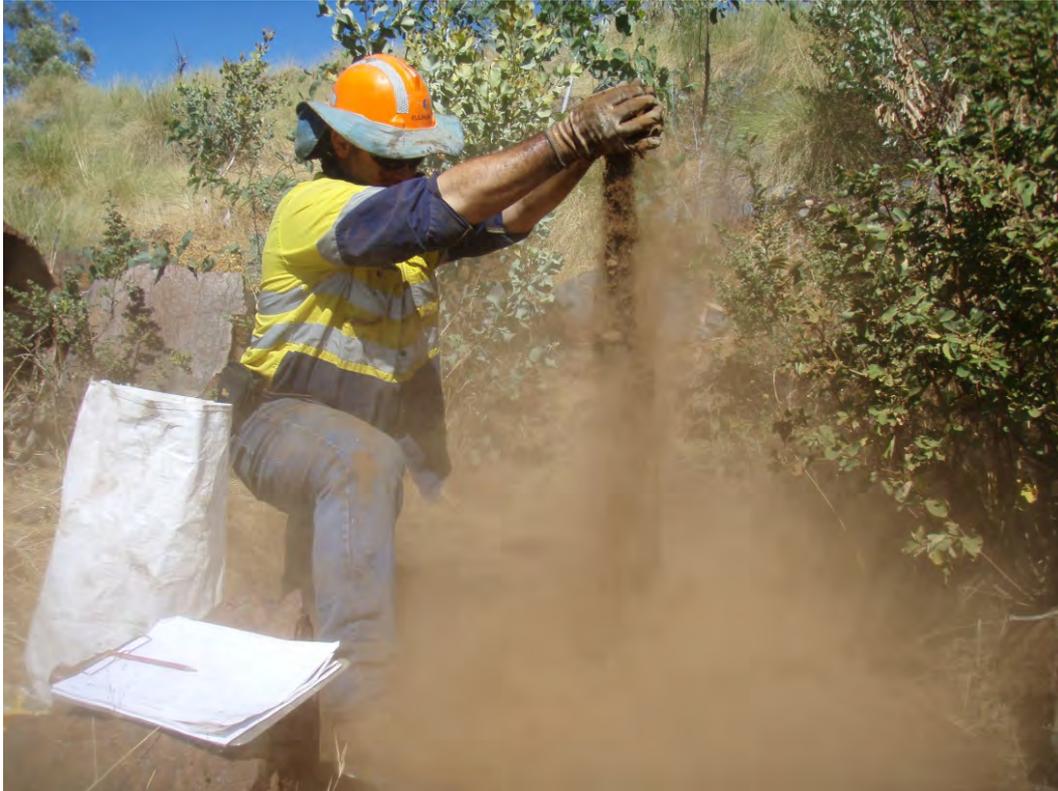
Plate 4.4: High wind erosion potential of the surface soils in SMU 1.

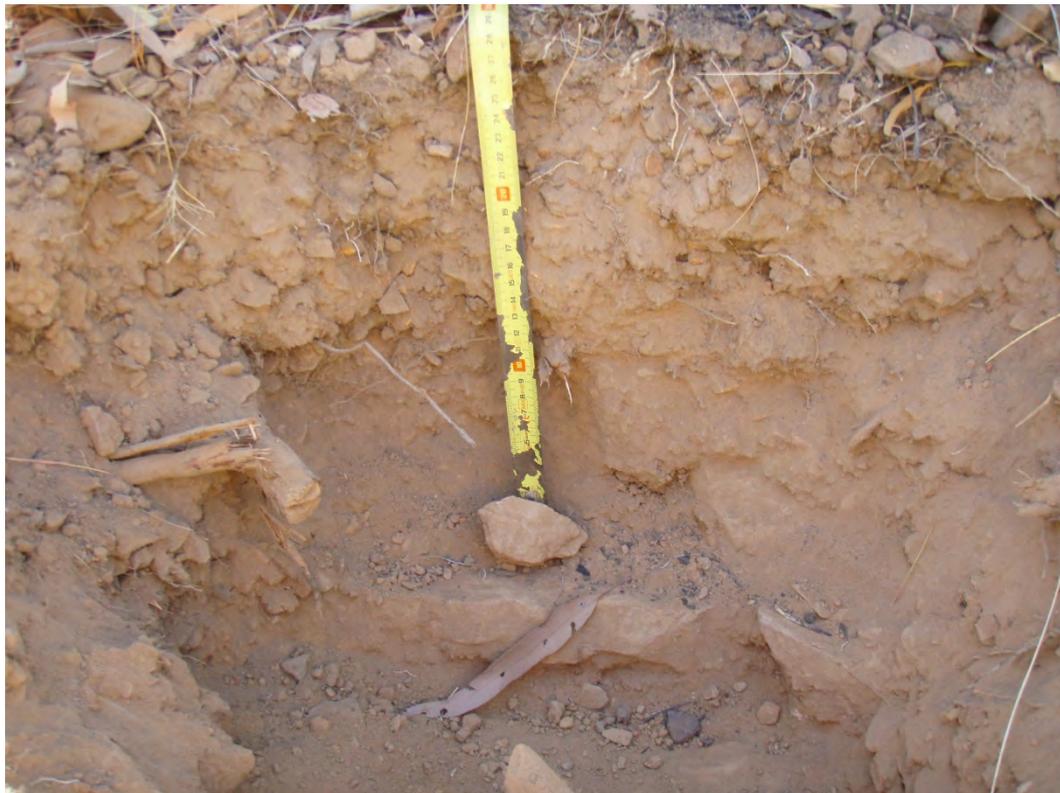
Plate 4.5: Characteristic soil profile in SMU 2.

This soil type represents a truncated version of SMU 1, with the surface gravelly soils having a depth of < 30 cm (Plate 4.5). This SMU occurs in areas of considerable relief (i.e. > 20 ° slope; Plate 4.6), and subsequently the majority of the surface soil profile has been eroded.

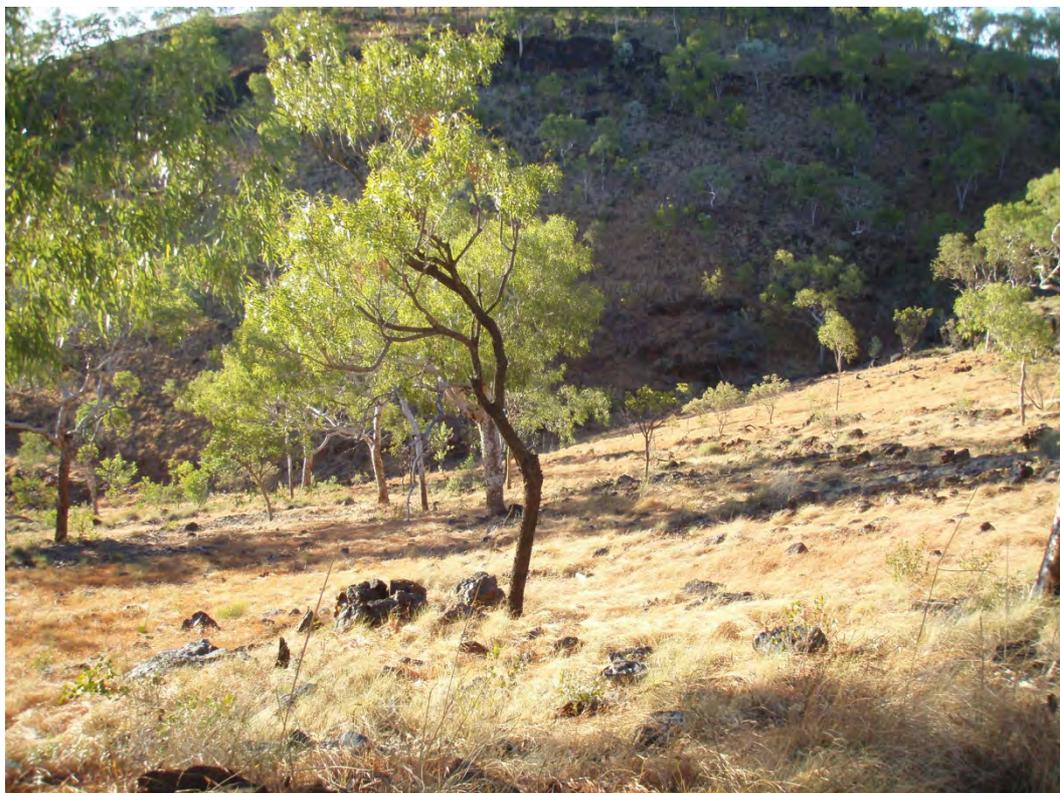
Plate 4.6: Location of SMU 2 on very steep slopes in SMU 1.

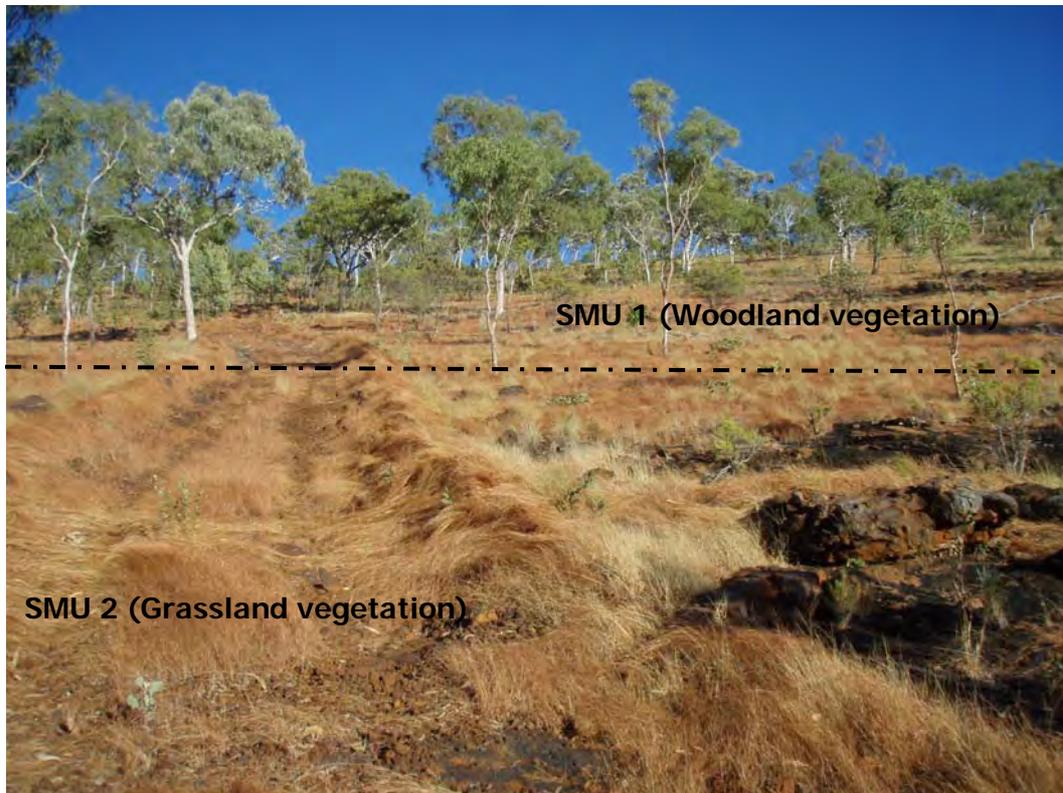
Plate 4.7: Transition from SMU 1 to SMU 2, marked by the change in vegetation structure from woodland to grassland.

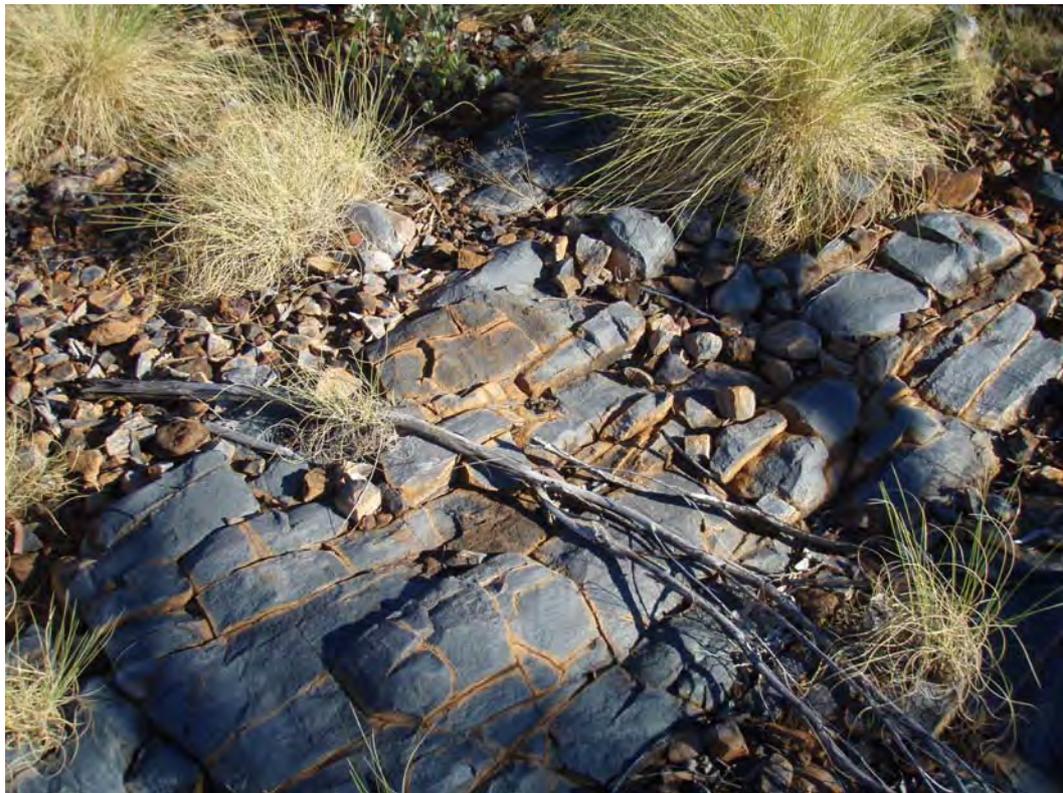
Plate 4.8: Presence of unweathered siltstone at the surface in SMU 3.

This soil type is restricted to the Tony Pit and corresponds to areas where unweathered remnant portions of the Golden Gate Siltstone (Section 2.5) occur at (Plate 4.8) or close to (i.e. < 10 cm of depth; Plate 4.9) the soil surface. The properties of the surficial gravelly soils are similar to those exhibited in SMU 1 and 2, and are slightly to strongly acidic, non-saline, non-sodic, structurally stable and non-erosive (Figure 4.5).

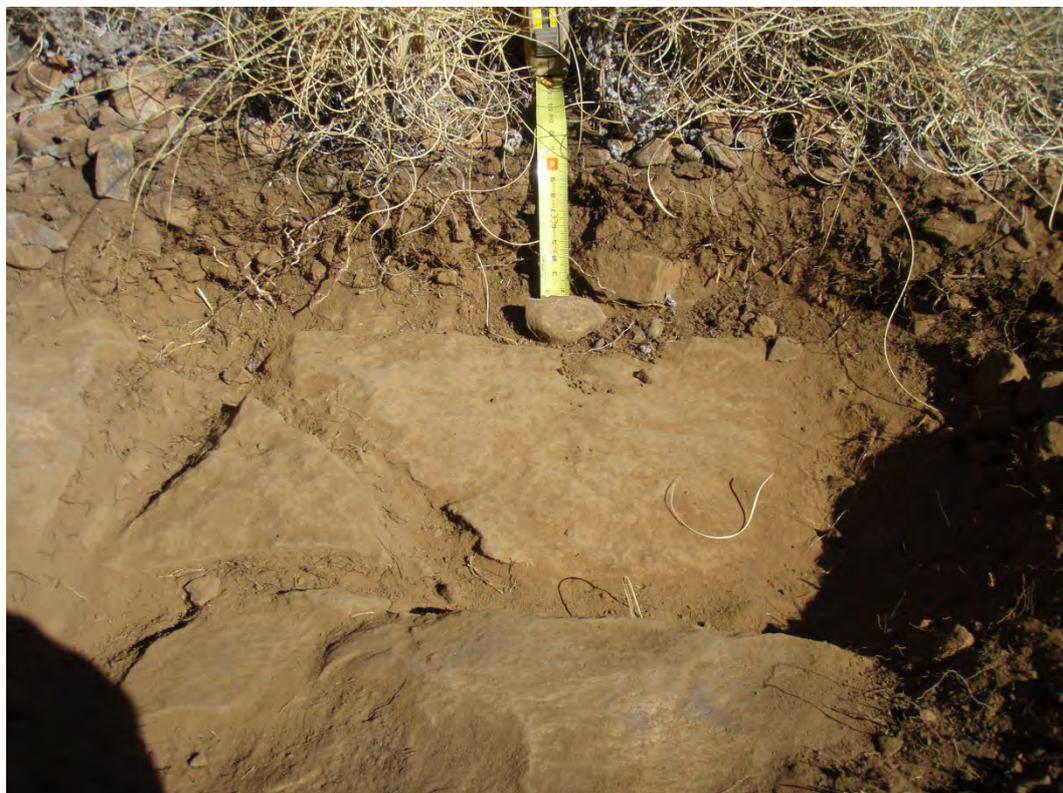
Plate 4.9: Presence of unweathered siltstone within the surface 10 cm of the profile in SMU 3.

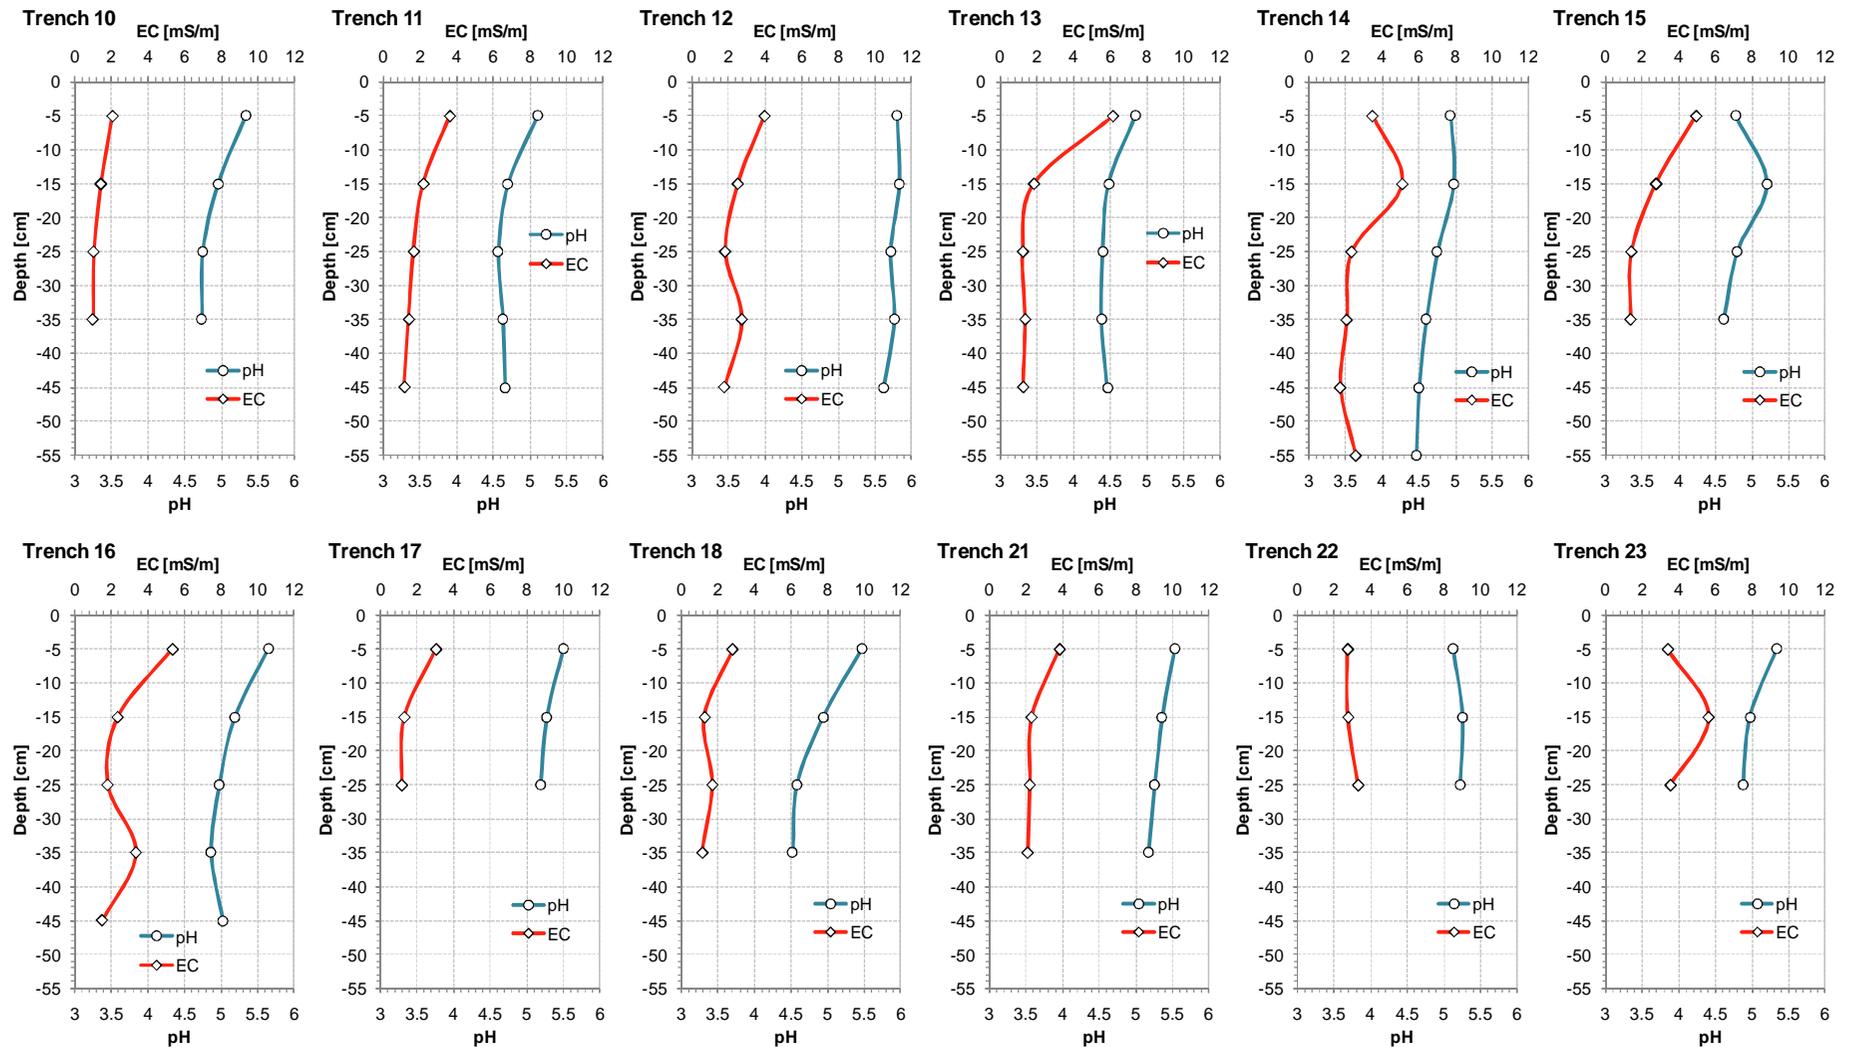
Kimberley Metals Group  
 RIOP SOIL AND WASTE CHARACTERISATION  
**pH AND EC DATA FOR SMU 1 SOILS  
 - SAM PIT**

The surficial gravelly soils in SMU 1 are slightly to very strongly acidic with pH values between 4 and 6 (Figures 4.3 and 4.4). This acidity is to be expected given the highly weathered nature of the soils and the dominance of iron oxides (i.e. ferrollysis results in the release of  $H^+$  ions which cause the pH of the materials to become acidic). All salts have been leached from the surface soils, resulting in EC values  $< 10$  mS/m and sodicity values typically  $< 6$  % (i.e. non-sodic soils; Figure 4.3 and 4.4). The surface soils are therefore structurally stable and non-dispersive.

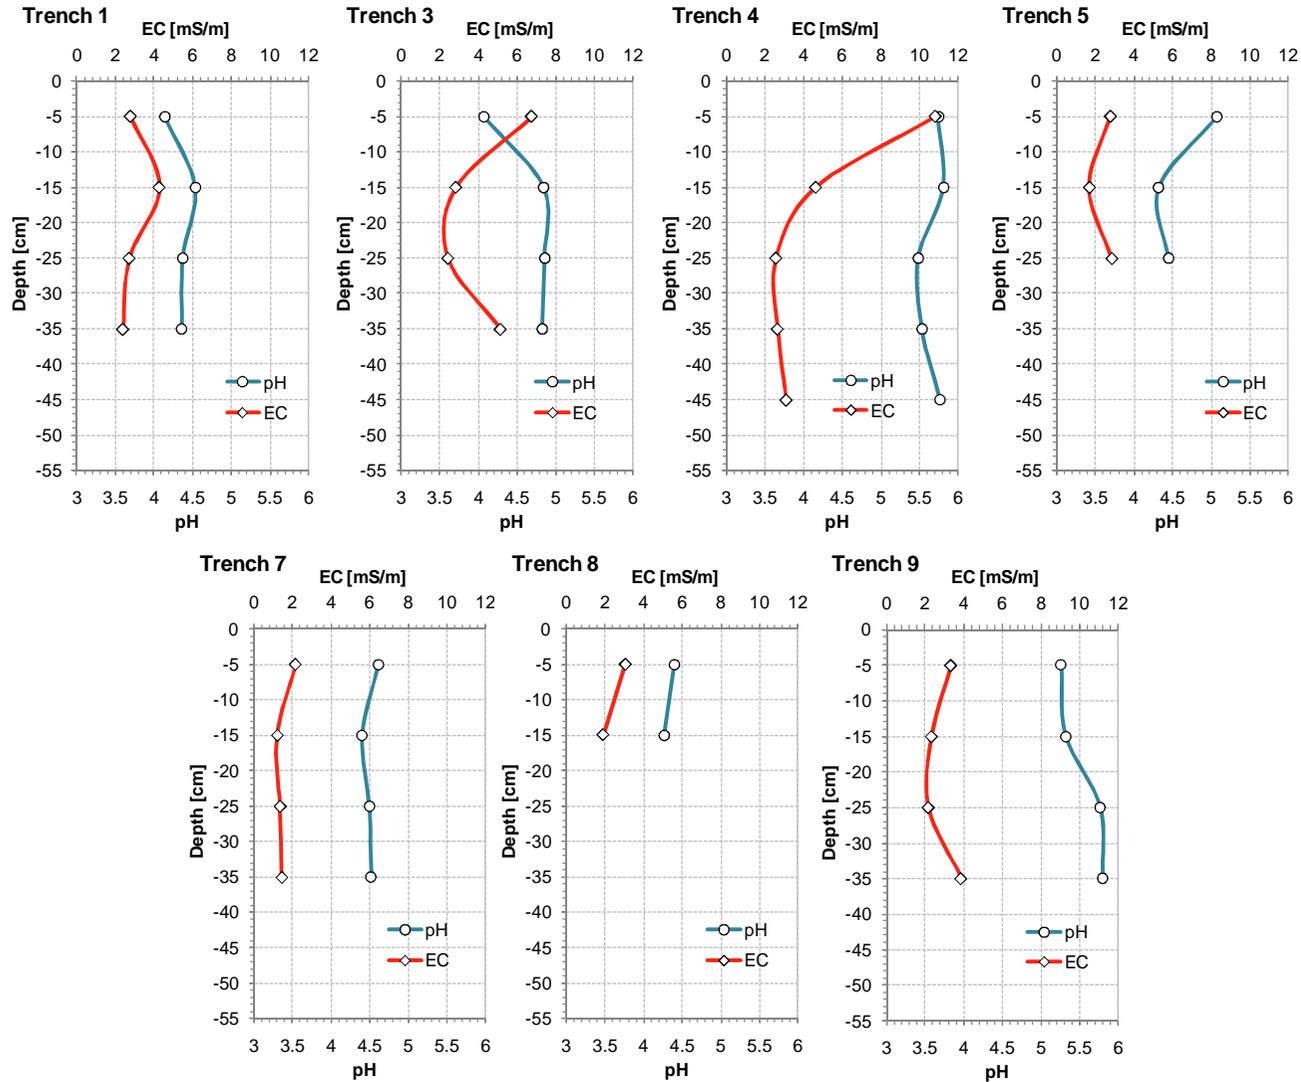
Kimberley Metals Group  
 RIOP SOIL AND WASTE CHARACTERISATION  
**pH AND EC DATA FOR SMU 1 SOILS**  
**- TONY PIT**

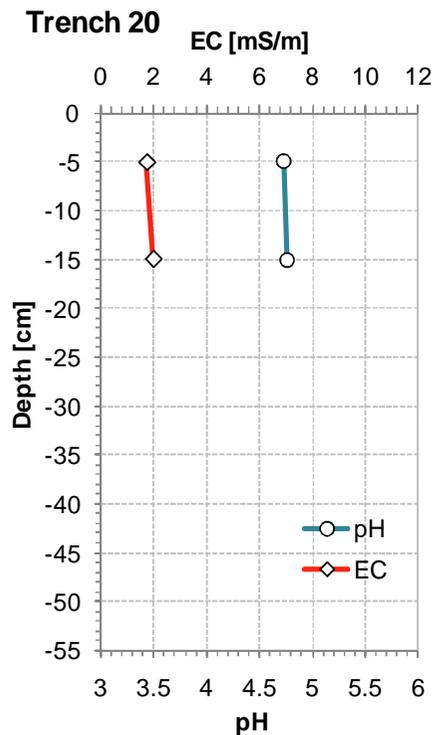
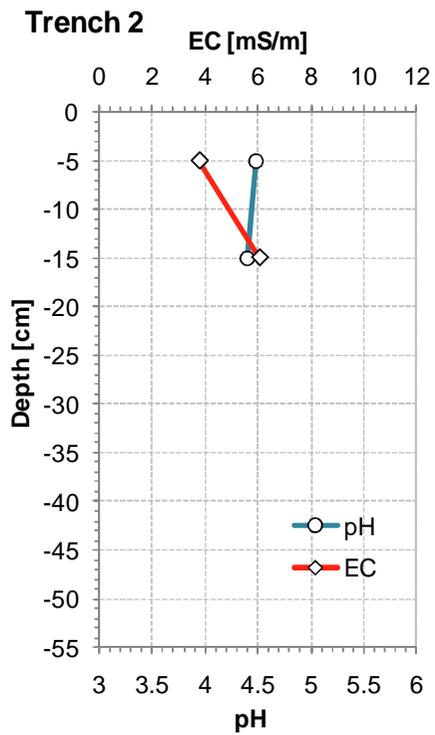
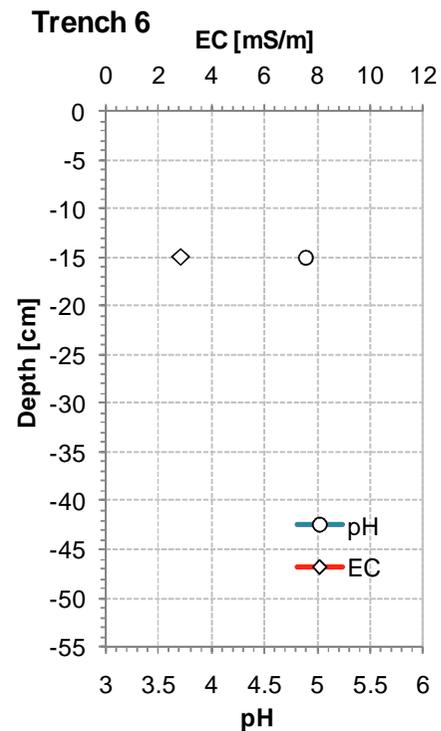
Kimberley Metals Group  
 RIOP SOIL AND WASTE CHARACTERISATION  
**pH AND EC DATA FOR SMU 2 & 3 SOILS**

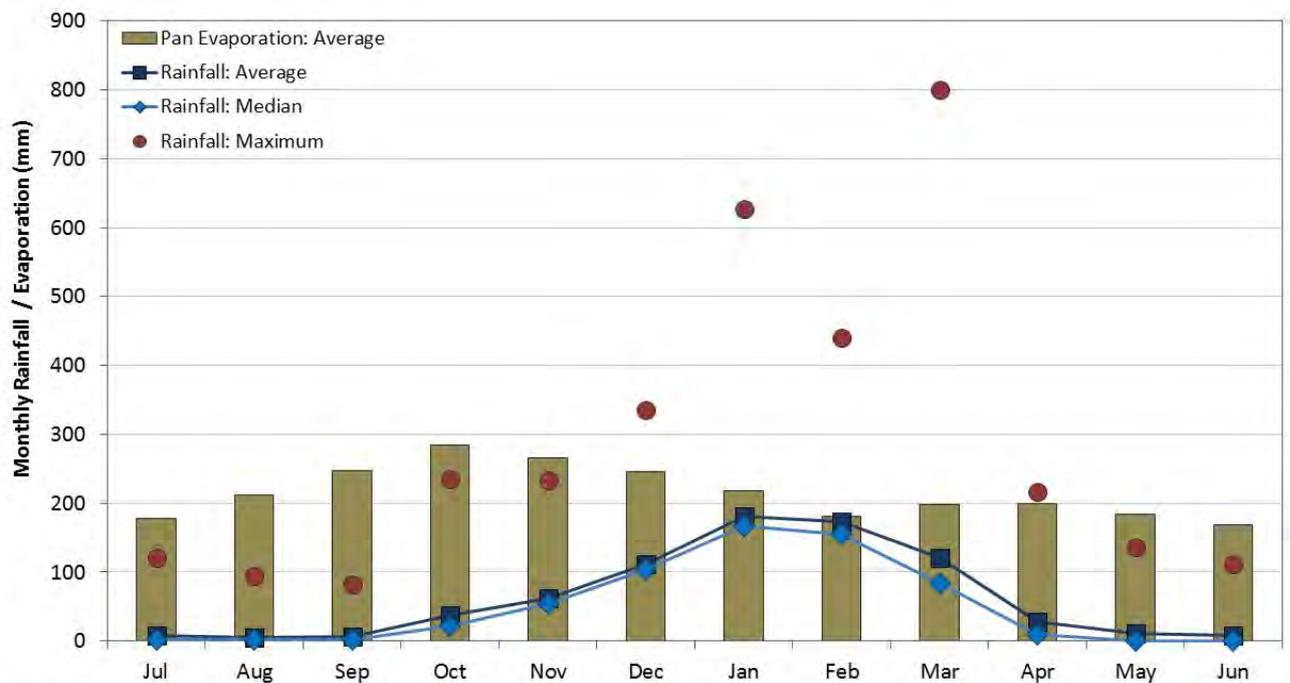
Figure 1: Monthly Rainfall and Evapotranspiration for the Region

The monthly rainfall statistics presented in Table 1 and Figure 1 show that the study area experiences a distinct seasonal distribution of rainfall with a wet summer period (November to March) and a dry winter period (April to October). The available data reflect a high degree of relative variability in extreme rainfall throughout the year, with extreme maximum observed monthly rainfalls exceeding 100 mm during the dry season and from 600 mm to 800 mm during the wet season.

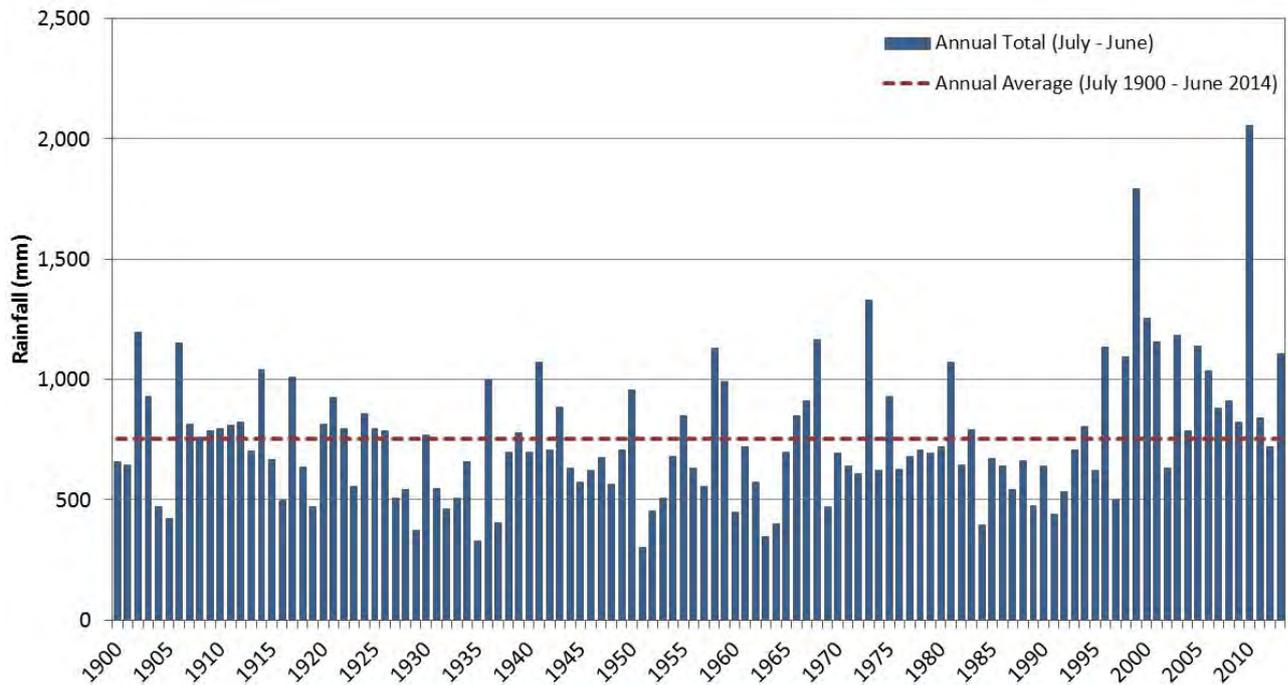
Figure 2: Annual Total and Annual Average Rainfall at the Matsu Project Study Area (July 1900 – June 2014)

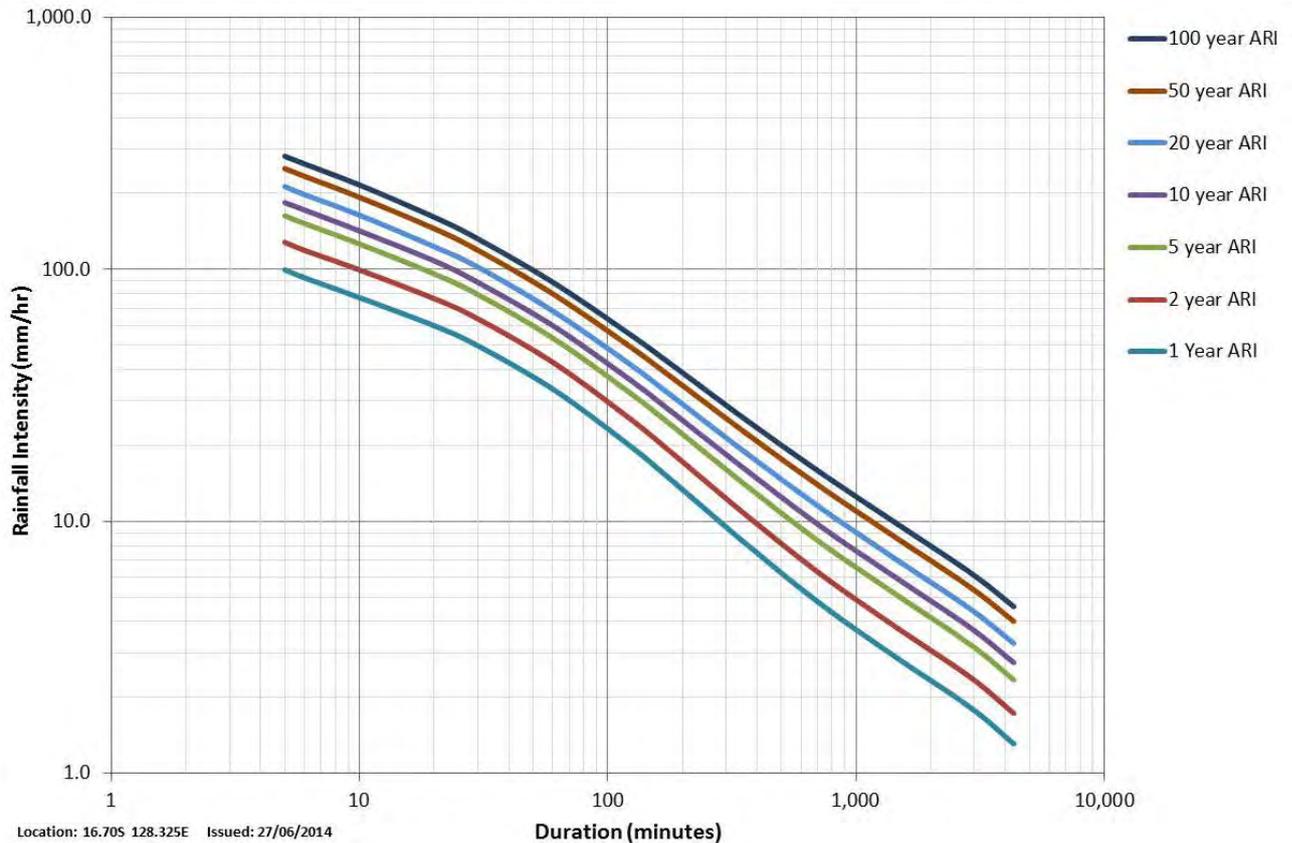
Figure 3: IFD Curves for the Matsu Project Study Area

Although design IFD rainfall data and subsequent estimates of peak flood discharges can be calculated for the range of ARI events, the 100 year ARI peak event is commonly adopted as the design criteria standard for projects such as the Matsu Project. This design condition provides a very high level of flood protection (e.g. 1% chance of being equalled or exceeded in any one year) and is consistent with the requirements of the DMP for the assessment of flood potential and drainage design in the preparation of mining proposals (DMP, 2006).
