**PROPOSED SAND EXTRACTION
LOT 510 OLD LEDGE POINT ROAD, LANCELIN
ENVIRONMENTAL ASSESSMENT**

Report No. J20013B
25 March 2021

**BAYLEY ENVIRONMENTAL SERVICES
30 Thomas Street
SOUTH FREMANTLE WA 6162**

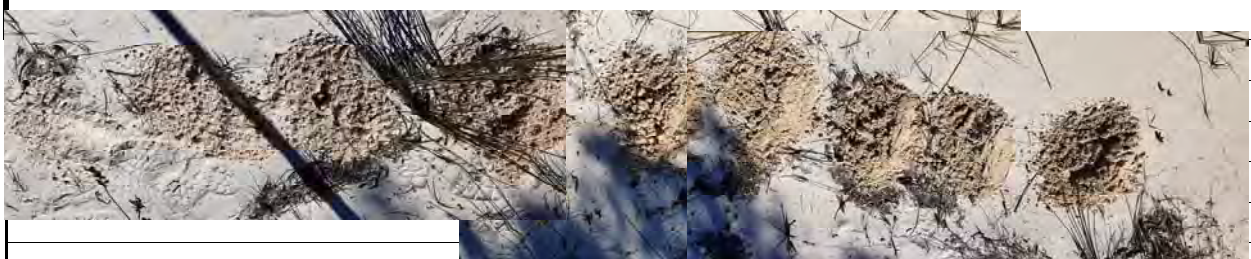
PROJECT NUMBER:	J20013
SITE ID:	IC1
EASTING:	343228
NORTHING:	6562018
METHOD:	Auger Rig
TOTAL DEPTH (mbgl):	6.0
REFUSAL (Y/N):	N
DATE:	18/02/2020
DEPTH TO WATER (mbgl)

SOIL PROFILE		SAMPLE DATA	
DEPTH (m)	SOIL DESCRIPTION	SAMPLE ID	INTERVAL (m)
0 - 6	Grey-white sand

Drilling at ten sites on the perimeter and within the site found a white to pale grey to pale yellow sandy soil profile to between 3.5m and 6m. Limestone was reported in one borehole at a depth of 9.5m (-5.6m AHD) during previous drilling. Figure 2 shows the locations of the drilling sites. Appendix A shows bore logs from the drilling.

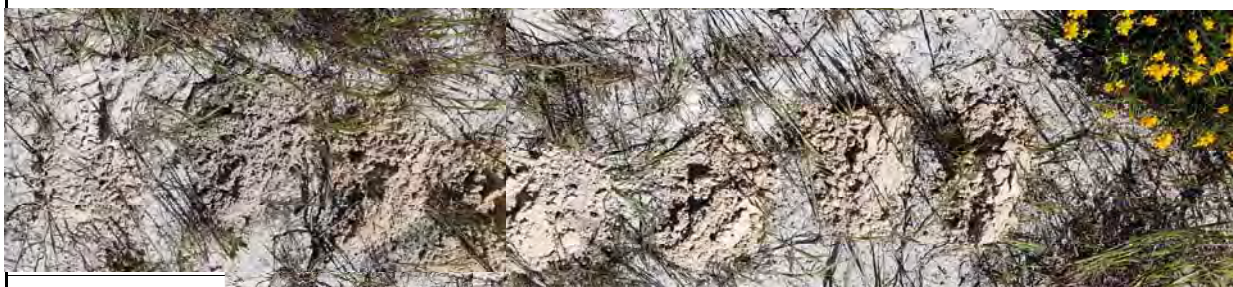
PROJECT NUMBER:	J20013
SITE ID:	IC2
EASTING:	343298
NORTHING:	6561858
METHOD:	Auger Rig
TOTAL DEPTH (mbgl):	6.0
REFUSAL (Y/N):	N
DATE:	18/02/2020
DEPTH TO WATER (mbgl)

SOIL PROFILE		SAMPLE DATA	
DEPTH (m)	SOIL DESCRIPTION	SAMPLE ID	INTERVAL (m)
0 - 1	V pale grey - white sand		
1 - 1.5	Pale grey-brown sand		
1.5 - 6	Very pale yellow-brown sand

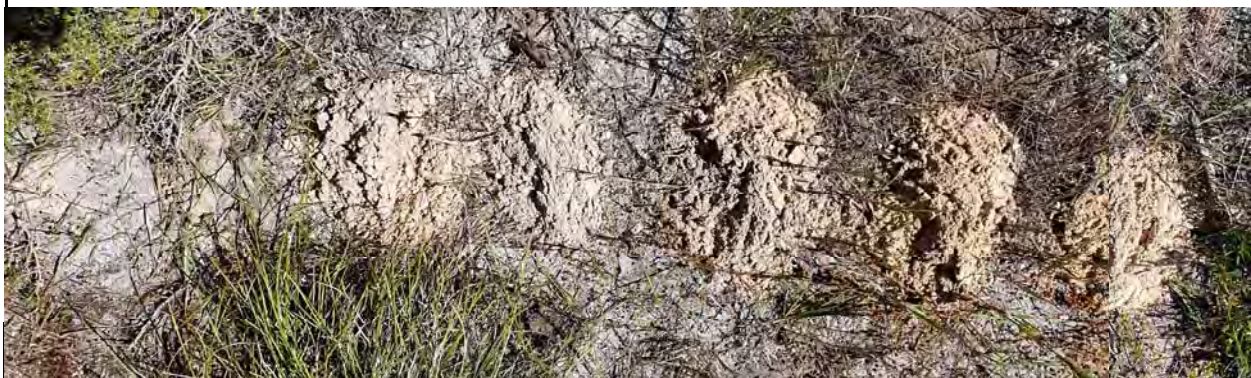
PROJECT NUMBER:	J20013
SITE ID:	IC3
EASTING:	343482
NORTHING:	6561522
METHOD:	Auger Rig
TOTAL DEPTH (mbgl):	5.0
REFUSAL (Y/N):	N
DATE:	18/02/2020
DEPTH TO WATER (mbgl)

SOIL PROFILE		SAMPLE DATA	
DEPTH (m)	SOIL DESCRIPTION	SAMPLE ID	INTERVAL (m)
0 - 0.5	Grey-brown sand		
0.5 - 5	Pale yellow-brown sand

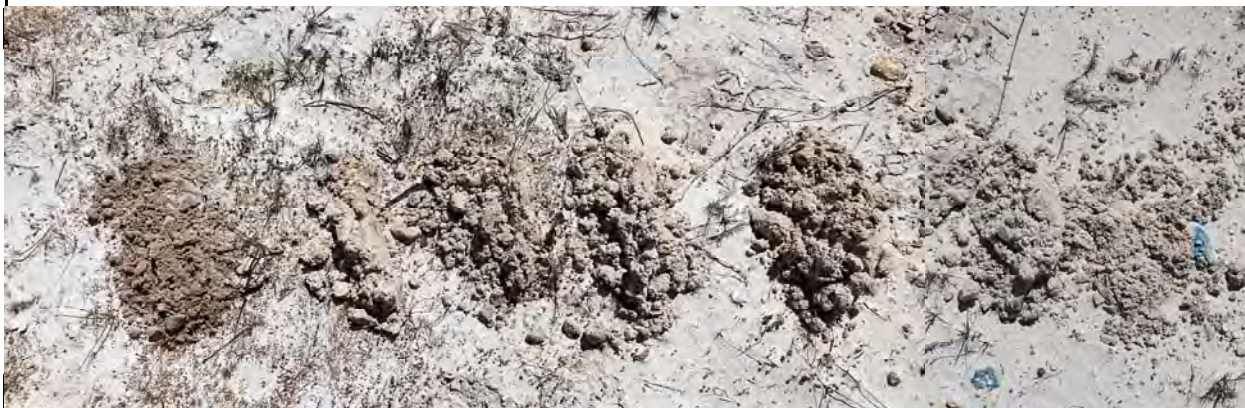
PROJECT NUMBER:	J20013
SITE ID:	IC4
EASTING:	342765
NORTHING:	6562043
METHOD:	Auger Rig
TOTAL DEPTH (mbgl):	3.5
REFUSAL (Y/N):	N
DATE:	18/02/2020
DEPTH TO WATER (mbgl)

SOIL PROFILE		SAMPLE DATA	
DEPTH (m)	SOIL DESCRIPTION	SAMPLE ID	INTERVAL (m)
0 - 0.5	Pale brown sand		
0.5 - 3.5	Very pale grey sand, wet from 1m

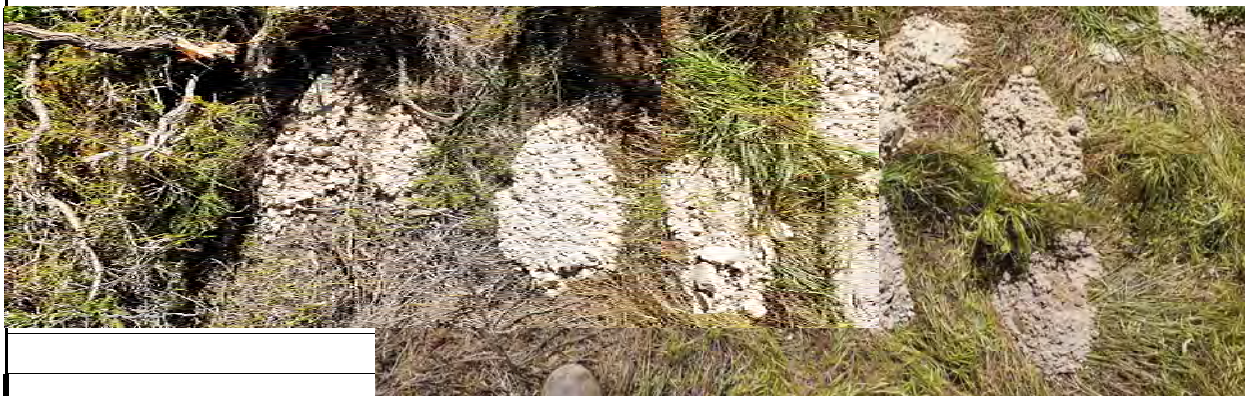
PROJECT NUMBER:	J20013
SITE ID:	IC5
EASTING:	343191
NORTHING:	6561624
METHOD:	Auger Rig
TOTAL DEPTH (mbgl):	6.0
REFUSAL (Y/N):	N
DATE:	18/02/2020
DEPTH TO WATER (mbgl)

SOIL PROFILE		SAMPLE DATA	
DEPTH (m)	SOIL DESCRIPTION	SAMPLE ID	INTERVAL (m)
0 - 1	Pale grey sand		
1 - 6	Very pale yellow sand

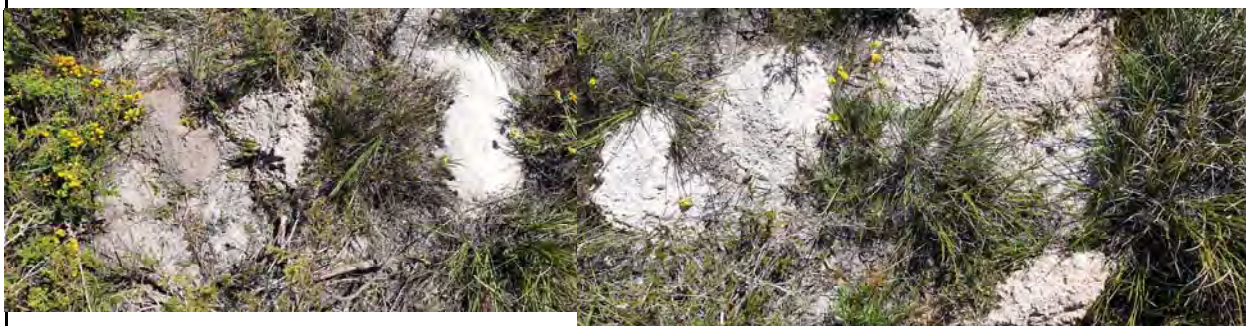
PROJECT NUMBER:	J20013
SITE ID:	ICR1
EASTING:	343288
NORTHING:	6561595
METHOD:	Auger Rig
TOTAL DEPTH (mbgl):	7.5
REFUSAL (Y/N):	N
DATE:	18/02/2020
DEPTH TO WATER (mbgl)

SOIL PROFILE		SAMPLE DATA	
DEPTH (m)	SOIL DESCRIPTION	SAMPLE ID	INTERVAL (m)
0 - 0.5	Pale grey sand		
0.5 - 1	Pale grey-brown sand		
1 - 2	Very pale yellow-white sand		
3 - 7.5	Pale grey sand

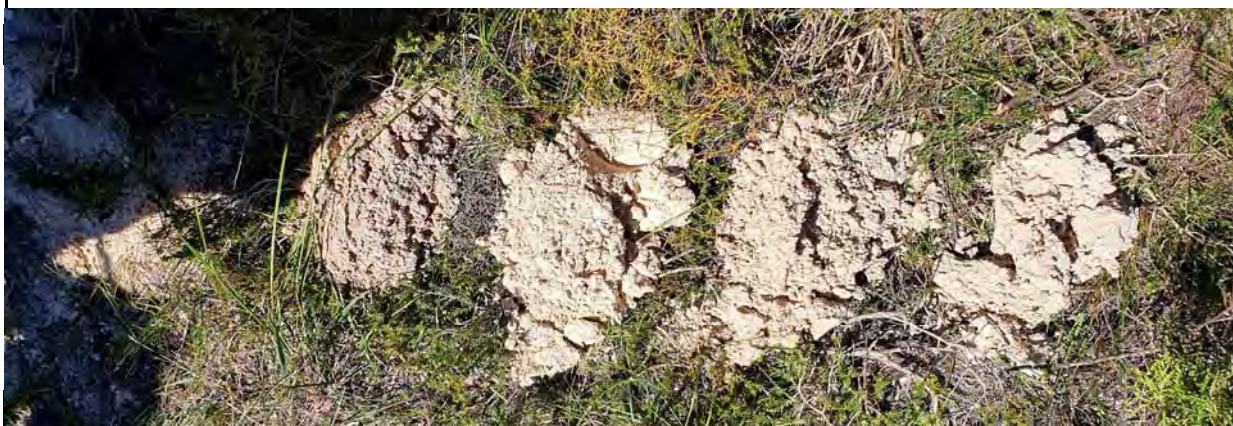
PROJECT NUMBER:	J20013
SITE ID:	ICR2
EASTING:	343136
NORTHING:	6561782
METHOD:	Auger Rig
TOTAL DEPTH (mbgl):	4.0
REFUSAL (Y/N):	N
DATE:	18/02/2020
DEPTH TO WATER (mbgl)

SOIL PROFILE		SAMPLE DATA	
DEPTH (m)	SOIL DESCRIPTION	SAMPLE ID	INTERVAL (m)
0 - 1	Pale grey-brown sand		
1 - 2	Pale yellow-brown sand		
2 - 4	Pale grey sand, wet at 4m

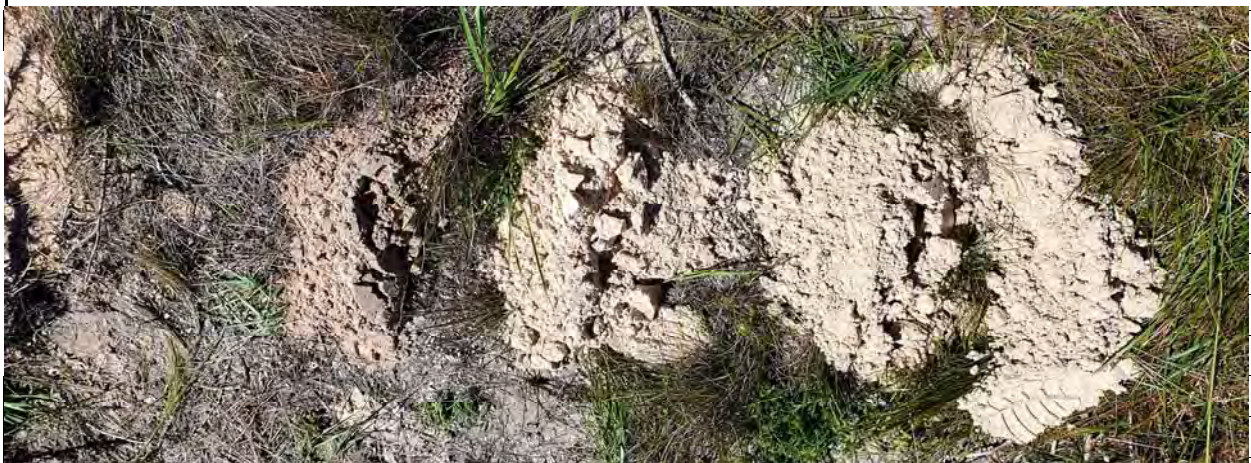
PROJECT NUMBER:	J20013
SITE ID:	ICR3
EASTING:	343101
NORTHING:	6561894
METHOD:	Auger Rig
TOTAL DEPTH (mbgl):	4.0
REFUSAL (Y/N):	N
DATE:	18/02/2020
DEPTH TO WATER (mbgl)

SOIL PROFILE		SAMPLE DATA	
DEPTH (m)	SOIL DESCRIPTION	SAMPLE ID	INTERVAL (m)
0 - 1	Grey-brown sand		
1 - 4	Pale yellow-brown sand

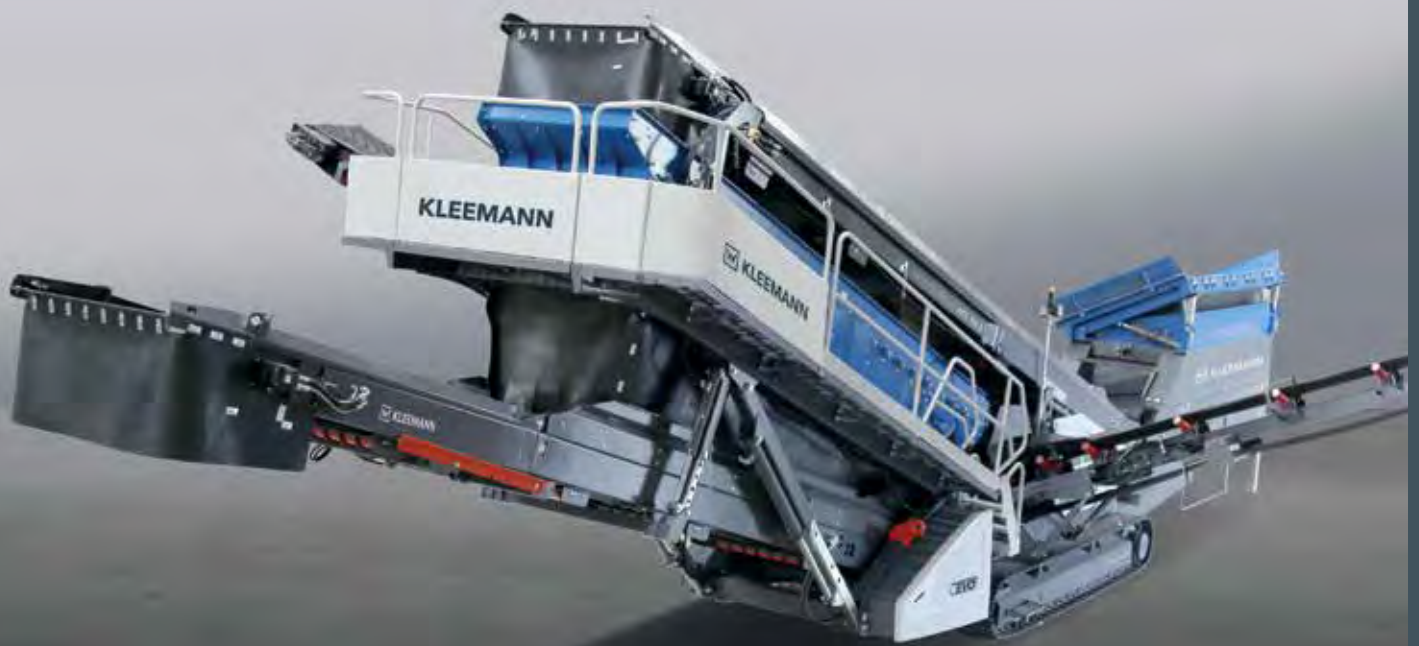
MOBISCREEN MS 952 EVO

TECHNICAL SPECIFICATIONS | TRACK-MOUNTED SCREENING PLANT

- ▣ Double-deck screening unit
- ▣ Diesel-hydraulic drive
- ▣ Classifying screen
- ▣ Max. feed size: 150 mm
