RE: Forrestdale Business Park West – Clearing Permit Application for the corner of Southern River Road and Ranford Road

1 Background

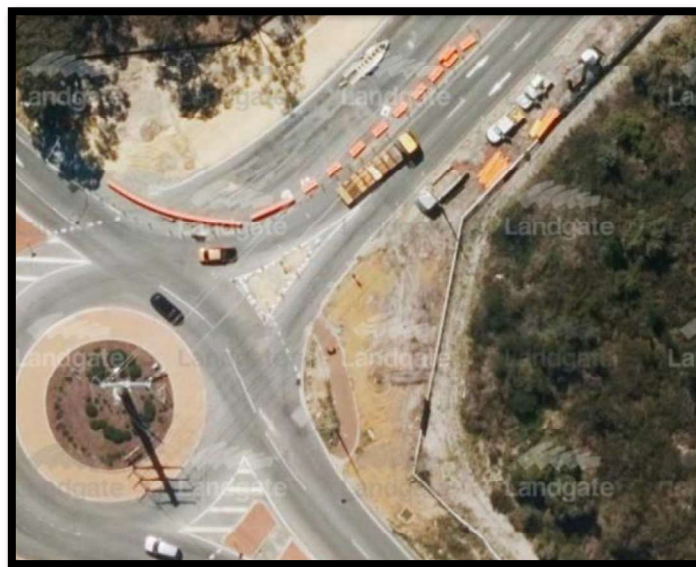
Plate 2: Aerial Photograph September 2015

Examination of historic aerial photographs reveals that the road reserve in this location was completely cleared in late 2015 as part of earthworks for the duplication of Southern River Road (Plate 2). The 2017 aerial photo shows that the area appears to have been landscaped (Plate 3). Two small trees can be seen very close to the fenceline, with one that appears to be right at the southern bend in the fence.

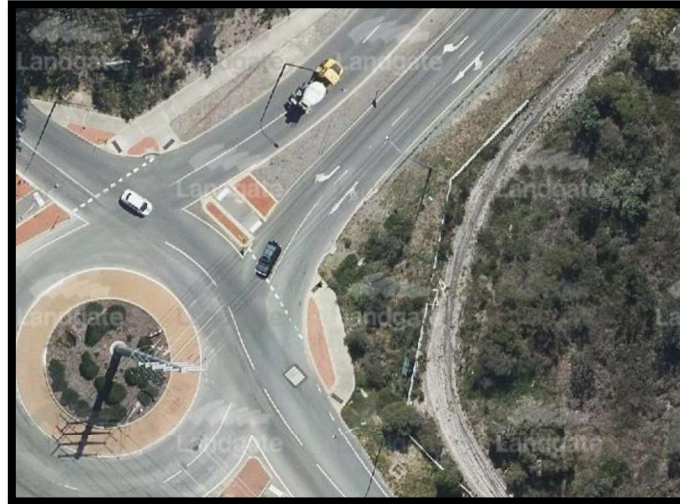
Plate 4: Aerial Photograph October 2020

Vegetation cover in the area increased since 2017 as shown in the aerial from October 2020 (Plate 4).

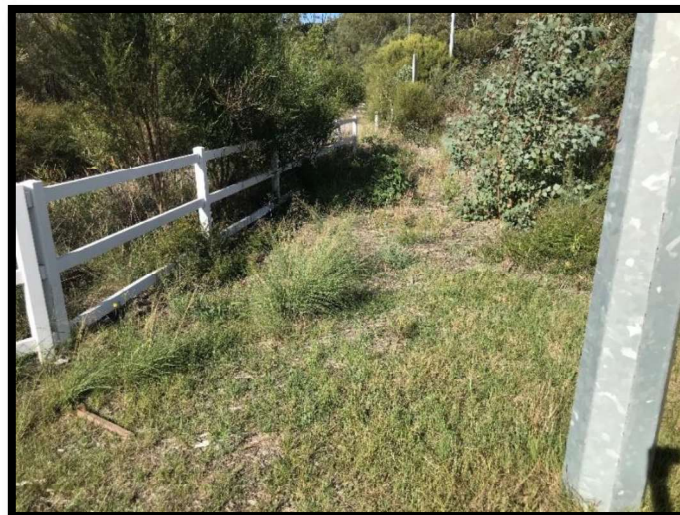
Plate 5: Weeds in the northern part of the area

Weed species were mostly African Lovegrass (*Eragrostis curvula*) and Couch Grass (*Cynodon dactylon*) with some Flatweed (*Hypochaeris glabra*) and Geraldton Carnation Weed (*Euphorbia terracina*) (Plate 5). The introduced weedy shrub *Acacia longifolia* is also present.

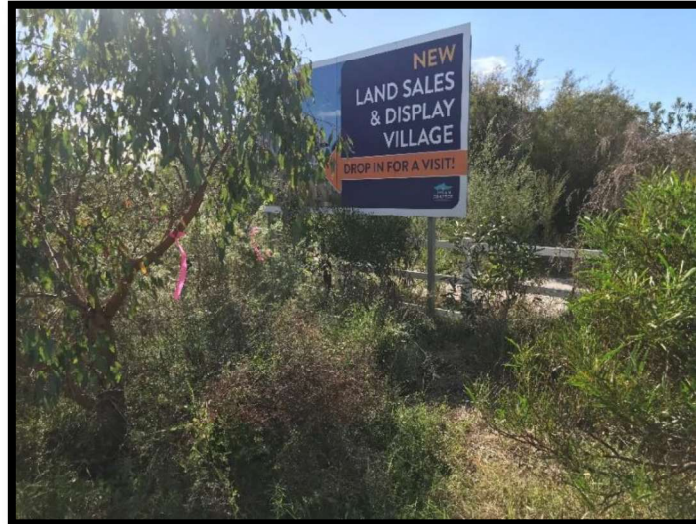
Plate 6: Regrowth native Flooded Gum and Jacksonia furcellata

Some native plants have regrown in the area, mostly young Flooded Gum saplings (*Eucalyptus rudis*) and *Jacksonia furcellata* and *Kunzea glabrescens* shrubs (Plate 6). The shrub at the southern fence corner seen in the 2017 aerial photograph is a native Paperbark (*Melaleuca preissiana*) about 4m high (Plate 7).

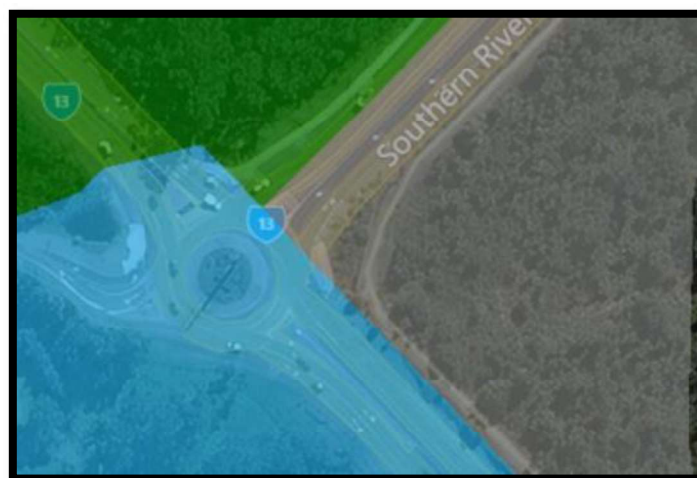
Plate 8: Wetland mapping

There are no watercourses that intersect the application area. A small part of Balannup Lake Multiple Use Wetland (UFI 14404) is mapped on the edge of the site and over the constructed Ranford Road (Plate 8). The wetland is highly modified and the clearing will not further impact on the wetland values.
