Proposed Access Track at Kahana Park, Butler

***Native Vegetation Clearing Permit Application
Supporting Documentation***

June 2021

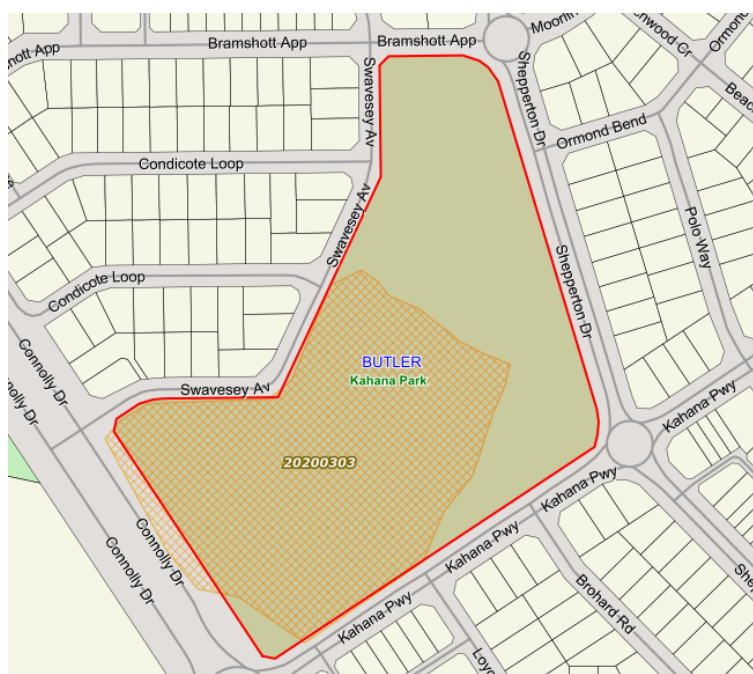
Figure 1: Map of arson fire within Kahana Park, occurring 3 March 2020 (red line – boundary of park; orange shading – arson burn area).

The construction of the access track has been prioritised by the City of Wanneroo as part of the City's Capital Works Program. In March 2020, an arson fire occurred within Kahana Park, burning a large portion of the western side of the Park (Figure 1). Due to the lack of an access track within this section of the park, Emergency Services were unable effectively access the area to contain and control the fire, resulting in the burning of a large portion of vegetation within the park. The aim of this project is to provide for an access track within the larger western portion of Kahana Park, to allow effective access for park maintenance, and fire mitigation, prevention and fighting activities.
