Dieback and Invasive Weed Management Plan CPS 9341/1

December 2021

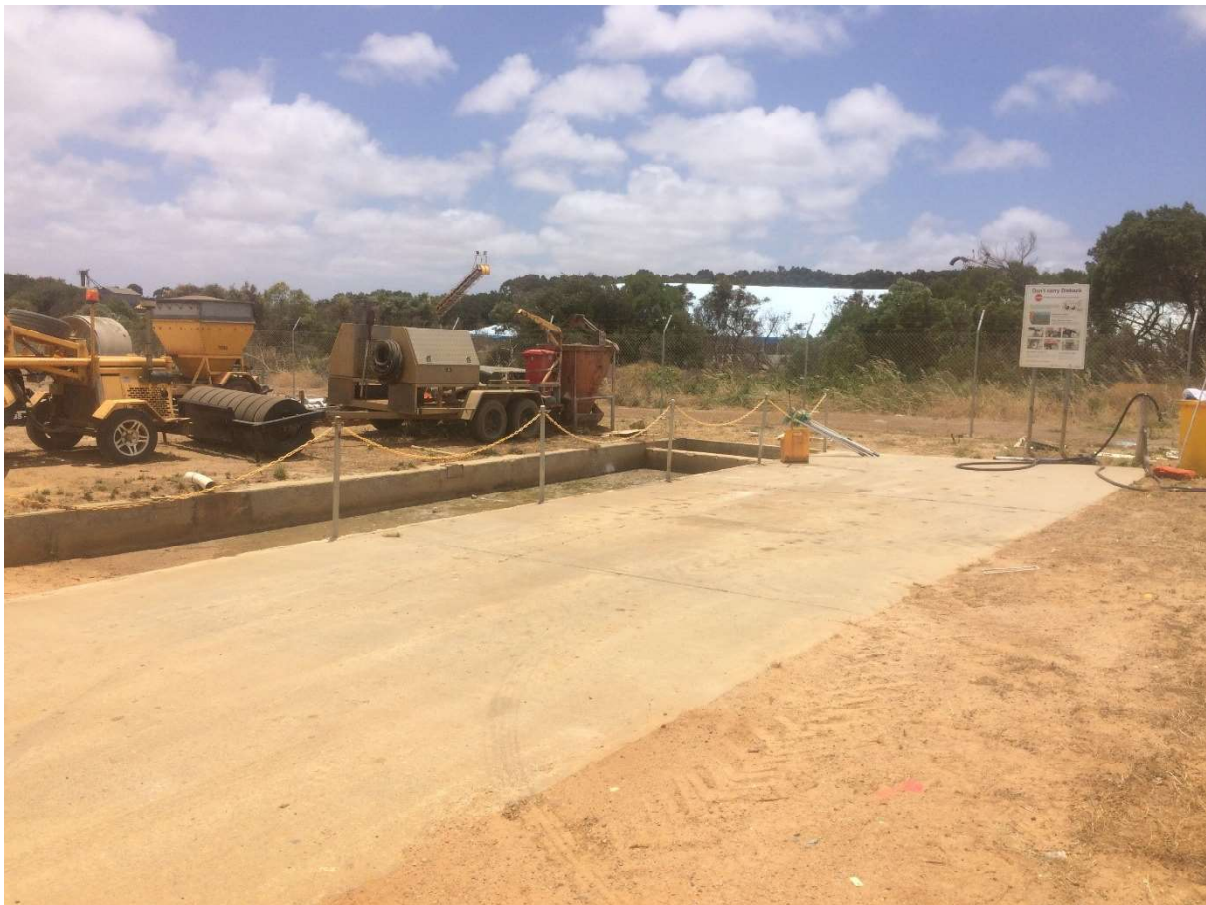
Figure 1: Shire of Esperance Depot vehicle washdown bay

The Shire of Esperance uses a combination of dry clean and wash-down methods. Dry clean is where compressed air or a spade/brush is used to blow weeds and dirt from machinery. Wash-down is where pressurised water spray unit to remove any remaining soil, mud and plant material. Wash-downs need to be done on a hard, well drained surface in low lying areas (e.g. road, ramp or grate). Shire of Esperance Environmental Services staff and Operations Supervisors have completed Dieback Green Card Training.

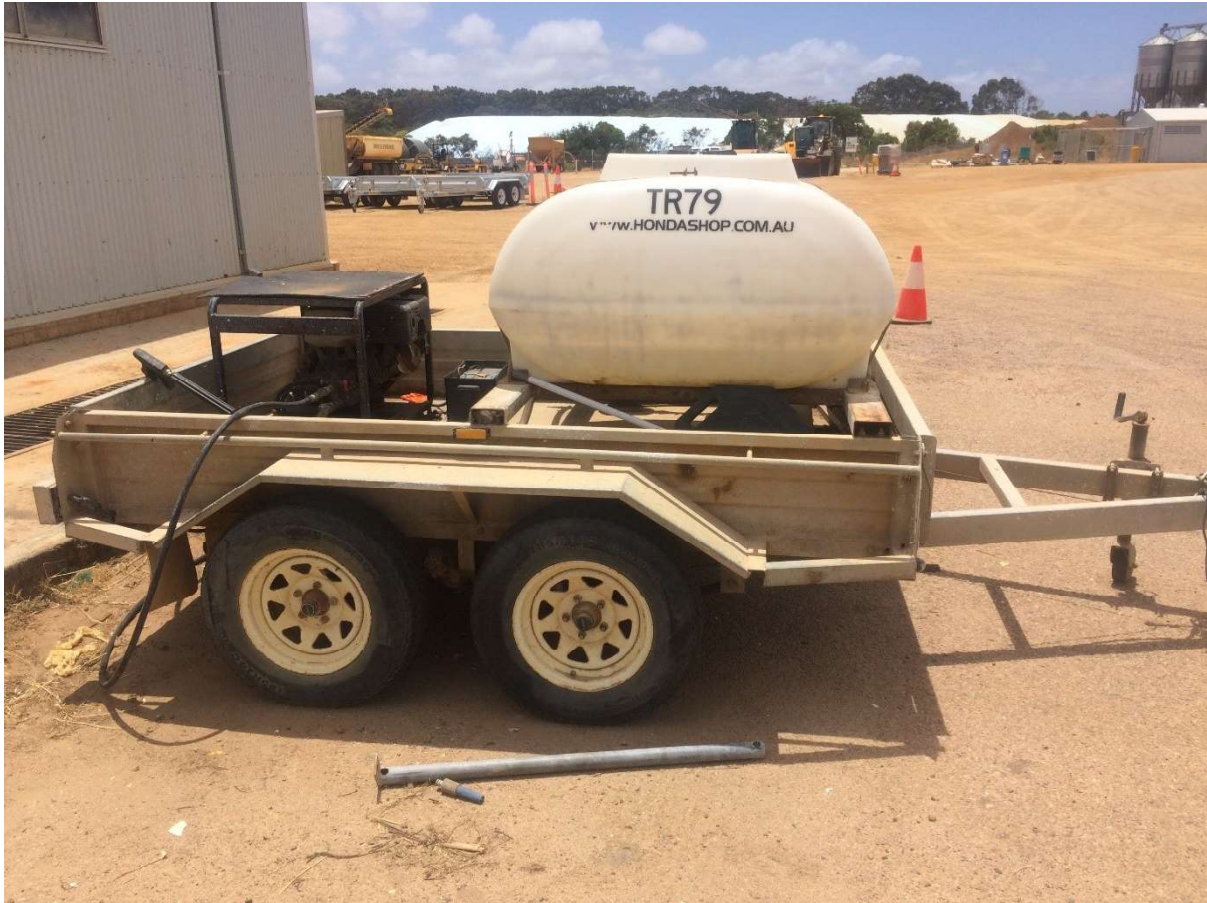
Figure 2: One of the Shire of Esperance's fleet of mobile washdown facilities

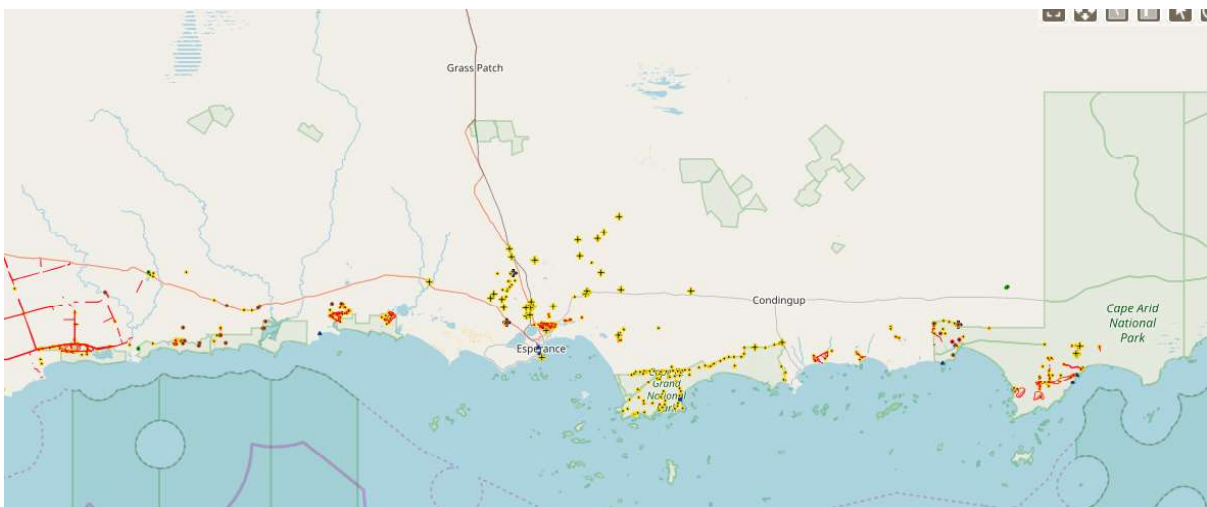
Figure 3: DIDMS map of known dieback occurrences within the Shire of Esperance

All project sites are checked for the most up to date disease status using Project Dieback's Dieback Information and Delivery Management System (DIDMS). DIDMS is a user registered web based platform for storage, viewing, basic mapping and sharing of spatial Phytophthora dieback information. Environmental Officers also inspect for visual signs of Dieback during flora surveys.

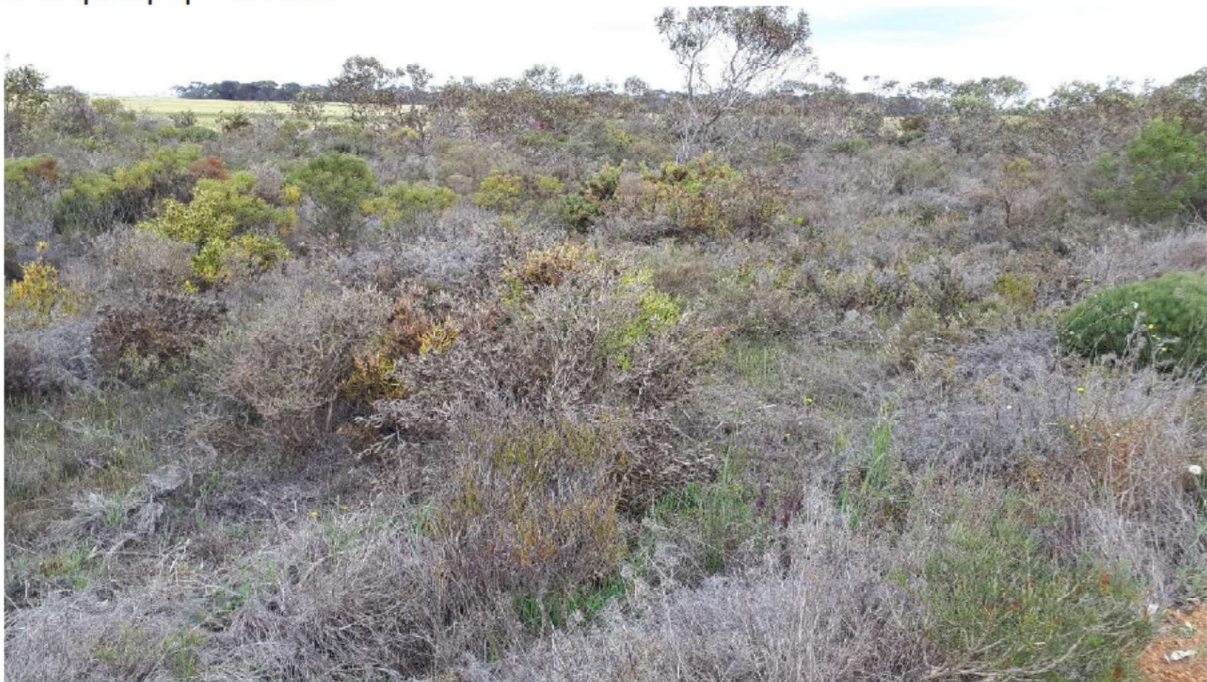
Figure 5 - Potential signs of dieback, including dead *Banksia* sp., observed in vegetation type B at 'Site B – Henkes Road Resheet and Howick Henkes Intersection upgrade'.

DIDMS data shows no records of *P. cinnamomi* or other *Phytophthora* sp. sample results in the immediate area. However, the presence of dead *Banksia media*, *Hakea laurina* and other Proteaceous plants was noted during the survey in vegetation types B, C, E, and H is likely an indicator of *P. cinnamomi* presence. This was not comprehensively mapped or sampled, but was visually observed to only occur in clustered locations scattered throughout the site. Proposed works will be conducted using appropriate hygiene measures to reduce risk and limit spreading of the disease, including clearing in dry conditions and clean down of vehicles and machinery before entering the site to complete proposed works.

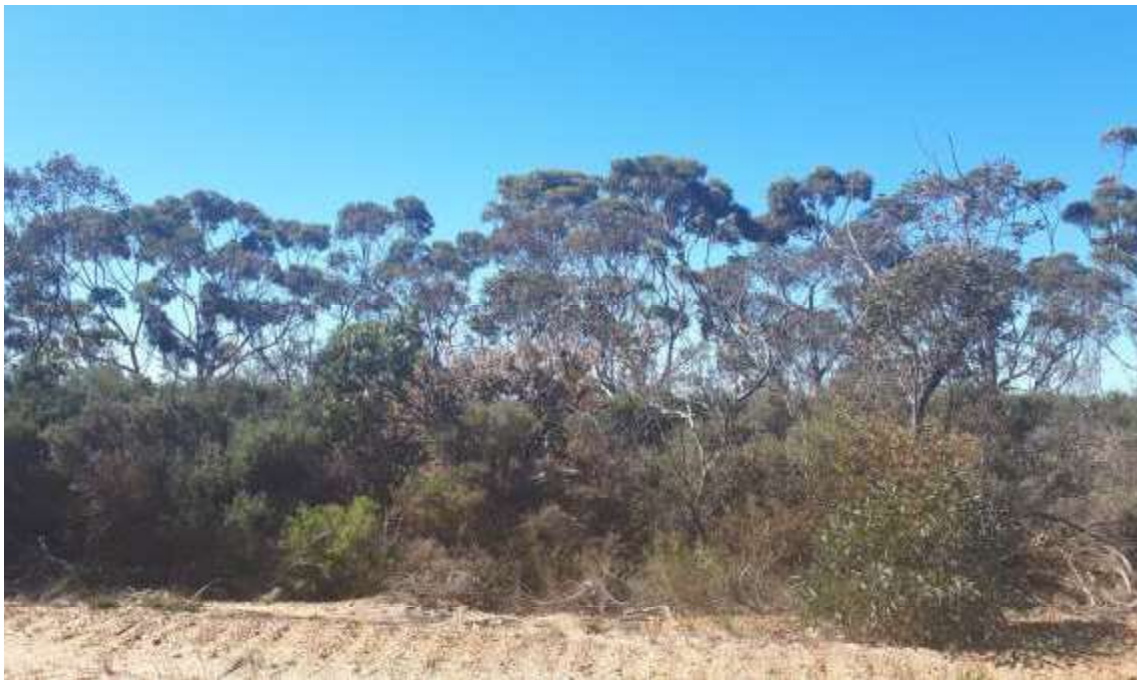
Figure 6 - Dead *Banksia media* observed in vegetation type A at 'Site C – Scaddan Road Construction, West of Backmans Rd'.

DIDMS data shows no positive or negative *Phytophthora cinnamomi* or other *Phytophthora* sp. Dieback sample results in the immediate area, likely due to the lack of sampling on road reserves in general. However, there were several positive *Phytophthora cinnamomi* sample results in the surrounding area, including on Wittenoom Road, a road which intersects with Scaddan Road approximately 10 km west of the survey area. Many dead Proteaceae species were observed during the survey, including *Banksia speciosa*, *B. media*, *B. armata* and Chittick, *Lambertia inermis*. There was no distinct cluster of dead species, and dead plants were sporadically scattered throughout the site. Vegetation types A and D are most susceptible to *P. cinnamomi* dieback due to the high prevalence of Proteaceae species in these vegetation communities, some limited signs of *P. cinnamomi* were present in the site (Figure 5). Proposed works will be conducted using appropriate hygiene measures to limit spreading of the disease, including clearing in dry conditions and clean down of vehicles and machinery before entering the site to complete proposed works.

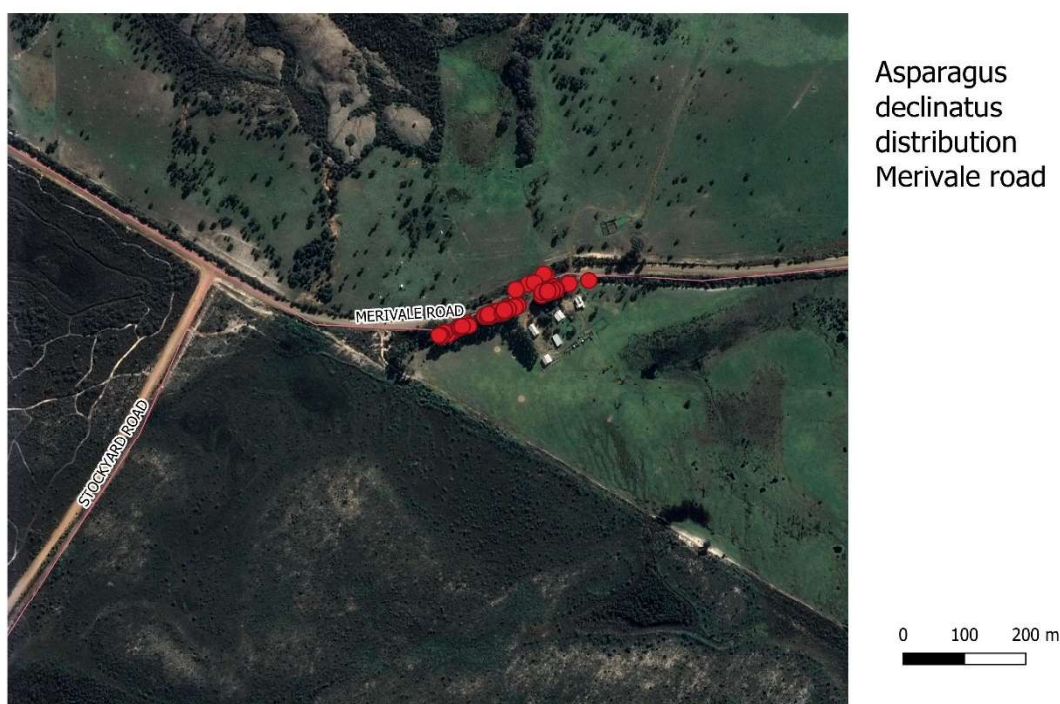
Figure 7 – *Asparagus declinatus* distribution Merivale Rd

There was extensive weed invasion across the entirety of the proposed 'Site P - Merivale Road Widening' area. Overall, 30 invasive species were identified within the project area (Appendix 8.2). The most concerning of these was a previously unrecorded population *Asparagus declinatus* (Bridal veil) Weed of National Significance. Until 2020, *Asparagus declinatus* was not known to occur within the Shire of Esperance, however in 2020 two populations were located, this one (located in shady areas under the tuarts on the south side of the road at -33.823488S, 121.111528E) and one discovered around the same time within the Esperance townsite, near the Esperance Port by Esperance Wildflower Society. The area of occupation of *Asparagus declinatus* has been mapped on 2/6/2021

Since the clearing permit application has been submitted, the Shire of Esperance have sprayed the *Asparagus declinatus* twice. Shire Environmental officers have also met adjoining landowners at the site and educated them about the weed and the landowner is also actively controlling *A. declinatus* via spraying.

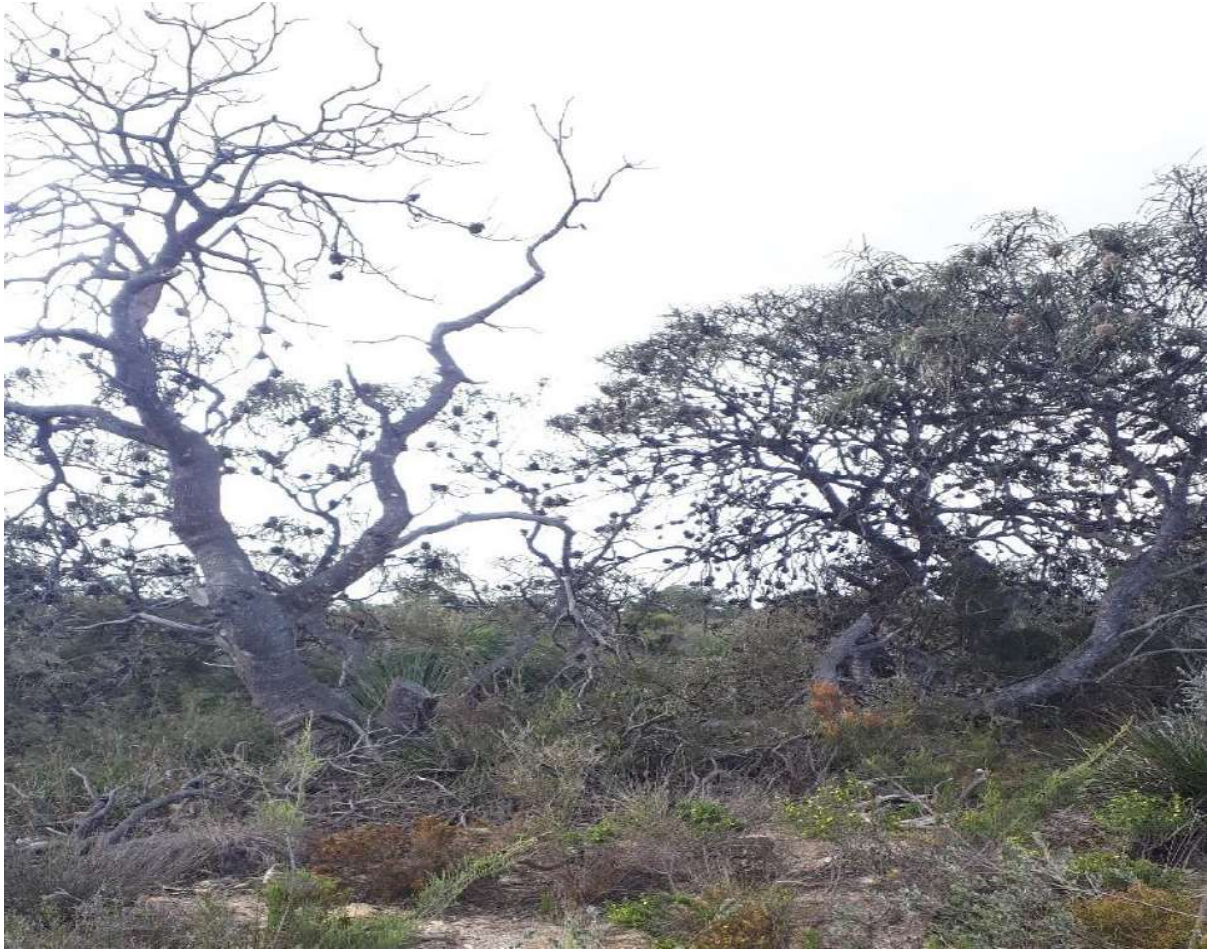
Figure 8 - Dying *Banksia speciosa* within SLK 4.01 to 4.45 of Coramup Rd and the 'Site S – Coramup Rd' area, this may indicate the presence of dieback, or may be natural senescence.

Dieback Information Delivery and Management System (DIDMS; GAIA Resources, SCNRM & State NRM 2020) data shows no *Phytophthora cinnamomi* or other *Phytophthora* sp. Dieback sample results in the immediate area, which is likely due to the lack of sampling that has occurred on road reserve. Despite this, in field surveys saw likely evidence of Dieback effected Banksia sp. and other Proteaceous species, with scattered deaths present (Figure 4). This may be due to natural senescence from old age. The indicator signs for a plant pathogen were mostly restricted from from SLK 4.01 to 4.45 of Coramup road. This area should be treated with extra precaution to limit the spread of the disease, and suggested to complete these works last or wash down prior to continuing with the road resheet. Proposed works will be conducted using appropriate hygiene measures to limit spreading of the disease, including clearing in dry conditions and clean down of vehicles and machinery before entering the site and commencing proposed works.

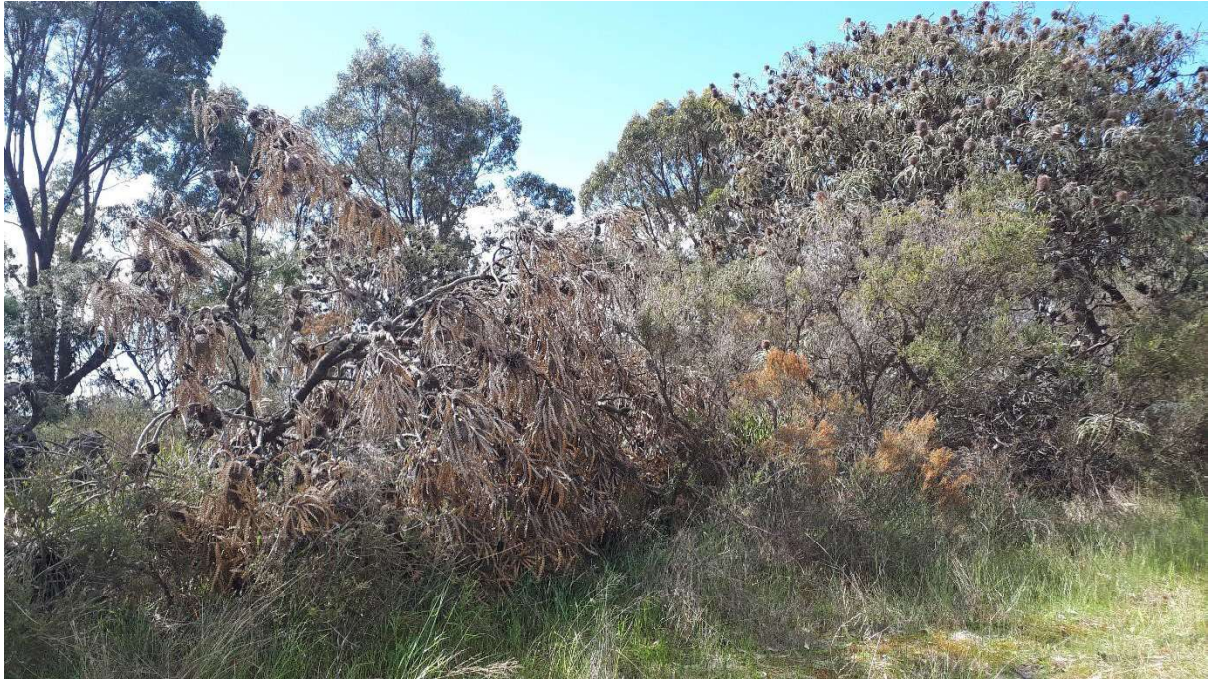
Figure 9 - Evidence of disease *Phytophthora cinnamomi* in vegetation type C, a *Banksia speciosa* specimen can be seen dead, while other flora persists 'Site X – Fisheries road, East of Daniels Road'.

Dieback Information Delivery and Management System (DIDMS; GAIA Resources, SCNRM & State NRM 2020) data shows no records *Phytophthora cinnamomi* or other *Phytophthora* sp. Dieback sample results in the immediate area, likely due to the lack of sampling that has occurred in the wider Esperance landscape. Despite no records found on the desktop survey, evidence of a plant pathogen, most likely *Phytophthora cinnamomi*, was found in the field survey, in the form of dying Proteaceae species, such as large *Banksia speciosa* plants. From this evidence, it is believed that dieback is present across almost the full extent of Site X – Fisheries Road Reconstruction. Appropriate hygiene measures will be employed prior to leaving the site to ensure the disease isn't spread elsewhere.
