Vegetation, Flora, Fauna and Environmental Considerations, and Targeted Flora Report

Shire of Esperance Strategic Purpose Permit 20/21 Site C – Scaddan Road Construction, West of Backmans Rd

Report compiled by Shire of Esperance Environmental Team:

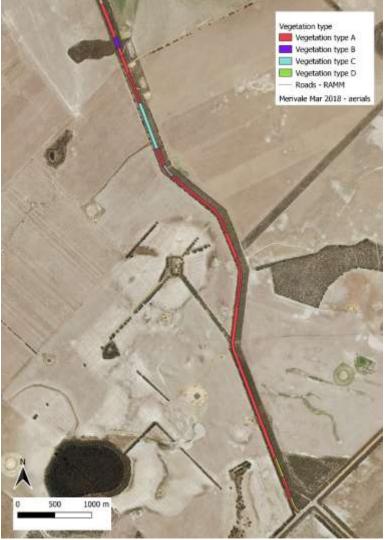
Figure 2. Map of vegetation types within the 'Site C - Scaddan Road Construction, West of Backmans Rd' area, from SLK 48 km to 53 along Scaddan Road.

Four vegetation communities were identified within the 'Site C - Scaddan Road Construction, West of Backmans Rd', as defined by structure and composition (Table 2). The incidental flora list identified a total of 235 species across all vegetation communities, 33 of these were invasive species. It is believed that the Beard (1973) vegetation associations identified (Section 3.6) are an appropriate match for all vegetation types observed, other than vegetation type B. Vegetation type B didn't match the two vegetation associations Beard (1973) mapped within the survey area, and is more similar to VA931 "Medium woodland; yate".

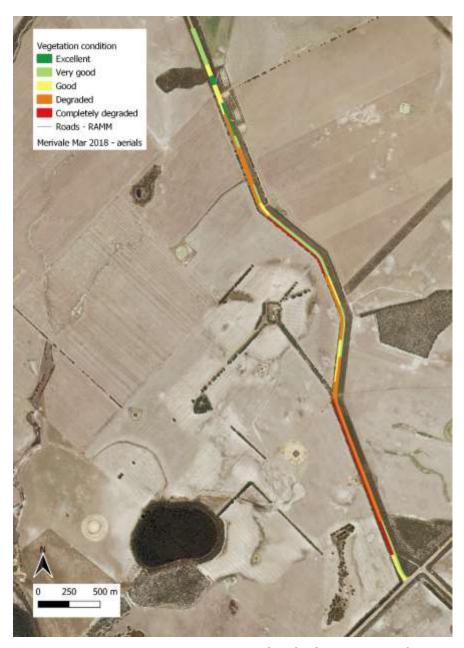
The vegetation condition varies dramatically across 'Site C – Scaddan Road Construction, West of Backmans Rd', ranging from completely degraded to excellent condition (Figure 3). This is primarily due to the extensive weed infestation of particularly African Lovegrass (*Eragrostis curvula*), on the periphery of the road footprint. As well as some impacts of *Phytophthora* dieback (Section 5.3). Additionally, the road reserve bordering the farmland has all been historically cleared, with only scattered native hardy shrubs remaining, consisting almost entirely of dense Tuart, *Eucalyptus gomphocephala* and Pine, *Pinus pinaster* trees. During the targeted flora survey, the adjacent property owner on the southern road reserve was clearing and removing the large invasive trees. Where possible it was evident they were leaving the occasional *Nuytsia floribunda* present. A historical gravel pit at approximately 48.65 SLK has led to disturbance and loss of upper-story species.

Figure 3. Vegetation condition across the 'Site C - Scaddan Road Construction, West of Backmans Rd' project, ranging from completely degraded to excellent condition, due to primarily to degradation from pine tree removal, gravel extraction, machinery disturbance, weed invasion and possible *Phytophthora cinnamomi* Dieback presence.

reserve where works occur. It is suggested that the road reconstruction occur from the north-west area and head south-east, from the better condition to the poorer condition area. This will hopefully limit the weed spread into the areas in better condition. Ideally, regular wash downs during the course of works to remove weed seeds or follow up herbicide control of invasive species needs to occur. However, this will be extremely expensive to employ contractors and mobilise equipment, which may not be feasible with given budgets.

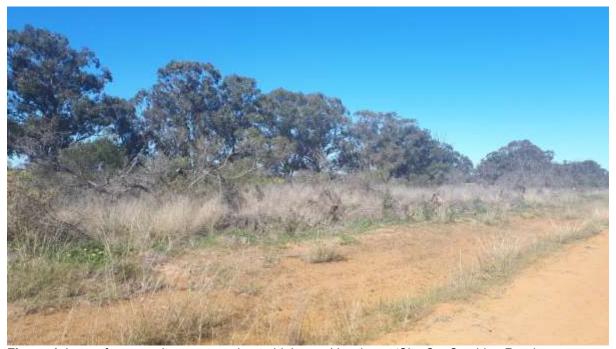
There was high levels of weed invasion across the entirety of the proposed 'Site C - Scaddan Road Construction, West of Backmans Rd' area. Overall, 33 invasive species were identified within the project area (Appendix 2, Table 8). Of these, the most extensive and of serious concern were African Love Grass, *Eragrostis curvula*, and Golden Wattle, *Acacia pycnantha*. African Love Grass and agricultural weeds were observed across the survey area, and *Acacia pycnantha* was observed to be scattered throughout vegetation type A. *Pinus pinaster* trees lined the fence lines of the adjacent agricultural properties. The weed burden was so high in some sections that it led to the complete breakdown of community structure (Figure 4). Control of *Acacia pycnantha* is recommended prior to consuming road works, as can rapidly become a serious environmental weed. It is highly likely that proposed works will increase the distribution of weeds and degrade vegetation along the entire road

Figure 4. Loss of community structure due to high weed burden at 'Site C – Scaddan Road Construction, West of Backmans Rd'.

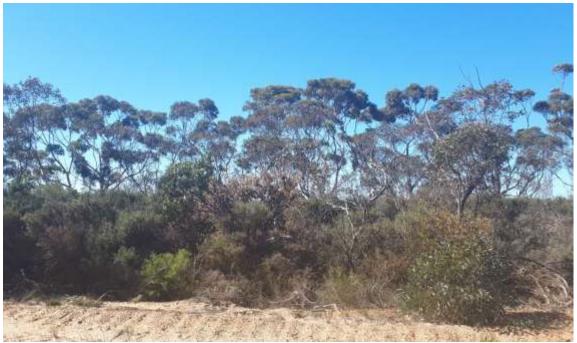
Figure 5. Dead *Banksia media* observed in vegetation type A at 'Site C – Scaddan Road Construction, West of Backmans Rd'.

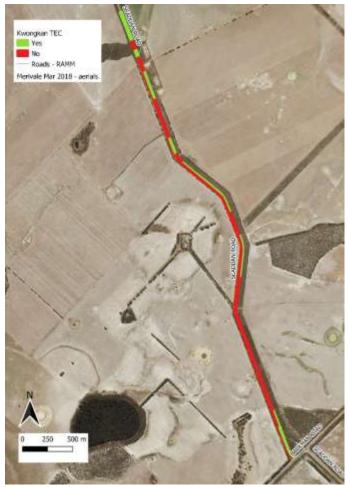
The field survey determined that there were two vegetation communities, vegetation types A and D, described as 'Open mixed scattered upper-story consisting of Mallee, Tallerack, Nuytsia and Chittick, and diverse shrubland with Melaleuca and a high dominance of Proteaceae species' and 'Banksia speciosa woodland with Allocasuaina dominated, diverse and mixed shrubland' met criteria to be considered as Kwongkan TEC. However, due to several degrading factors including historical gravel extraction and weed invasion, only areas within these vegetation communities in very good or excellent condition were considered as Kwongkan TEC (Figure 6). In total, 1.406 ha of vegetation within a 4.42 ha footprint was considered as Kwongkan TEC present within 'Site C – Scaddan Road Construction, West of Backmans Rd' area.

Figure 6. Vegetation communities of vegetation type A and D in excellent or very good condition met threatened ecological community (TEC) 'Proteaceae Dominated Kwongkan Shrublands of the Southeast Coastal Floristic Province of Western Australia (Kwongkan)' within 'Site C – Scaddan Road Construction, West of Backmans Rd' project.

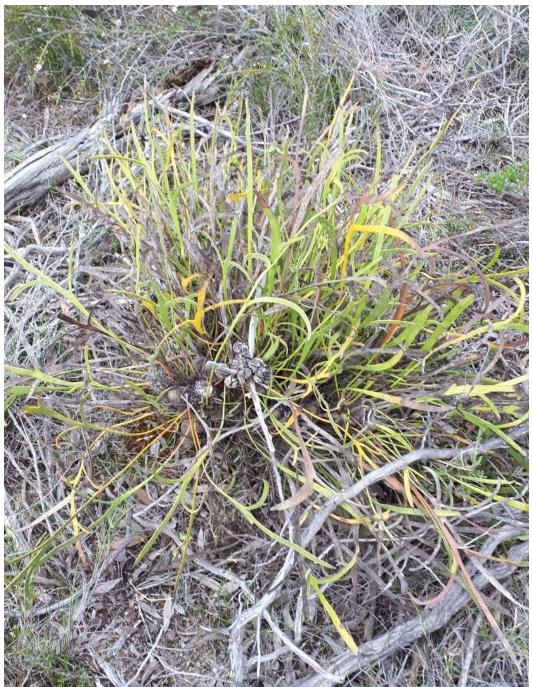
A specimen of *Isopogon alcicornis* (*Figure 7*) was sent to the WA Herbarium for identification confirmation (KW112; Accession 8652 with specimen retained by WA Herbarium). It was confirmed by Michael Hislop on 10/12/20. A Threatened and Priority Reporting Form (TPFL) was completed and sent to Department of Biodiversity, Conservation and Attractions (DBCA) District Flora Conservation Officer and Species and Communities Branch on 15/01/21 (Appendix 3). If proposed works occur, 6 plants will be impacted upon, from a population total of 14 live plants. It is highly likely that more plants would be located within the area 1.5km to the north of the end of the survey area as there was suitable habitat here, however no survey was completed outside the application area.

Figure 7. Photo of *Isopogon alcicornis* found in the field, photo was taken by Katie White on 22/10/2020

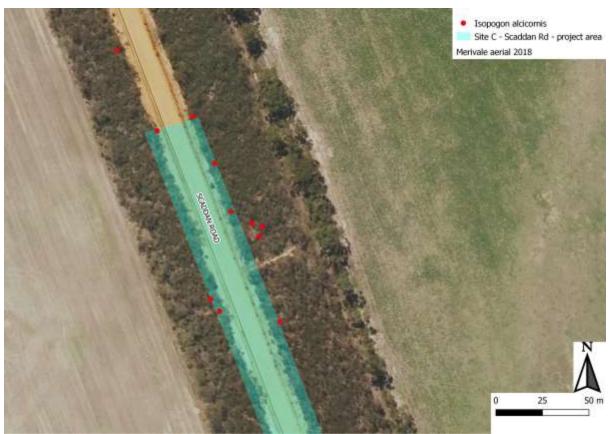
Figure 8. Locations of *Isopogon alcicornis* found at Site C – Scaddan Road Construction, West of Backmans Rd

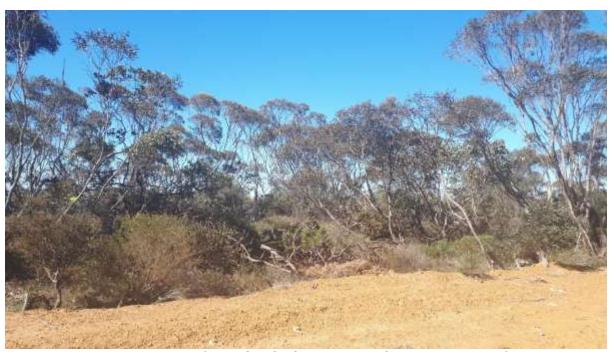
Figure 9. Vegetation type A identified in 'Site C - Scaddan Road Construction, West of Backmans Rd' project, described as 'Open mixed scattered upper-story consisting of Mallee, Tallerack, Nuytsia and Chittick, and diverse shrubland with Melaleuca and a high dominance of Proteaceae species'.

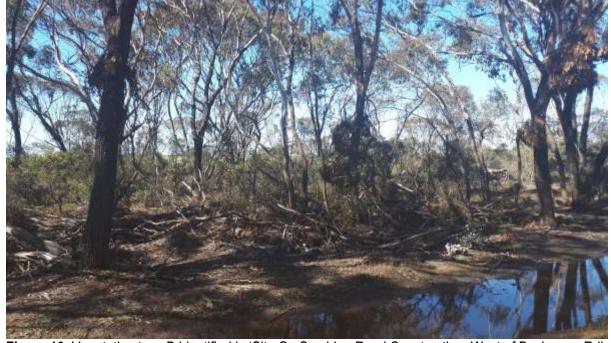
Figure 10. Vegetation type B identified in 'Site C - Scaddan Road Construction, West of Backmans Rd' project, described as 'Yate with Melaleuca'.

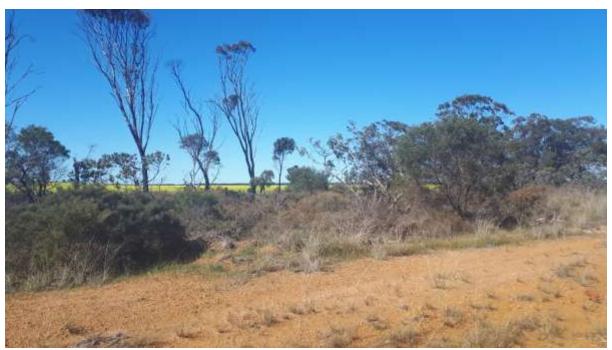
Figure 11. Vegetation type C identified in 'Site C - Scaddan Road Construction, West of Backmans Rd' project, described as 'scattered Tallerack with dense/dominant Allocasuarina shrubland'.

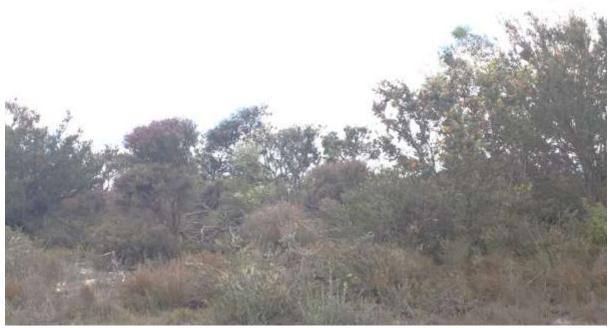
Figure 12. Vegetation type D identified in 'Site C - Scaddan Road Construction, West of Backmans Rd' project, described as '*Banksia speciosa* woodland with Allocasuaina dominated, diverse and mixed shrubland'.
