Phytophthora Dieback Occurrence Survey Bunbury Water Resource Recovery Scheme

12537061-00000-EN-RPT-007

19 October 2020

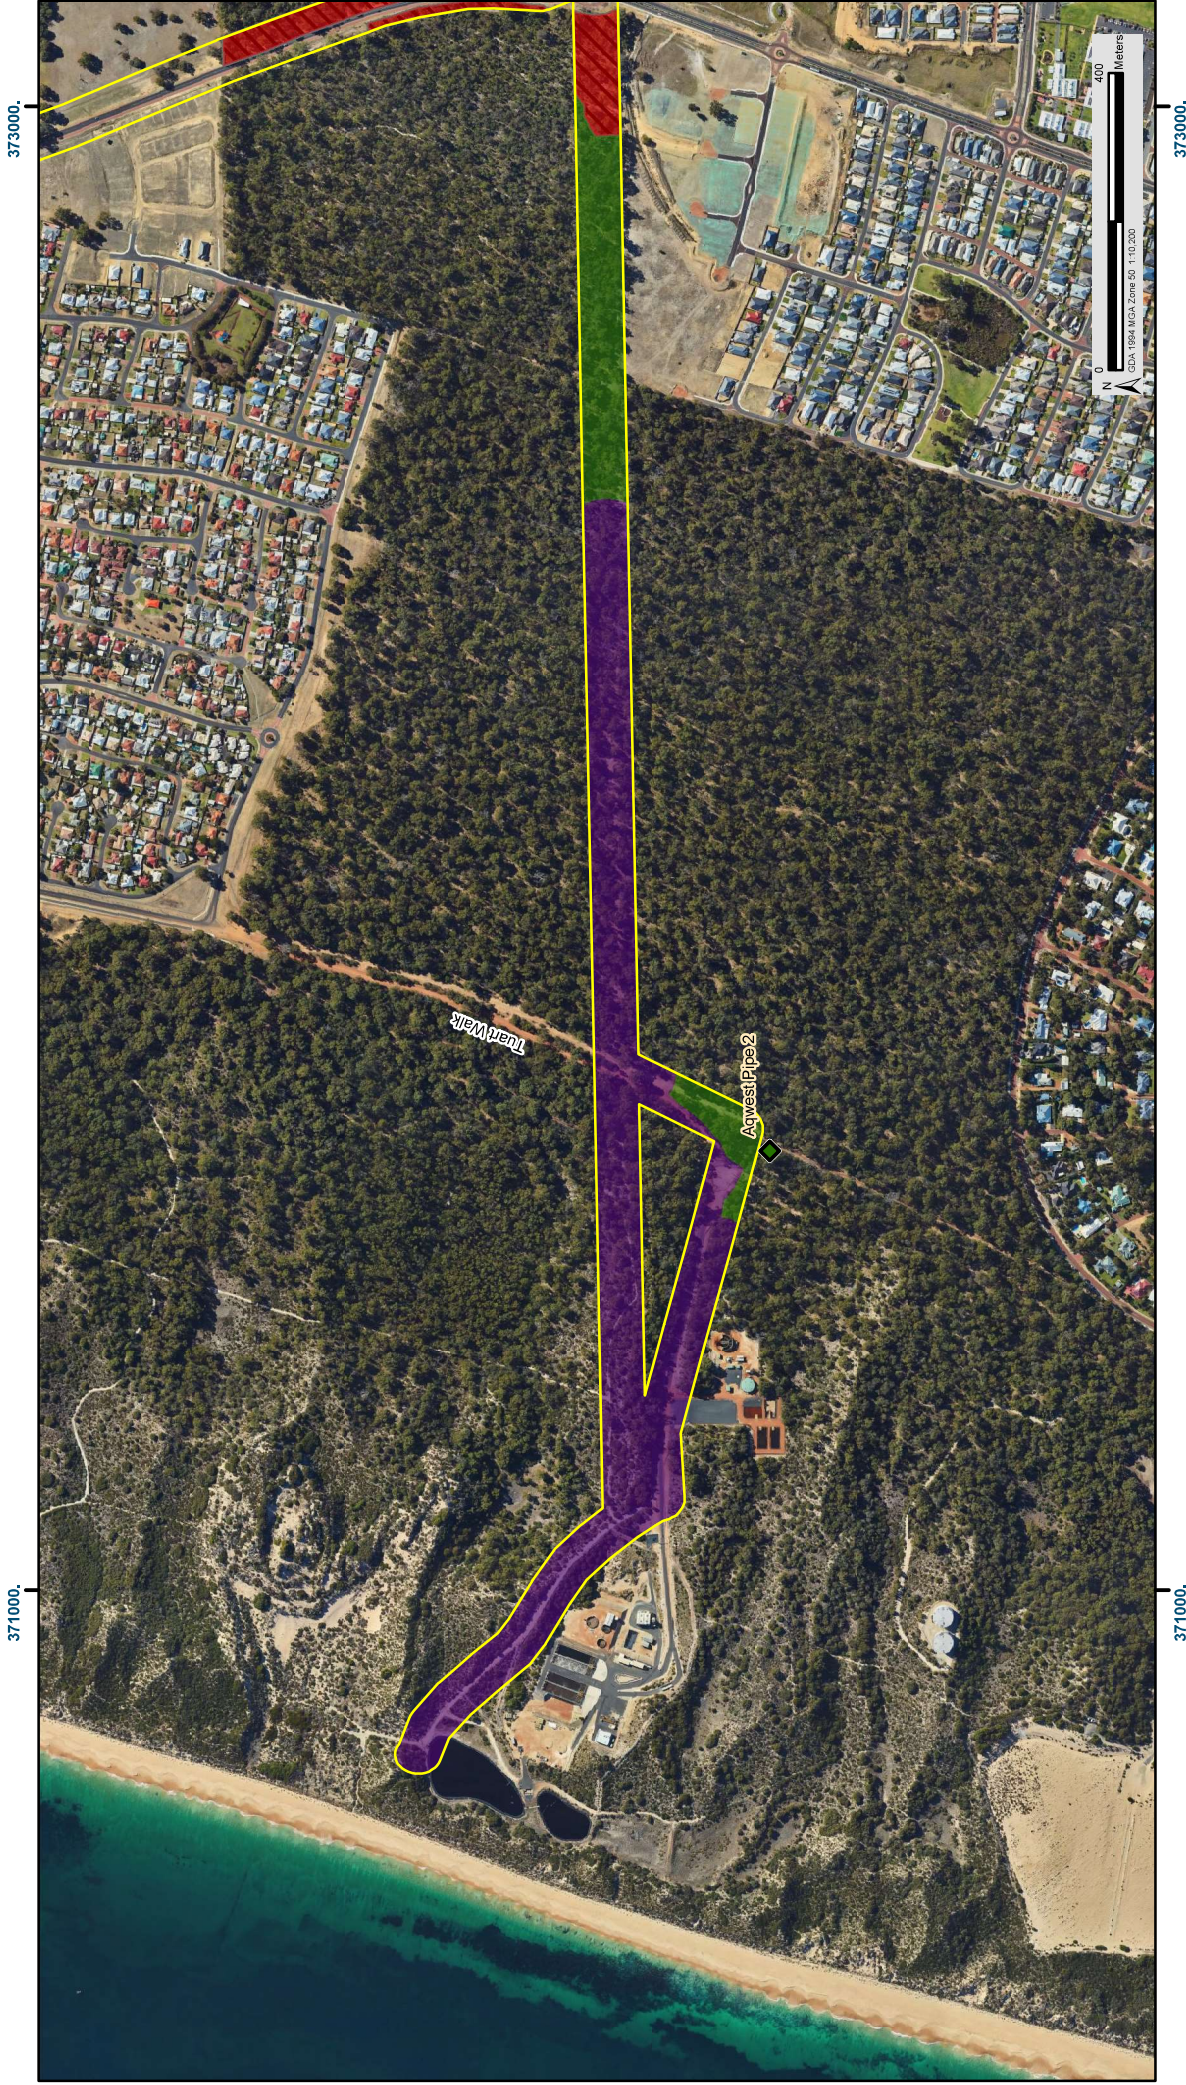
Figure 3A: WRRS Stage 2 Phytophthora Dieback occurrences showing protectable vegetation and sample locations

Phytophthora Dieback disease expression in assessable vegetation was observed through fresh deaths of *Banksia* species and some deaths of *Xanthorrhoea gracilis* and *X. preissii* were noted on the western side of Parade Road. To the east of the Bussell Highway there were also several old deaths of *Banksia* species and were used to map the extent of disease occurrence.

The same infested area in Stage 1 extends into Stage 2 and spreads west along the Stage 2 alignment for a short distance. The disease was also identified in the cleared wetland area to the east of the Bussell Highway and a third infested area was identified on Centennial Rd where it terminates outside the Bunbury Regional Prison.

All coastal heath vegetation and the Tuart Forest vegetation have been classified as uninterpretable due to the lack of disease indicator species and the majority of the Peppermint and *Banksia* woodlands have been classified as uninfested.

All uninfested areas within the Stage 2 alignment Study Area have been classified as protectable as they:

The uninterpretable *Melaleuca* wetland along Centenary Road, west of the Bussell Highway has been classified as unprotectable as it:
