Clearing Permit

Coronation Road

SLK 10.96 to 11.51

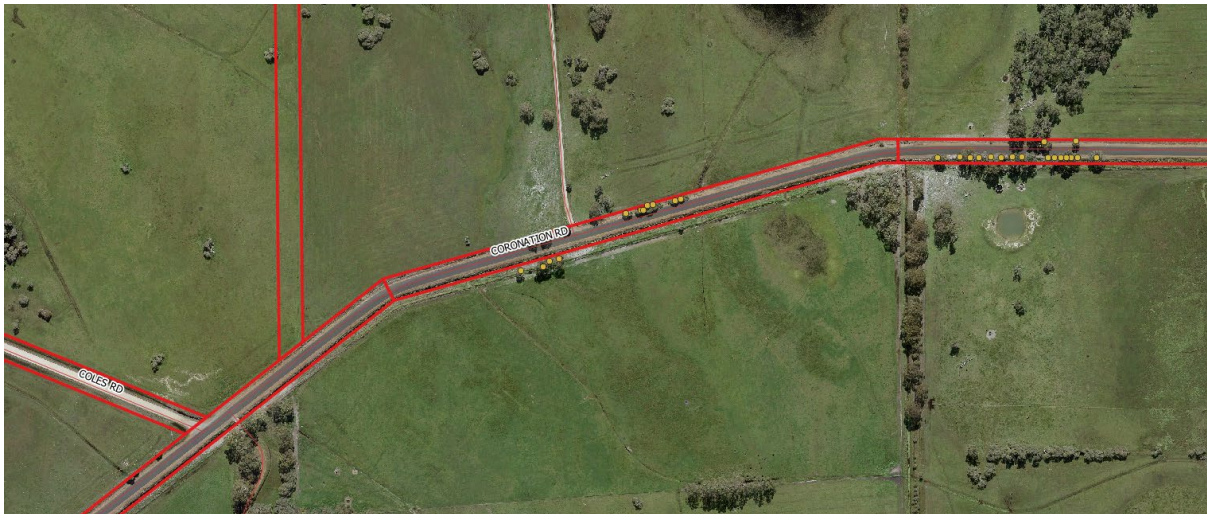
5. Aerial Map

* The Map above shows Coronation Road running in a East/ West direction from the with the nearest cross road being Coles Road.

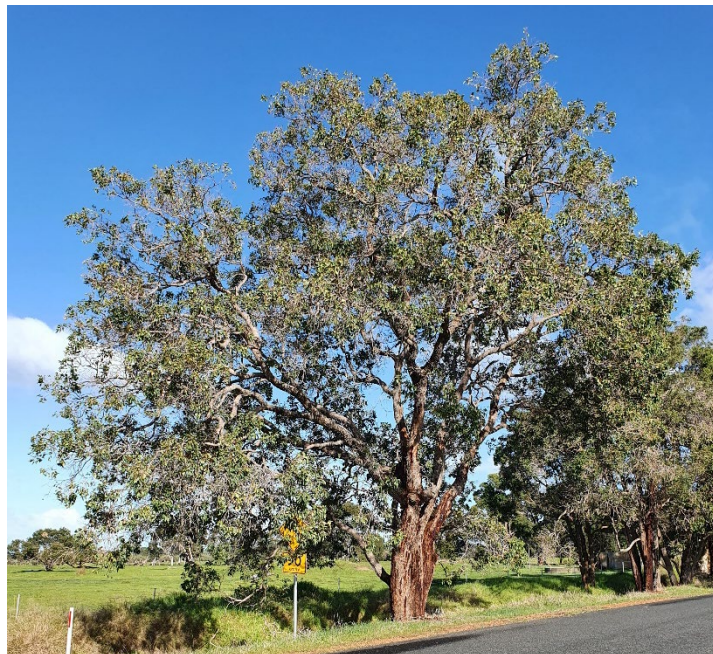
| Tree ID | Description | Trunk (m) | Canopy (m) | Pruning/ Removal | Observations |
|---|---|---|---|---|---|
| 743 | <i>Corymbia Calophylla</i> | 0.3m | 7m | Removal | No visible signs of nesting or hollows. |

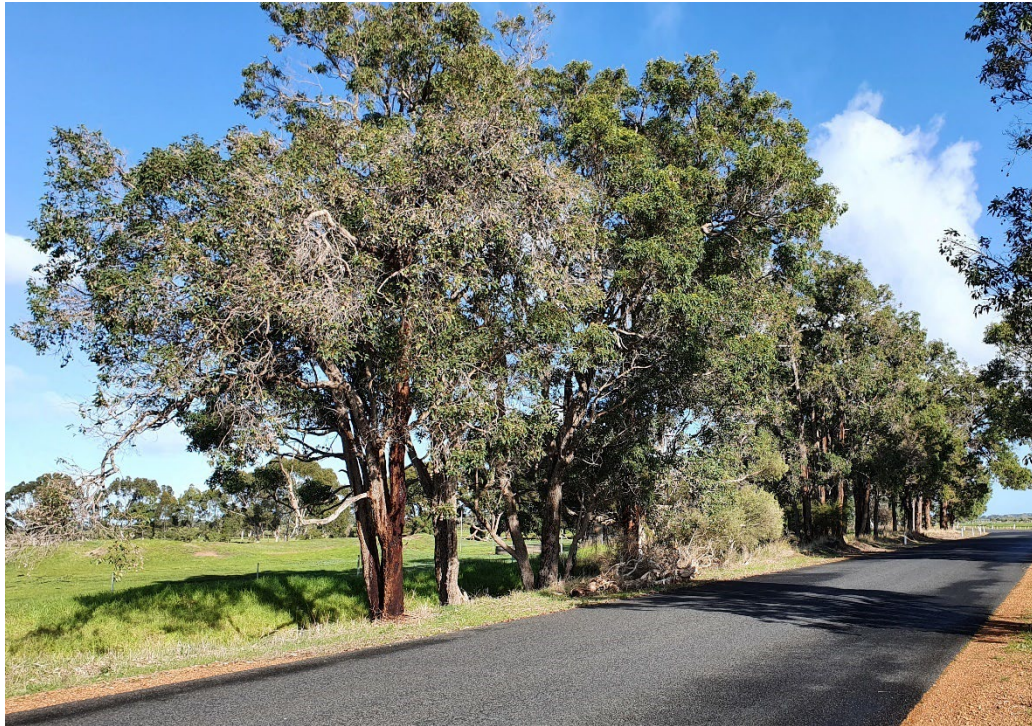
| Tree ID | Description | Trunk (m) | Canopy (m) | Pruning/ Removal | Observations |
|---|---|---|---|---|---|
| 744 | <i>Corymbia Calophylla</i> | 0.3m | 7m | Removal | No visible signs of nesting or hollows. |
| 745 | <i>Corymbia Calophylla</i> | 0.3m | 7m | Removal | No visible signs of nesting or hollows. |
| 746 | <i>Corymbia Calophylla</i> | 0.3m | 7m | Removal | No visible signs of nesting or hollows. |
| 747 | <i>Corymbia Calophylla</i> | 0.3m | 7m | Removal | No visible signs of nesting or hollows. |
| 748 | <i>Corymbia Calophylla</i> | 0.3m | 7m | Removal | No visible signs of nesting or hollows. |

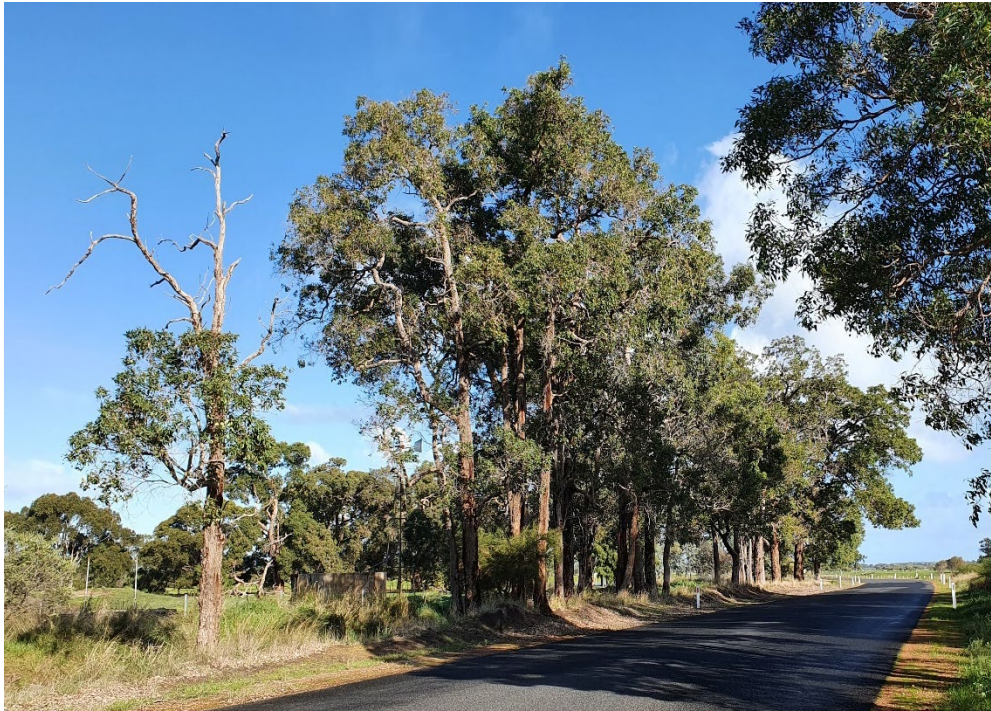
| Tree ID | Description | Trunk (m) | Canopy (m) | Pruning/ Removal | Observations |
|---|---|---|---|---|---|
| 749 | <i>Corymbia Calophylla</i> | 0.3m | 7m | Removal | No visible signs of nesting or hollows. |
| 751 | <i>Corymbia Calophylla</i> | 0.3m | 7m | Removal | No visible signs of nesting or hollows. |
| 752 | <i>Corymbia Calophylla</i> | 0.3m | 7m | Removal | No visible signs of nesting or hollows. |
| 753 | <i>Corymbia Calophylla</i> | 0.3m | 7m | Removal | No visible signs of nesting or hollows. |
| 754 | <i>Corymbia Calophylla</i> | 0.3m | 7m | Removal | No visible signs of nesting or hollows. |
| 755 | <i>Corymbia Calophylla</i> | 0.3m | 7m | Removal | No visible signs of nesting or hollow. |
| 756 | <i>Corymbia Calophylla</i> | 0.3m | 7m | Removal | No visible signs of nesting or hollows. |
| 757 | <i>Corymbia Calophylla</i> | 0.3m | 7m | Removal | No visible signs of nesting or hollows. |
| 759 | <i>Corymbia Calophylla</i> | 0.3m | 7m | Removal | No visible signs of nesting or hollows. |

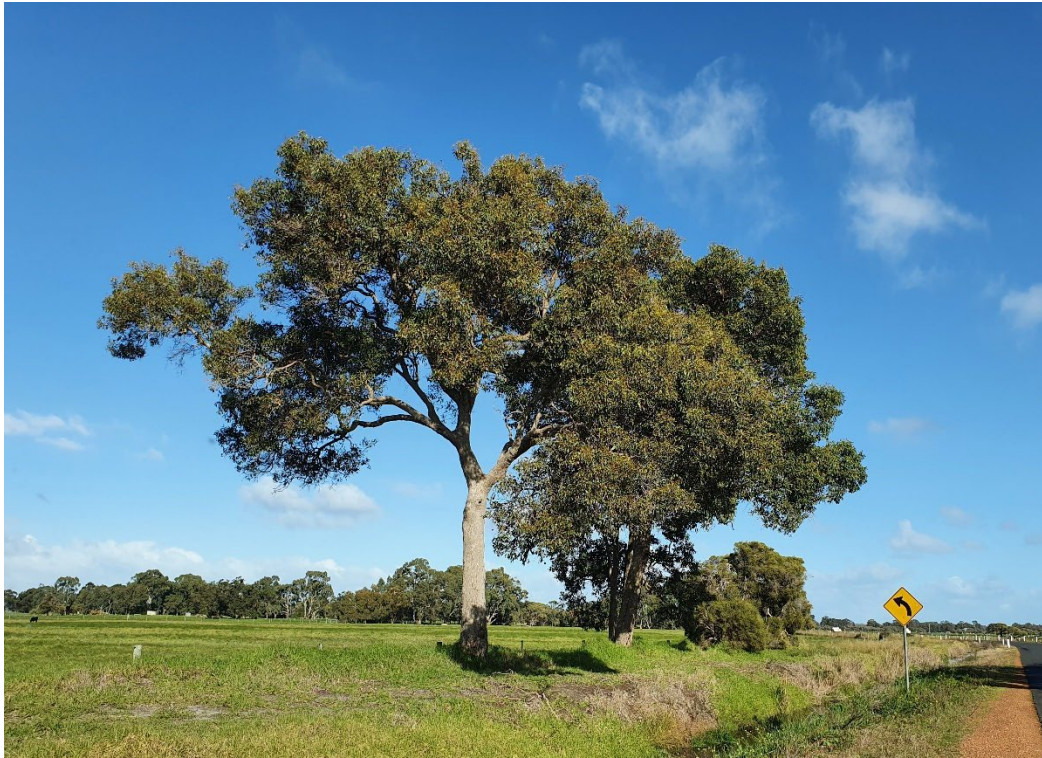
| Tree ID | Description | Trunk (m) | Canopy (m) | Pruning/ Removal | Observations |
|---|---|---|---|---|---|
| 522 | <i>Corymbia Calophylla</i> | 0.6m | 12m | Possible Pruning | No visible signs of nesting or hollows. |
| 523 | <i>Corymbia Calophylla</i> | 0.6m | 12m | Possible Pruning | No visible signs of nesting or hollows. |
| 525 | <i>Melaleuca Rhapsiophylla</i> | 0.4m | 8m | Possible Pruning | No visible signs of nesting or hollows. |
| 529 | <i>Melaleuca Rhapsiophylla</i> | 0.4m | 8m | Possible Pruning | No visible signs of nesting or hollows. |

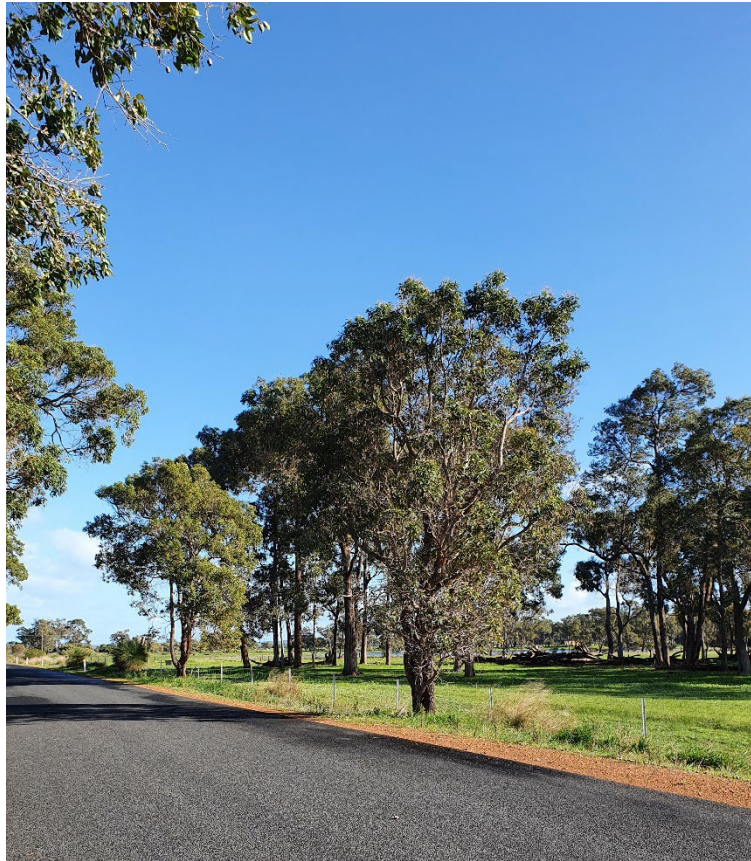
| Tree ID | Description | Trunk (m) | Canopy (m) | Pruning/ Removal | Observations |
|---|---|---|---|---|--|
| 717 | <i>Corymbia Calophylla</i> | 0.4m | 8m | Pruning | No visible signs of nesting or hollows. Tree is outside of corner realignment. |
| 712 | <i>Corymbia Calophylla</i> | 0.4m | 8m | Pruning | No visible signs of nesting or hollows. Tree is outside of corner realignment. |

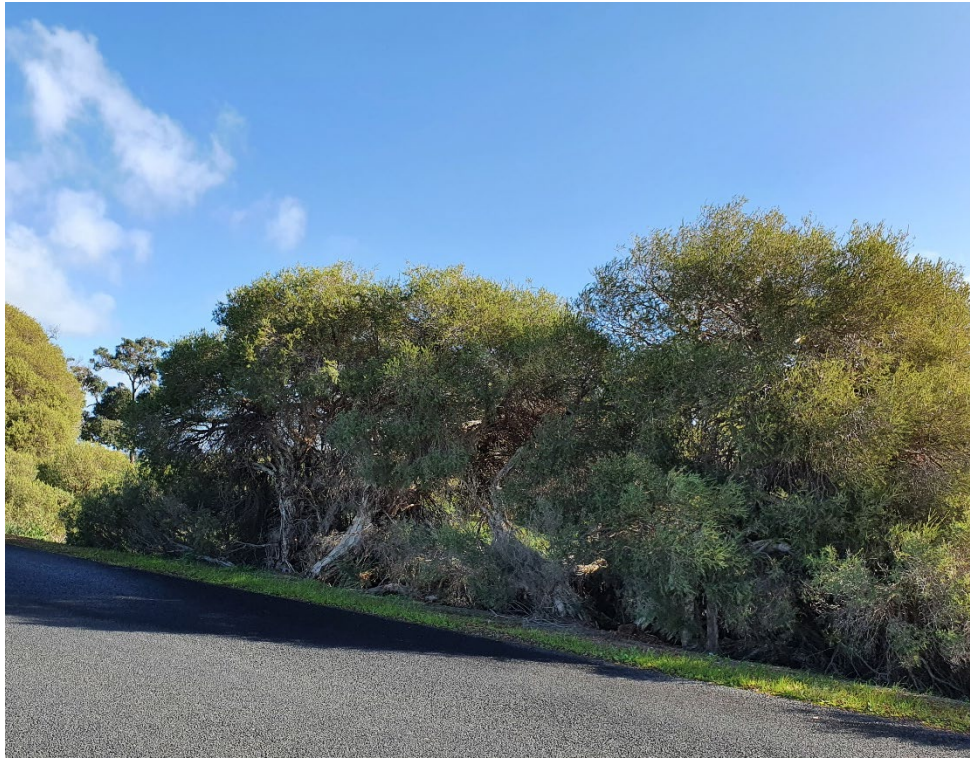
| Tree ID | Description | Trunk (m) | Canopy (m) | Pruning/ Removal | Observations |
|---|---|---|---|---|--|
| 667 | <i>Melaleuca Rhapsiophylla</i> | 0.5m | 10m | Pruning | No visible signs of nesting or hollows. Tree is outside of corner realignment. |
| 666 | <i>Melaleuca Rhapsiophylla</i> | 0.5m | 10m | Pruning | No visible signs of nesting or hollows. Tree is outside of corner realignment. |

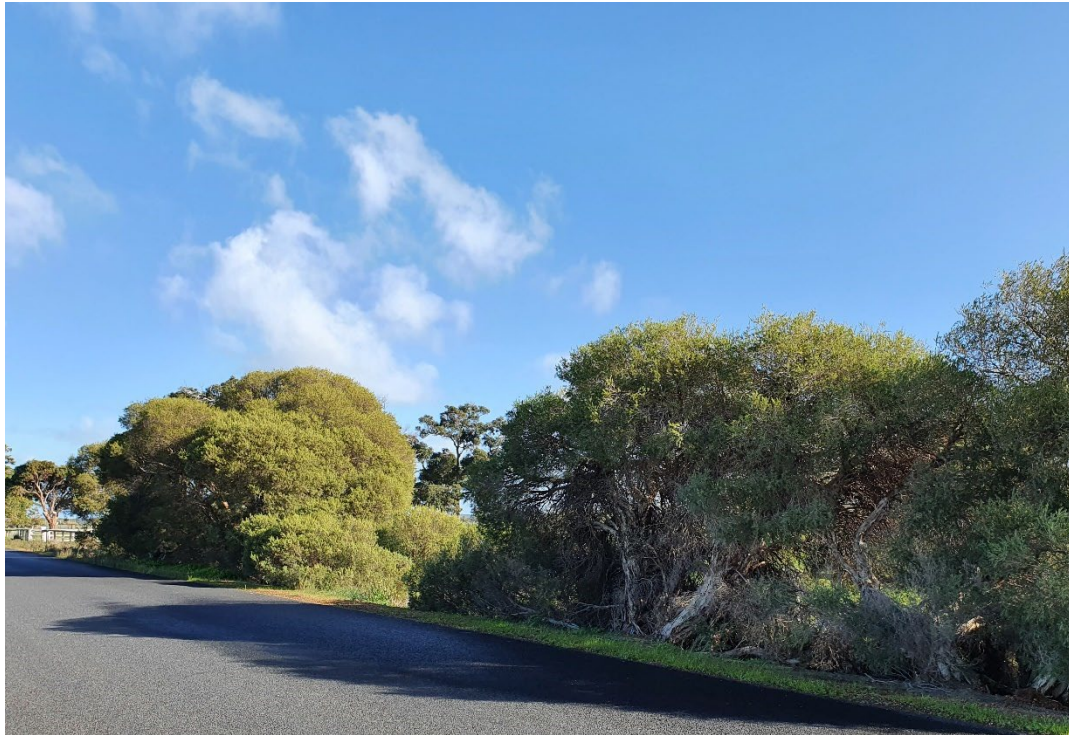
| Tree ID | Description | Trunk (m) | Canopy (m) | Pruning/ Removal | Observations |
|---|---|---|---|---|--|
| 663 | <i>Melaleuca Rhapsiophylla</i> | 0.5m | 10m | Pruning | No visible signs of nesting or hollows. Tree is outside of corner realignment. |
| 662 | <i>Melaleuca Rhapsiophylla</i> | 0.5m | 10m | Pruning | No visible signs of nesting or hollows. Tree is outside of corner realignment. |
| 661 | <i>Melaleuca Rhapsiophylla</i> | 0.4m | 8m | Pruning | No visible signs of nesting or hollows. Tree is outside of corner realignment. |
| 660 | <i>Melaleuca Rhapsiophylla</i> | 0.4m | 8m | Pruning | No visible signs of nesting or hollows. Tree is outside of corner realignment. |
| 657 | <i>Melaleuca Rhapsiophylla</i> | 0.4m | 8m | Pruning | No visible signs of nesting or hollows. Tree is outside of corner realignment. |

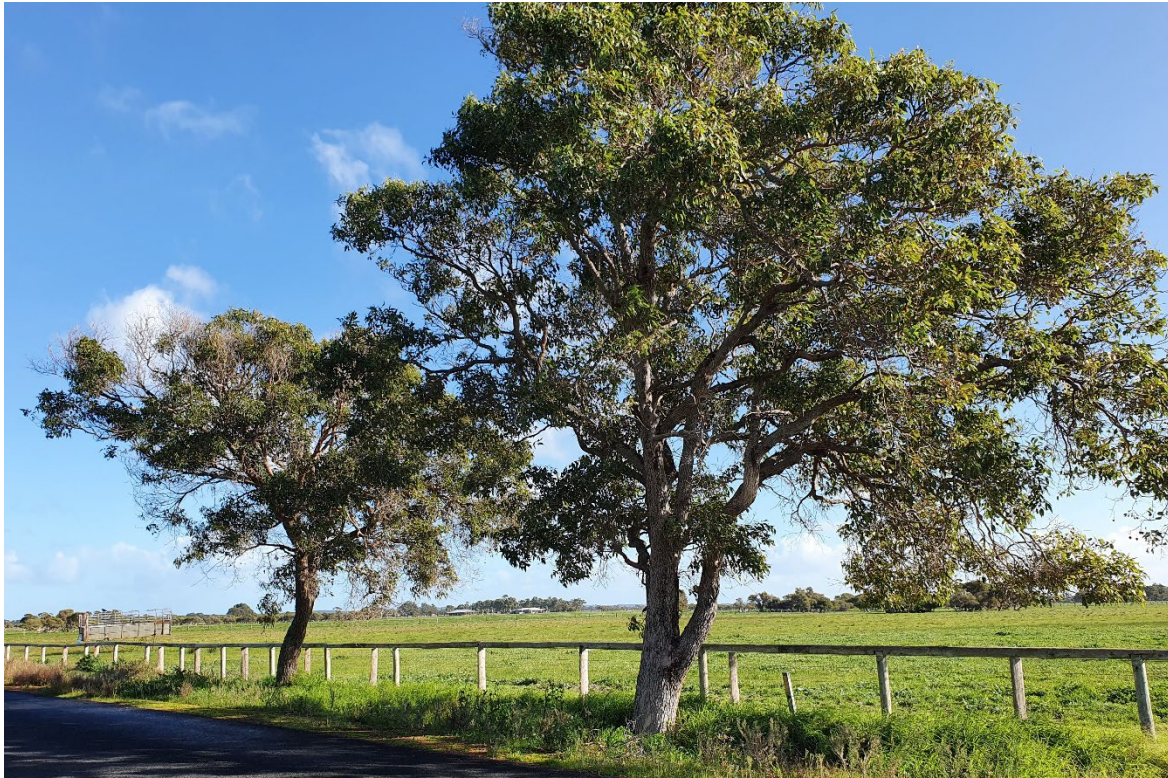
| Tree ID | Description | Trunk (m) | Canopy (m) | Pruning/ Removal | Observations |
|---|---|---|---|---|--|
| 304 | <i>Corymbia Calophylla</i> | 0.4m | 8m | Pruning | No visible signs of nesting or hollows. Tree is outside of corner realignment. |
| 305 | <i>Corymbia Calophylla</i> | 0.4m | 8m | Pruning | No visible signs of nesting or hollows. Tree is outside of corner realignment. |
