# ROAD SAFETY INSPECTION

## Harris Road (No 2040431), Picton between Slk 0.00 - 1.20.

**Inspection Ref: bbc2020.163**

**City of Bunbury**

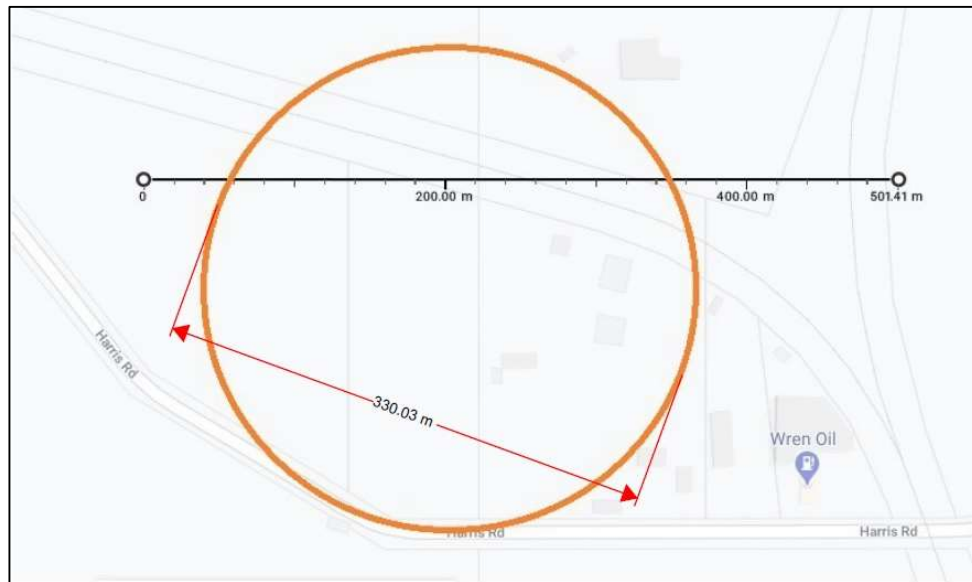
**Figure 2 - Shows estimated curve radius**

The curve at Slk 0.26 is estimated to have a radius of approximately 165 m using mid chord measurements and basic drawing techniques (Note: the actual radius should be determined by surveying the site), see Figure 2 below.

The site inspection determined that the superelevation of the curve was about 4%. Using figure 7.8 Rural Road from Austroads Guide to Road Design Part 3: Geometric Design (2016) and a radius of 165 m, the operating speed should be approximately 70 km/h. The curve radius and superelevation need to be confirmed.

There are no advance warning signs for the curve.

Determine the radius, superelevation and recommended operating speed of the curve. Install advance curve warning signage and consider additional measures (Speed advise tag, guideposts, raised pavement markers, edge line with audible tactile marking, pavement widening) to guide the road user.

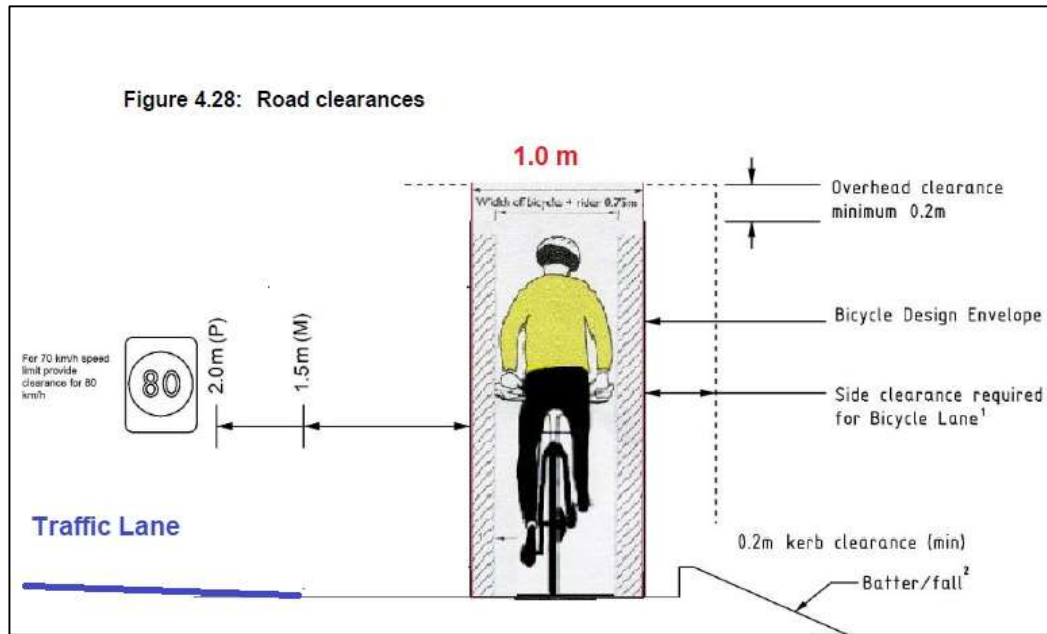
Figure 3 - Sketch from Austroads Road Design

*Austroads Guide to Road Design Part 3: Geometric Design (2016)* indicates that due to the side wind forces exerted on cyclists from heavy vehicles, roads should be designed to provide satisfactory clearances between the bicycle envelope and passing vehicles. The clearance that should be provided between a cyclist envelope and a truck in the adjacent lane to enhance cyclist safety is 1.5 m for 70/80 km/h speed zones. The minimum cycle lane wide is 1.0 m.

Provide bicycle lanes to Harris Road as per the Austroads Guides.

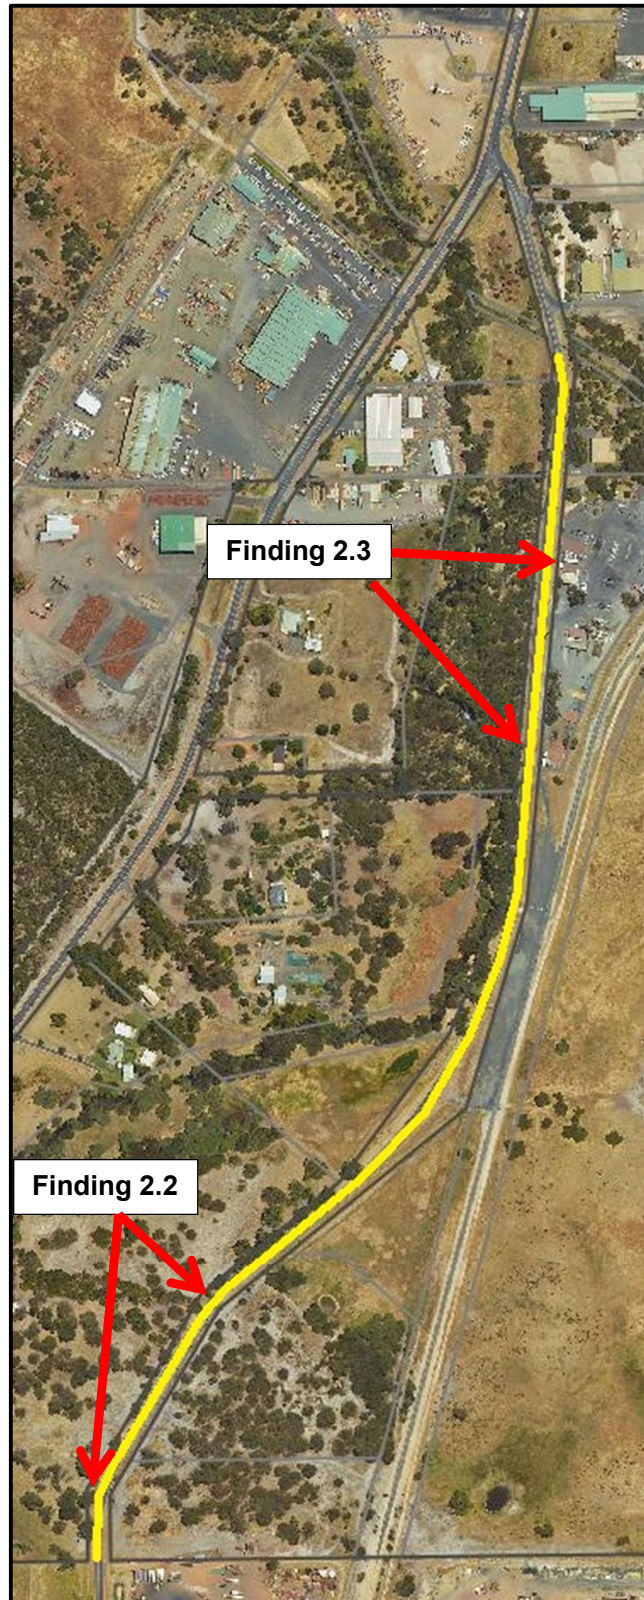
**Figure 4 - General Location Plan**

\* Most findings were located at numerous sites throughout the project and have not been detailed specifically at one location.

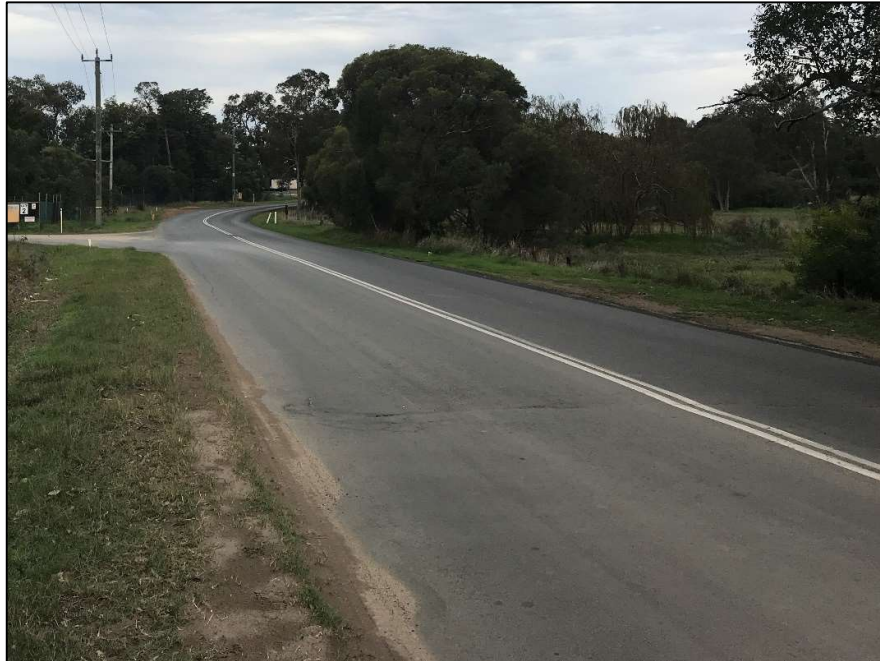
The sealed pavement width is 7.4 m with no formal shoulder. The verge slopes from the hinge point at about 1.0 m from the edge of the traffic lane, the batters vary along the road but are generally 4:1. There are large wooden power poles reinforced with steel supports along the northern verge approximately 4 m from the traffic lane. The southern verge tends to drop away towards the Ferguson River and has mature trees in places close to the traffic lane. There are no streetlights along the road and few guideposts, the only delineation is the painted centreline.

The desirable traffic lane width is 4.2 m. This width allows large vehicles to pass without either vehicle having to move sideways towards the outer edge of the lane.

For a road with traffic volumes between 1,000 - 3,000 vehicles per day with a high percentage of large vehicle (30%), a pavement width of 12.4 m consisting of two traffic lanes of 4.2 m and shoulders 2.0 m of which 1.0 m is sealed is recommended. Note that on substandard curves the shoulder sealed width should be increased.

**Finding 2.1 – Harris Road, 7.4 m wide without constructed shoulders.**

Widen the sealed pavement to accommodate the traffic and large vehicles in accordance with Austroads Guides.

Findings and Recommendations	Project Manager		
	Agree / Disagree	Reason for Disagreeing	Proposed Action and Comments
<p><b>3.1 Finding – Width of Road.</b></p> <p>The desirable traffic lane width is 4.2 m. This width allows large vehicles to pass without either vehicle having to move sideways towards the outer edge of the lane.</p>			
<p><b>Recommendation</b></p> <p>Widen the sealed pavement to accommodate the traffic and large vehicles in accordance with Austroads Guides.</p> <p><b>[IMPORTANT   VERY HIGH]</b></p>	Agree	***	<p>The City will use the MRWA RAV Guidelines Appendix C – RAV2-4 80-100km Undivided with Cycle Lane; this requires a seal width of 5.5m from the centreline. CoB will provide a 3.7m traffic lane, 1.8m cycle lane &amp; 0.5m unsealed shoulder. This will provide a consistent seal width with Stage 1 of the Harris Rd upgrade for CoB, and the proposed upgrade of Harris Rd within the Shire of Dardanup – to be included in Harris Rd Stage 2 Design (Applying for RRG &amp; Blackspot for Construction).</p>

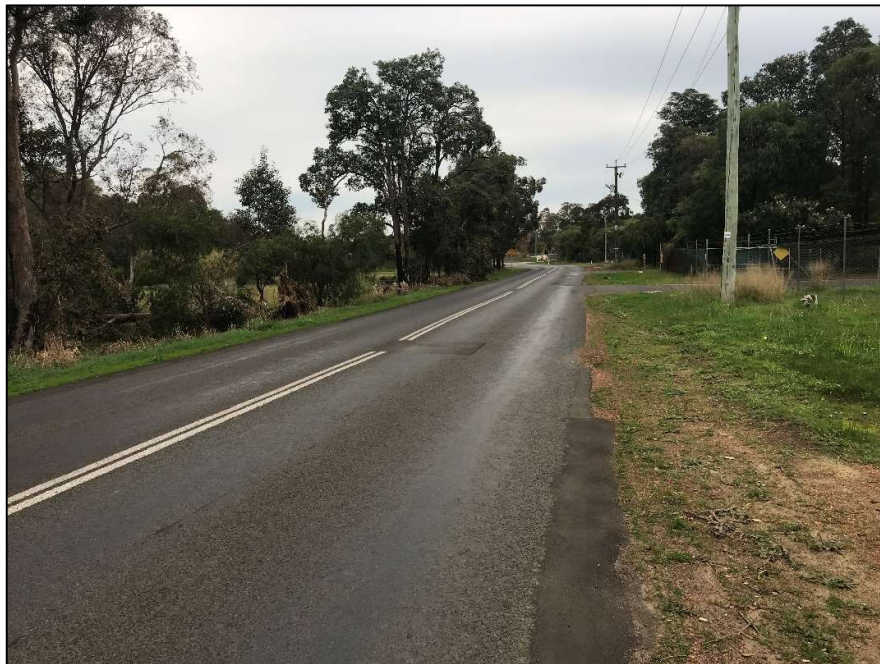
**Finding 2.1 – Harris Road 3.7 m traffic lanes, no constructed shoulder no guideposts, no street lighting.**

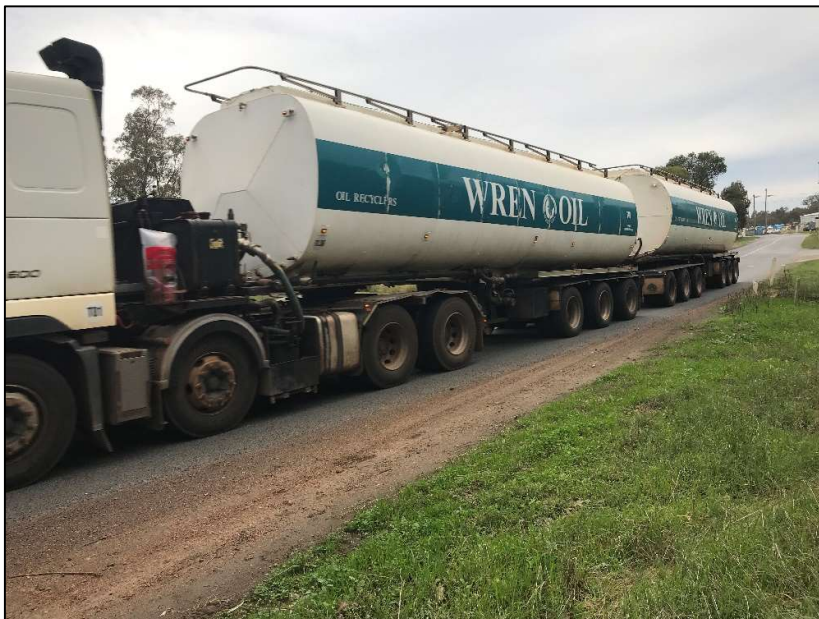
**Finding 2.1 – Large trucks using the road.**

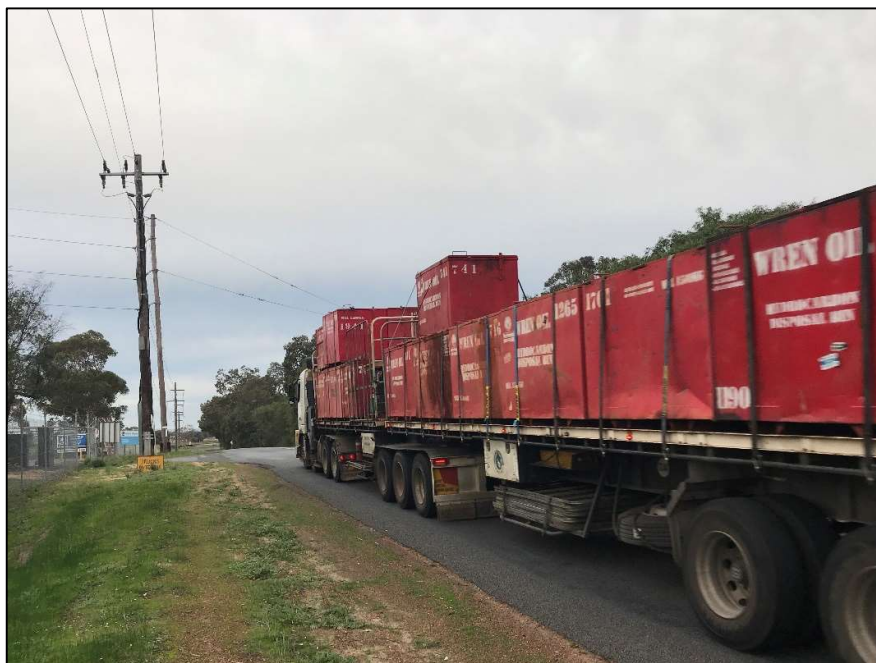
**Finding 2.1 – Large trucks using Harris Road.**

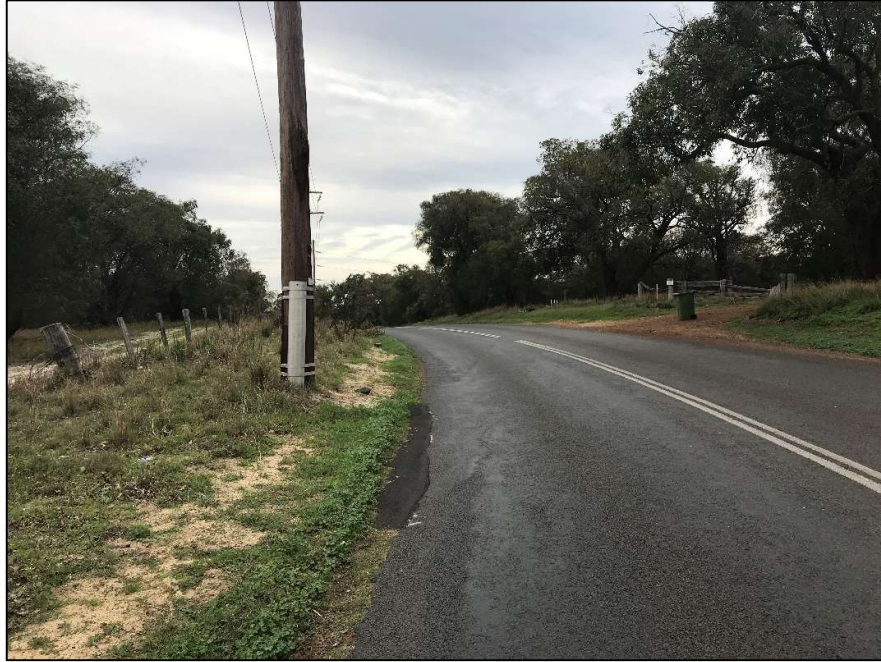
An isolated curve causing a sudden speed reduction elevates the risk of an Off-Path casualty crash.

**Finding 2.2 – Isolated curve with no guideposts, no widening of the pavement, no advance warning signs with an operating speed less than the speed zone of 80 km/h.**

Findings and Recommendations	Project Manager		
	Agree / Disagree	Reason for Disagreeing	Proposed Action and Comments
<p><b>3.2 Finding – Isolated Curves of Small Radius.</b></p> <p>An isolated curve causing a sudden speed reduction elevates the risk of an Off-Path casualty crash.</p>			
<p><b>Recommendation</b></p> <p>Determine the radius, superelevation and recommended operating speed of the curve. Install advance curve warning signage and consider additional measures (Speed advise tag, guideposts, raised pavement markers, edge line with audible tactile marking, pavement widening) to guide the road user.</p> <p><b>[IMPORTANT   VERY HIGH]</b></p>	Agree		Install advanced warning signs/advisory speed signs, guideposts and audible edge lines at isolated curves of small radius, pending radius investigations – to be included in Harris Road Stage 2 Design (Applying for RRG & Blackspot for Construction).

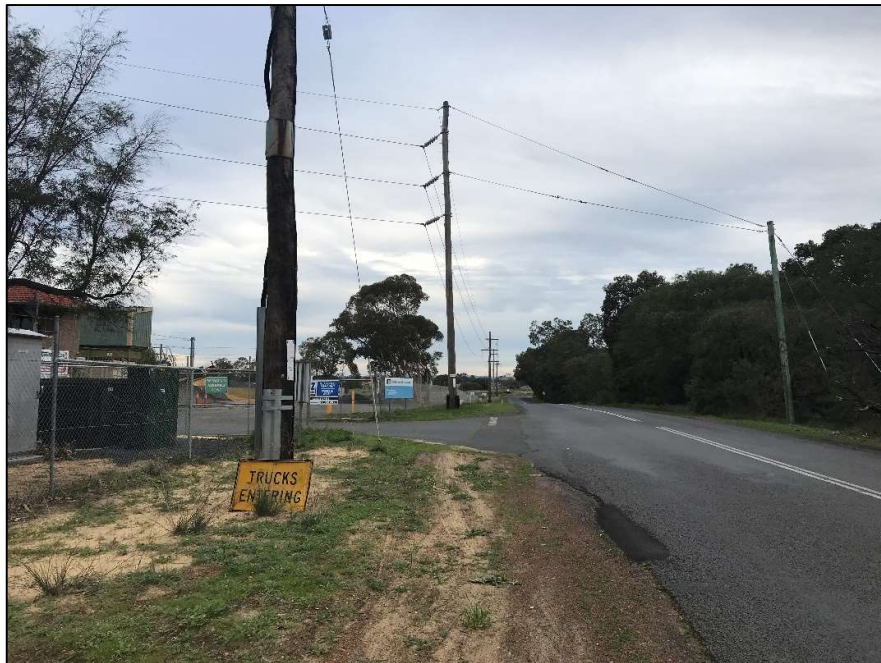
There are large power poles in the northern verge and numerous mature trees along the southern road verge that pose a risk to vehicle occupants in the event an errant vehicle leaves the roadway.

The power poles in the northern verge are a significant size, reinforced with steel and located approximately 4 m from the edge of the traffic lane. Widening of the existing road pavement would result in the poles being closer to the traffic lane.

The power poles are significant assets and would be a high cost to move or underground, placing barriers and or a combination of moving the traffic lane away from the power poles may achieve suitable mitigation.

**Finding 2.3 – Existing power poles with steel supports approximately 4.0 m from the traffic lane within the clear zone.**

Provide suitable clear zones along the road, when this is not possible, consider other mitigations such as a road safety barrier, edge lines, lower speed etc.

Findings and Recommendations	Project Manager		
	Agree / Disagree	Reason for Disagreeing	Proposed Action and Comments
<p><b>3.3 Finding – Non-Frangible Objects in the Clear Zone.</b></p> <p>There are large power poles in the northern verge and numerous mature trees along the southern road verge that pose a risk to vehicle occupants in the event an errant vehicle leaves the roadway.</p>			
<p><b>Recommendation</b></p> <p>Provide suitable clear zones along the road, when this is not possible, consider other mitigations such as a road safety barrier, edge lines, lower speed etc.</p> <p><b>[IMPORTANT   HIGH]</b></p>	Agree		Clear trees within the clear zone, install audible edge lines, install barriers and lobby Main Roads for Speed Reduction – to be included in Harris Road Stage 2 Design (Applying for RRG & Blackspot for Construction).

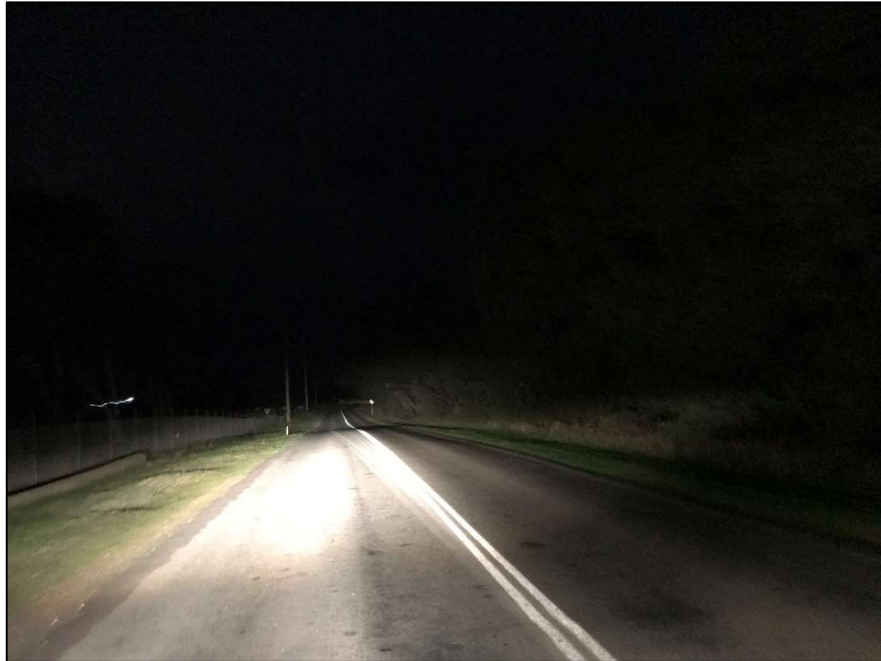
Few guideposts were visible in dark conditions and they did not provide clear guidance to the road user. This can result in the road user misjudging the road layout resulting in an Off-Path crash.

**Finding 2.4 – No guideposts visible in dark conditions with high beam on.**

Install guidepost to the Australian Standard.

Findings and Recommendations	Project Manager		
	Agree / Disagree	Reason for Disagreeing	Proposed Action and Comments
<b>3.4 Finding – Guideposts.</b>  Few guideposts were visible in dark conditions and they did not provide clear guidance to the road user. This can result in the road user misjudging the road layout resulting in an Off-Path crash.			
<b>Recommendation</b> Install guidepost to the Australian Standard. <b>[IMPORTANT   HIGH]</b>	Agree		Install Guideposts to Australian Standard – to be included in Harris Road Stage 2 Design (Applying for RRG & Blackspot for Construction).
<b>3.5 Finding – Cyclist on Road with Trucks.</b>  Many cyclists and cycling groups use Harris Road. The mix of large trucks and cyclists on a narrow traffic lane with a high-speed zone has a high risk of an incident.			
<b>Recommendation</b> Provide bicycle lanes to Harris Road as per the Austroads Guides. <b>[IMPORTANT   HIGH]</b>	Agree		Install 1.8m Cycle Lane as per MRWA RAV Guidelines Appendix C – to be included in Harris Road Stage 2 Design (Applying for RRG & Blackspot for Construction).

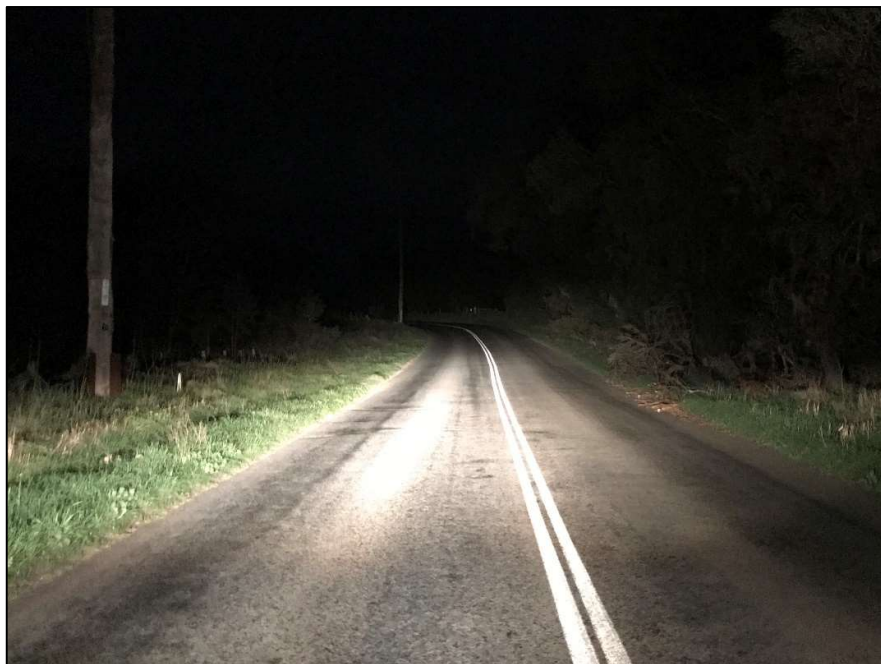
**Finding 2.4 – No guideposts visible in dark conditions at the approach to curve  
with high beam on.**

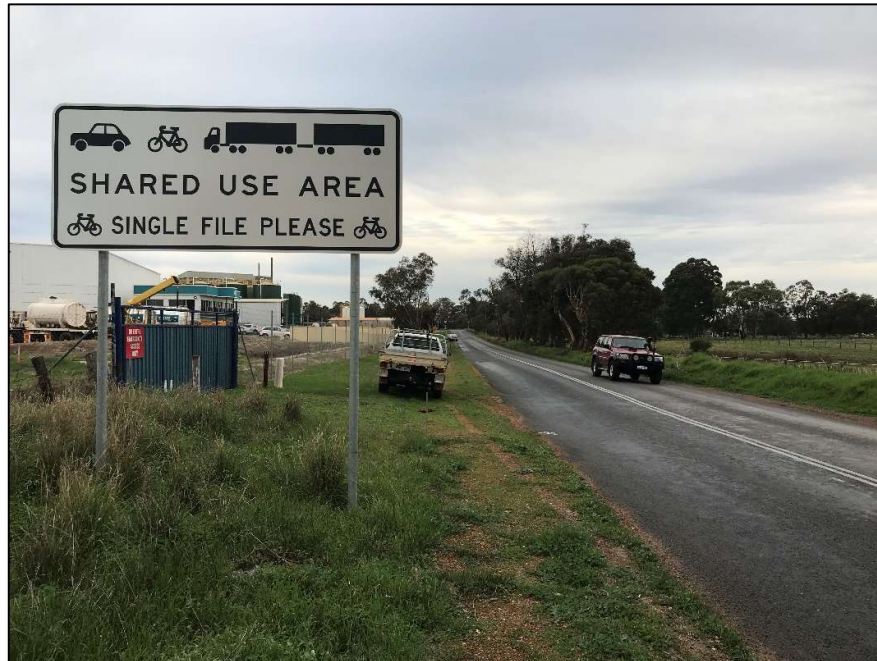
Many cyclists and cycling groups use Harris Road. The mix of large trucks and cyclists on a narrow traffic lane with a high-speed zone has a high risk of an incident.

**Finding 2.5 – Harris Road has high cyclists use.**

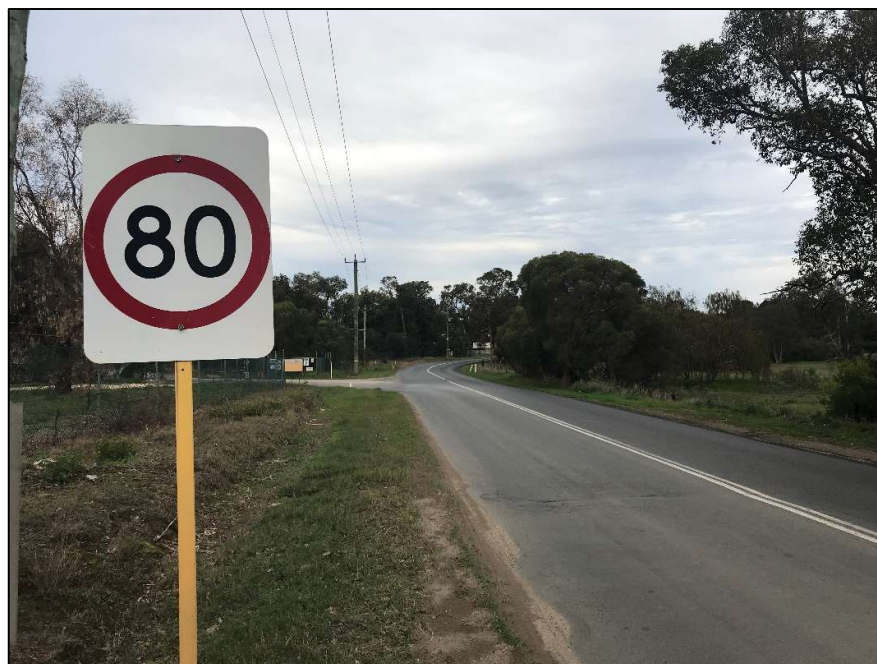
Several large businesses along the road operate with high truck use. The posted speed for the road is 80 km/h for its entire length. Some of the businesses have truck warning signs indicating there may be an issue for trucks accessing and exiting properties.

**Finding 2.6 – Harris Road 80 km/h speed zone.**

Determine if the current speed zoning is appropriate for an industrial precinct with direct business access.

Findings and Recommendations	Project Manager		
	Agree / Disagree	Reason for Disagreeing	Proposed Action and Comments
<p><b>3.6 Finding – Speed Zoning.</b></p> <p>Several large businesses along the road operate with high truck use. The posted speed for the road is 80 km/h for its entire length. Some of the businesses have truck warning signs indicating that there is an issue for trucks accessing and exiting properties.</p>			
<p><b>Recommendation</b></p> <p>Determine if the current speed zoning is appropriate for an industrial precinct with direct business access.</p> <p><b>[IMPORTANT   LOW]</b></p>	Agree		Lobby Main Roads for the speed limit reduction for the section of Harris Road adjoining businesses with heavy truck movements, approx. SLK 0.8-1.4

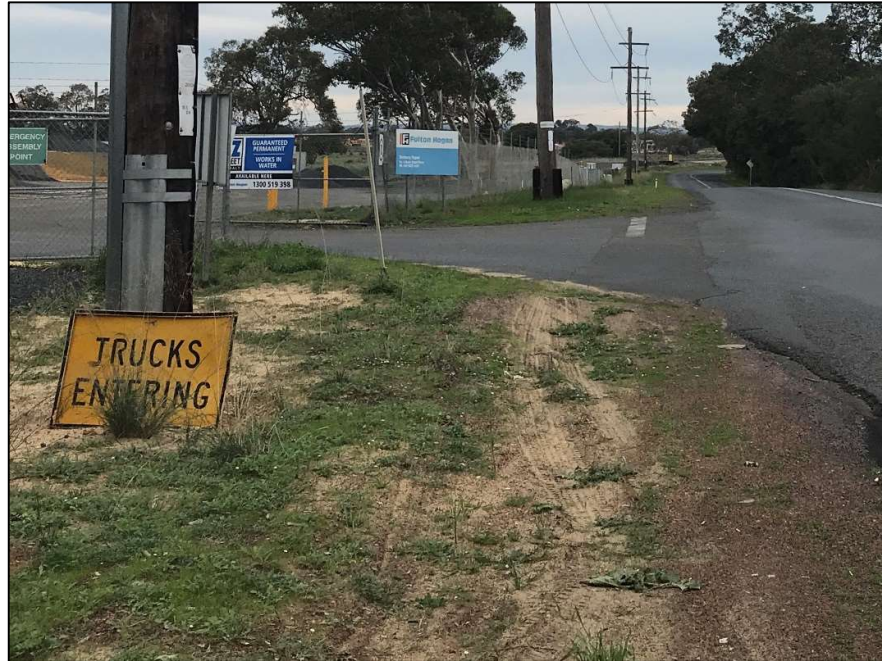
**Finding 2.6 – Trucks Entering signage off Harris Road.**
