Main Roads Western Australia

Great Eastern Highway Bypass Interchanges Project

Phytophthora Dieback occurrence assessment – Revision 0

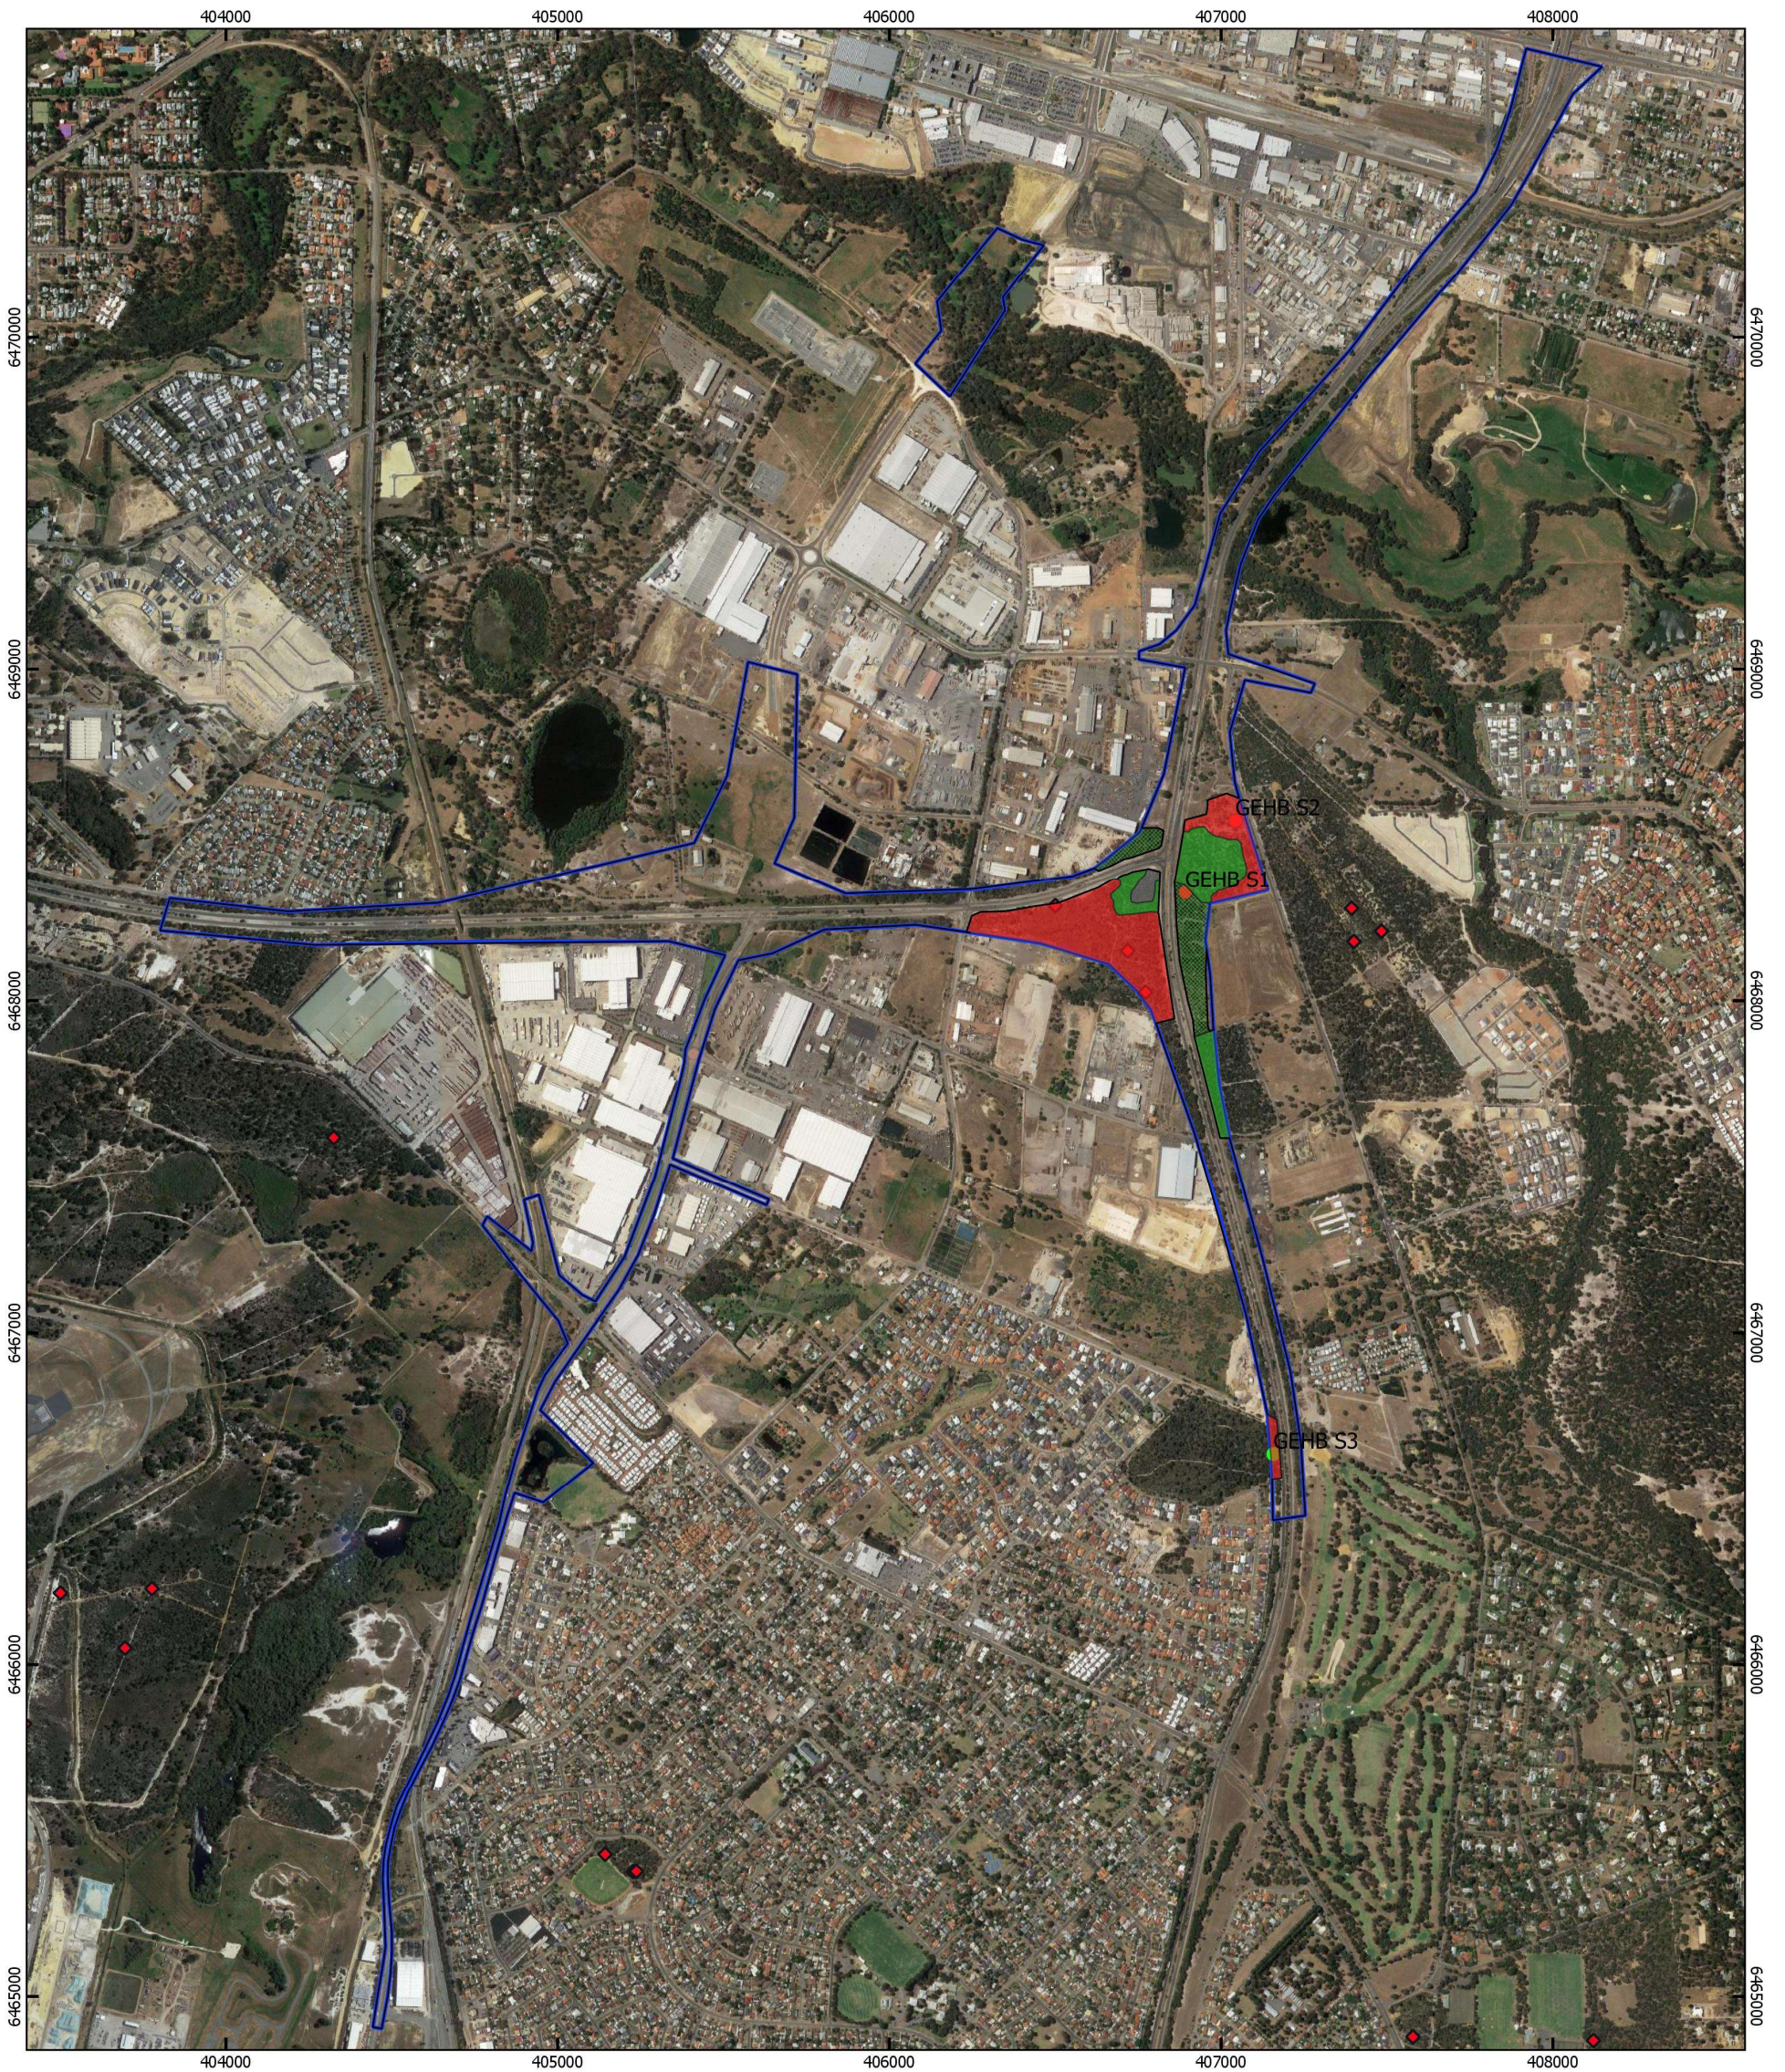
Map 1
Phytophthora Dieback
Occurrence Map

Three protectable uninfested areas, comprising a total of 5.7 ha were identified during the assessment. Three *Phytophthora* Dieback infestations, covering 13.2 ha were observed during the assessment (Map 1). An area covering 0.6 ha was mapped as temporarily uninterpretable due to fire disturbance. An additional 4.1 ha of unprotectable uninfested vegetation was also identified. The remaining 135.3 ha of development envelope was excluded from the assessment due to being degraded or void of vegetation (as per DPAW 2015).

A desktop assessment of previous *Phytophthora* spp. recoveries for the area indicates that *Phytophthora cinnamomi* was previously recovered from three locations within the development envelope (Map 1).

The provided map is the Phytophthora Dieback occurrence map. The project area is displayed as a blue boundary line. The following categories are also shown (if present in the project area):

- Excluded (shown as uncoloured). Areas of high disturbance where natural vegetation has been cleared and is unlikely to recover to a level that is interpretable.
- Infested (shown as red). Determined from the assessment to have the plant disease caused by *Phytophthora cinnamomi*. Phytophthora Dieback caused by other *Phytophthora* species will be displayed as other colours, typically shades of orange and yellow.
- Uninfested (shown as green). Determined from the assessment to be free of plant disease Phytophthora Dieback.
- Uninterpretable (shown as purple). Undisturbed areas where susceptible plants are absent, or too few to decide the presence or absence of Phytophthora Dieback.
- Temporarily Uninterpretable (shown as grey). Areas of disturbance where natural vegetation is likely to recover.

Three protectable areas are located within the development envelope. A section of one of the protectable areas has been recently burnt and is temporarily uninterpretable (Map 1). The burnt section is surrounded by uninfested vegetation and did not exhibit any evidence of disease presence. When the size of the burnt area is added to the surrounding uninfested area, the total size meets the minimum requirements for protectable areas. One of the protectable areas mapped is relatively narrow (Map 1), however it is contiguous with a larger area of uninfested vegetation outside the development envelope.

Two uninfested areas were classified as unprotectable due to their size. The area immediately north west of the GEHB Bypass / Tonkin Hwy intersection is less than 1 ha and therefore does not meet the minimum size requirements (1 ha minimum recommended by Glevan). The other unprotectable area is on the eastern side of the Roe Hwy (Map 1) and is considered to be too narrow in some areas. In addition, there are several small degraded areas associated with disturbance activity in this narrow section.

Despite a negative sample result (Sample 3) being recorded, a section at the southern end of the development envelope (Map 1) has been mapped as infested. The area exhibited several symptoms consistent with the presence of Phytophthora Dieback and cannot be mapped as

uninfested. It is also immediately adjacent to Hawkesvale Reserve, which appeared to be uninfested and protectable. As such, movement between the infested area and Hawkesvale Reserve should be avoided. Pushing soil and plant material towards the reserve during clearing operations should also be avoided. The infested section is bordered to the south and north by degraded, excluded areas and no hygiene points are required when moving north or south.
