CLEARING PERMIT

Purpose Permit number:	CPS 9483/1
Permit Holder:	Goldfields Margaret River Pty Ltd
Duration of Permit:	From 17 March 2022 to 17 March 2037

The permit holder is authorised to clear *native vegetation* for the purpose of a sewer extension.

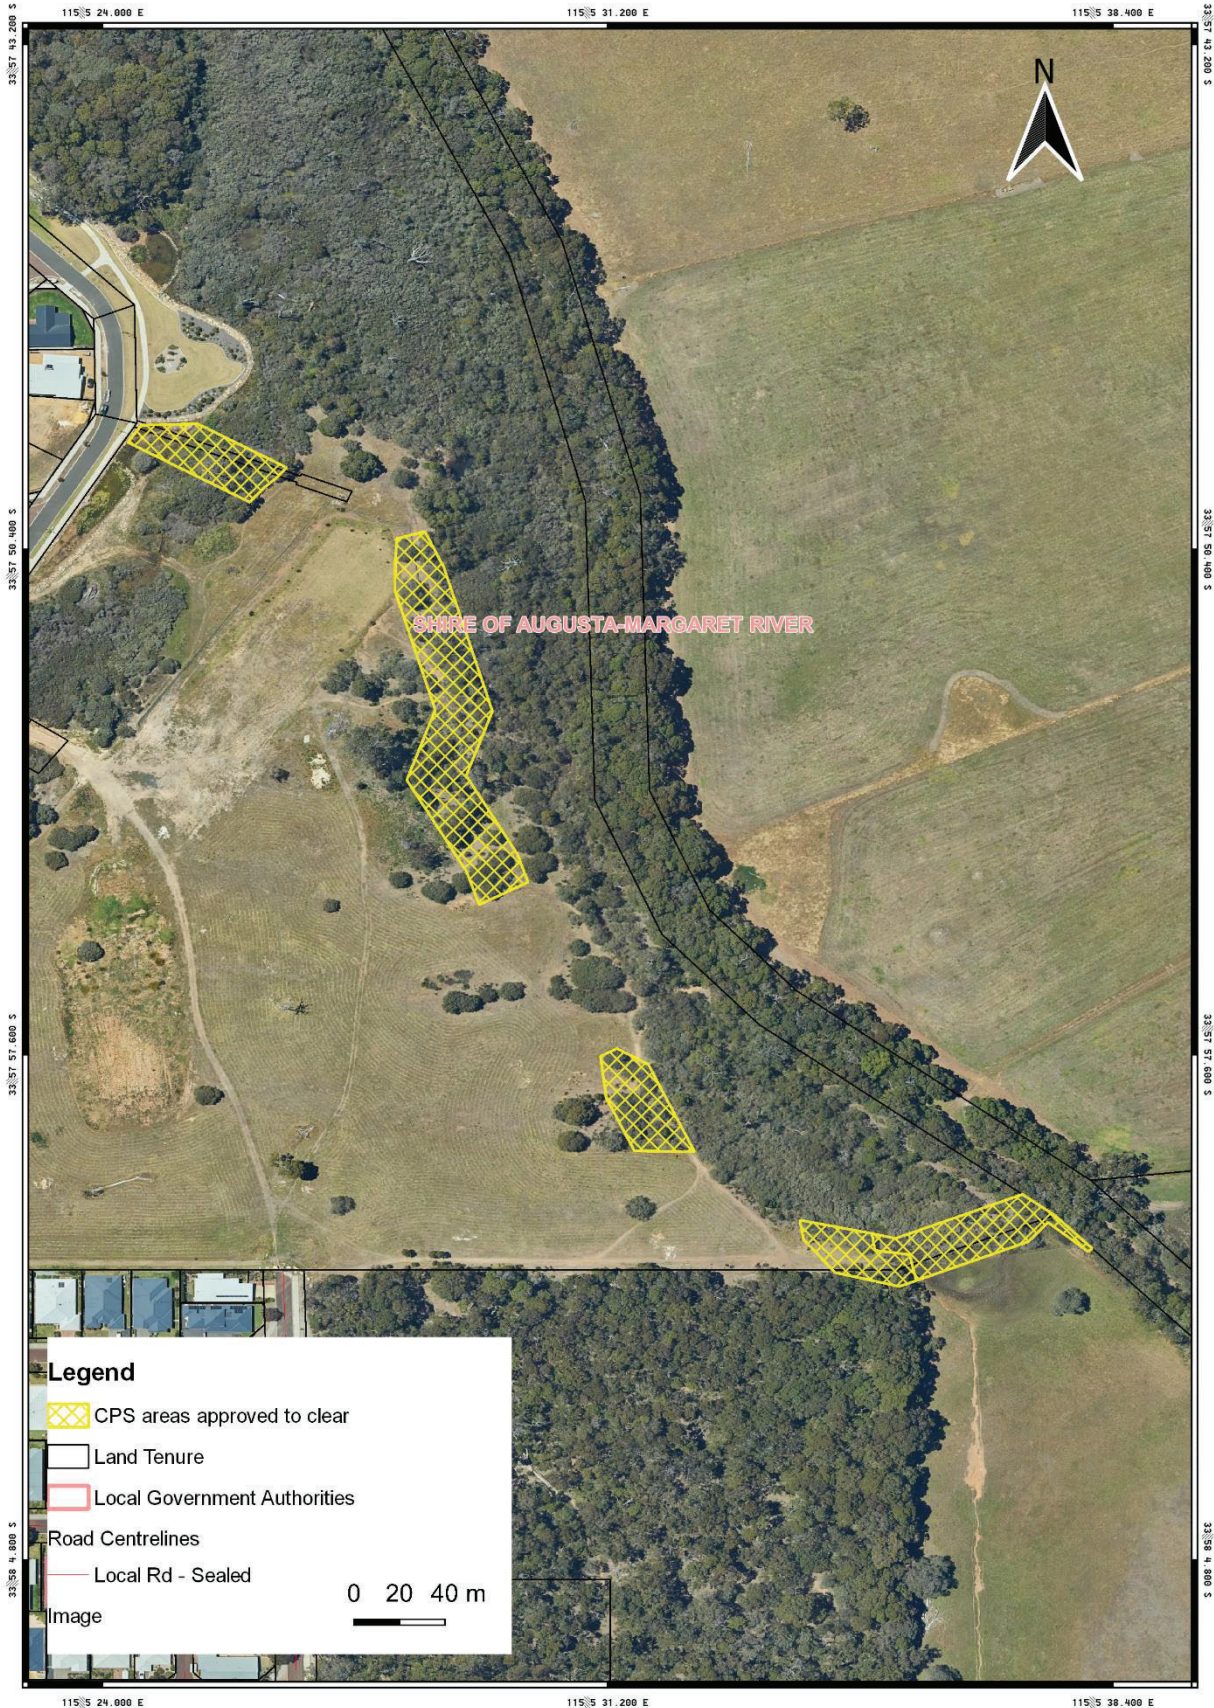
Figure 1: Map of the boundary of the area within which clearing may occur

The boundary of the area authorised to be cleared is shown in the map below (Figure 1).

The permit holder must not clear more than 0.69 hectares of *native vegetation* within the area cross-hatched yellow in Figure 1 of Schedule 1.

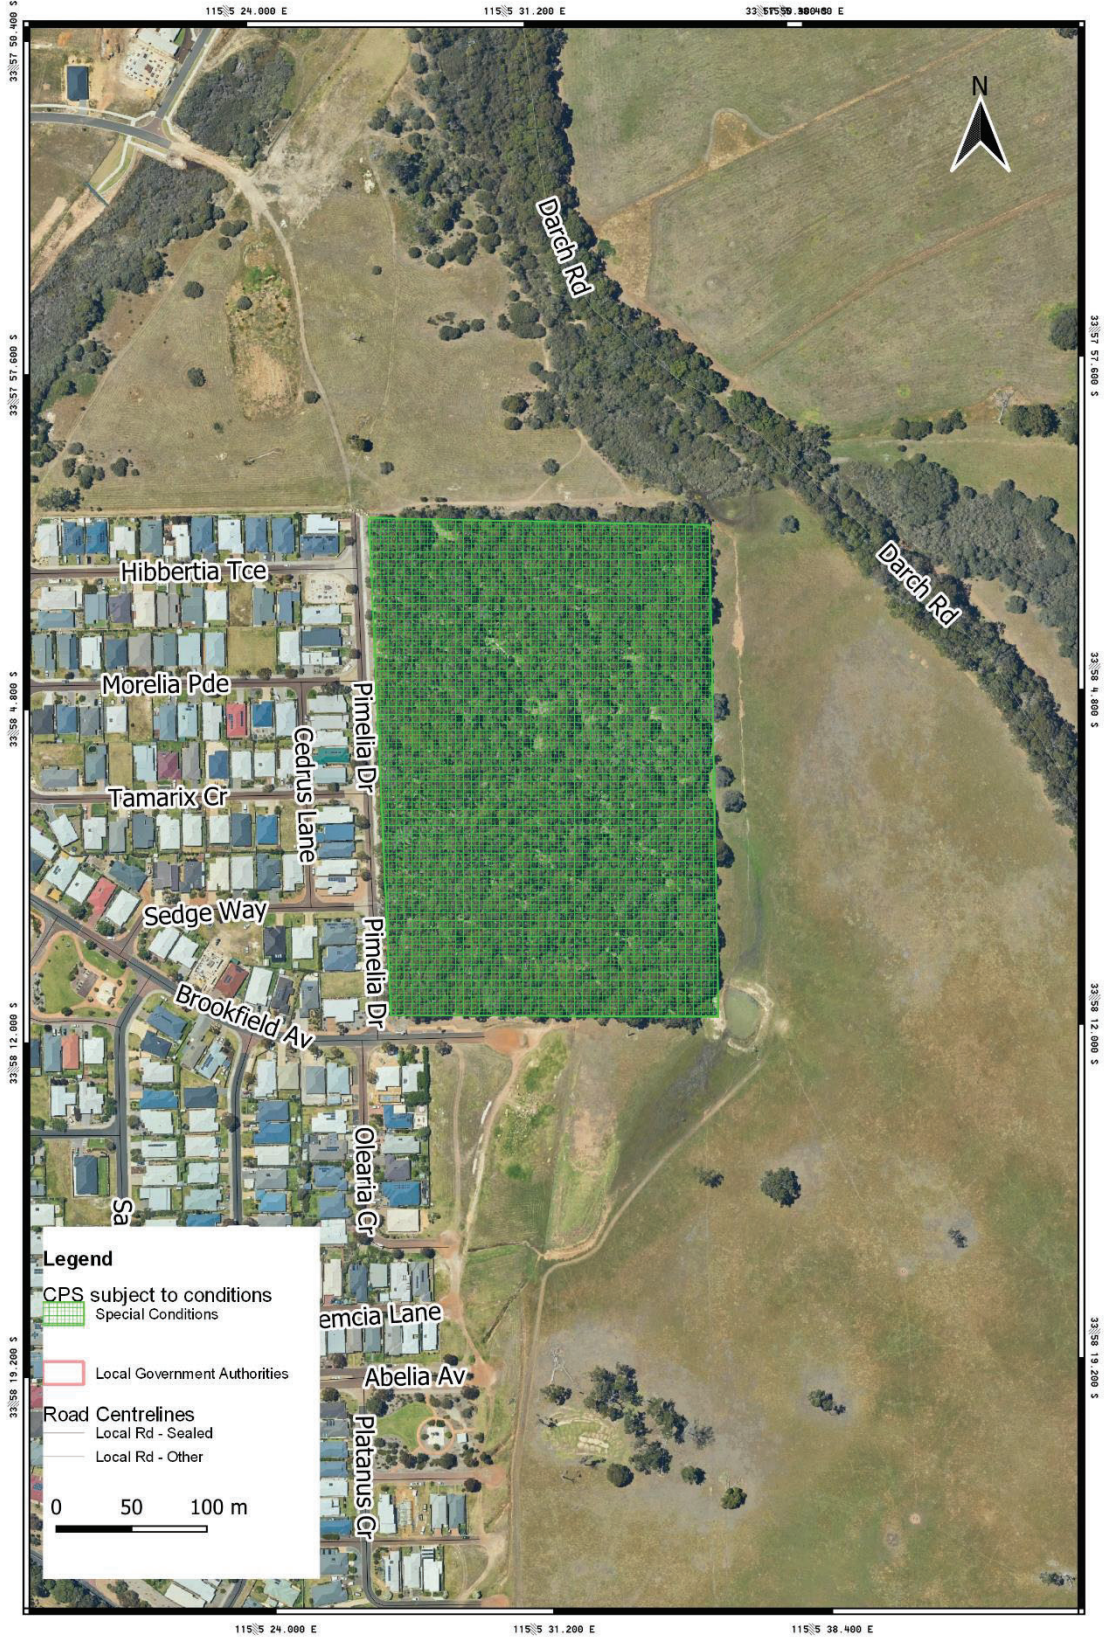
Figure 2: Map of the boundary of the area within which conditions apply

The boundary of the area within which artificial hollows are to be installed is shown cross-hatched green in the map below (Figure 2).

- (i) The artificial black cockatoo nest hollow(s) required by condition 9(g) of this permit must:
 - (i) be installed within the area cross-hatched green on Figure 2 of Schedule 1;

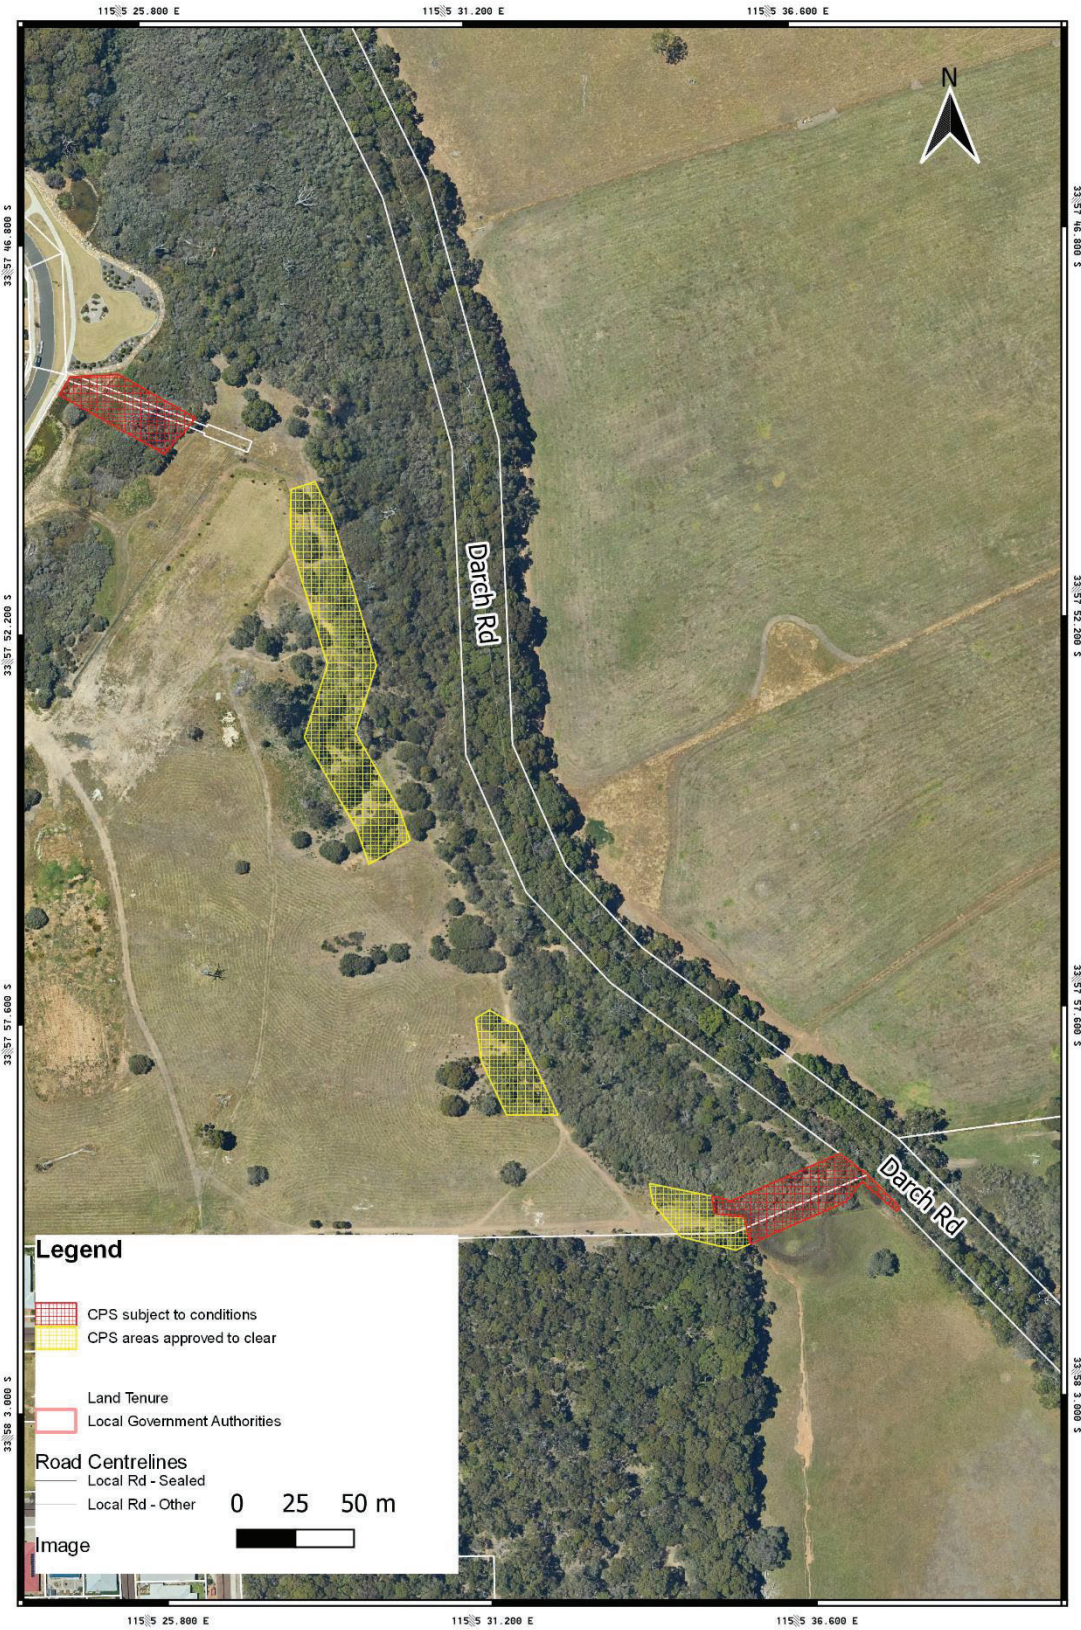
Figure 3: Map of the boundary of the area within which conditions apply

The boundary of the area within which revegetation is to occur is shown cross-hatched red in the map below (Figure 3).

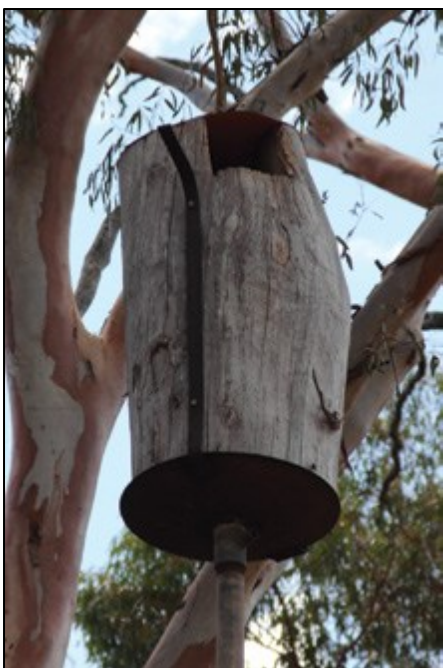
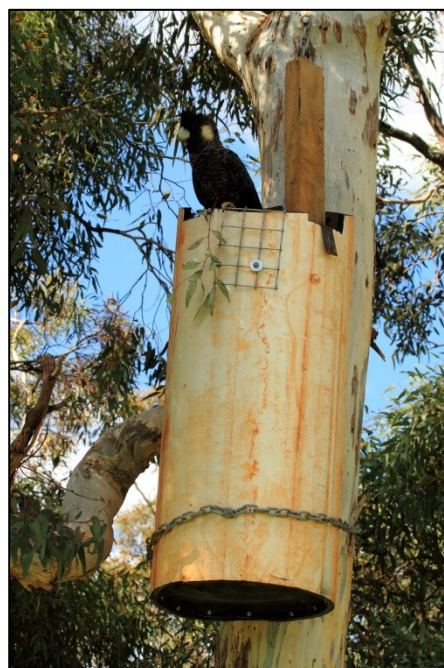
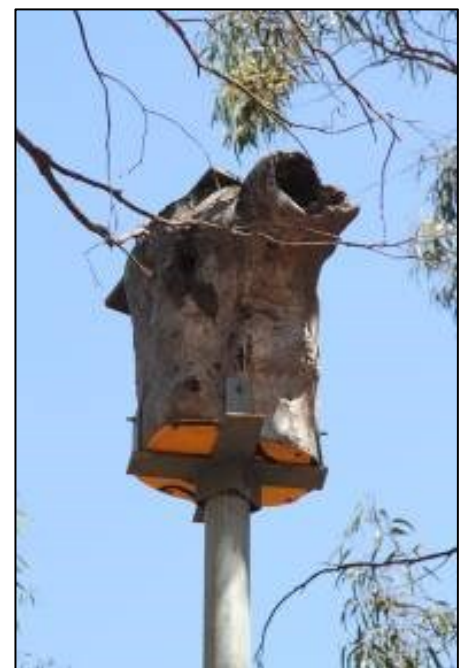
Below are three examples of successful artificial hollows used by Carnaby's cockatoo for nesting. Artificial hollows made from a natural log with cut side entrance (left), white industrial pipe with top entrance (centre) and natural log with natural side entrance (right).

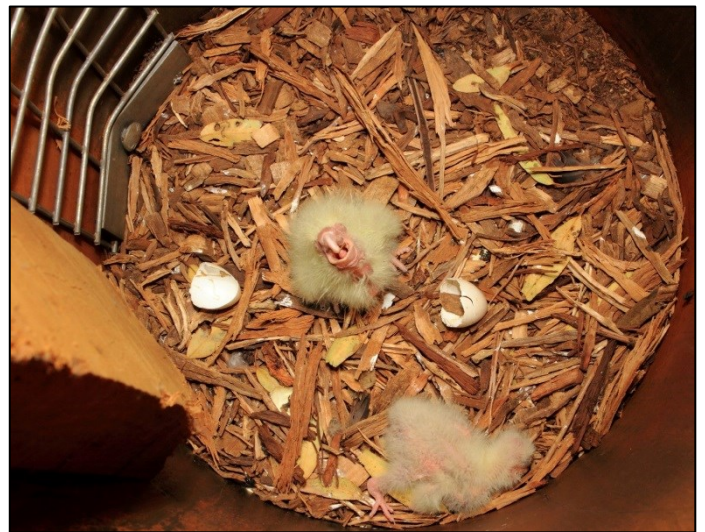
Bottom of an artificial hollow showing ladder that is fixed to the wall and a chewed sacrificial post which is 200 mm from the floor.

It is recommended that at least two posts are provided. Posts 70 x 50 mm have been used, but require replacing at least every second breeding season when the nest is active. Birds do vary in their chewing habits and therefore the frequency at which the chewing posts require replacement will also vary.

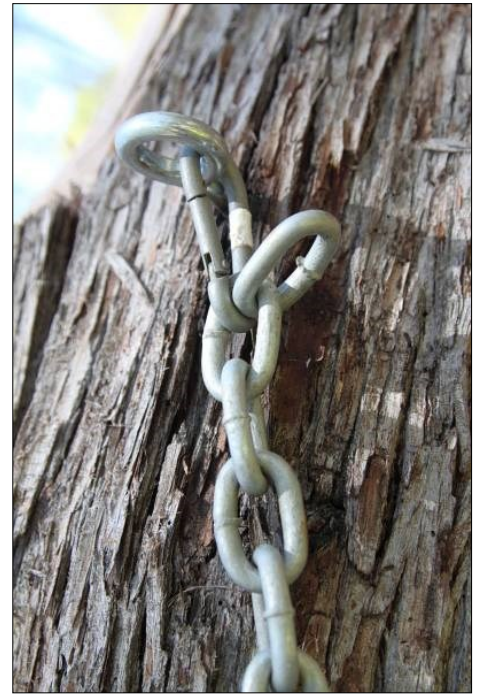
Example fixing for artificial hollow
Photo by Christine Groom

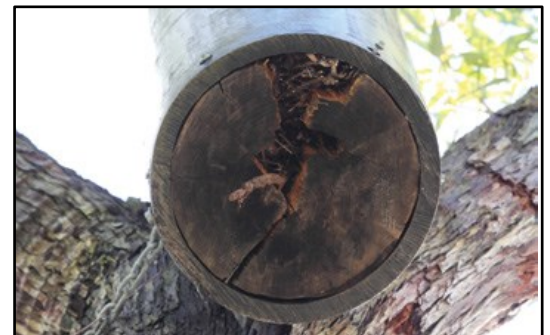
Artificial hollow base needing repair.
Photo by Christine Groom

Any problems identified during maintenance checks should be addressed, and any repairs required done, as soon as possible. If breeding is currently occurring, maintenance may need to be delayed if it is likely to disturb the parents or nestling. Likely maintenance needs include replacement of chewing posts (frequently) or nest bases (occasionally) and repairing of any cracks (infrequently). Maintenance concerns regarding the security of attachment points or the stability of the tree or pole should be addressed as a priority for safety reasons.

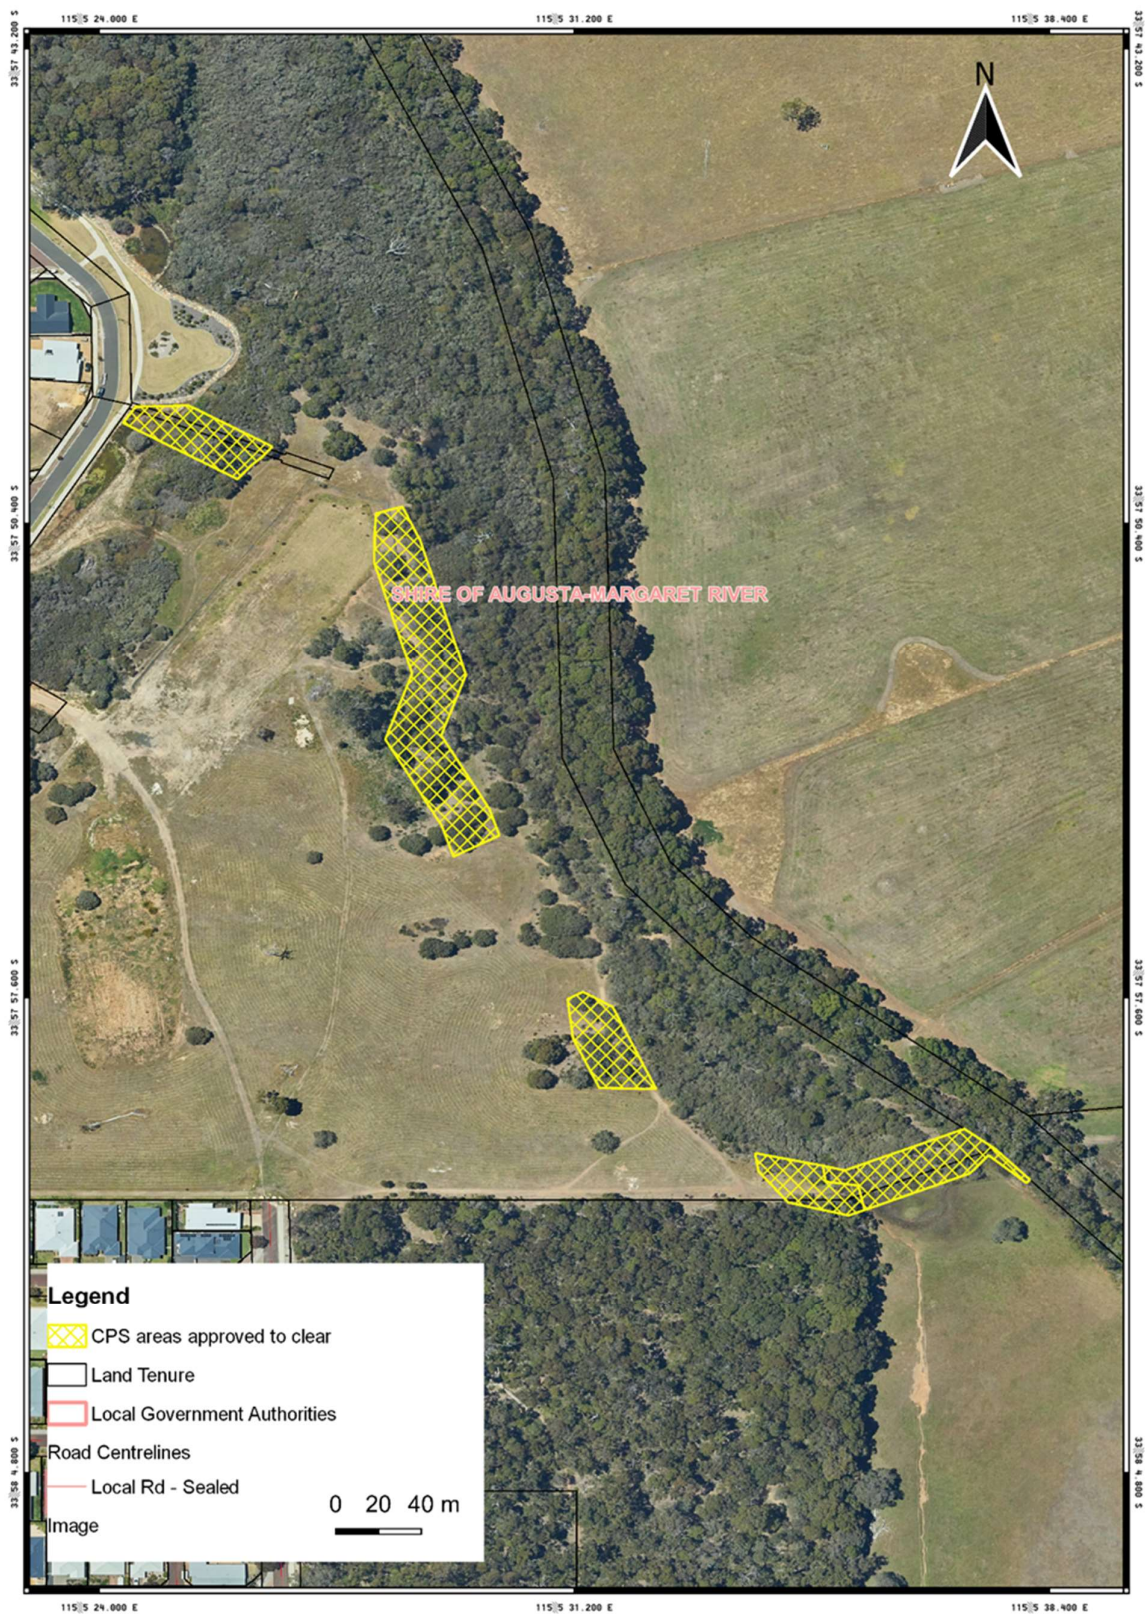
Figure 1 Map of the boundary of the area within which clearing may occur.

The areas cross-hatched yellow indicate the areas authorised to be cleared under the granted clearing permit.

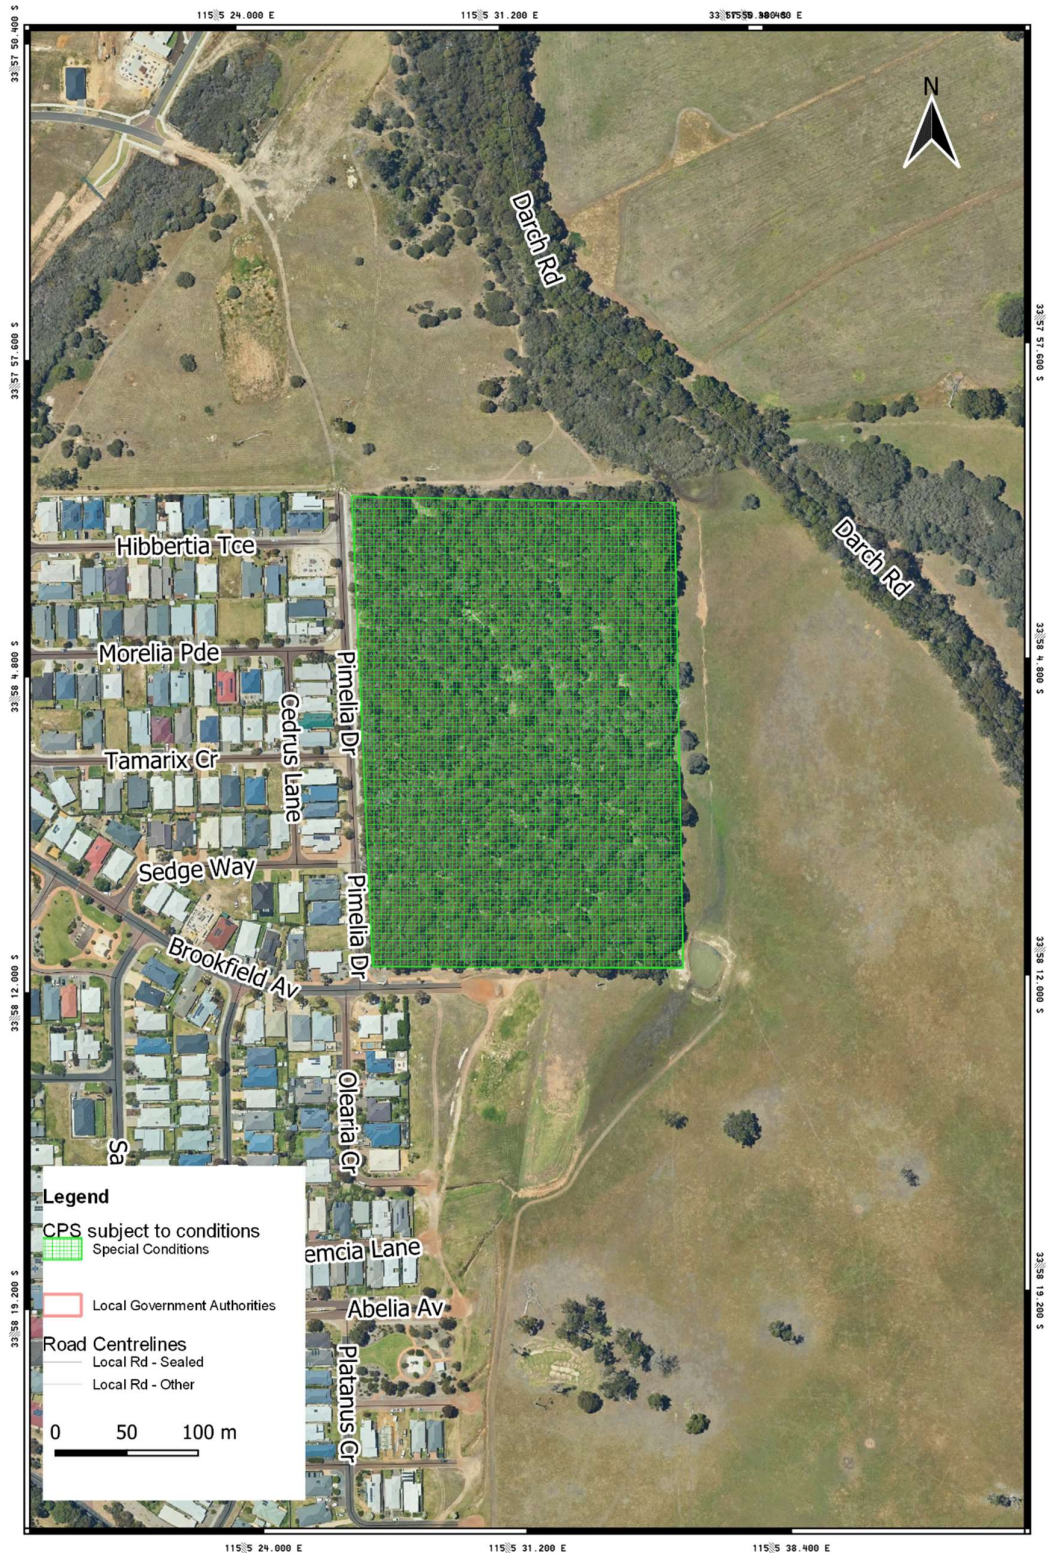
Figure 2 Map of the boundary of the area within which fauna conditions apply.

The area cross-hatched green indicates the area within which artificial hollows are to be installed under condition 9 of the Permit.

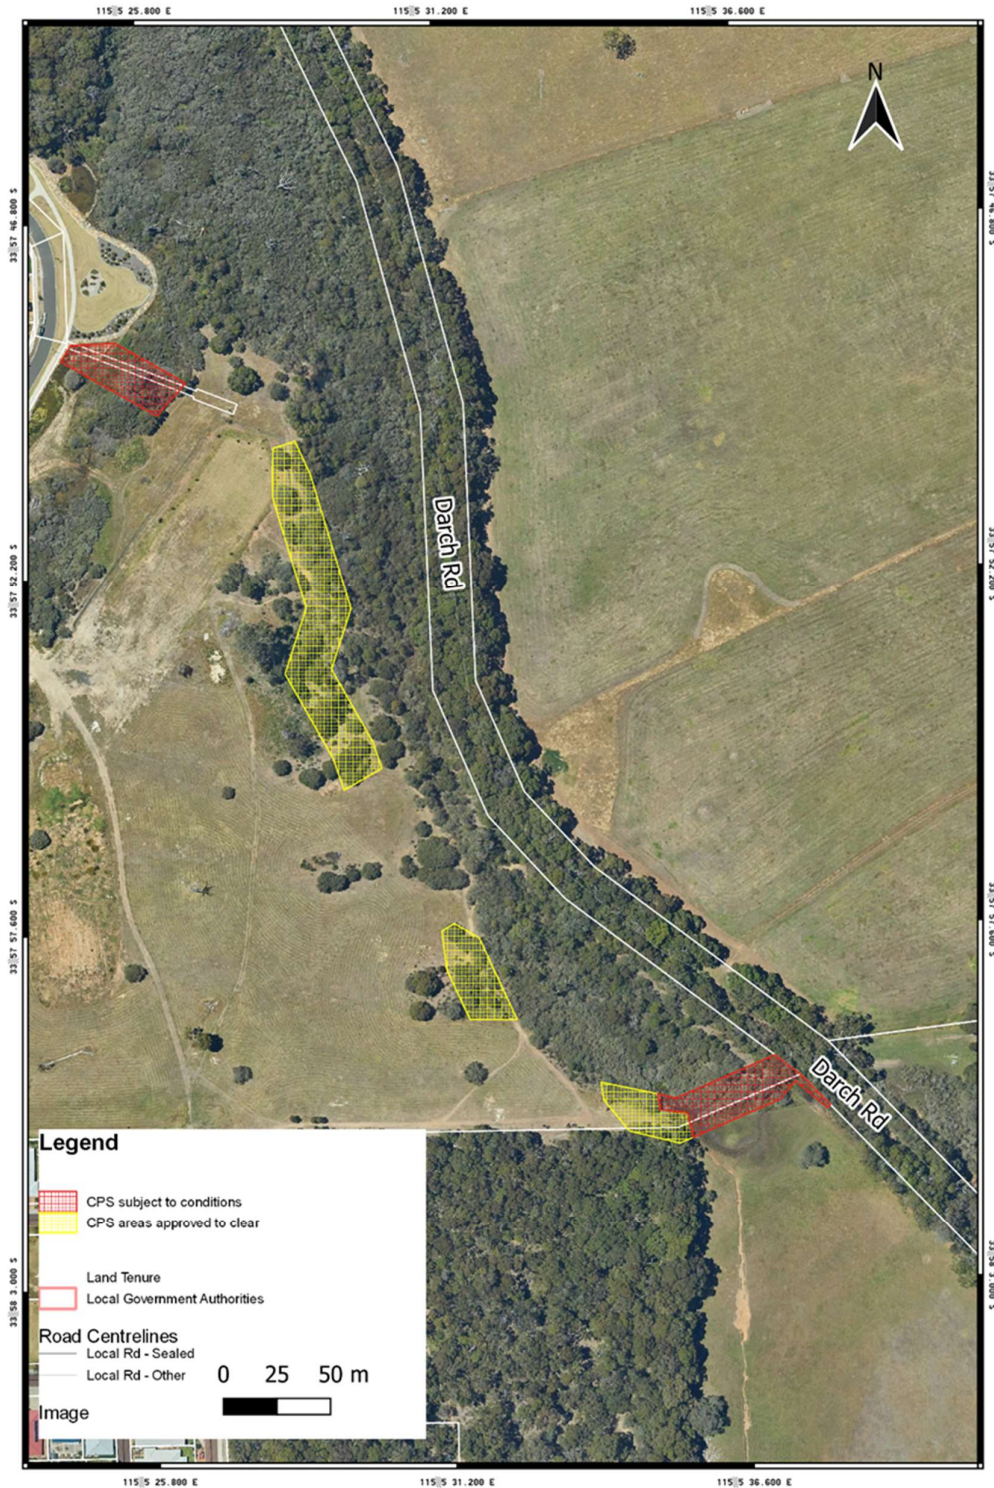
Figure 3 Map of the boundary of the area within which revegetation conditions apply.

The area cross-hatched red indicates the area within which revegetation is required in accordance with condition 10 of the Permit.
