Dieback and Invasive Weed Management Plan CPS 9524/1

Julie Waters – BEnvSc (Hons), Environmental Coordinator
Dylan Gleave – BScEng, Manager Parks and Environment

April 2023

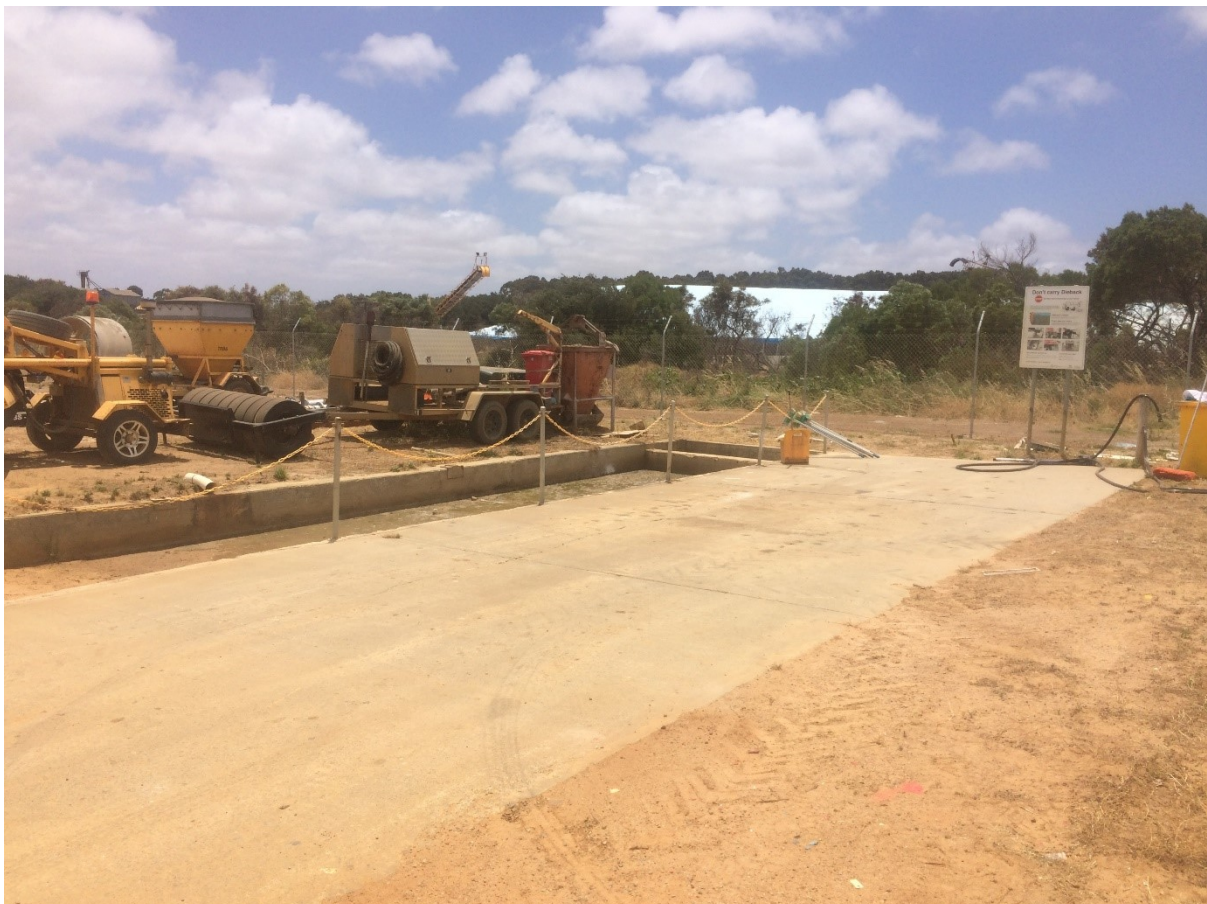
Figure 1. Shire of Esperance Depot vehicle washdown bay

The Shire of Esperance uses a combination of dry clean and wash-down methods. Dry clean is where compressed air or a spade/brush is used to blow weeds and dirt from machinery. Wash-down is where pressurised water spray unit to remove any remaining soil, mud and plant material. Wash-downs need to be done on a hard, well drained surface in low lying areas (e.g. road, ramp or grate). Shire of Esperance Environmental Services staff and Operations Supervisors have completed Dieback Green Card Training.

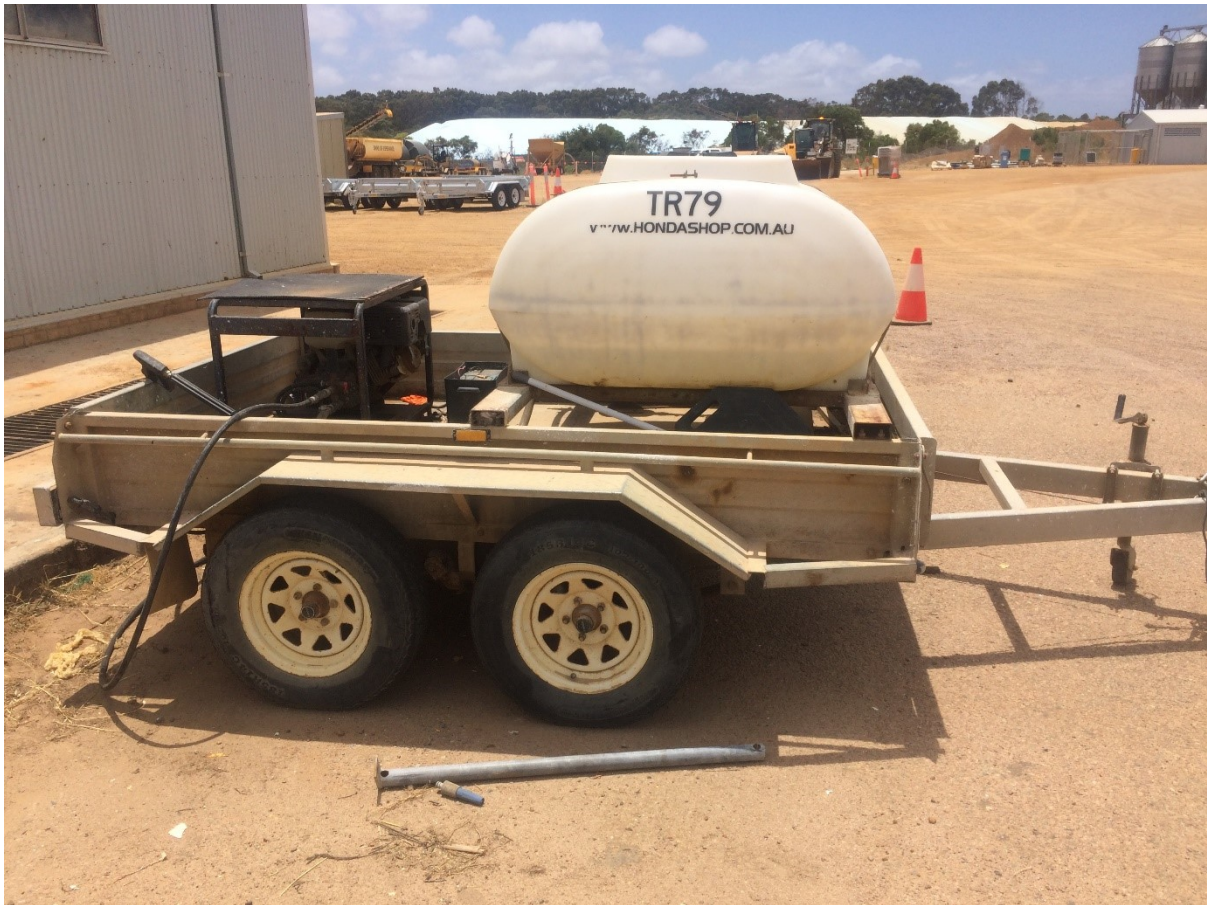
Figure 2. One of the Shire of Esperance’s fleet of mobile washdown facilities

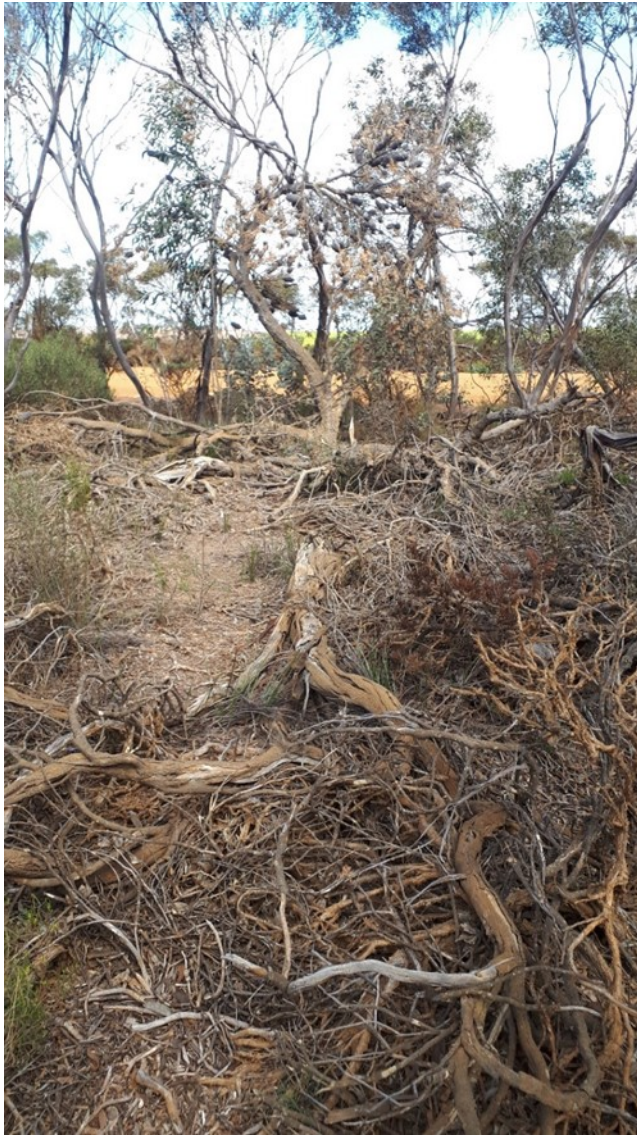
Figure 4. Potential signs of dieback, which are likely to just be natural senescence, including dead *Banksia media*, observed in vegetation type A in Pit 1 at 'Site A – Cascade Road and Gravel Pits'.

Concerns about scattered Dieback within Pit 1 at 'Site A – Cascade Road and Gravel Pits' were noted during surveys, with dead *Banksia media* and other Proteaceae species being observed. There were no signs of Dieback observed in Pit 2, which is likely due to the disturbed nature of the site from chaining. Due to the recent fire, in some areas at Pit 1 and 2 it was impossible to detect any signs of *Phytophthora cinnamomi* dieback disease. It is known to take at least five years for visual markers of Dieback to become apparent due to the tolerance of juveniles to the adverse effects of *P. cinnamomi*, A qualified dieback interpreter also cannot determine dieback presence for five years after fire. There were no signs of dieback along Cascade Road, the northern section which contained a high proportion of proteaceous species would be particularly susceptible to the spread of dieback.

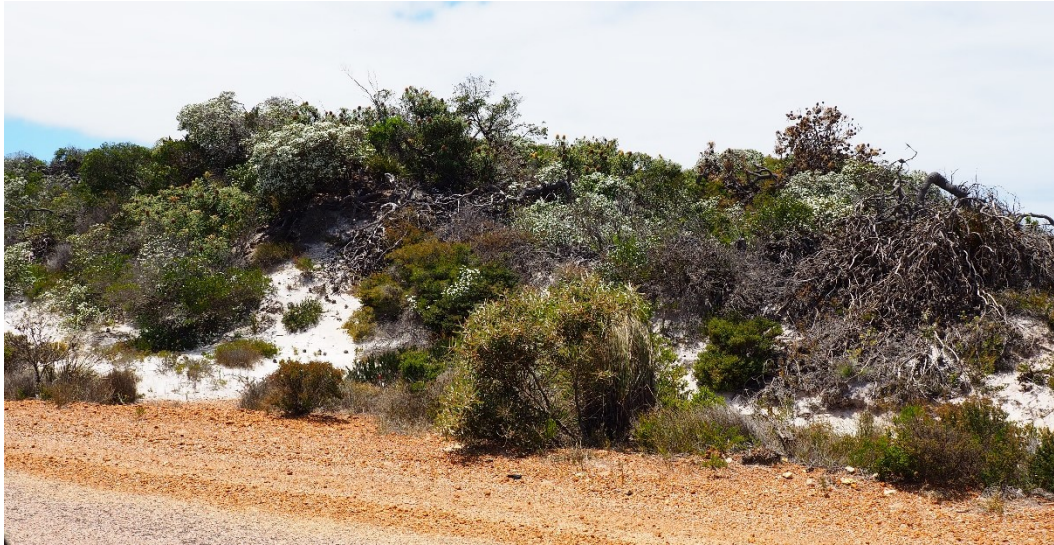
Figure 5. Dead *Banksia speciosa*, a species known for its susceptibility to *Phytophthora cinnamomi* along Wharton road

Dieback Information Delivery and Management System (DIDMS; GAIA Resources, SCNRM & State NRM 2021) data shows no positive or negative *Phytophthora cinnamomi* or other *Phytophthora* sp. Dieback sample results in the immediate area. There was several confirmed samples of *Phytophthora* Dieback 3-4km from the proposed works, in addition the Dieback Hazard Dispersion Model (GAIA Resources, State NRM & SCNRM, 2021) indicates that the entire proposed works site is at risk of dieback infection. During the flora survey several patches with dead mature *Banksia speciosa* were observed, potentially indicating dieback presence within the site.

Based on Dieback Management Plans prepared for Shire of Esperance road construction and management projects. Proposed works will be conducted using appropriate hygiene measures to limit spreading of the disease, including mulching in dry conditions and clean down of vehicles and machinery before entering the site. However, there is always a possibility that proposed works will spread *P. cinnamomi* dieback along Wharton Road due to proposed works.
