# Environmental Management Plan

## Lot 9 Brookton Highway, Karragullen

Project No: EP20-040(14)

**Prepared for Vinci Gravel Supplies Pty Ltd  
September 2021**

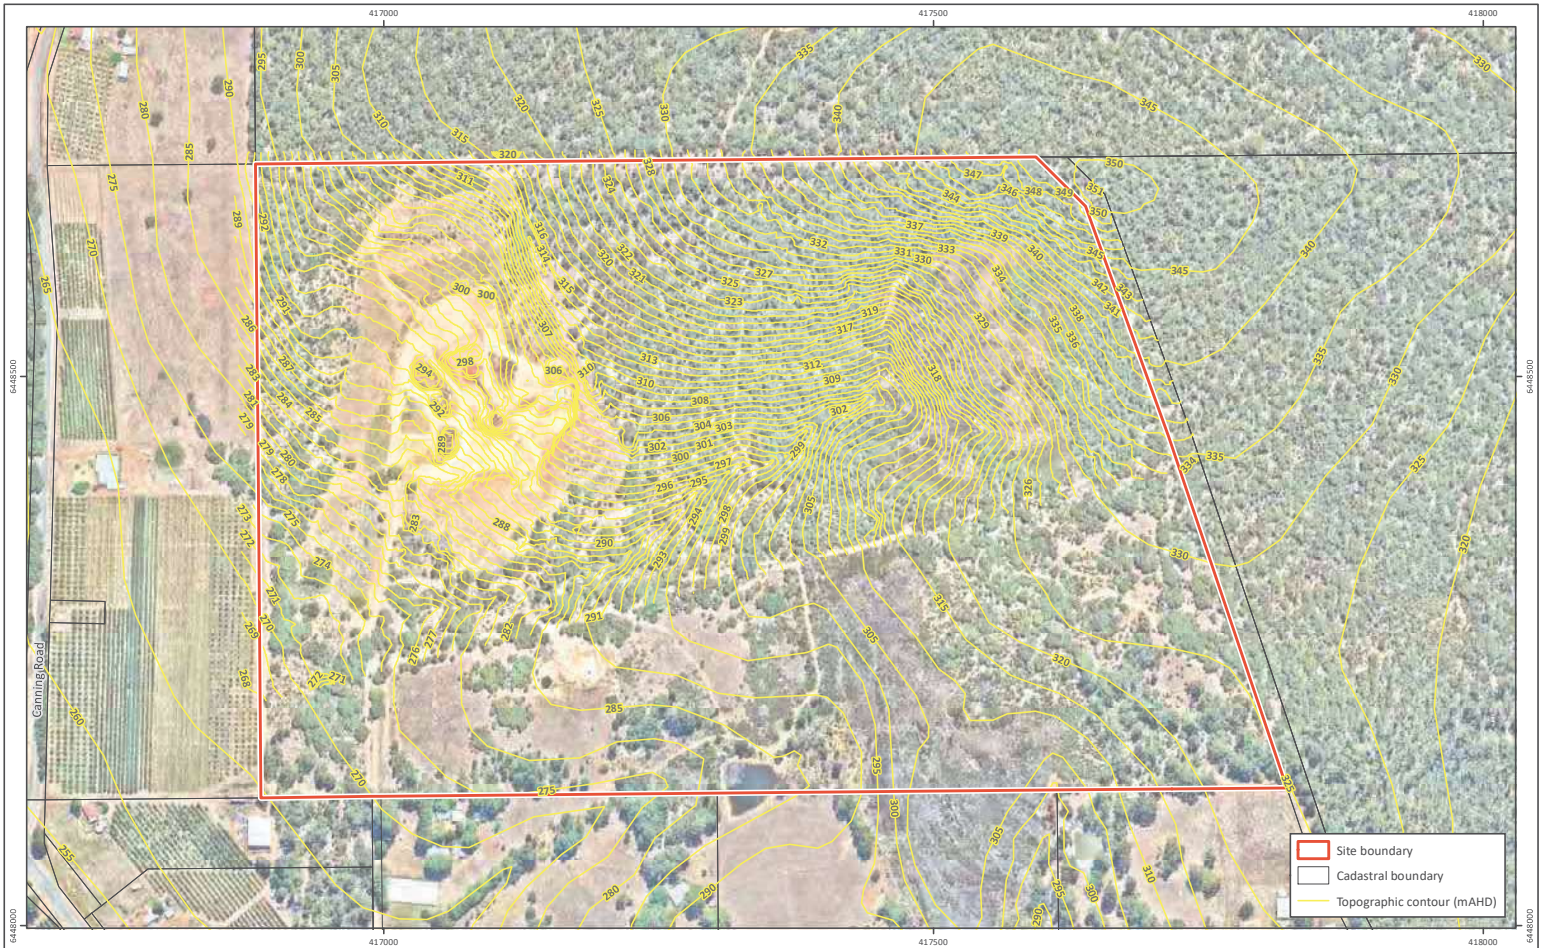
**Figure 3: Topography**

The topography of the site slopes in a south westerly direction, with elevation ranging from approximately 349 metres Australian height datum (AHD) in the north-eastern corner to 268 m AHD in the south western corner (**Figure 3**).

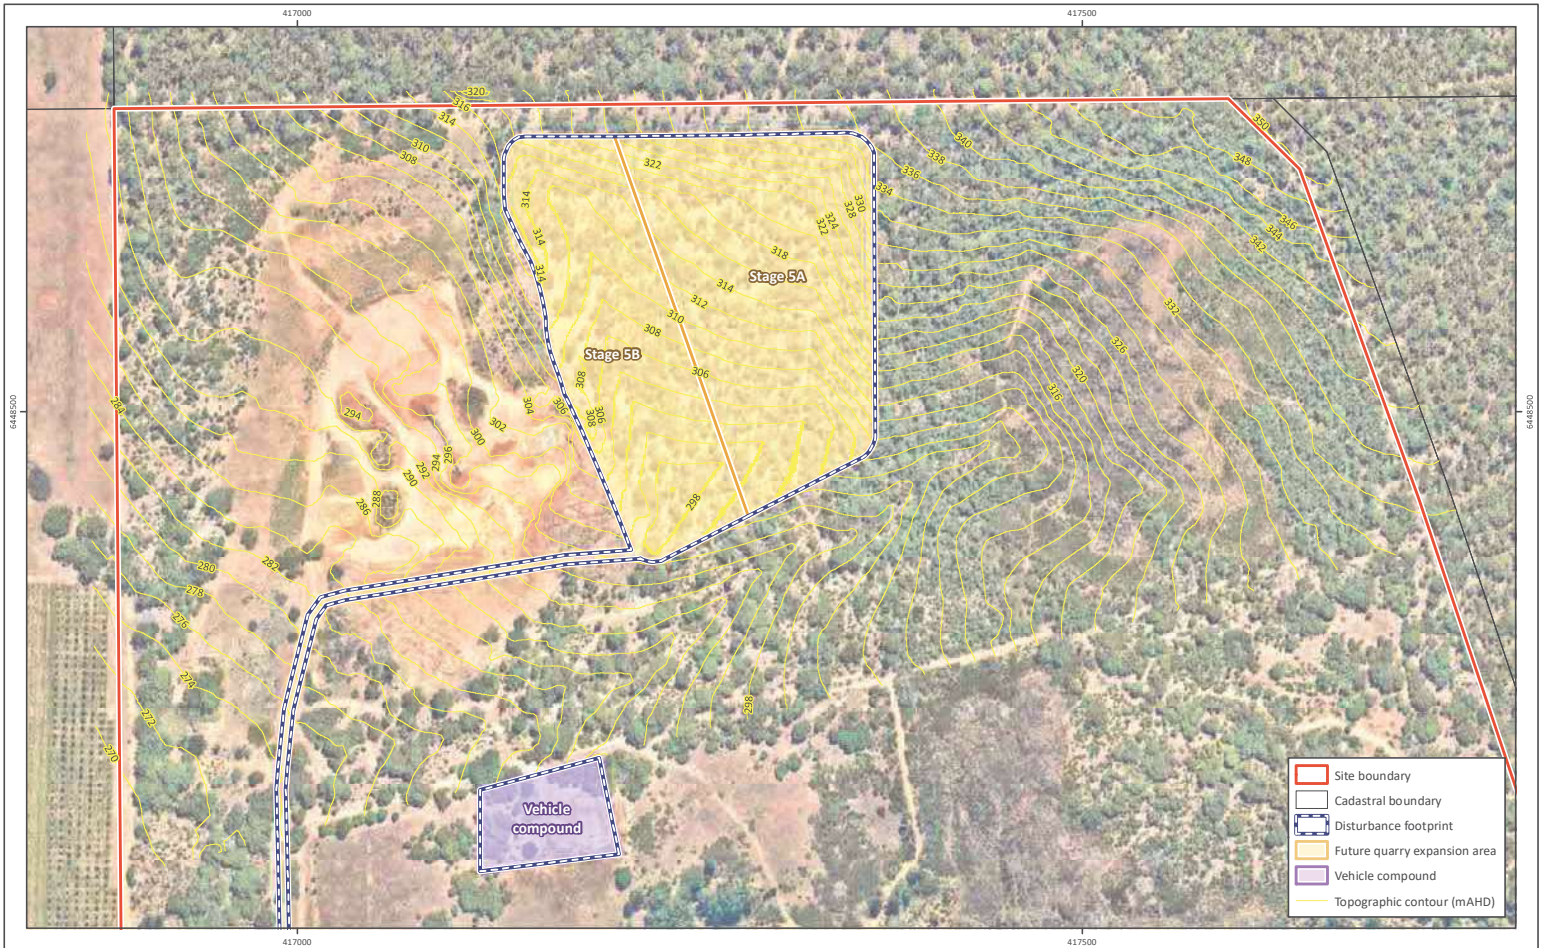
**Figure 14: Quarry Closure Contours**

In areas where excavation is completed, and prior to the ultimate re-forming of the area for subsequent revegetation, slopes around the perimeter of the excavation area will be re-contoured to achieve stable gradients (less than 1:4 vertical to horizontal) and the quarry floor will have at least a 1:100 fall. The post-quarried stage 5 will be recontoured to the above dimensions, this is depicted based on existing topographic contours, in **Figure 14**.
