# **Two Rocks Beach Access Road**

***Native Vegetation Clearing Permit Application  
Supporting Documentation***

**January 2022**

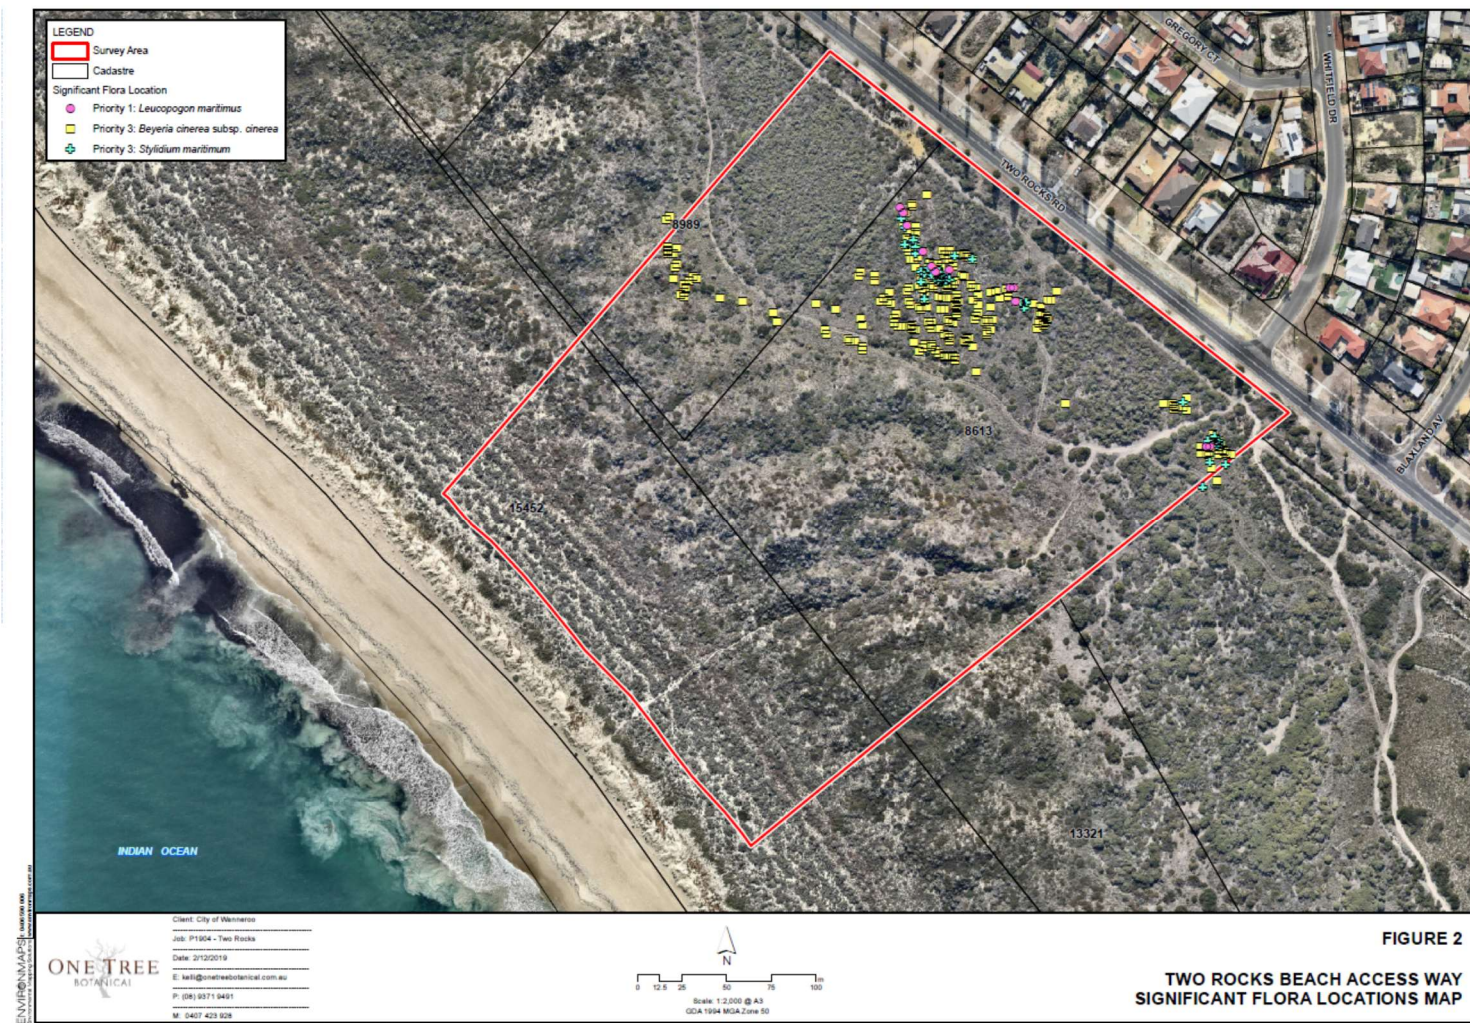
**Figure 5:** Two Rocks Beach Access Way - Significant Flora Locations Map (Source: One Tree Botanical (2020))

Figure 3 illustrates the location of significant flora species within the survey area.

Priority Flora is not common in near coastal areas and three in a single near-coastal vegetation type is unusual. This is an unusually high number for a very small 12.68 hectare near-coastal area. All three species were dominant species within a small area of a single vegetation type (Vegetation Type C - Figure 5) (One Tree Botanical, 2019).

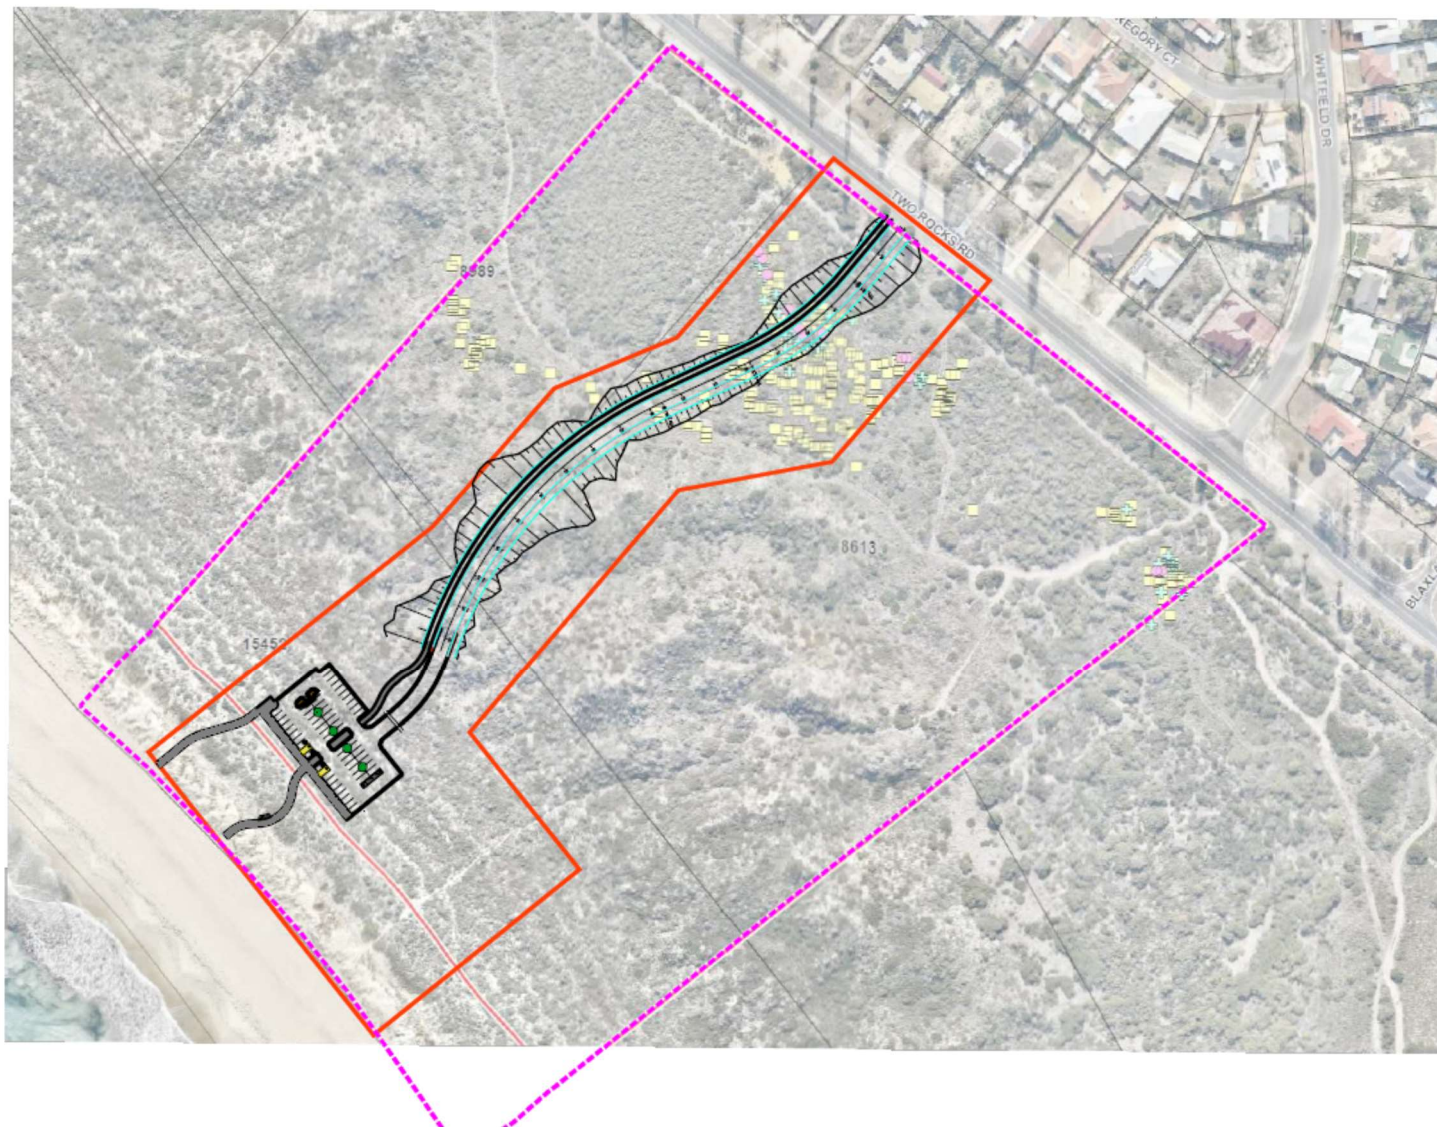
**Figure 6:** Two Rocks Beach Access Way – Original concept and Significant Flora Locations Map

To reduce the direct impact on priority species, the beach accessway and carpark has been realigned. The realignment (Figure 6) reduces the clearing impact from 36 Priority species to four Priority 3 species.

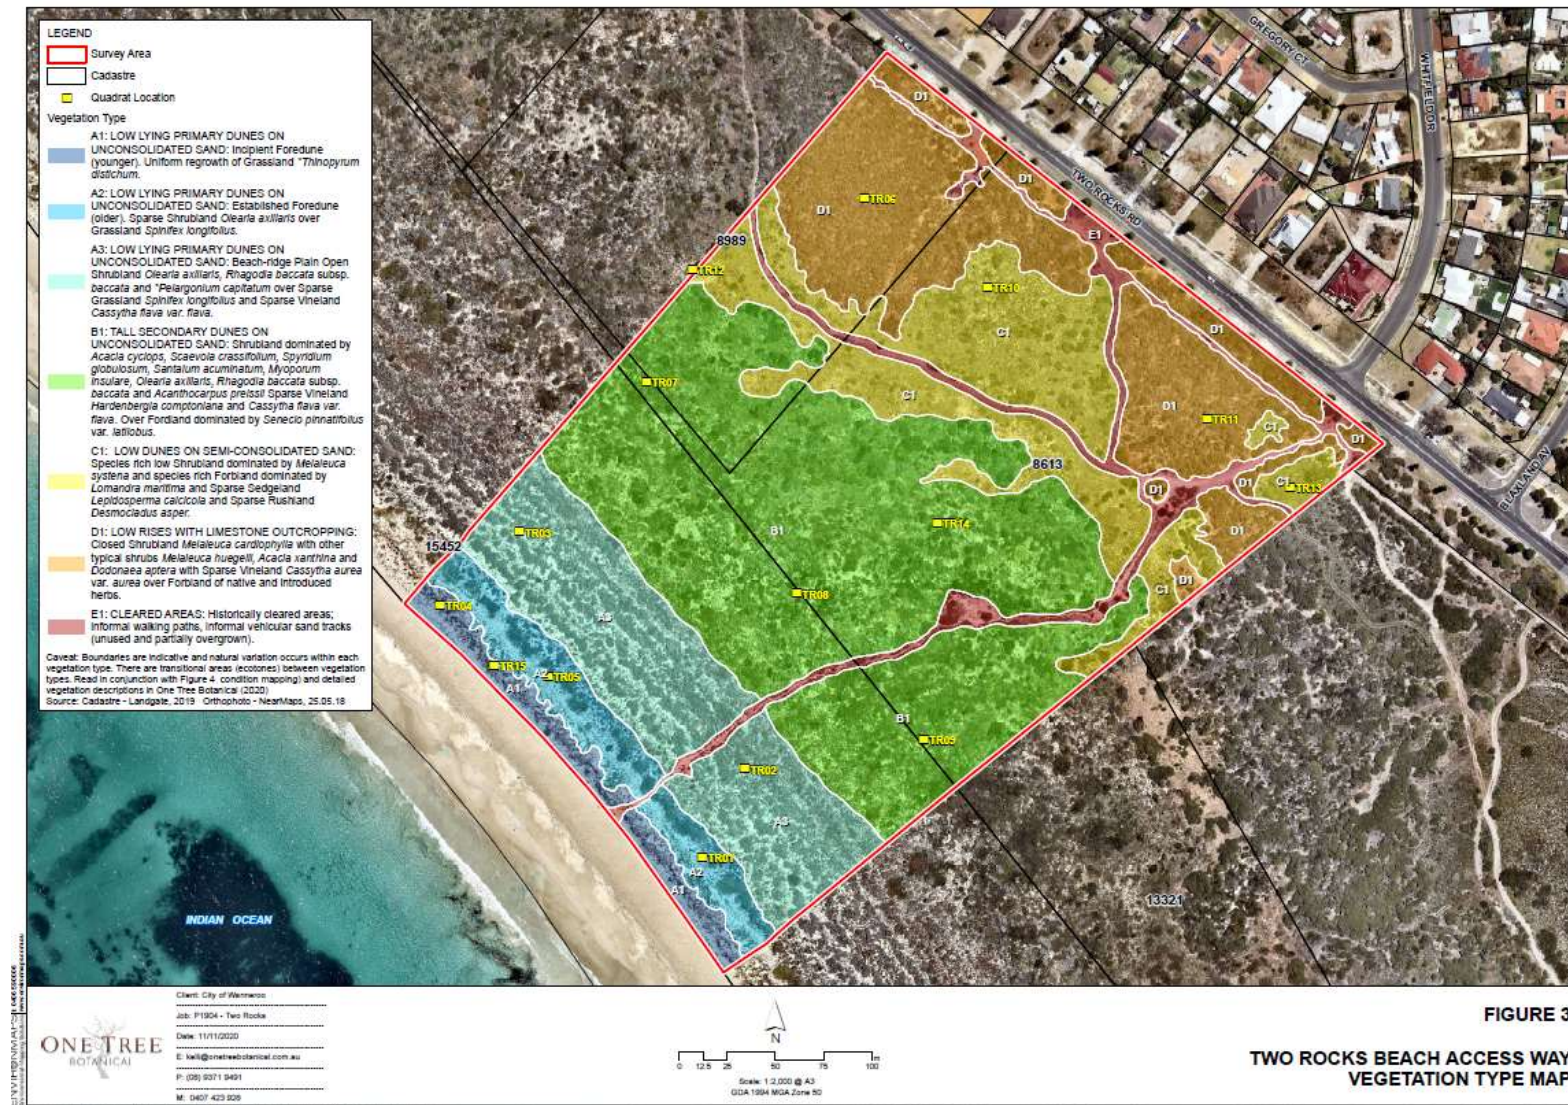
Figure 7: Two Rocks Beach Access Way – Vegetation Type Map (Source: One Tree Botanical (2020))

Photos and further information for each of the vegetation types in the area proposed to be cleared are provided in Section 5.2.2 of the Flora and Vegetation Survey (Attachment C). Figures 7 and 8 illustrate the vegetation type and vegetation condition within the survey area, respectively.
