3.4 Foreshore Stabilisation and Revegetation

3.4.2 River Edge Treatments

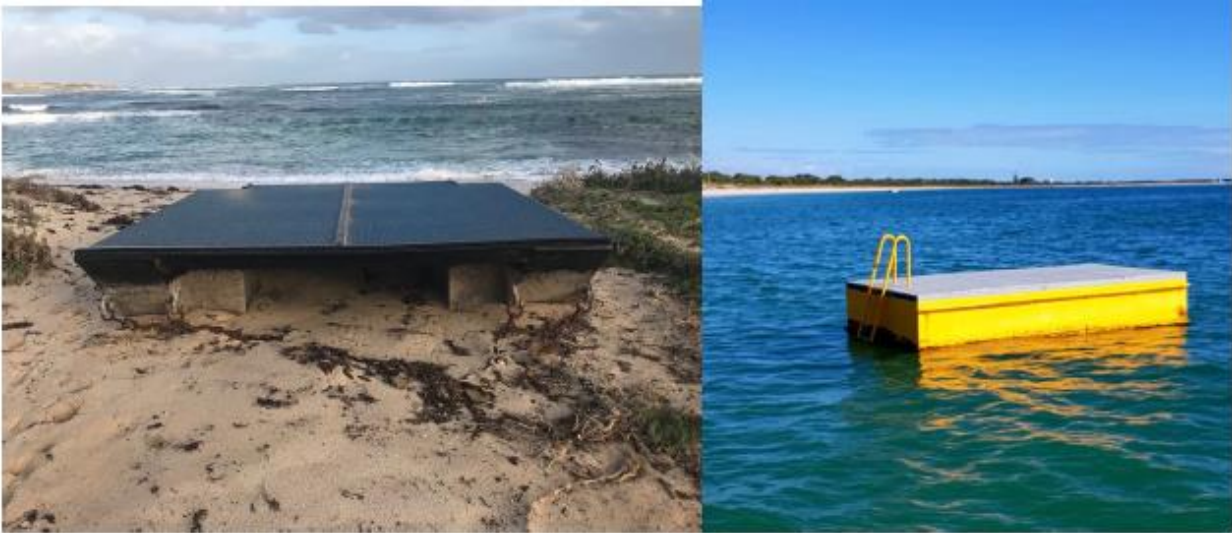
Figure 11: Typical swimming pontoons at Gracetown (L) and Coogee (R) from Shore Coastal Technical Note

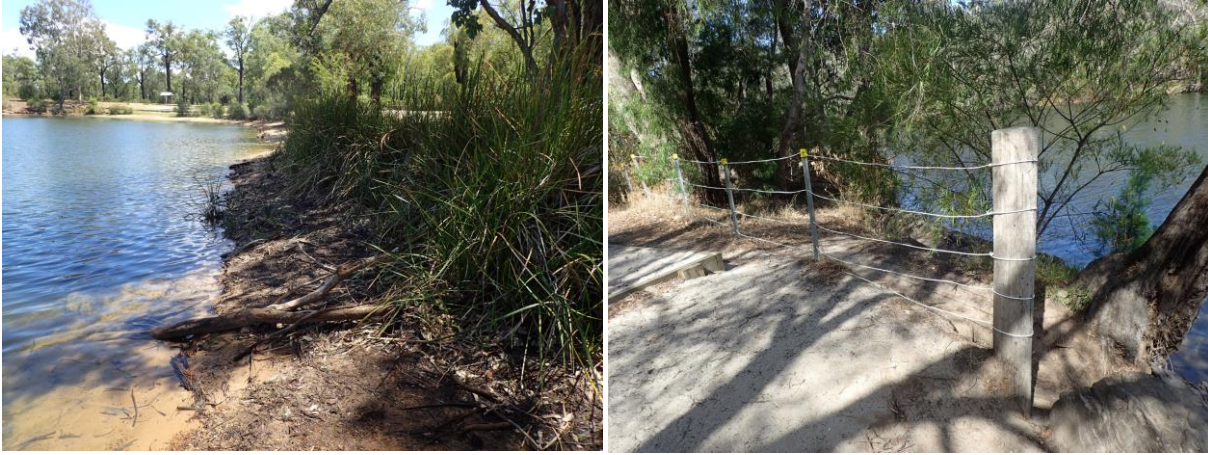
Figure 12: L: Established reed beds and stable foreshore at mouth of drain line R: Typical temporary fence

Some sections of the foreshore are already stable and these will remain as they are and will inform proposed revegetation.

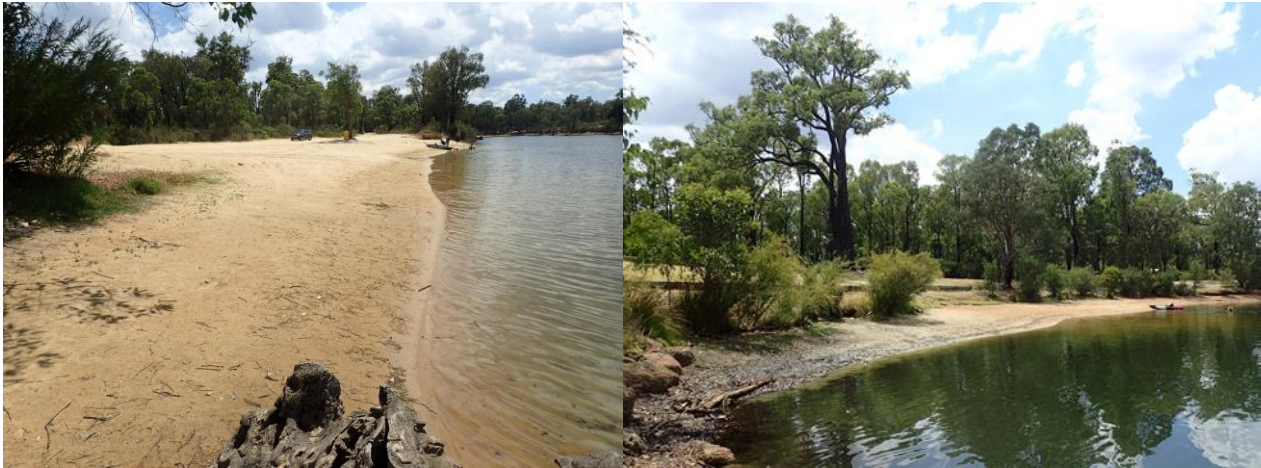
Figure 13: L: Sandy Beach - location for Type 1 Treatment R: Either side of Terrace Beach use Type 1 Treatment

1. Gently (less than 1:5, 1 Vertical: 5 Horizontal) sloping shorelines with no vegetation or some vegetation and minimal erosion on HWL – Retain existing vegetation if any. Coir Log (300mm diameter) may be required along HWL if there is any evidence of erosion and if there is no stabilising vegetation present. Old access tracks will likely need coir logs. To establish reed beds below HWL a second coir log should be installed 1m beyond HWL with rushes and sedges planted up slope of the coir log.

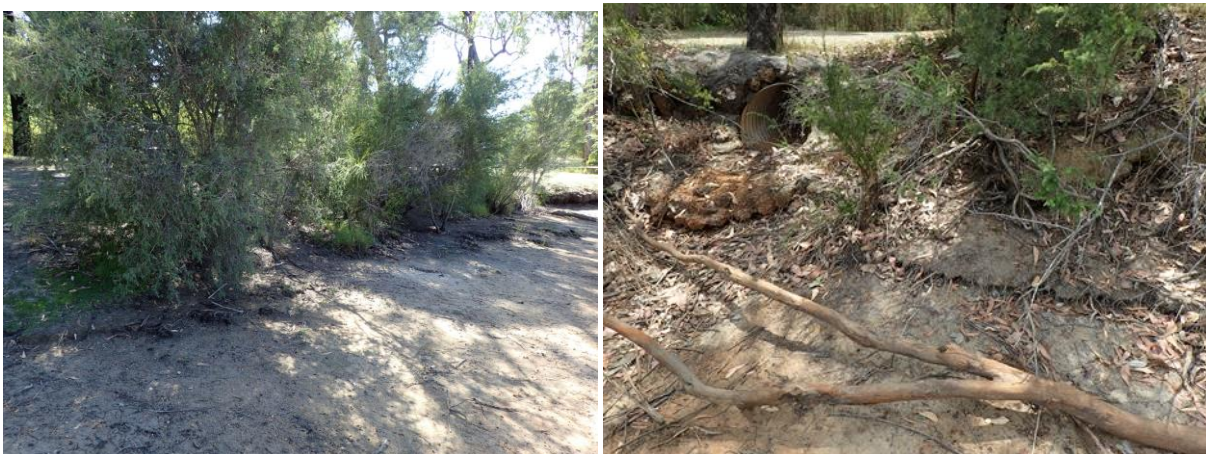
Figure 14: L: Steep bank W of old pump needs Type 2 Treatment R: Coir logs needed along eroding edge of pitching and to continue below steep bank as Type 2 Treatment

2. Steeply sloping banks (greater than 1:5) with shrub vegetation, possibly with eroding shoreline – Retain vegetation and coir logs to be placed at HWL in gaps in the vegetation, such as along old access tracks. To establish reed beds below HWL a (second) coir log should be installed 1m beyond HWL with rushes and sedges planted up slope of the log.

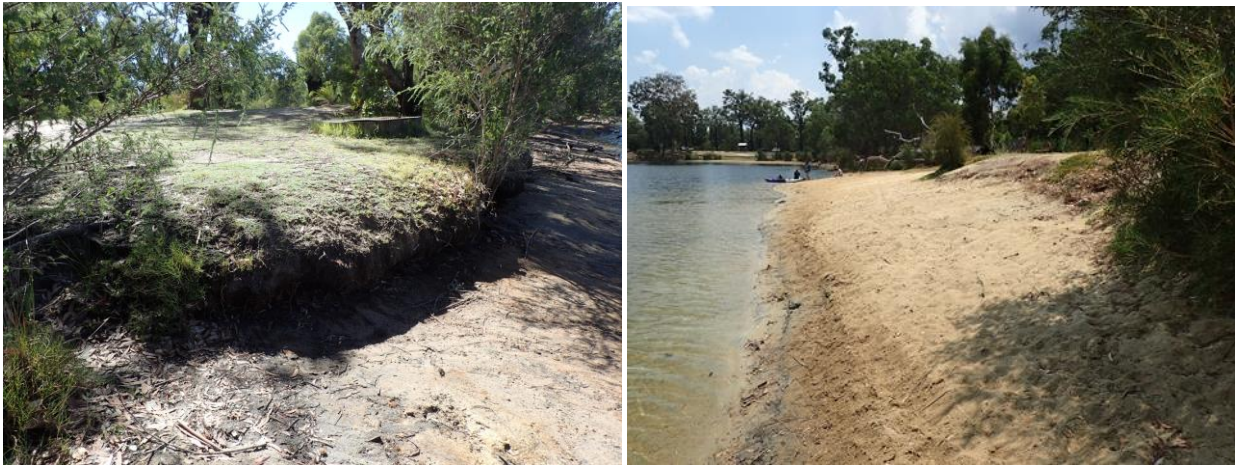
Figure 15: L: Bank at old pump needs Type 3 Treatment R: Steep shoreline Type 3 near Rowing Club in foreground (retain old Rowing Club foundations) with gently sloping beach beyond

3. Steeply sloping banks (greater than 1:5) with no shrub vegetation, possibly with eroding HWL – reshape bank if feasible (i.e. if there's enough space and the bank is not bound by roots) and place 1 – 3 coir logs along the HWL to prevent further erosion while vegetation establishes. To encourage rushes and sedges to establish below HWL a second log should be installed 1m beyond HWL with rushes and sedges planted up slope of the log. If there is no root mat in the remaining bank consider surfacing with jute matting, but likely mulching may be sufficient until vegetation establishes.

Where there is room to grade the bank out further (i.e. achieve a 1:5 slope or less) such as in front of the Rowing Club developing / extending the beach will be considered.

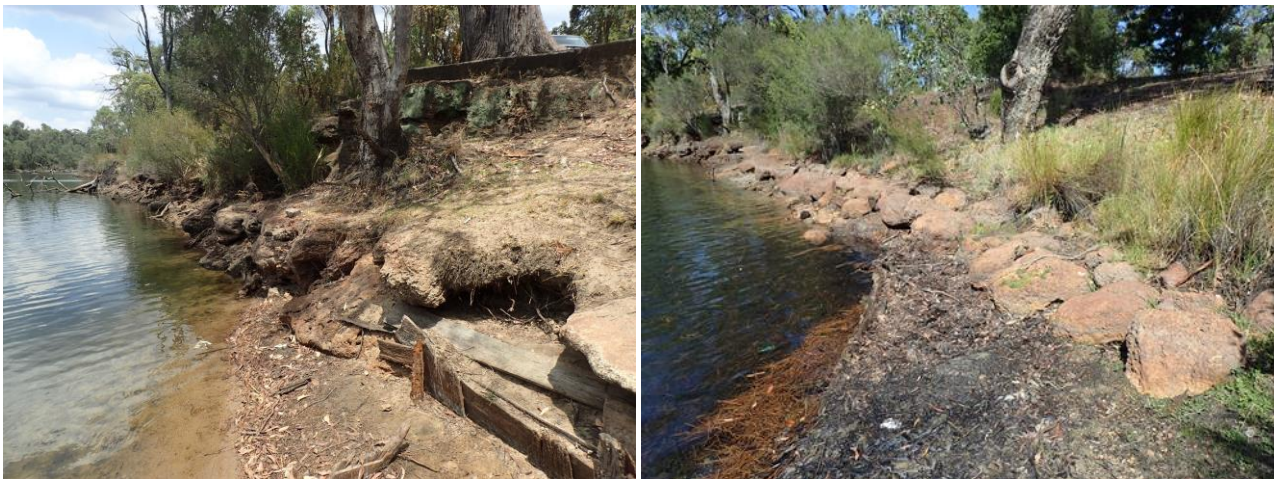
Figure 16: Type 4 Treatment L: Shoreline S of concrete steps, bottom of steps in foreground R: Shoreline N of concrete steps

- Sections of existing reinforcing rocks –consider laying coir logs at the toe of the existing rock and where there is no vegetation above the rocks install more coir logs. This is proposed to replace lifting the existing rock work, laying geofabric and relaying (or adding new where the steps are removed) the rocks. Rushes planted in association with coir logs will assist with stabilisation. Coir logs should generally be placed above any hard toe protection works so this proposal (which aims to minimise disturbance and be a softer approach) will need considering and approving by an engineer (who may advise it is inappropriate) and DWER before installation. Ensure any new rocks match existing rocks.

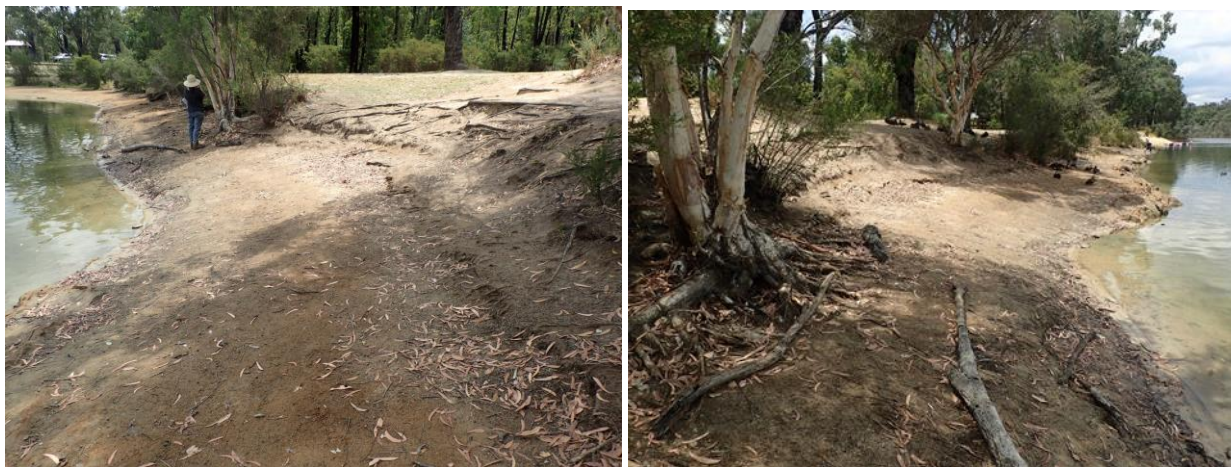
Figure 17: L: Type 5, access stairs proposed for over exposed roots and to water's edge R: View from where person standing in previous picture. Vegetation to be established in line with remnant rushes in mid distance

- Shoreline reinstatement – where the foreshore has eroded inland it is proposed it will be re-established once the erosion pressures (foot traffic) have been removed (by installing decks and stairs). Fill will be placed along the shoreline to re-establish the original banks (including under the decks), covered with jute matting and planted. Parallel coir logs will be placed along the re-established shoreline at HWL to prevent shoreline erosion and 1m beyond HWL to encourage reed bed establishment. Where the foreshore is rocky, coir logs are to be set where they can be secured

as close to LWL as is feasible. Engineers will be designing the river access structures and this foreshore treatment will need considering by the engineer and including in the construction details as appropriate.

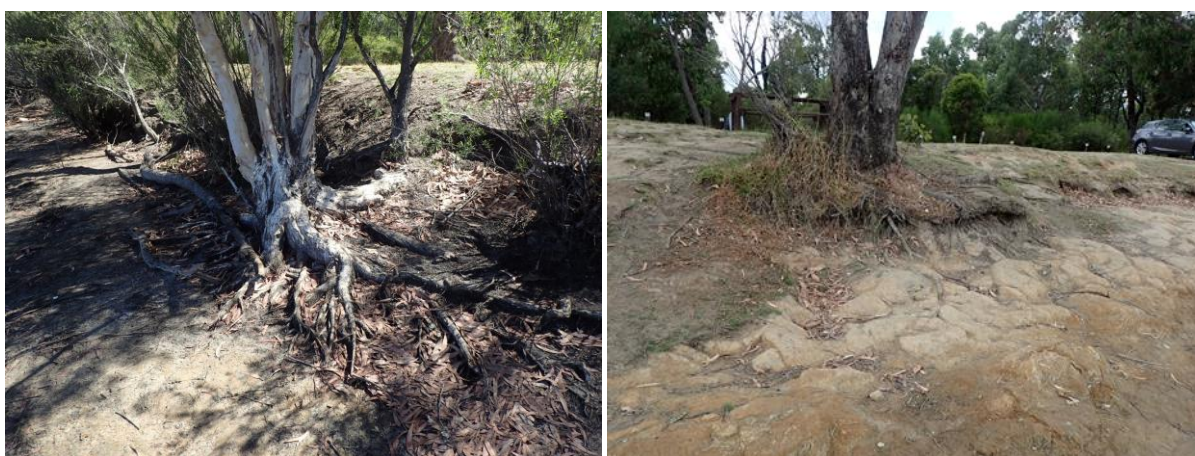
Figure 18: L and R: Exposed tree roots to be protected with Type 6 treatment

6. Tree stabilisation – where the root system of a tree is exposed, coir logs should be placed just beyond (minimum 500mm or further if tree is in an area of shoreline reinstatement) the perimeter of the exposed roots in a semi-circle and rushes and sedges planted upslope of the log in soil pockets without disturbing the existing tree roots).

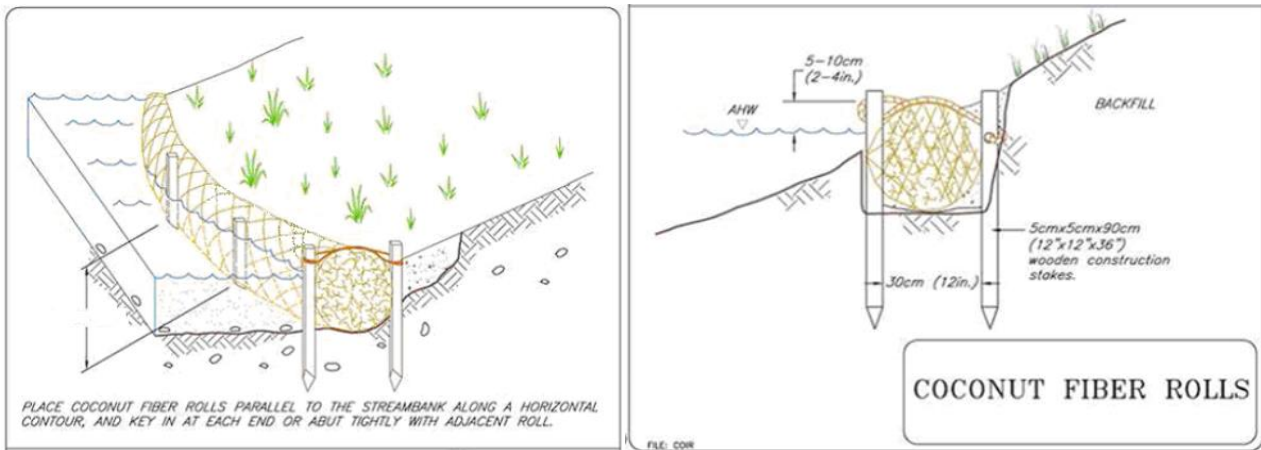
Figure 19: Typical coir log detail, source Swan River Trust 2009 adapted from McCullah and Gray (2005) and WDFW (2003)

1. Dig a shallow trench wide enough for the log and at a depth slightly below the channel grade.
2. Lay coir logs in the trench and lace ends together. They may also be laced together on dry ground before placement in the trench.

3. Bend the upstream and downstream ends towards the bank and bury in the bank if possible.
4. Secure the coir log in the trench by driving the stakes in the ground on either side of the log. Netting should be held open and stakes driven through the netting on either side of the logs, not through the centre of the log. Pairs of stakes (one on either side) should be installed at approximately one metre intervals. Stakes should be flush with the top of the log when completed.

5. Strap together stake pairs (next to each other) to hold the coir log in place and prevent lifting. Holes can be predrilled in stakes or drilled onsite. Coir twine, plastic tree ties or similar are used to tie one stake to the other.

6. Fill and shape behind the logs if required. Additional techniques such as jute matting or brush mattsing can also be used at this stage.
7. Plants should be planted behind the coir logs and up the bank as desired'.

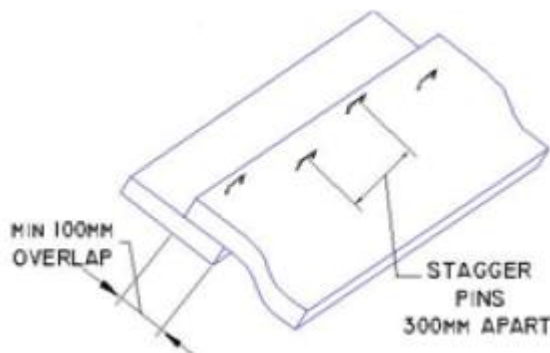
Figure 21: Overlap detail when high surface flow is not expected⁸.

3. Matting Overlap – The joins in the matting are potential points of failure and so there should be overlap of approximately 100mm, which is secured and the upstream edge should overlap the downstream edge to minimise the likelihood of undercutting.

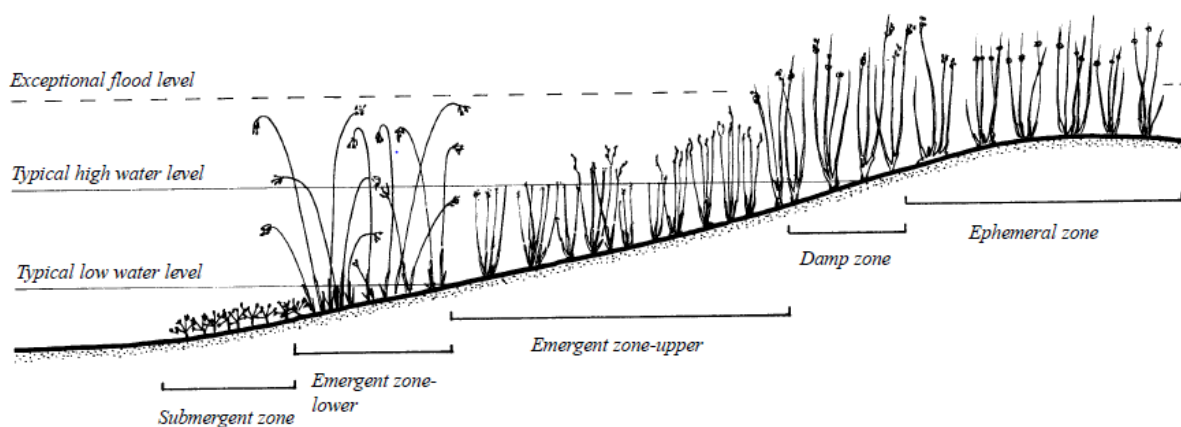
Figure 1: Wetland zones and typical distribution of some sedge and rush species.

Figure 22: Taken from Water and Rivers Commission (WRC) 2000, Using rushes and sedges in revegetation of wetland areas in the south west of WA, Water and Rivers Commission, River Restoration Report No. RR 8¹¹

The selection of plant species that are suited to their position in the landscape is particularly important along the river's edge and the zones illustrated in the figure below (have been used to select river edge species). The emergent zone – lower and the submergent zone will not be planted as it is expected they will naturally revegetate once the upper zones are revegetated due to the likely stability of the water levels resulting from the re-established weirs.

Further analysis was undertaken of the reed / rush species noted on site (noted*), together with some referred to in the WRC report to determine which wetland zone they're suited to.

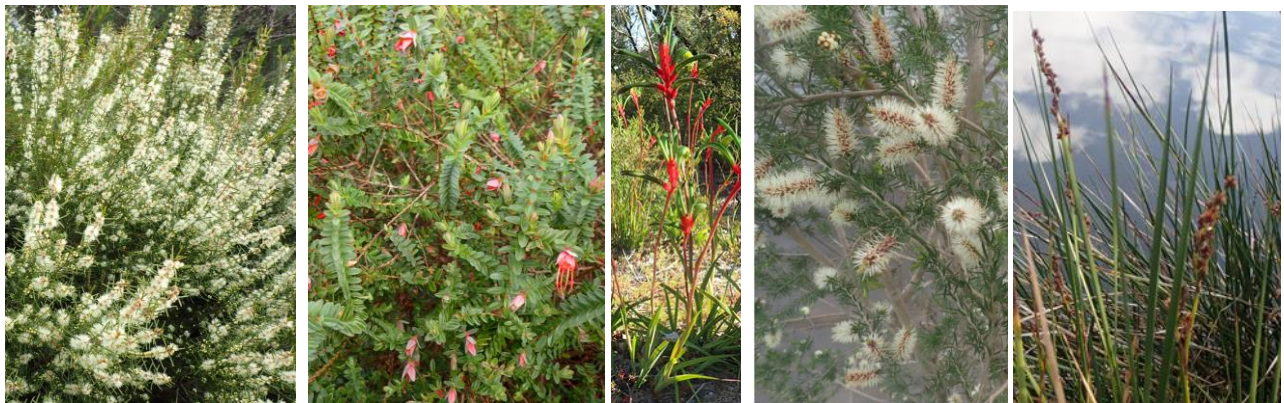
Figure 23: L – C: Local Shrub Species

R: Rush species

- **Cyperus polystachyos*? – noted in Damp zone
- **Ficinia nodosa* syn *Isolepis nodosa*– Knotted Club Rush – Ephemeral to damp zone
- *Gahnia trifida* – Coast Saw sedge – Damp zone
- **Hypolaena exsulca*? Possibly *Leptocarpus laxus* or *Chaetanthus aristatus* –winter wet depressions so probably damp zone
- **Juncus kraussii* subsp *australiensis* – Shore Rush – Damp zone to 30cm into emergent zone
- **Juncus pallidus* – Pale Rush – Ephemeral to damp zone
- **Lepidosperma longitudinale*- Pithy sword sedge - Damp zone to 20cm into emergent zone
- **Lepidosperma squamatum* – observed in Damp – Ephemeral Zone
