**Our ref: AU213002646.001 BMR Rapids Landing Clearing Permit Application**

### **Clearing permit application: Rapids Landing residential estate drainage infrastructure**

**Foreshore Management Plan  
Rapids Landing Margaret River, WA**

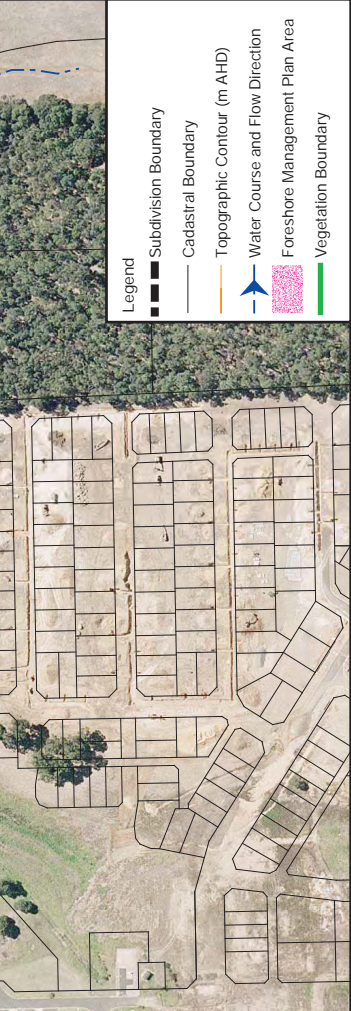
The condition of the vegetation was assessed as part of the ATA Environmental Vegetation and Flora Survey in 2004 using the scale of Keighery published in Bush Forever (Government of WA, 2000). Vegetation condition is mapped in Figure 3 and discussed in detail above.

Foreshore areas in the eastern portion of the Lot have been classified as Good and Very Good to Excellent in the undisturbed dense heath vegetation of the Darch Brook. Localised areas of riparian vegetation that were partially cleared approximately four years ago are naturally regenerating in this area. However foreshore areas along the southwestern tributary and areas directly adjacent to Darch Brook (mapped as vegetation community CcEp in Figure 3) are Degraded and require intensive weed control and revegetation.

**VEGETATION TYPES AND CONDITION**

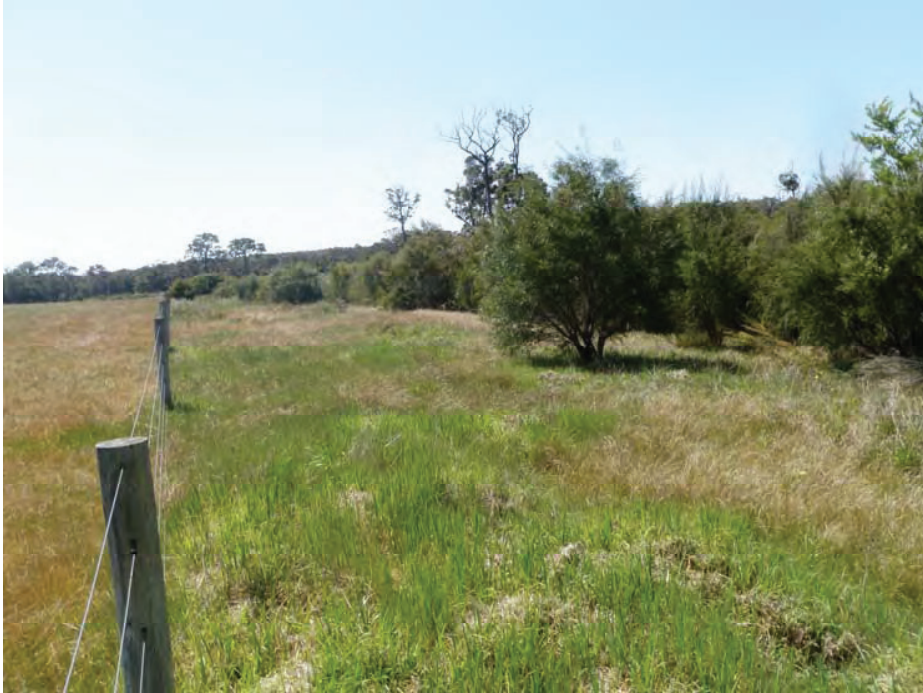
**Plate 1** South western Tributary

The foreshore along the southwestern tributary has become degraded through past land use, particularly through historical unrestricted stock access to the creekline (Plates 1-4). The creek is currently fenced however stock would have had access to the creekline in recent past. Many weeds are present including Kikuyu (*Pennisetum clandestinum*), Couch (*Cynodon dactylon*), Bullrush (*Typha orientalis*) and Blackberry (*Rubus anglocandicans*). Native vegetation occurs directly along the creekline, characterised by shrubland to open heath of *Agonis linearifolia*, *Agonis flexuosa* and *Mirbelia dilatata* over scattered stands of *Juncus pallidus* (Figure 3, Plate 5). Vegetation directly along the creekline was observed to be in good condition in 2004 and 2010 however native vegetation ceases immediately after the bank of the creekline where annual grasses dominate. The foreshore of the southwestern tributary consists of a few large shrubs with an understorey consisting entirely of weeds, mainly annual grasses (Plate 1).

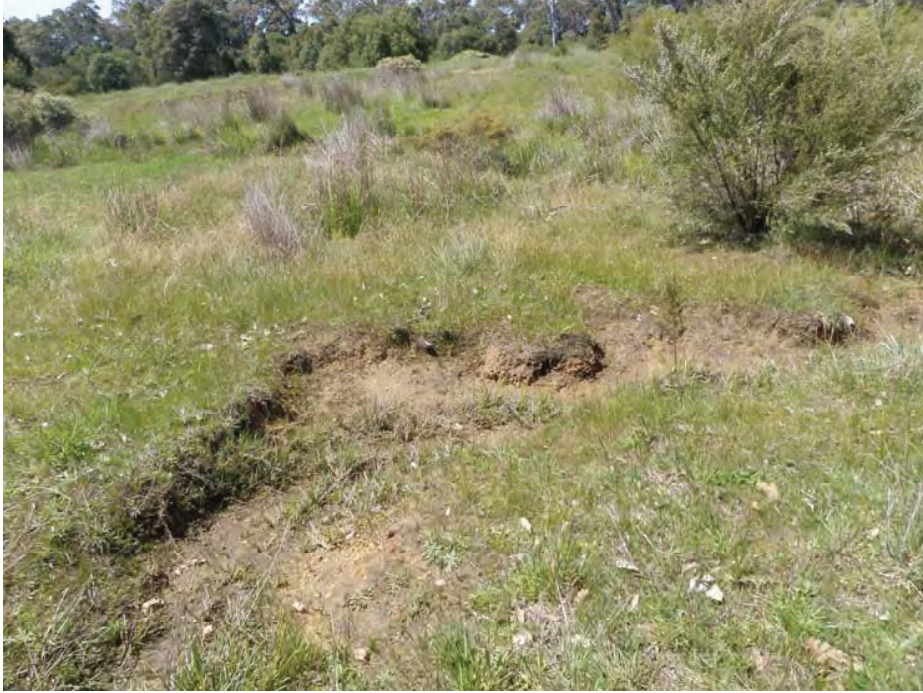
**Plate 3** South western Tributary - erosion

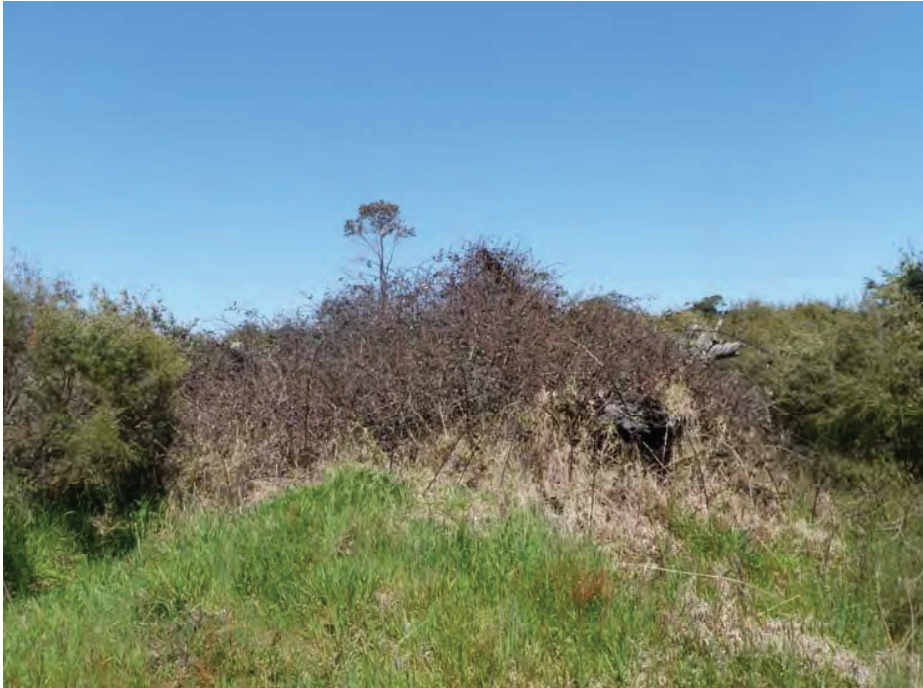
**Plate 4 South western Tributary – Blackberry Infestation**

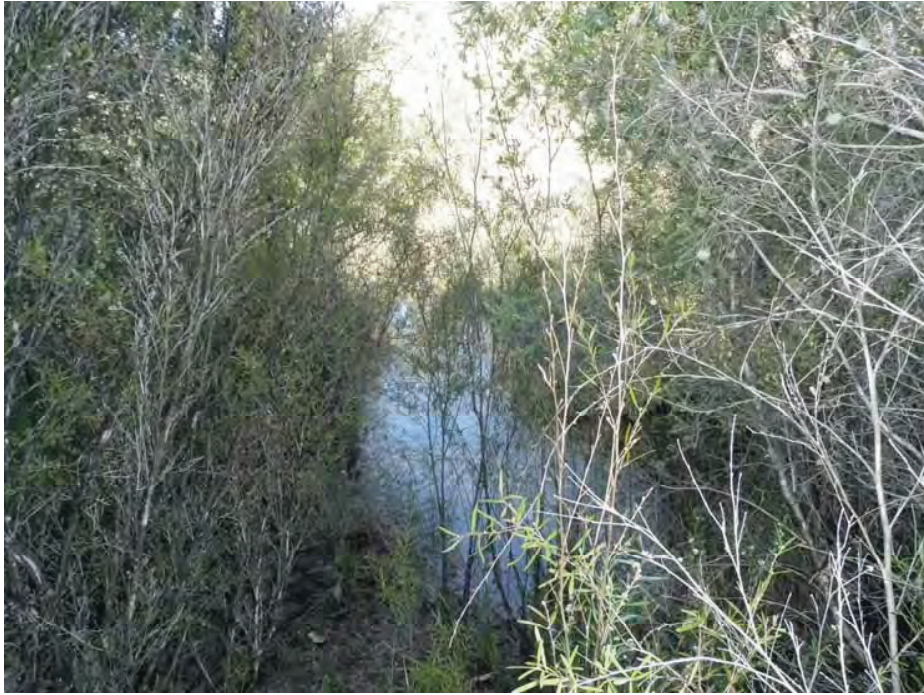
The Darch Brook along the eastern boundary of Lot 27 Bussell Highway consists of five different vegetation types in varying condition (Plates 6-11). The north-eastern boundary of the site is in Very Good to Excellent condition characterised by a closed heath of *Agonis linearifolia*, *A.juniperina*, *Leptospermum erubescens* and *Melaleuca hamulosa* (Plate 11). South and west of this vegetation

**Plate 11**      **Darch Brook – North**

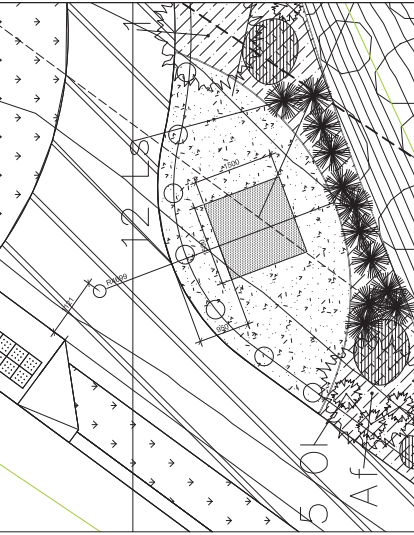
**CONCRETE PAD AND SEATING PLATFORM LAYOUT**  
SCALE 1:50
