CLEARING PERMIT

Purpose Permit number:	CPS 9715/1
Permit Holder:	Regional Power Corporation trading as Horizon Power
Duration of Permit:	From 16 September 2023 to 16 September 2029

Clearing Permit Decision Report

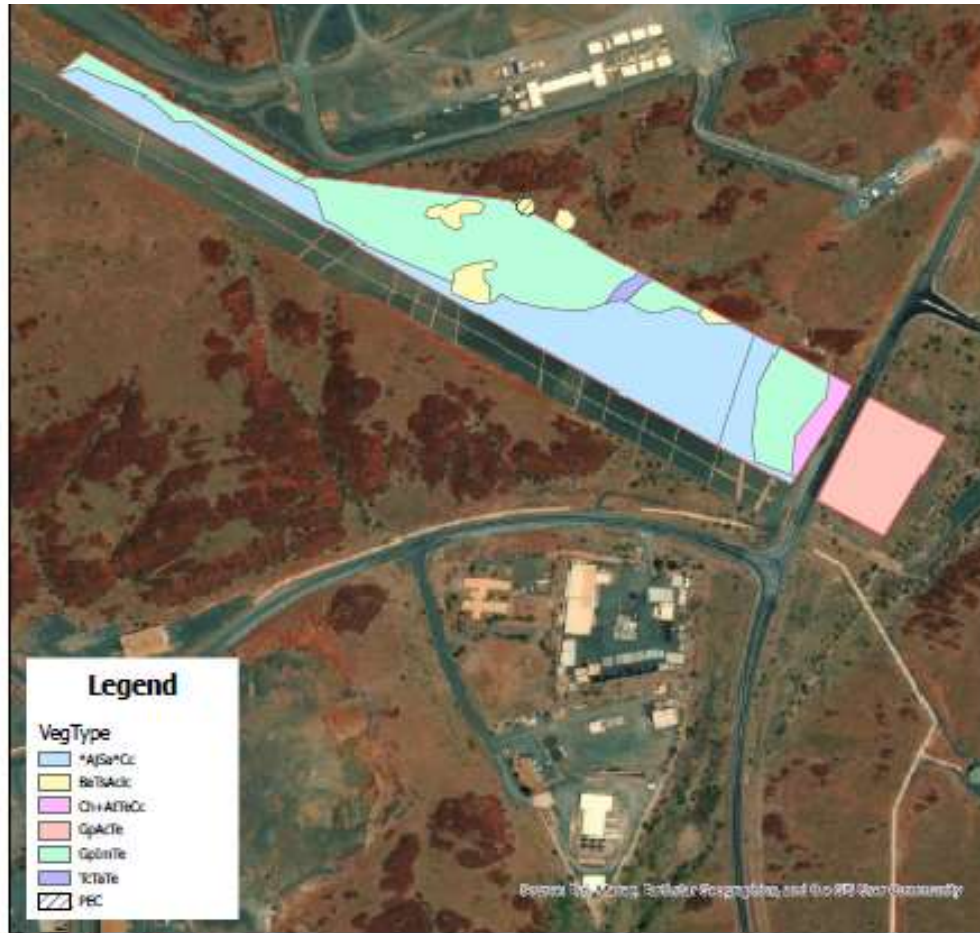
Figure 1 | Vegetation Type

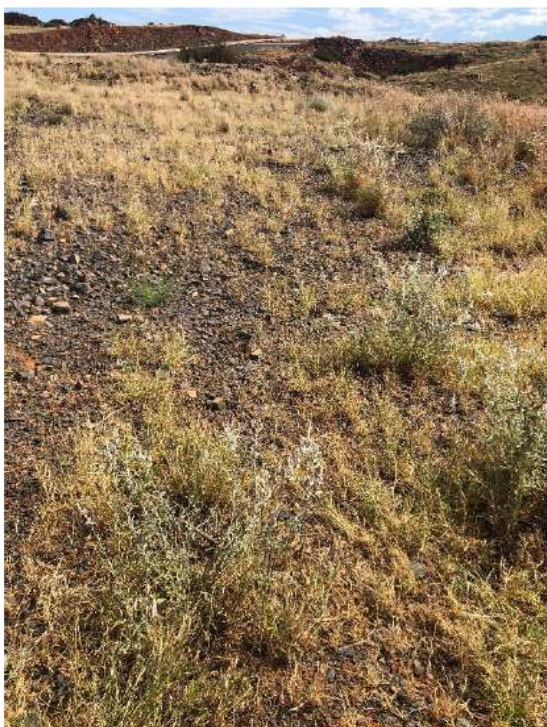
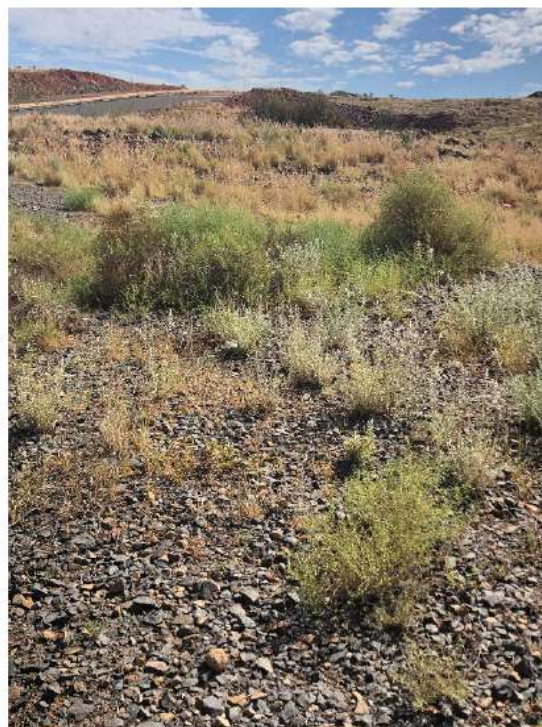
Plates 1 & 2 : Degraded area, previously disturbed and now supports 90% mixed *Cenchrus ciliaris* (buffel grass), *Aerva javanica* (kapok) with colonising *Salsola australis* (tumble weed). (Vegetation **AjSa*Cc*)

Figure 8 – Plates 1 and 2 – Vegetation type **AjSa*Cc* (VLA, 2023)

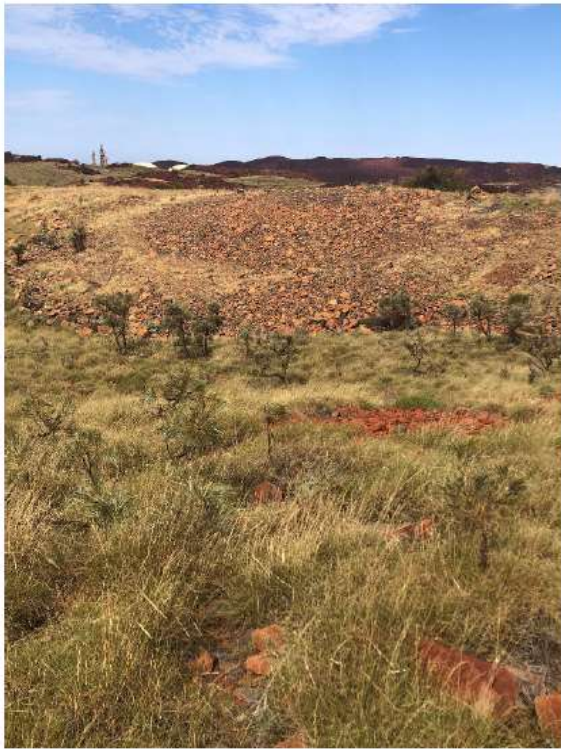
Plate 3: Showing distinct boundary between native undisturbed vegetation type **GplmTe** (foreground) and previously cleared area with ***AjSa*Cc** vegetation (background),

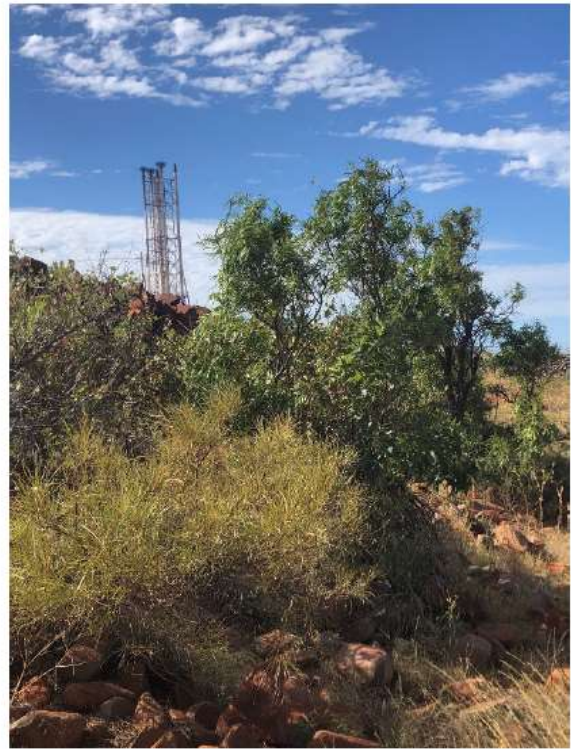
Plate 4: Small rockpile PEC with *Brachychiton acuminatus*, *Terminalia supranitifolia*, *Acacia coriacea*, *Ipomoea costata*, scattered *Triodia epactia*. (Vegetation Type: **BaTsAcIc**)

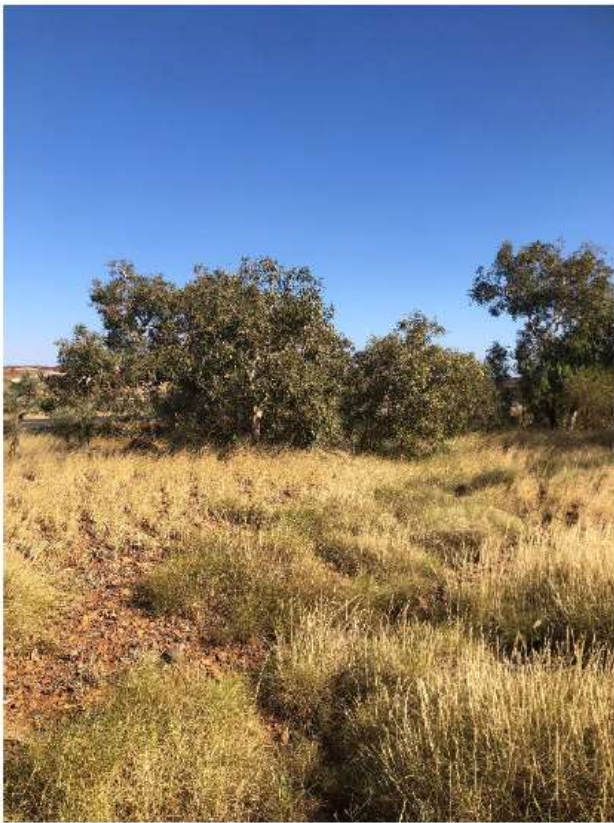
Plate 7 Vegetation Type Ch+AtTe*Cc

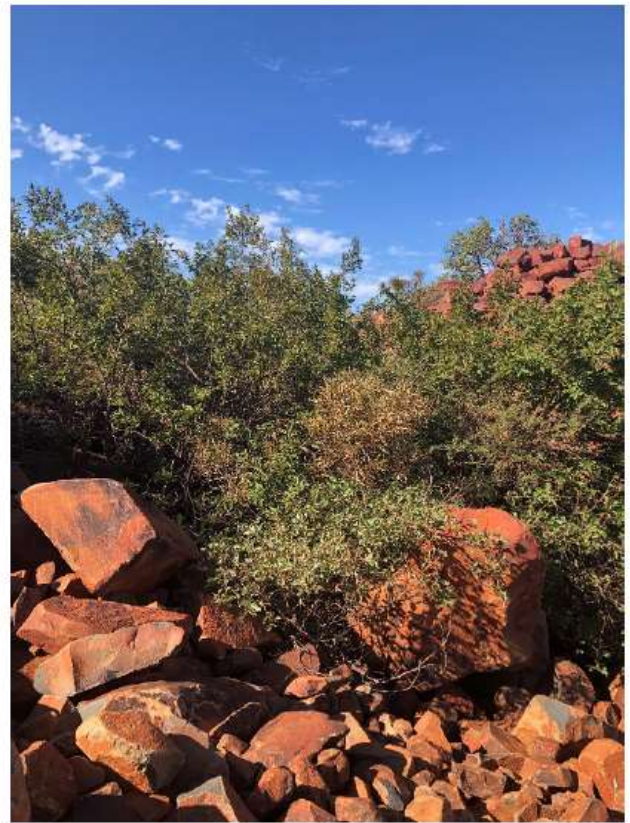
Plate 8: PEC vegetation near existing pipeline corridor; no longer a PEC because degraded by buffel grass.

Based on the above criteria, three (3) Burrup Rockpile PECs were identified in the application area, however, two were degraded by buffel grass (weed invasion) and therefore cannot be considered a PEC. Another two (2) rockpiles were also identified, however, as they harboured single tree species, often large, spreading and covering a large area, these do not meet the criteria for a Burrup Rockpile PEC (see Figure 7, Appendix E) (VLA, 2023).
