**RE: South Western Highway – Clearing Permit Application for Water Main**

On behalf of Aqwest please find attached an application for a Purpose Permit to clear 2,558m<sup>2</sup> of native vegetation in the South Western Highway road reserve in Bunbury (Figure 1). The proposed clearing is to install an underground water pipeline to ensure Aqwest is able to continue to meet service standards in relation to the provision of water services.

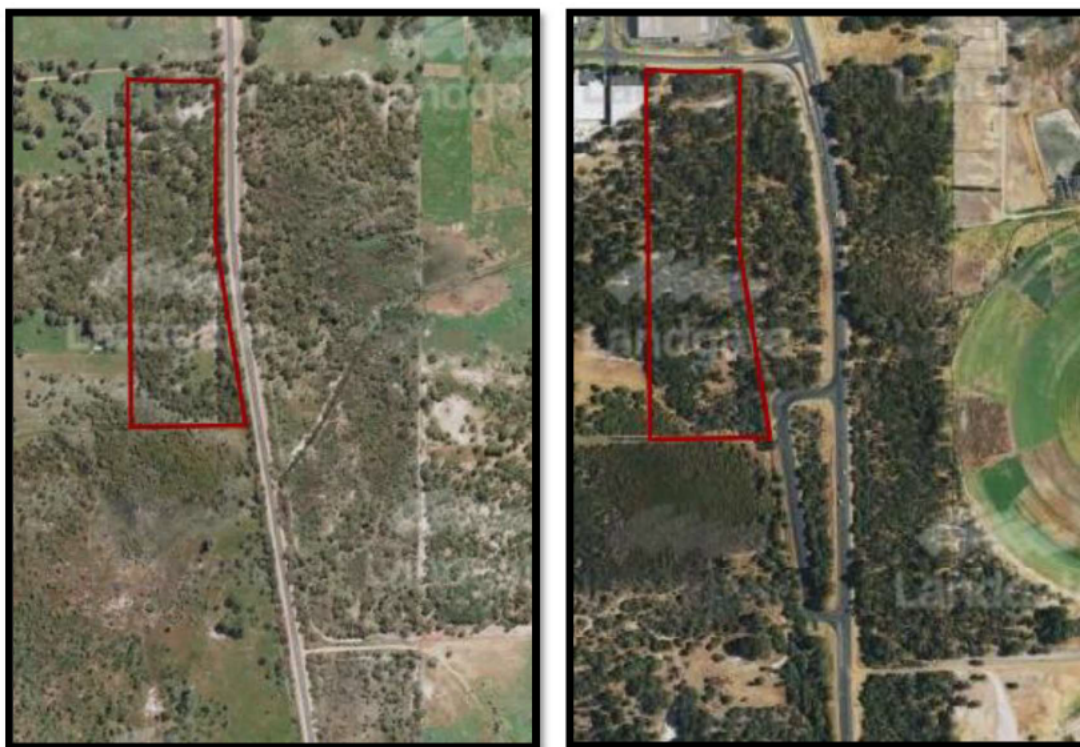
**Plate 1: Aerial Photograph 1992 (left) and 2021 (right)**

Examination of historic aerial photographs shows that the northern part of the pipeline route was formerly a part of the South Western Highway (Plate 1). The Highway was realigned to its current location slightly further east in the late 1990s. A section of the old Highway was turned into a large parking bay as shown on Plate 1. The northern section of the old Highway was partly revegetated and partly left as a track.

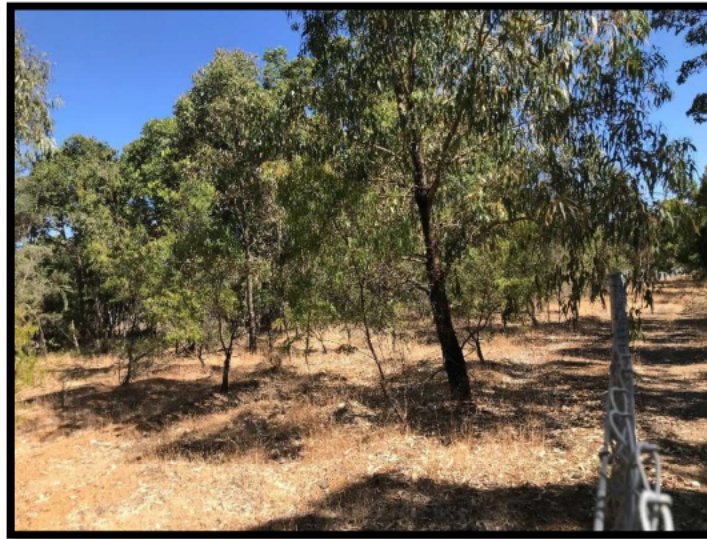
**Plate 2: Marri/Peppermint Woodland**

This vegetation type occurs at the northern end of the pipeline route. The vegetation is mostly rehabilitation on the old South Western Highway road reserve (Plate 2). The understorey is all grassy weeds due to the past disturbance for the old Highway.

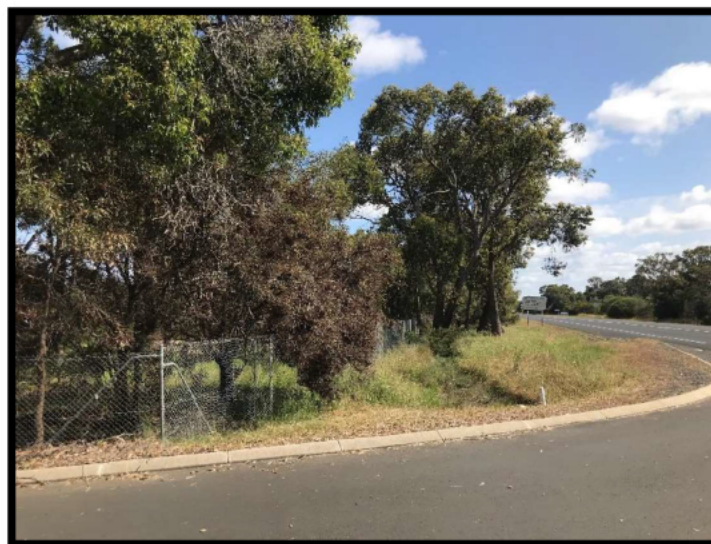
**Plate 3: Marri Woodland with Paperbark (Mp)**

A section of the alignment contains Marri trees to 12m high with occasional Paperbark (*Melaleuca preissiana*) trees between the fence shown in Plate 3 and the Highway. The understorey is all grassy weeds.

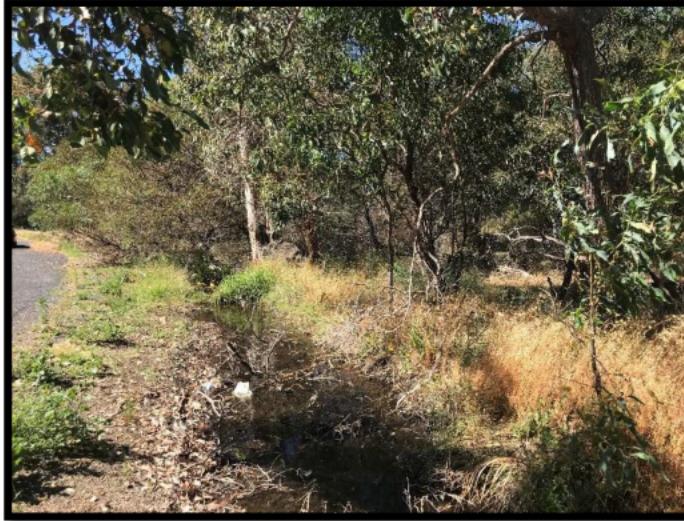
**Plate 4: Marri Woodland with Flooded Gum (Er)**

A short section of this vegetation type occurs south of the parking area and close to the western boundary of the road reserve. The alignment is close to an existing stormwater drain and contains Marri and Flooded Gum trees, some Paperbarks and a weedy understorey (Plate 4).

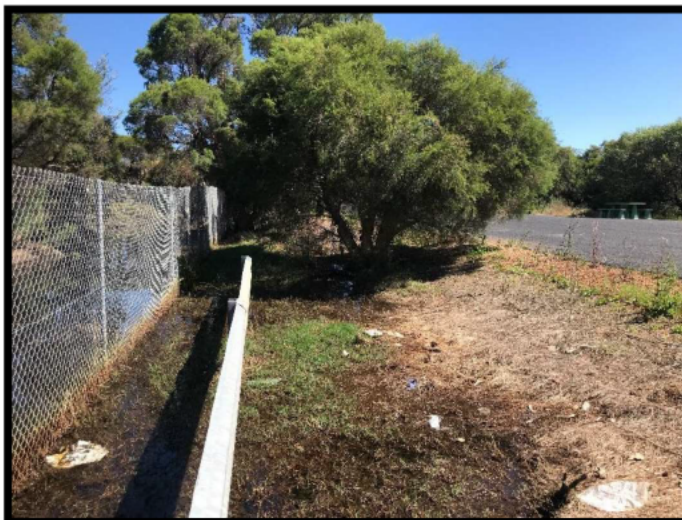
**Plate 5: Paperbark Low Woodland (Mp)**

Some Paperbark trees occur on the western side of the large parking bay and the western end of the road reserve (Plate 5). This area has periods of inundation, therefore the pipeline is proposed to be installed as close as possible to the pavement of the parking bay as possible. A few native species, *Lepidosperma longitudinale* and *Kunzea glabrescens*, occur with the Paperbark trees.

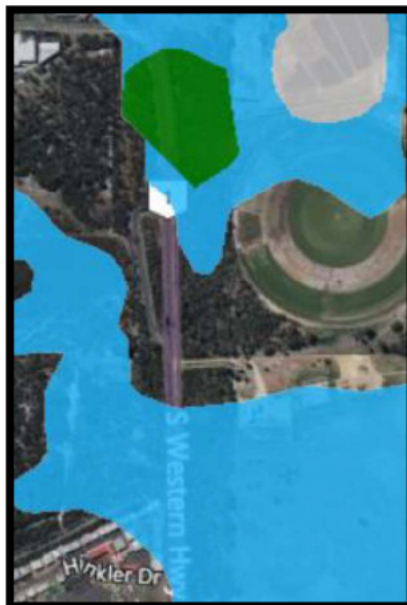
**Plate 7: Geomorphic Wetland Map**

The southern end of the pipeline passes through a portion of wetland mapped as a Multiple Use Palusplain (Unique Feature Identifier (UFI) 15450) (blue area on Plate 7). The northern end of the pipeline route is 20m to the west of a Conservation Category Palusplain (UFI 14516). Installation of the pipeline will not impact directly on the wetland vegetation or indirectly on the groundwater as no dewatering is anticipated for the installation. The proposed clearing is not considered to be at variance to this principle.

There are no surface watercourses in the application area. A part of Multiple Use Sumpland (UFI 15450) is mapped on the site. The wetland is highly modified, and the clearing will not further impact on the wetland values.

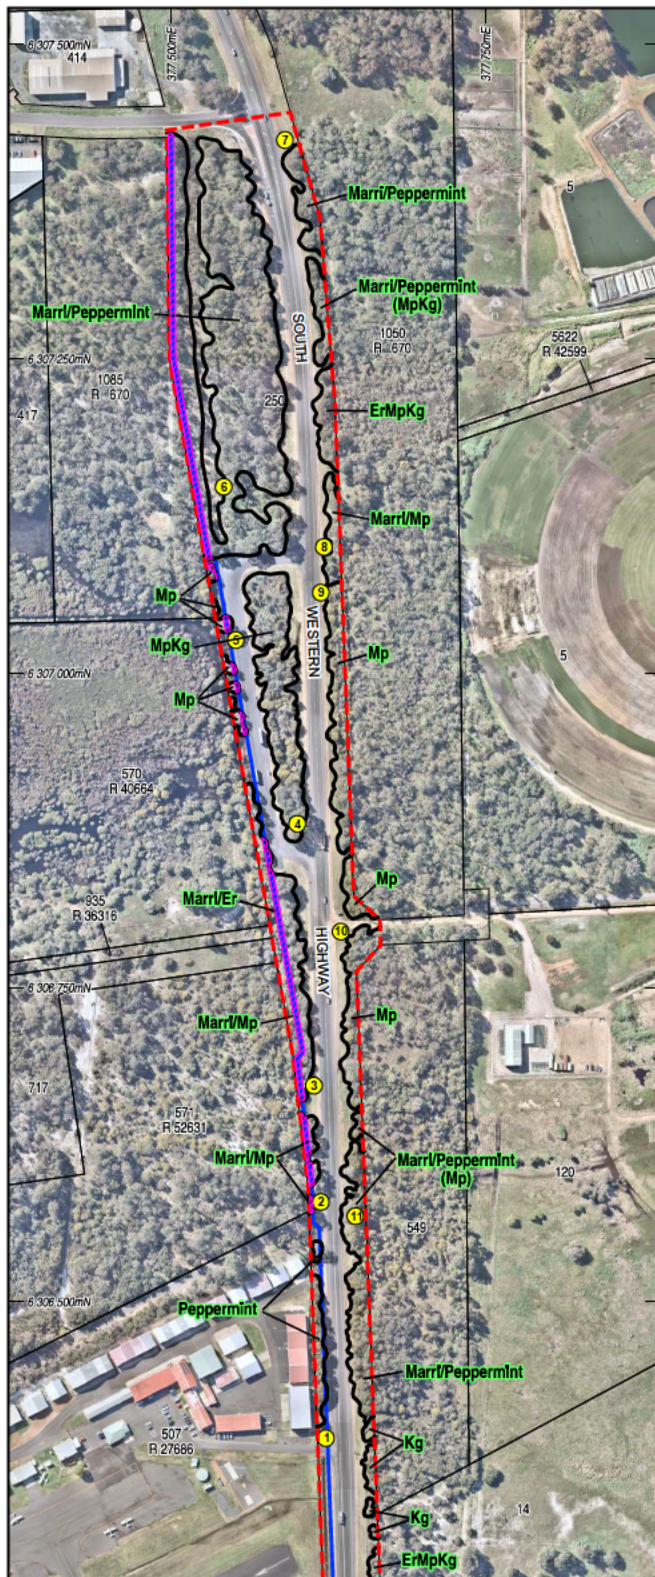
## NATIVE VEGETATION

The proposed route of the water pipeline is on the western side of the South Western Highway road reserve, extending from Halifax Road at the northern and linking with an existing water pipe near the southern boundary of the Bunbury Motocross Club (Figure 1). The total length of the pipeline is around 1.84km.

Figure 1 shows the location of native vegetation types recorded in the survey area. Attachment 1 shows photos of the various vegetation types at locations relevant to this clearing permit application.
