City of Swan
Workshops Avenue. Midland

Native Vegetation Clearing Permit – Purpose Permit
Supporting Documentation

9 February 2022

59422-132444 (Rev 0)

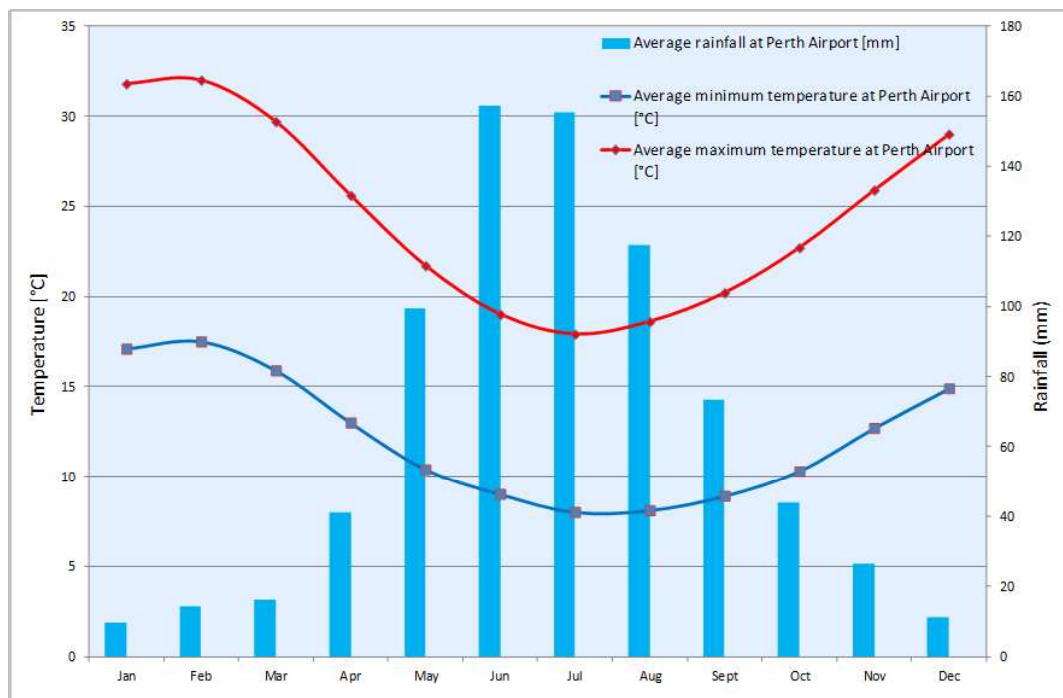
Figure 2.1: Climate data for Perth Airport - 09021 (nearest meteorological station) (Source: Bureau of Meteorology 2020)

Summary climate data for the Perth Airport meteorological station is presented in Figure 2.1.

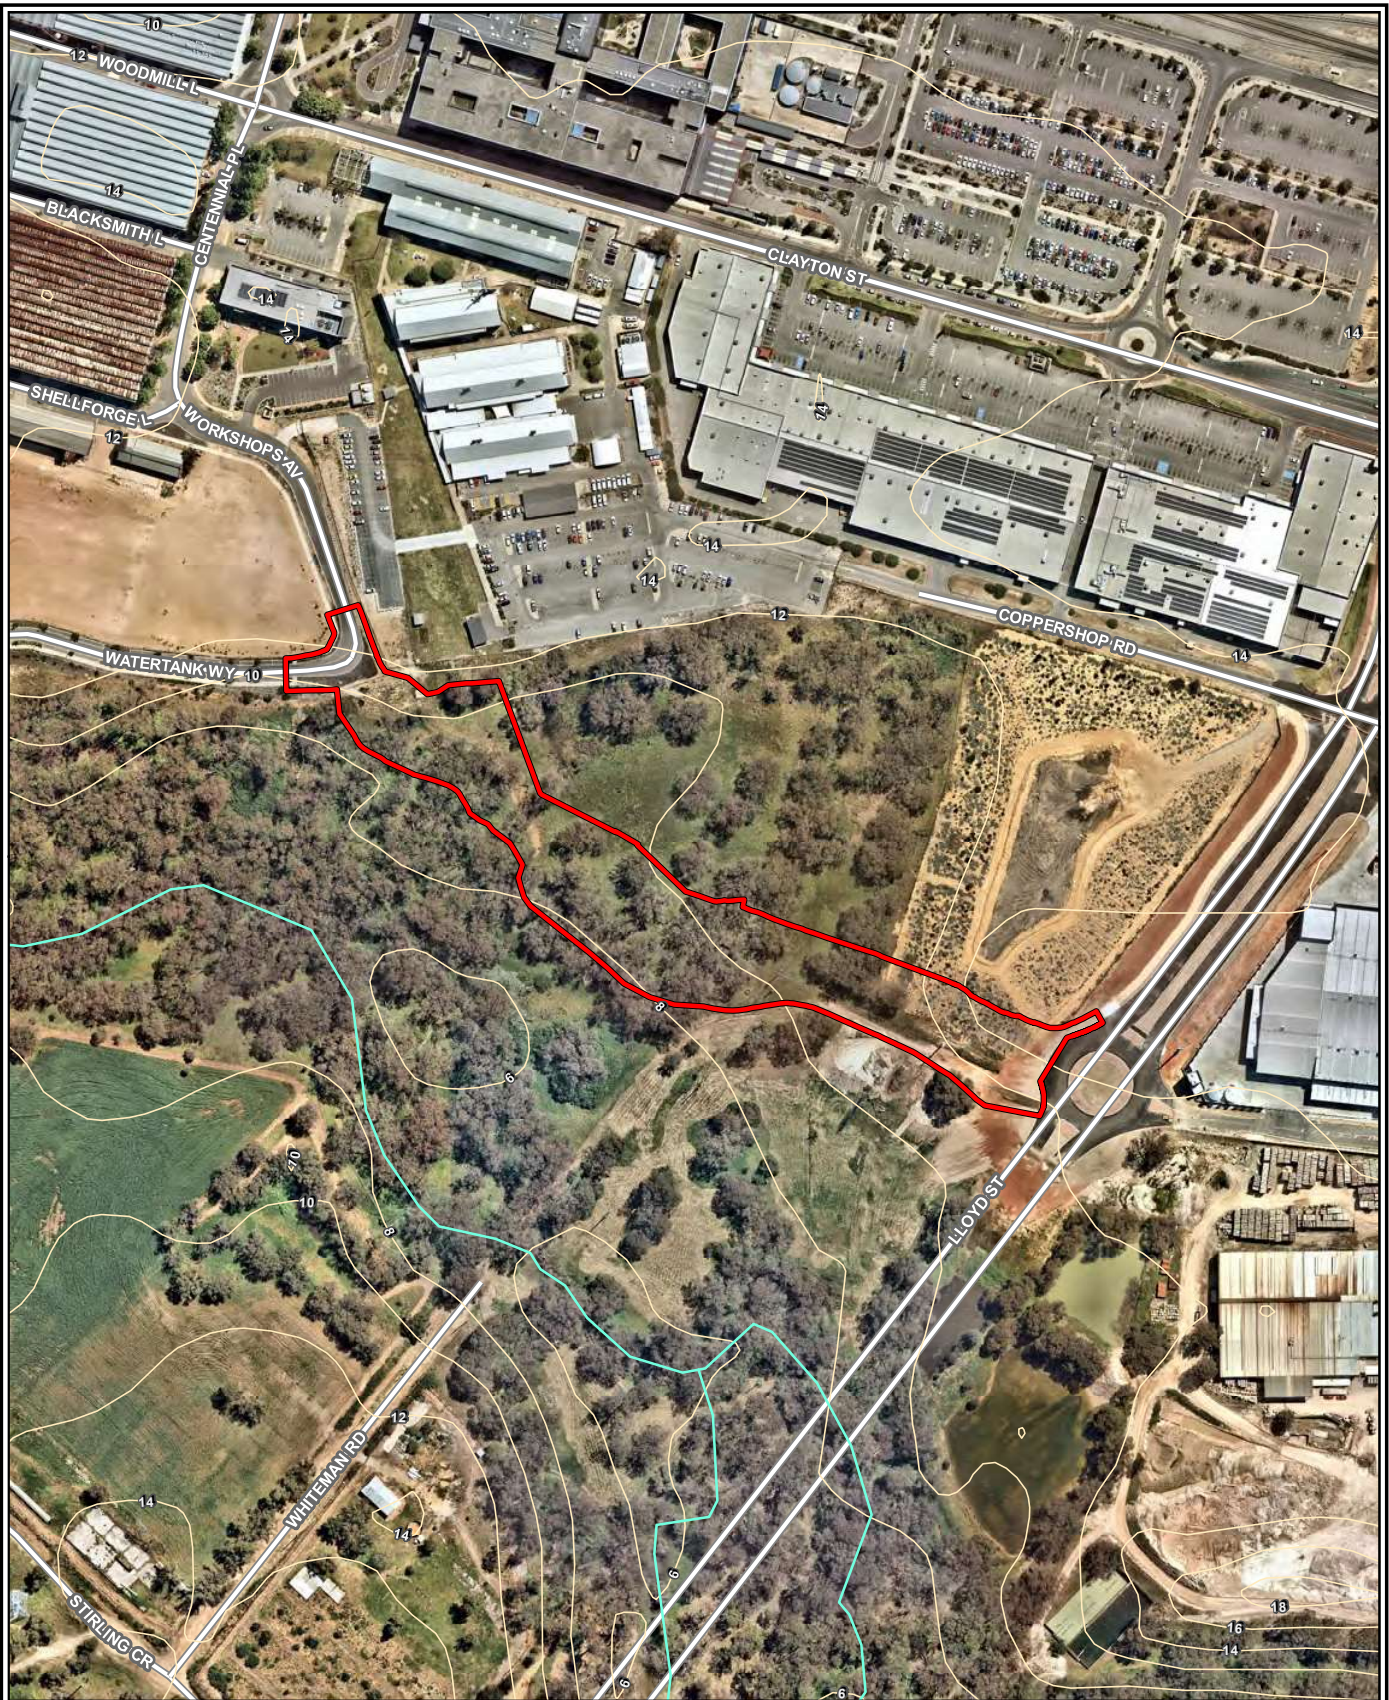
The Project Area is located within and immediately adjacent to the Helena River floodplain (refer to Section 2.4).

Local modifications to topography have occurred and are occurring as a result of construction of the current infrastructure for the Midland Central commercial area and Lloyd Street extension.

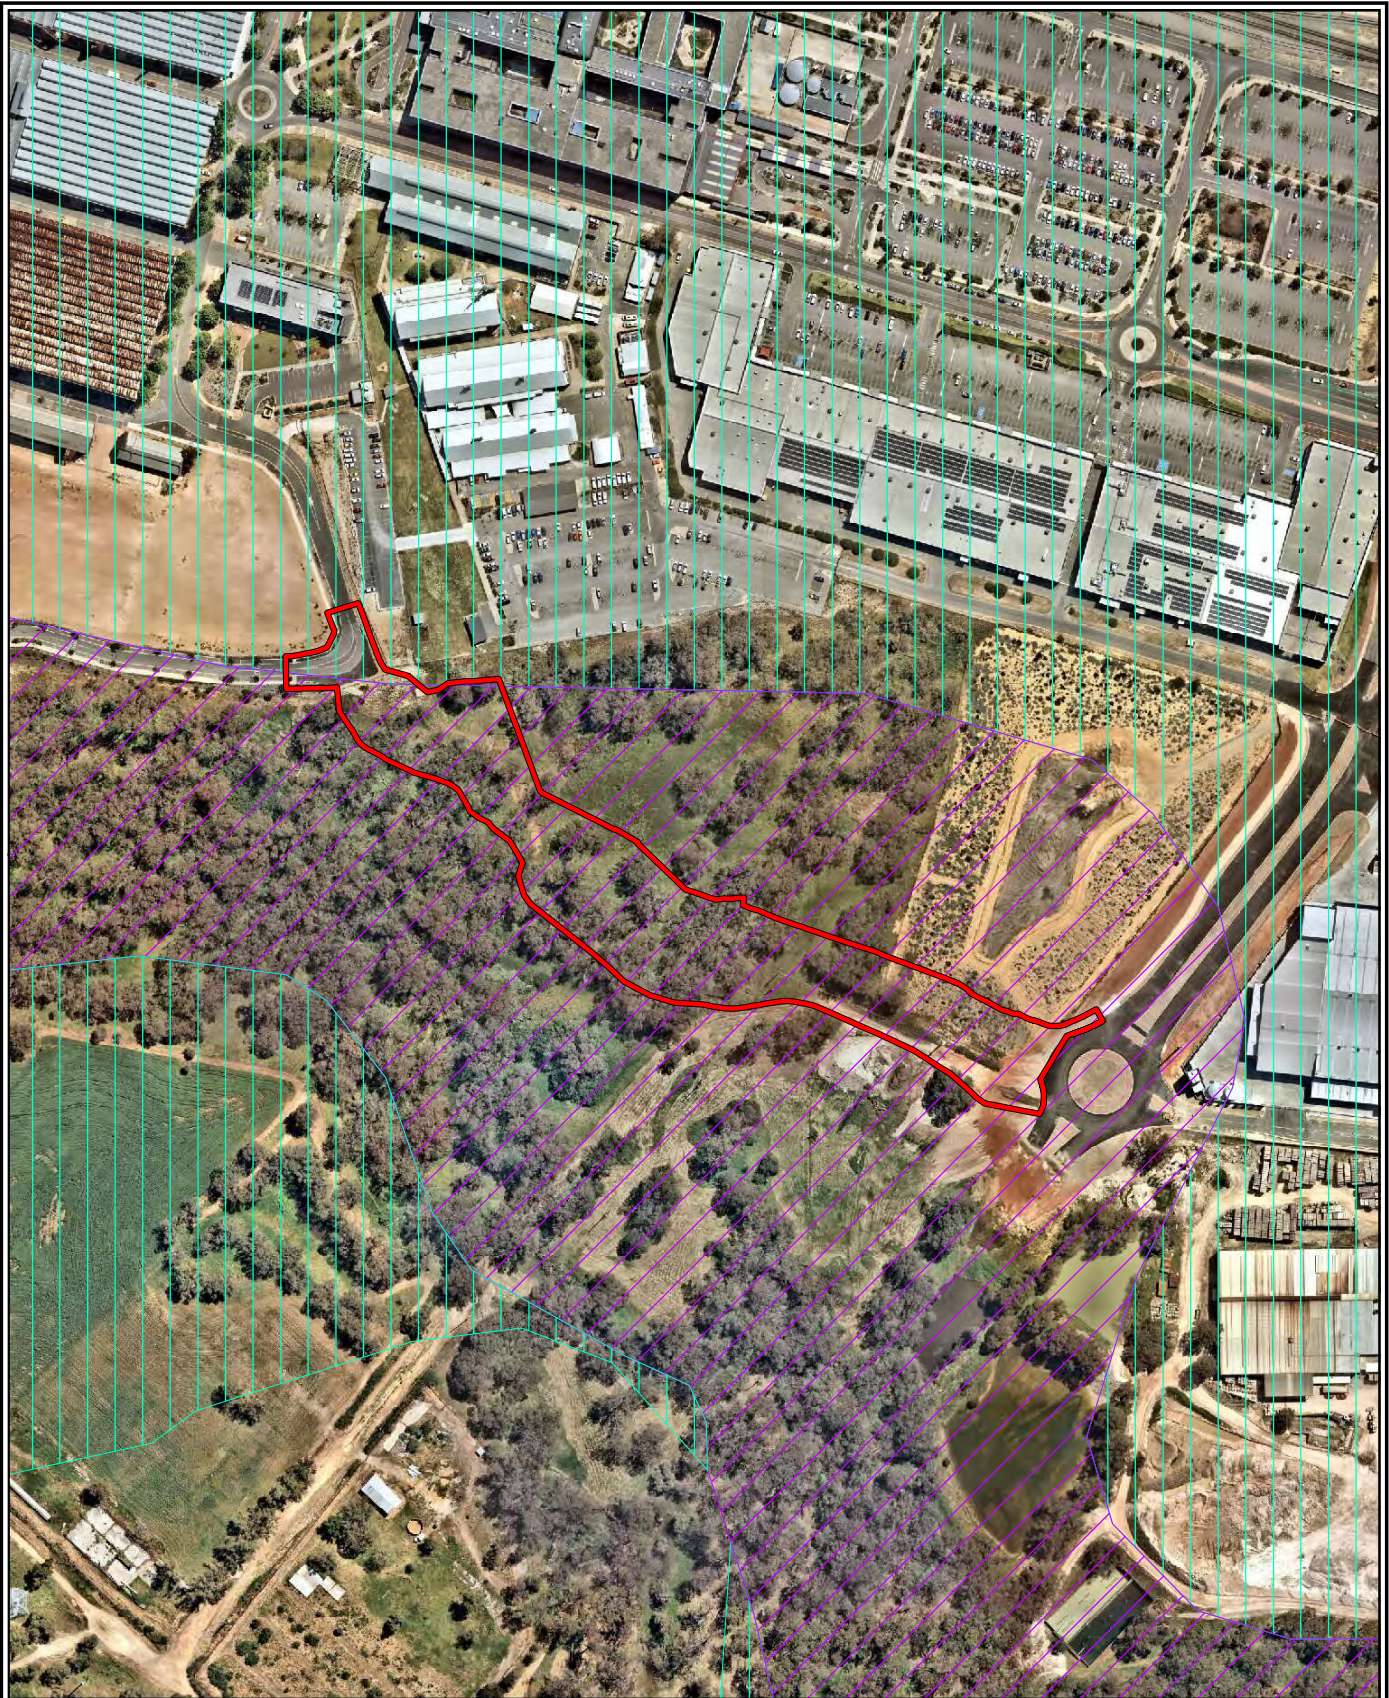
FIGURE 2.3

The Project Area is located within the Swan Coastal Plain 2 (SWA2 – Swan Coastal Plain subregion) of Western Australia (Mitchell et al. 2002) (refer Figure 2.3). The Swan Coastal Plain comprises five major geomorphologic systems that lie parallel to the coast, namely (from west to east) the Quindalup Dunes, Spearwood Dunes, Bassendean Dunes, Pinjarra Plain and Ridge Hill Shelf (Churchward & McArthur 1980; Gibson *et al.* 1994). Each major system is composed of further subdivisions in the form of detailed geomorphologic units (Churchward & McArthur 1980; Semeniuk 1990; Gibson *et al.* 1994). Beard (1990) describes the Swan Coastal Plain as a low-lying coastal plain, often swampy, with sandhills also containing dissected country rising to the duricrusted Dandaragan plateau on Mesozoic, mainly sandy, yellow soils. The project is located within the Pinjarra system which is described as:

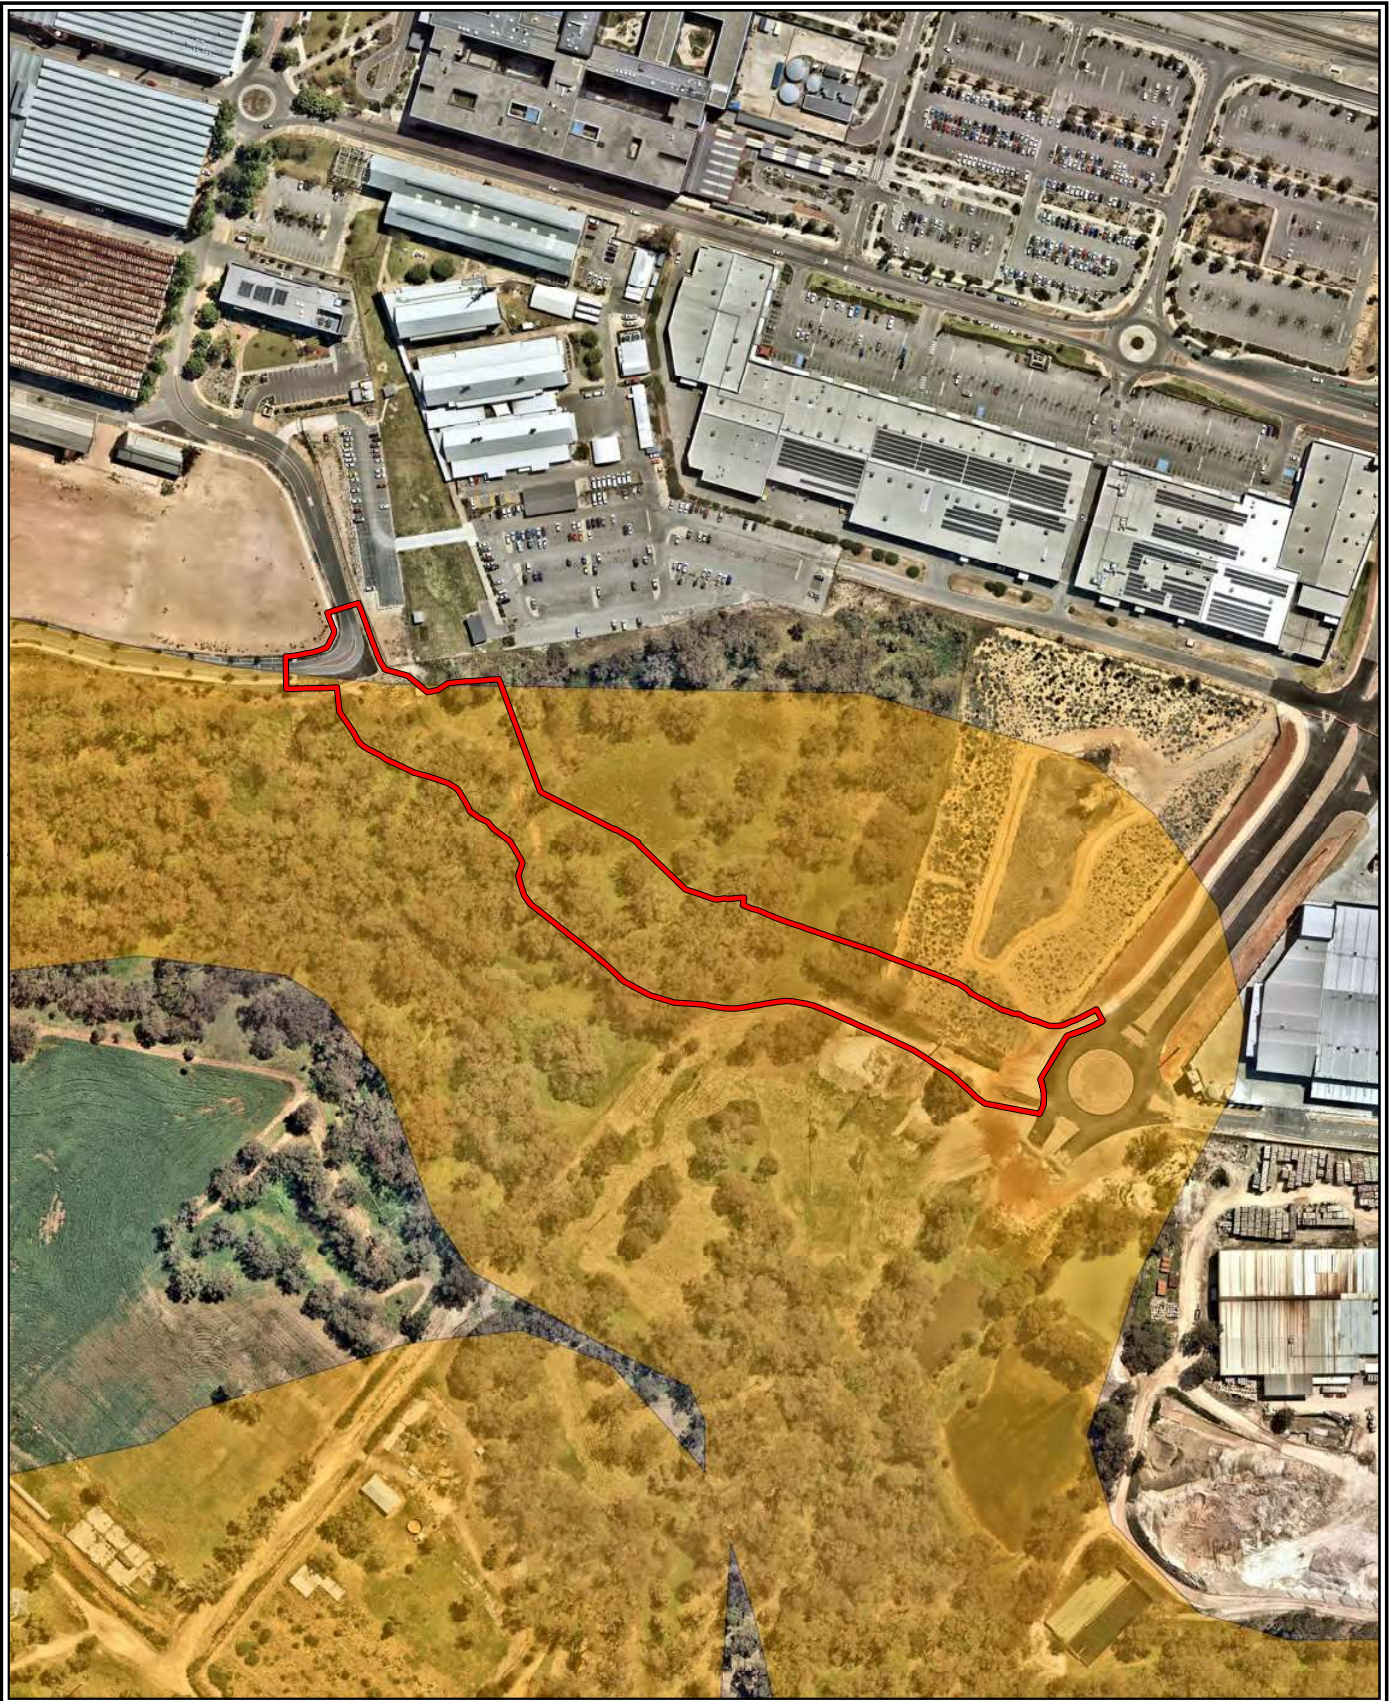
FIGURE 2.4

The proposed footprint is located in an area with a low to moderate risk of acid sulfate soils (ASS) occurring within 3 m of the soil surface (Figure 2.4). These ASS are related to the alluvial clay deposits associated with the Helena River (Figure 2.5).

- Application area
- Acid sulfate soil (DWER)
- Moderate to low risk

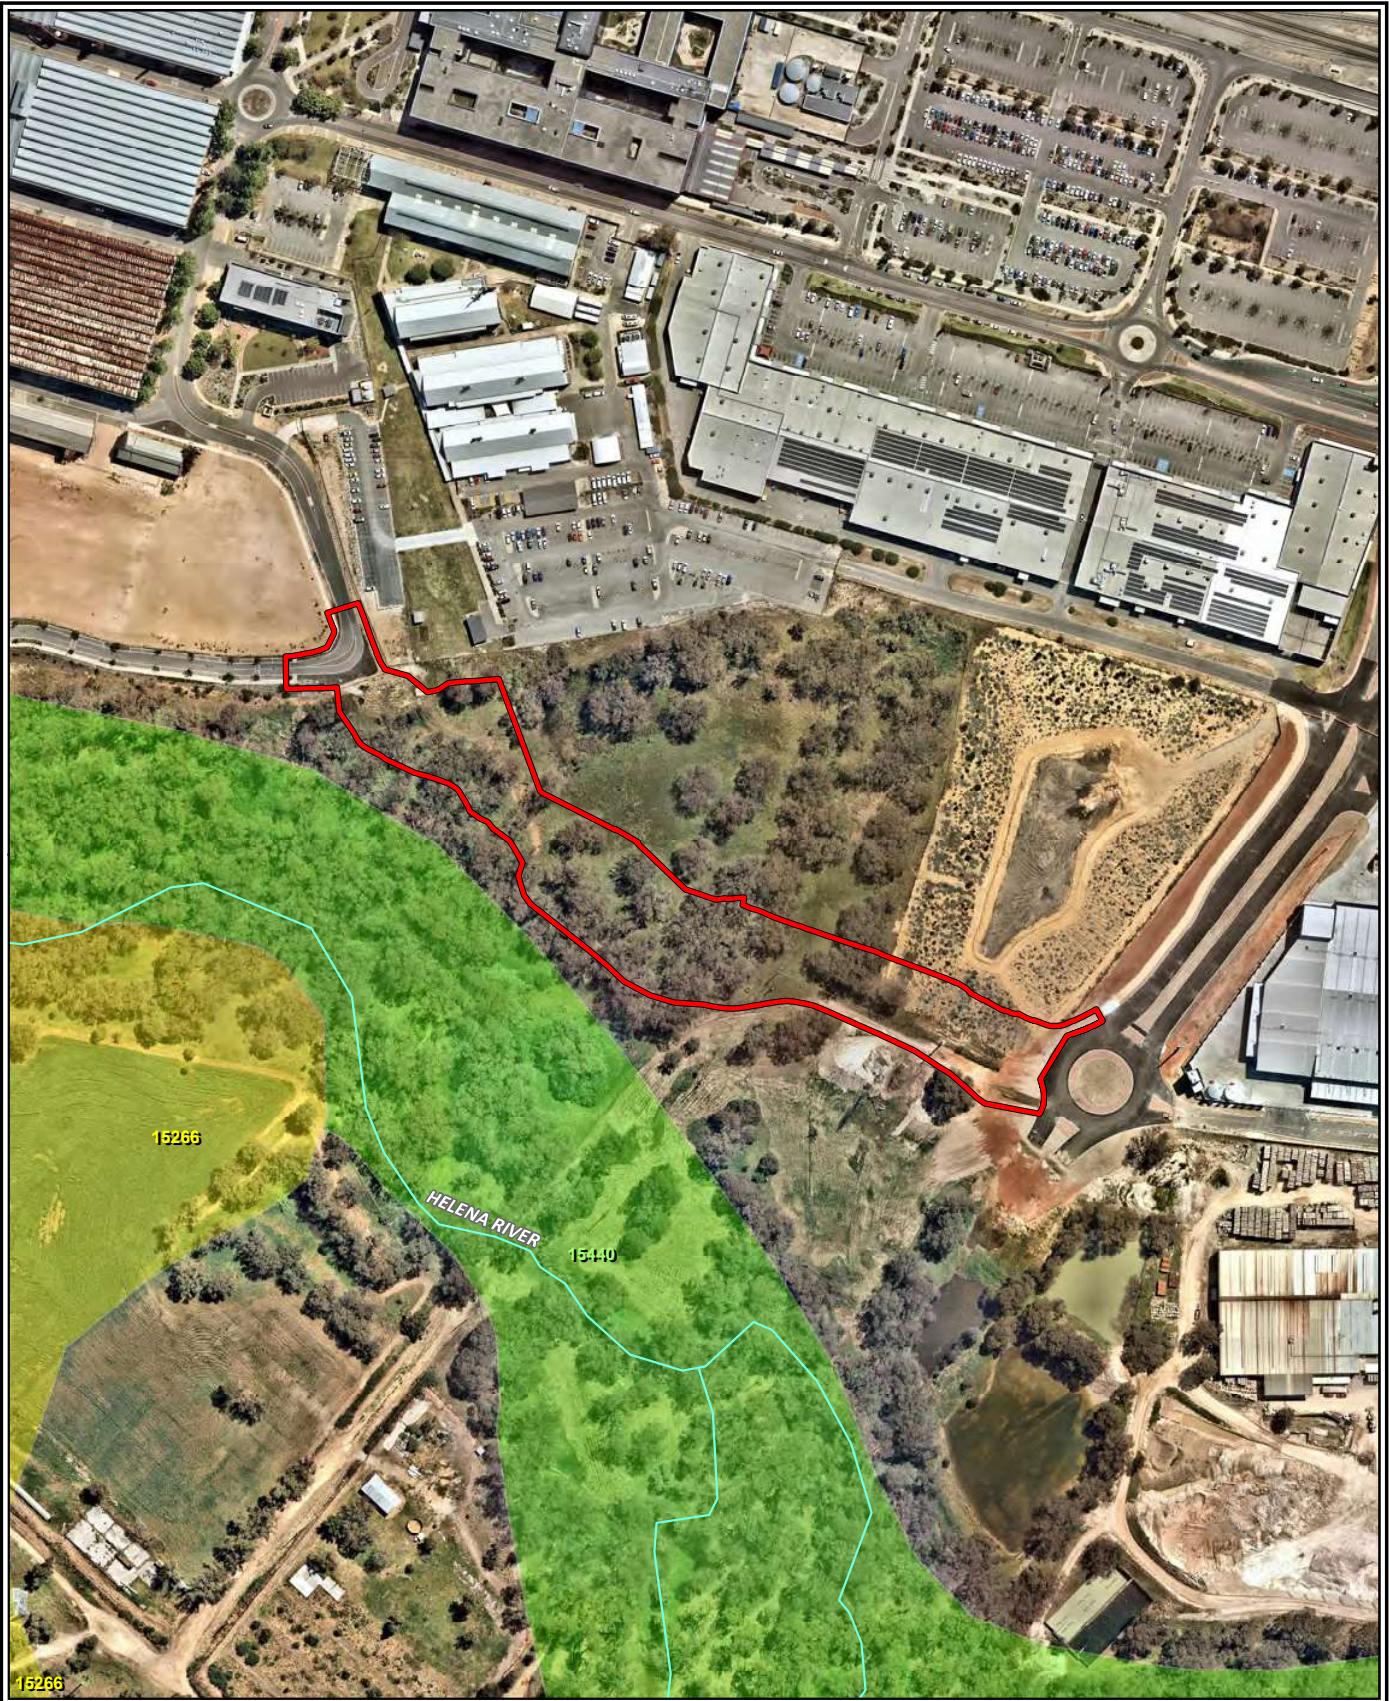
Legend <div><div></div> Application area</div> Geomorphic Wetlands <div><div></div> Conservation</div> <div><div></div> Multiple use</div> <div><div></div> Watercourse</div>	Scale 1:3,500 at A4 <div><div>02550</div><div>metres</div></div>		Workshop Avenue City of Swan	
	Coord. Sys. GDA 1994 MGA Zone 50 <div><div></div></div>			SURFACE WATER AND WETLANDS
	Job No: 59422			
	Client: City of Swan			
	Version: A		Date: 10-May-2022	FIGURE 2.5
	Drawn By: cthatcher		Checked By: RD

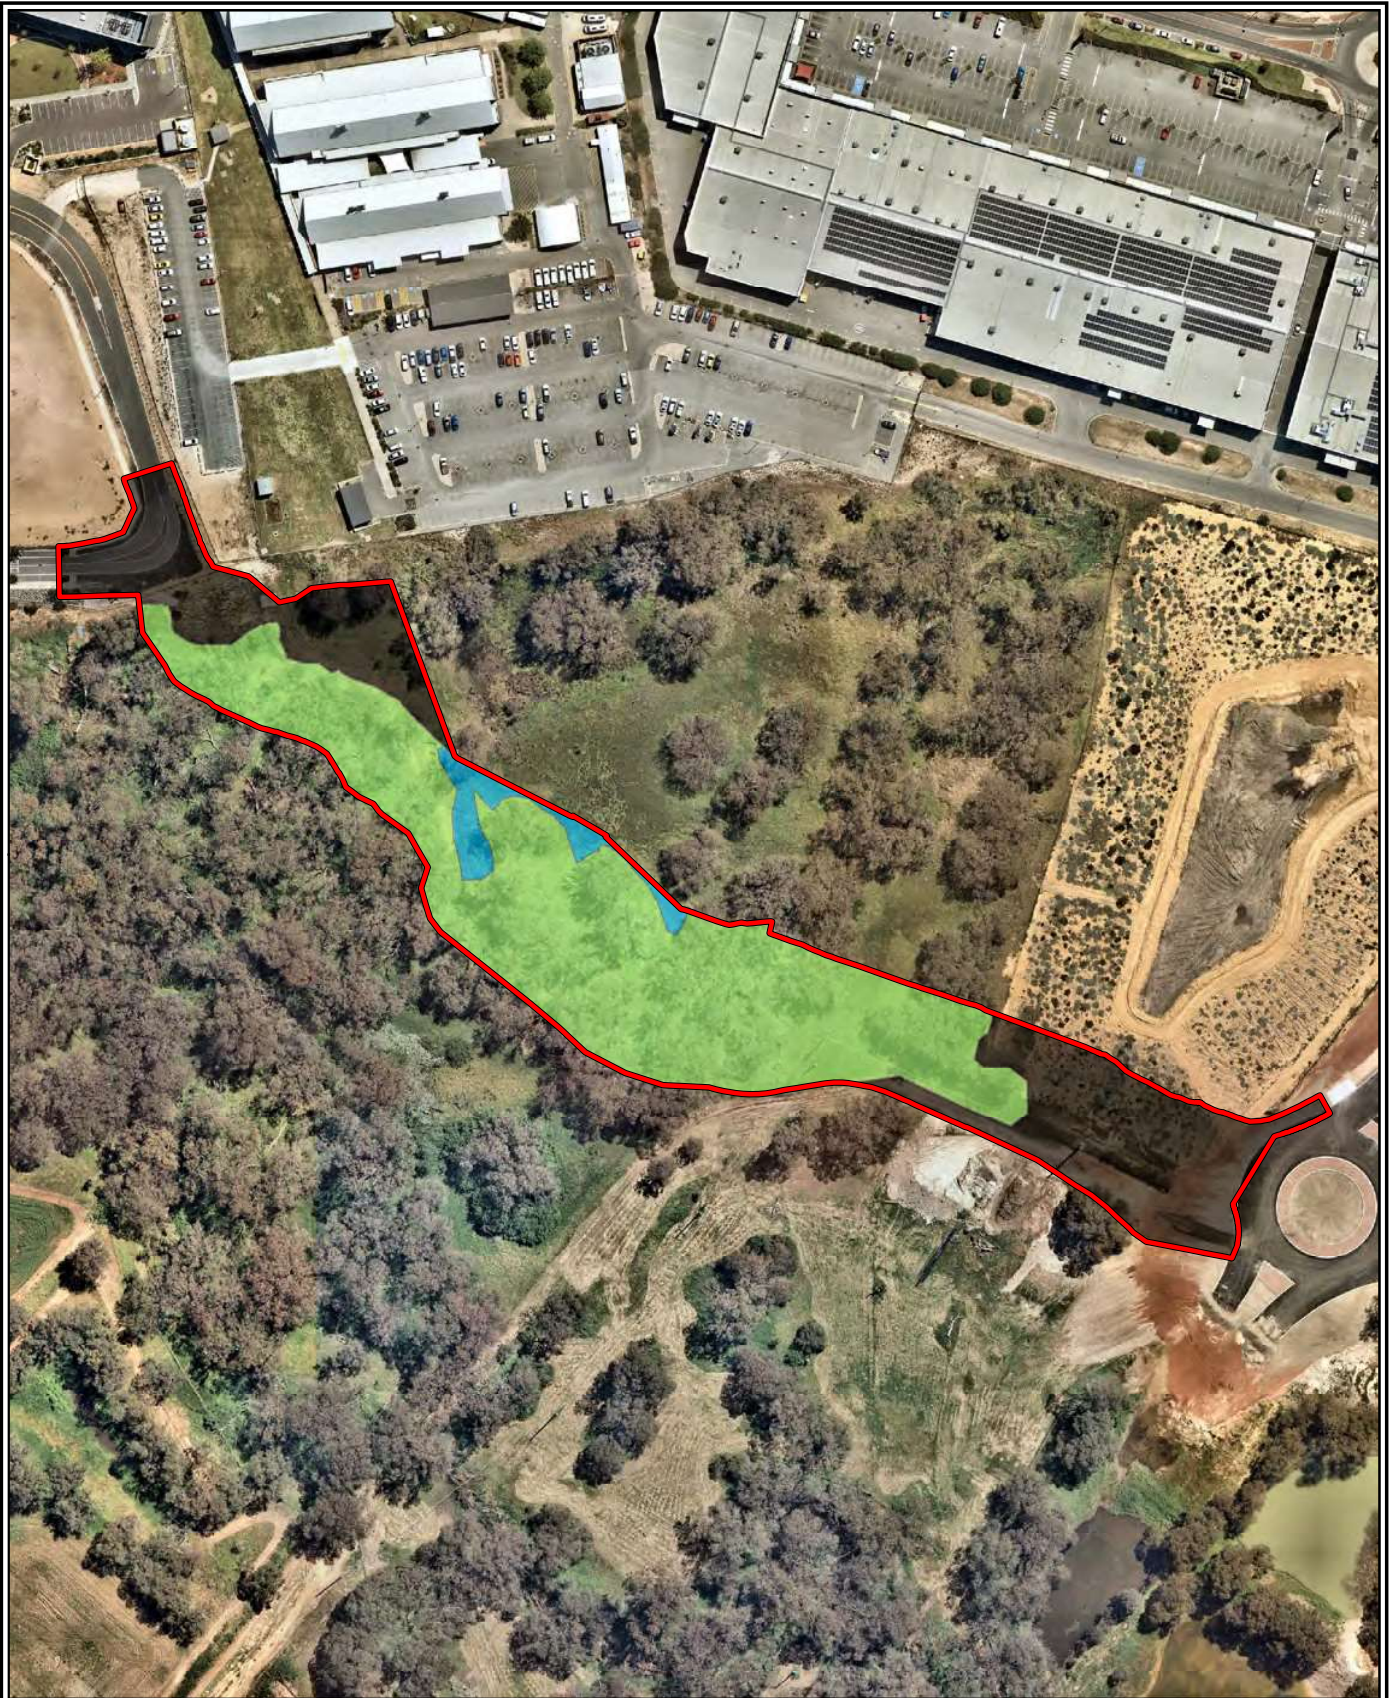
FIGURE 2.8

The total area mapped within the survey area and in relation to the project was 13.65 ha which includes fully cleared areas (Table 2.3, Figure 2.8). The dominant native VT within the survey area was VT 1 which can be broadly described as; *Eucalyptus rudis* and **Ficus carica* woodland over mixed weeds.

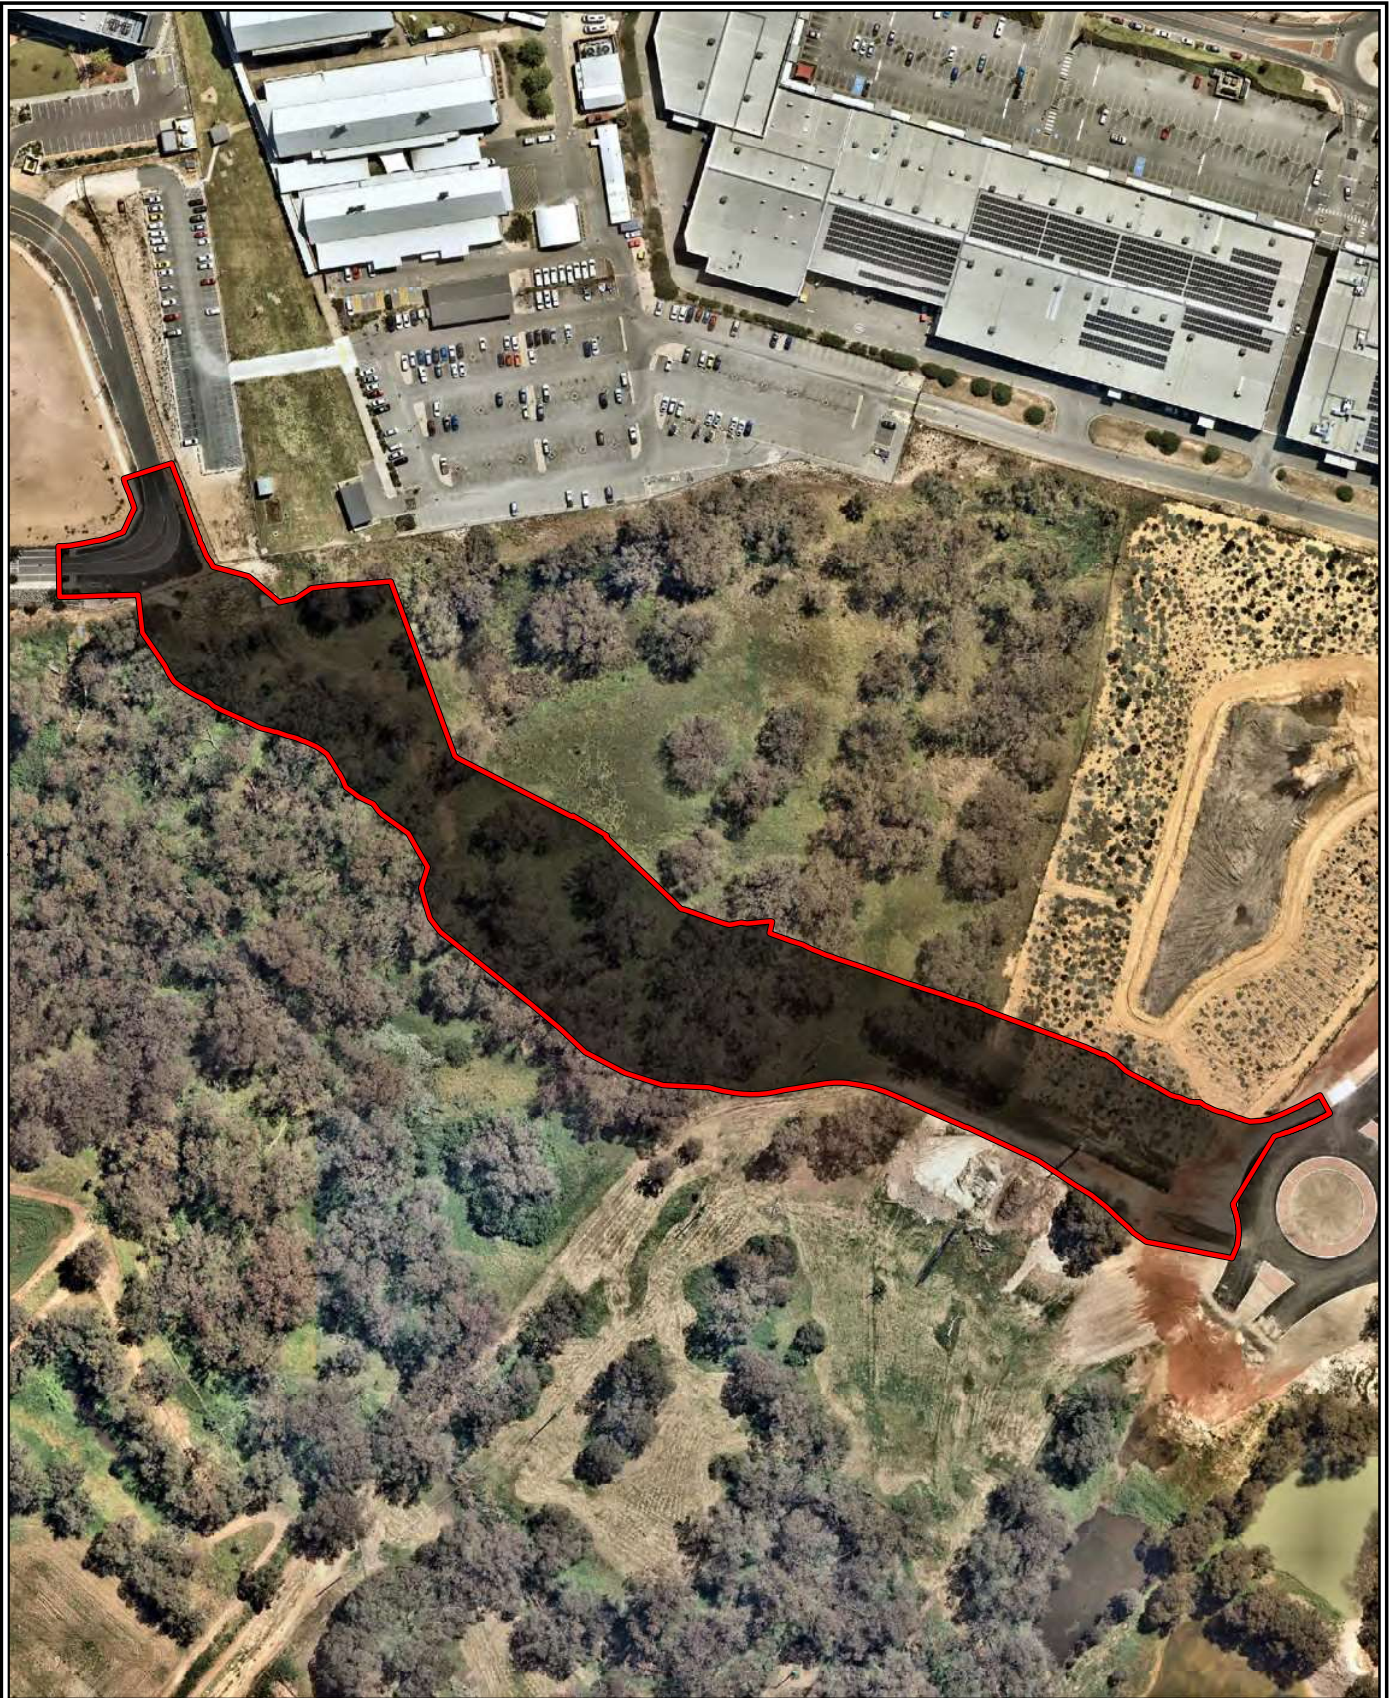
VEGETATION CONDITION

The survey area shows signs of having been degraded for a long period of time. Historical land uses within the survey area and neighbouring properties are likely to have contributed to the level of weed infestation within the survey area and modification to vegetation structure in areas. Consequently, vegetation condition within the entire survey area (i.e. 13.65 ha) was rated as Completely Degraded (Keighery, 1994, Figure 1.1; Table 2.4).

- Application area
- Vegetation condition
- Completely degraded

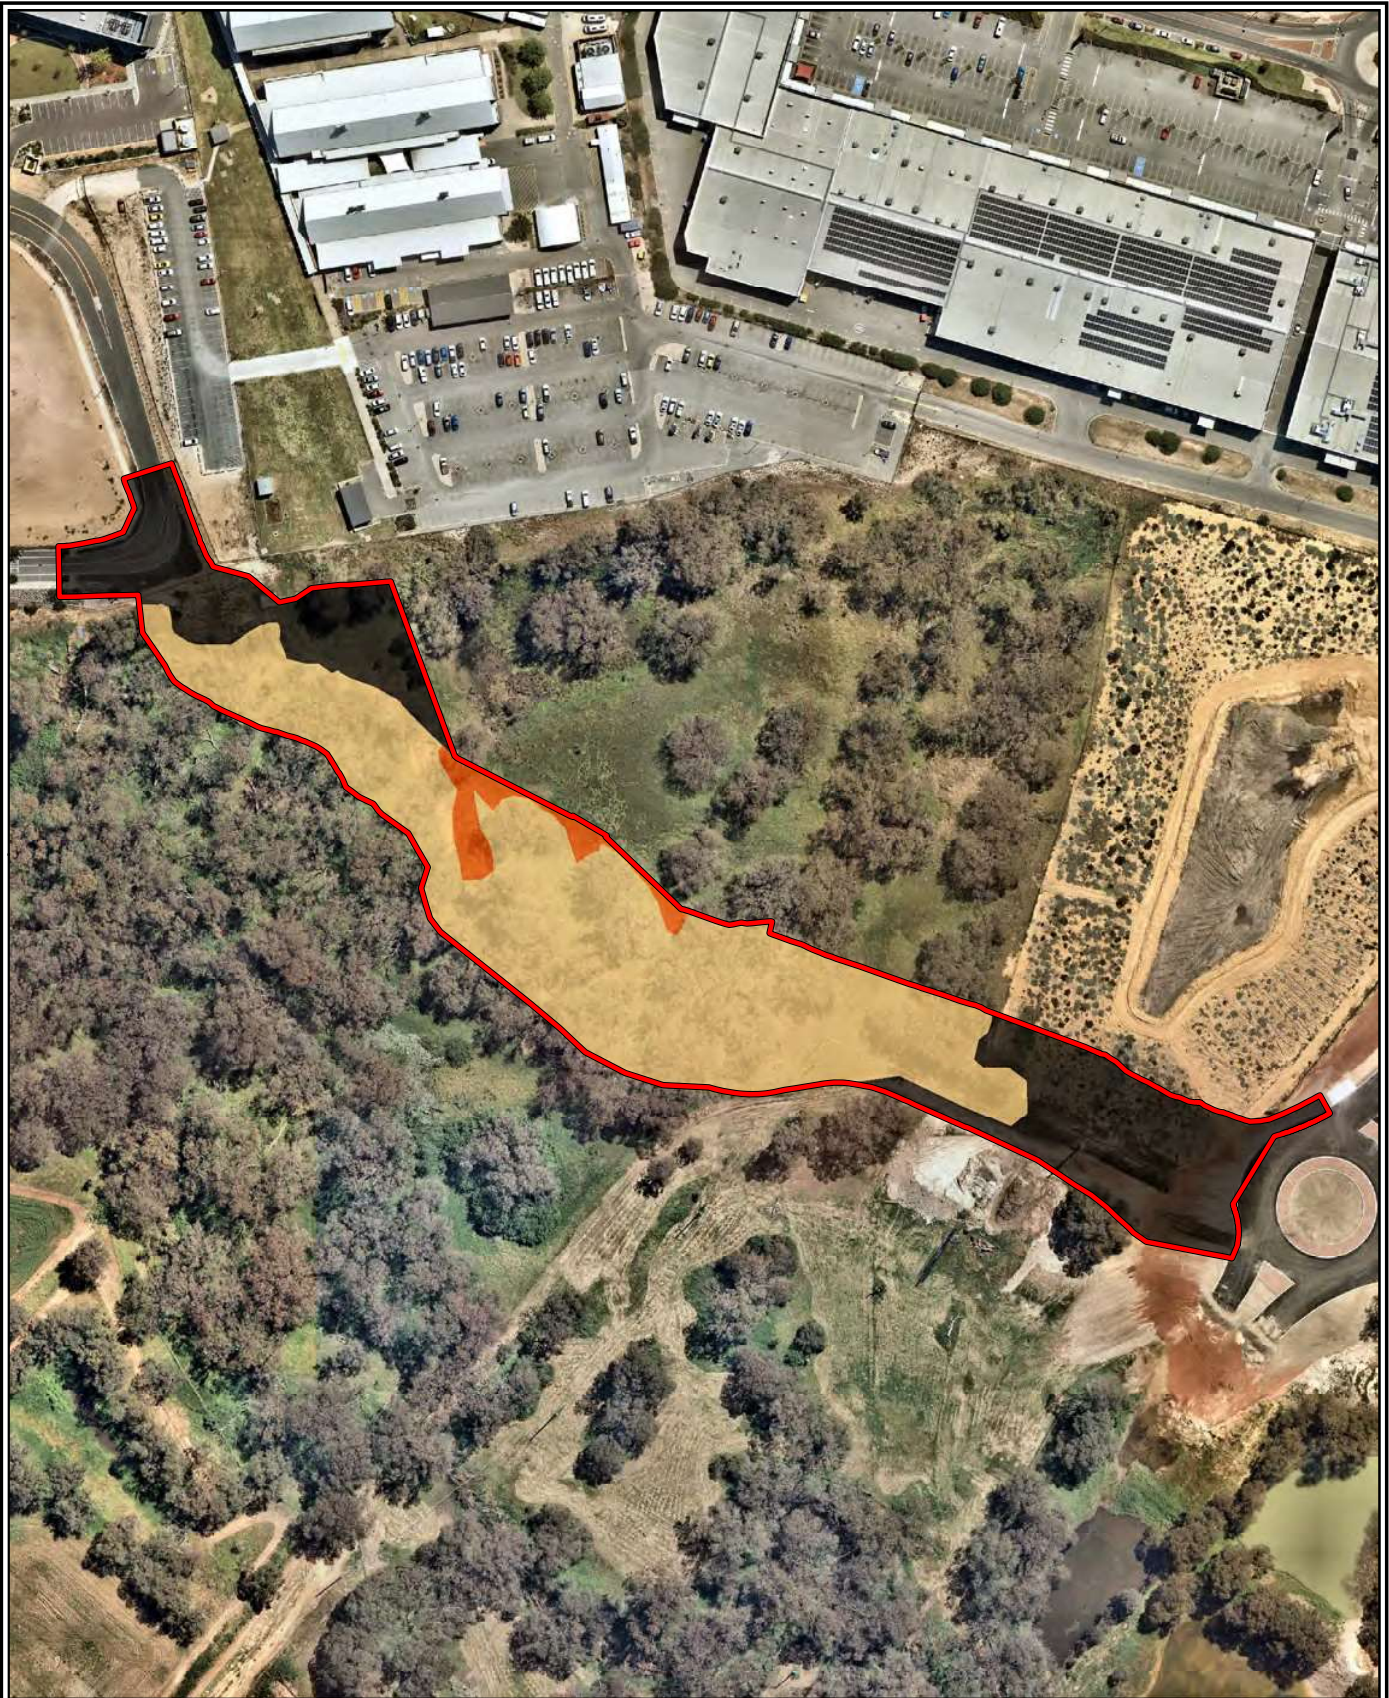
FIGURE 2.11

Foraging habitat quality is displayed in Figure 2.11. Both VTs contained the same foraging species for CBC (*Eucalyptus rudis* and *Ficus carica*); however, the density of suitable foraging species was significantly higher in VT 1 than VT 2.

- Application area
- Black Cockatoo habitat
- Moderate-Good (CBC only)
- Very poor (CBC only)
- Nil

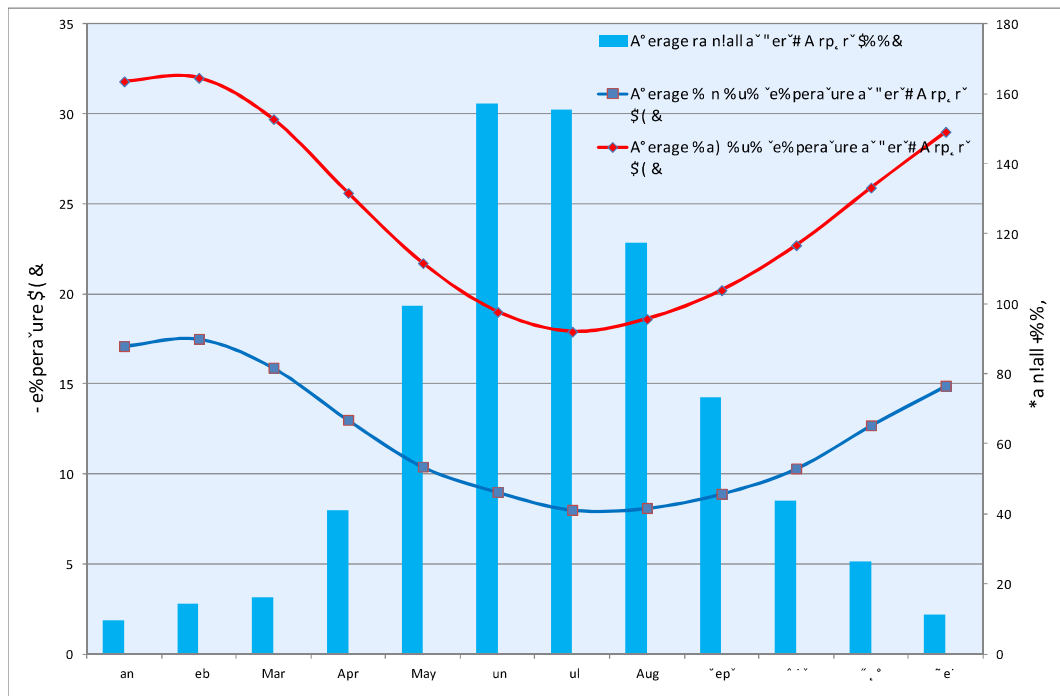
Figure 2: Mean monthly climatic data (temperature and rainfall) for Perth Airport

The Midland locality experiences a Mediterranean climate characterised by mild, wet winters and warm to hot, dry summers. The nearest Bureau of Meteorology (BoM) weather station at Perth Airport (Station No. 9021) provides average monthly climate statistics for the Midland locality (Figure 2). Average annual rainfall recorded at Perth Airport since 1944 is 767.4 mm (BoM 2016). Rainfall may occur at any time of year; however, most occurs in winter in association with cold fronts from the southwest. Highest temperatures occur between December and March, with average monthly maximums ranging from 29°C in December to 32°C in February (BoM 2016). Lowest temperatures occur between June and September, with average monthly minimums ranging from 8°C in July to 9°C in June (BoM 2016).

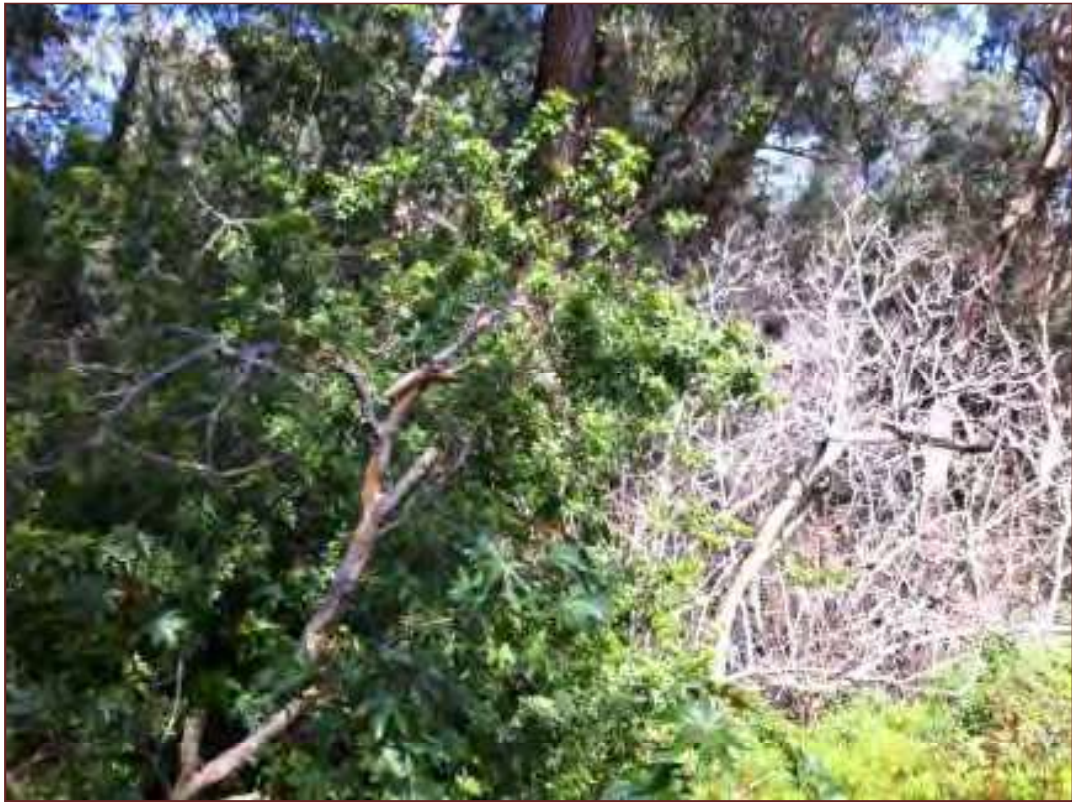
VT1: *Eucalyptus rudis* and *Ficus carica* woodland over *Ricinus communis* tall shrubland over *Typha orientalis* sedgeland or *Ehrharta calycina* and Poaceae sp. open bunch grassland over *Oxalis pes-caprae* low herbland on sandy, clay-loam soils.

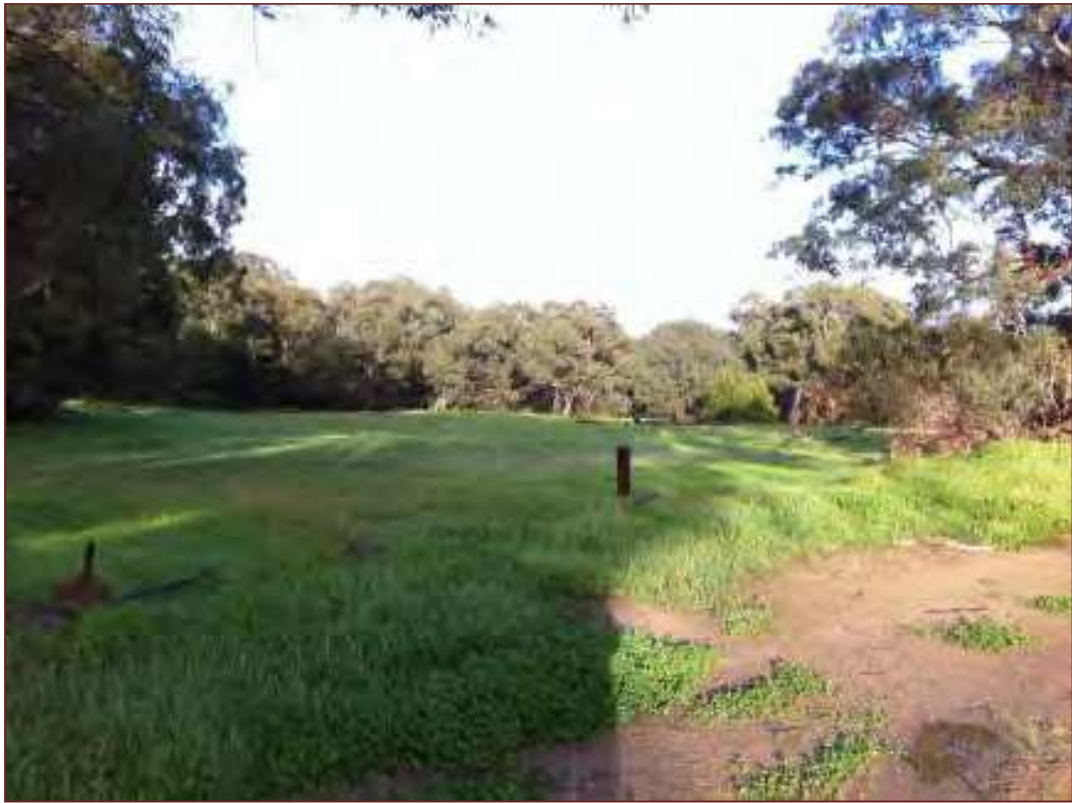
VT2: *Ehrharta calycina* and *Cenchrus setaceus* open bunch grassland over *Oxalis pes-caprae* herbland with scattered native and exotic trees and shrubs.
