City of Swan
Workshops Avenue. Midland

Native Vegetation Clearing Permit – Purpose Permit
Supporting Documentation

9 February 2022

59422-132444 (Rev 0)

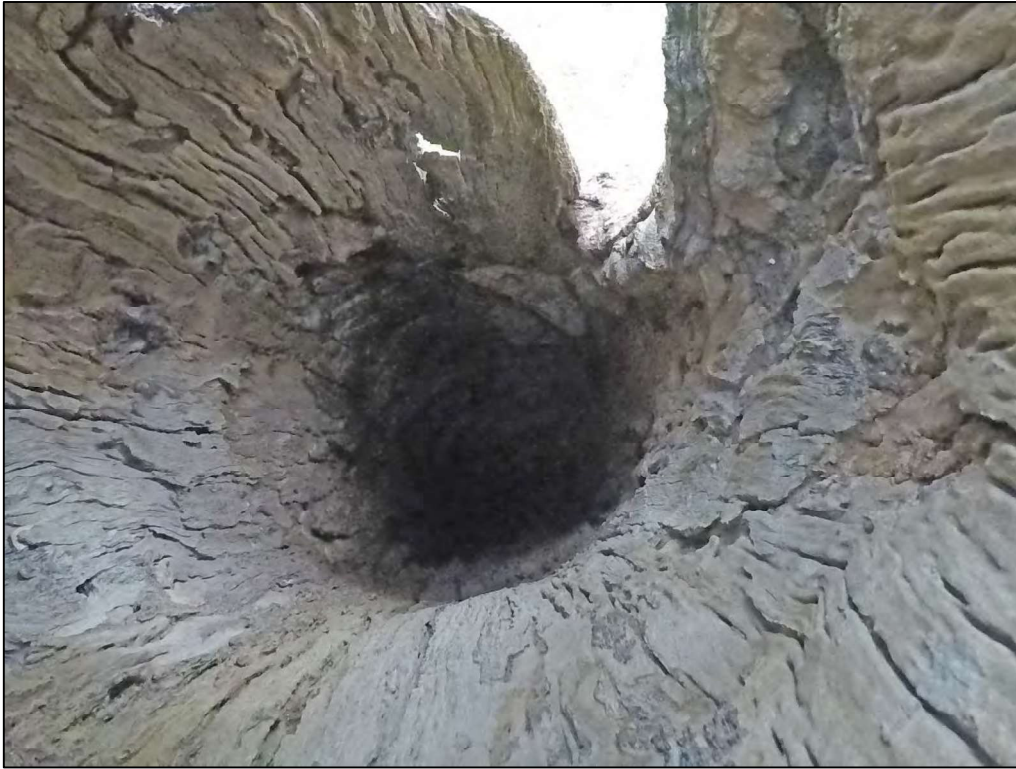
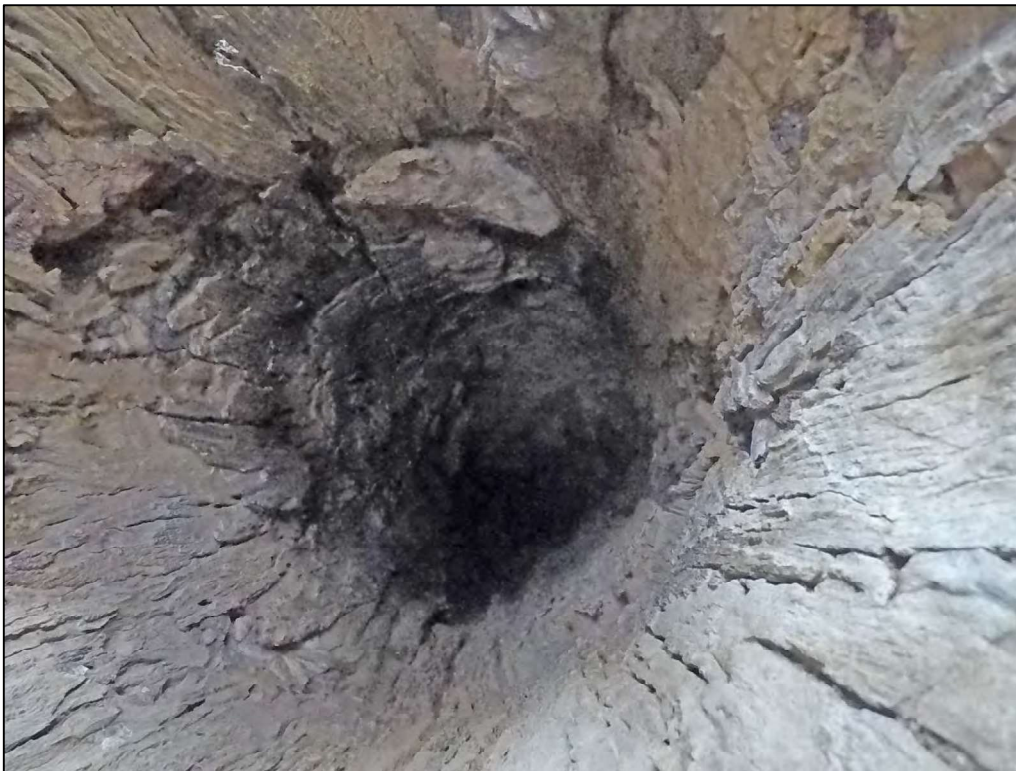
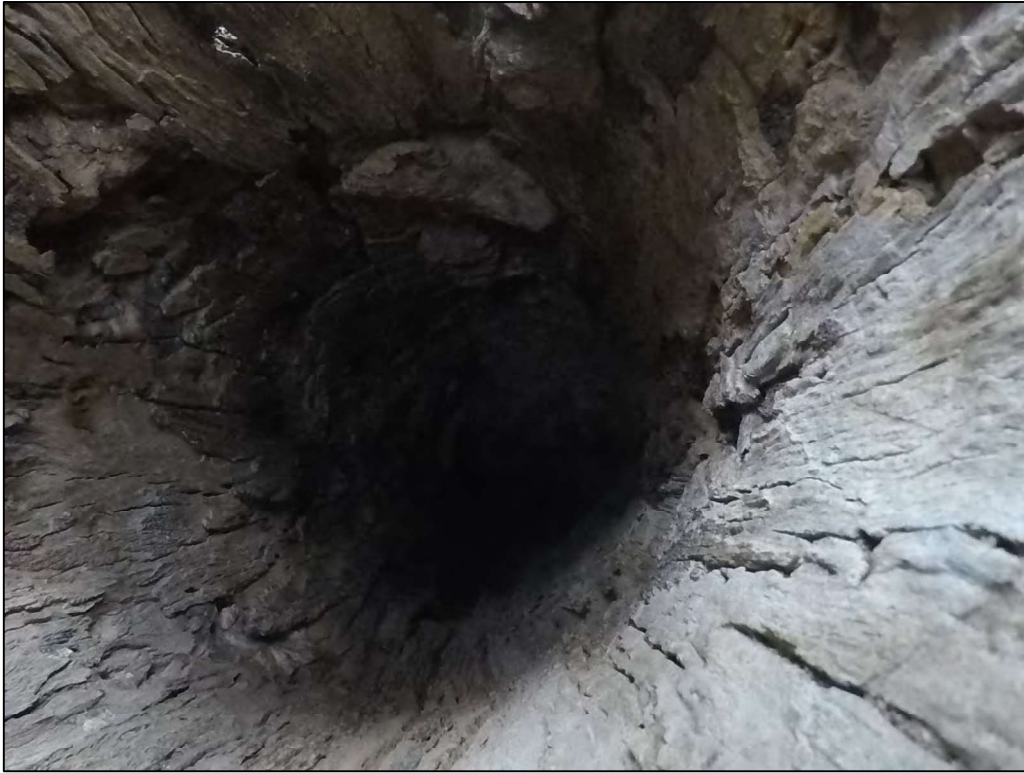
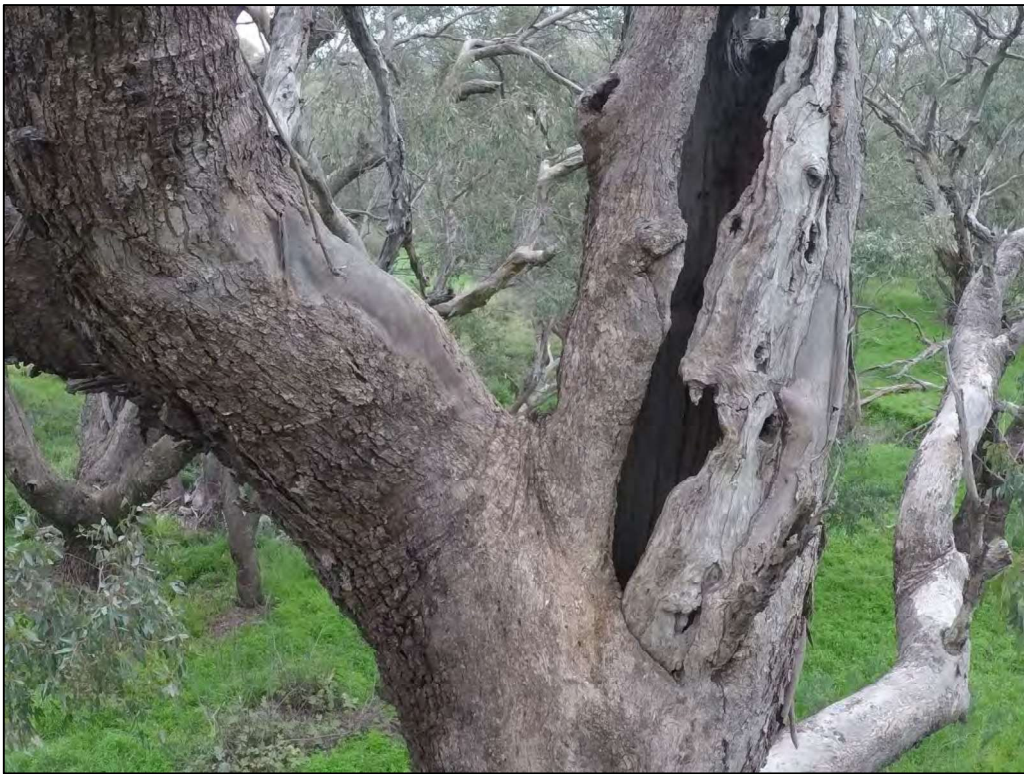
Figure 1: Tree 279 – hollow

Figure 2: Tree 279 – hollow

Figure 3: Tree 279 – hollow

Figure 4: Tree 279 – hollow

The assessment did not observe any hollows within these 42 individual trees that were suitable for use by CBC or evidence that CBC had used the hollows. Two trees had larger hollows which on closer examination were seen to be unsuitable for use by CBC as they were either too shallow or poorly shaped internally. Other trees had small hollows which were occupied by feral bees and small parrots (Australian Ringneck or Rainbow Lorikeet, both of which were observed in the area).

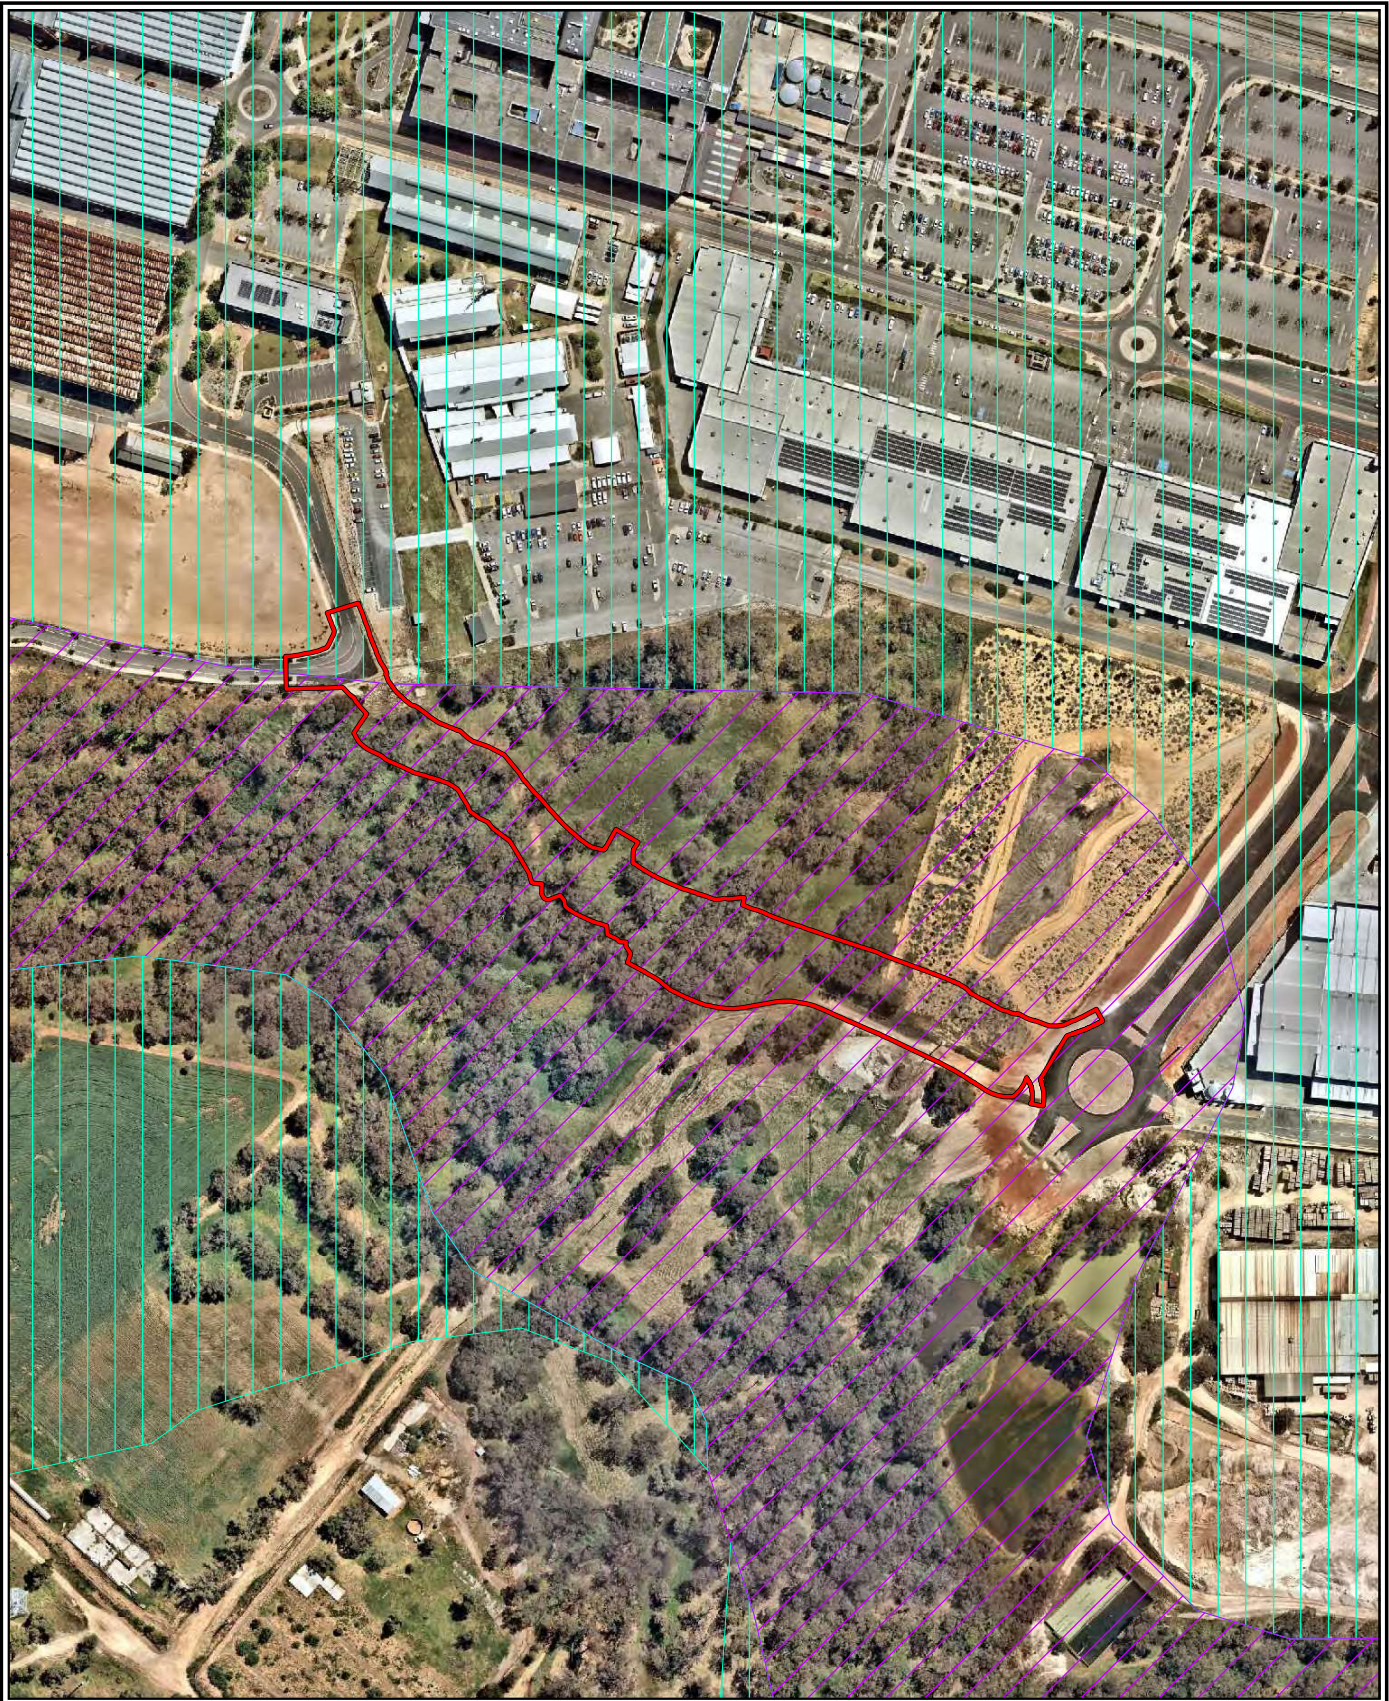
FIGURE 2

The sites underlying geology has been obtained from the following (Figure 2):

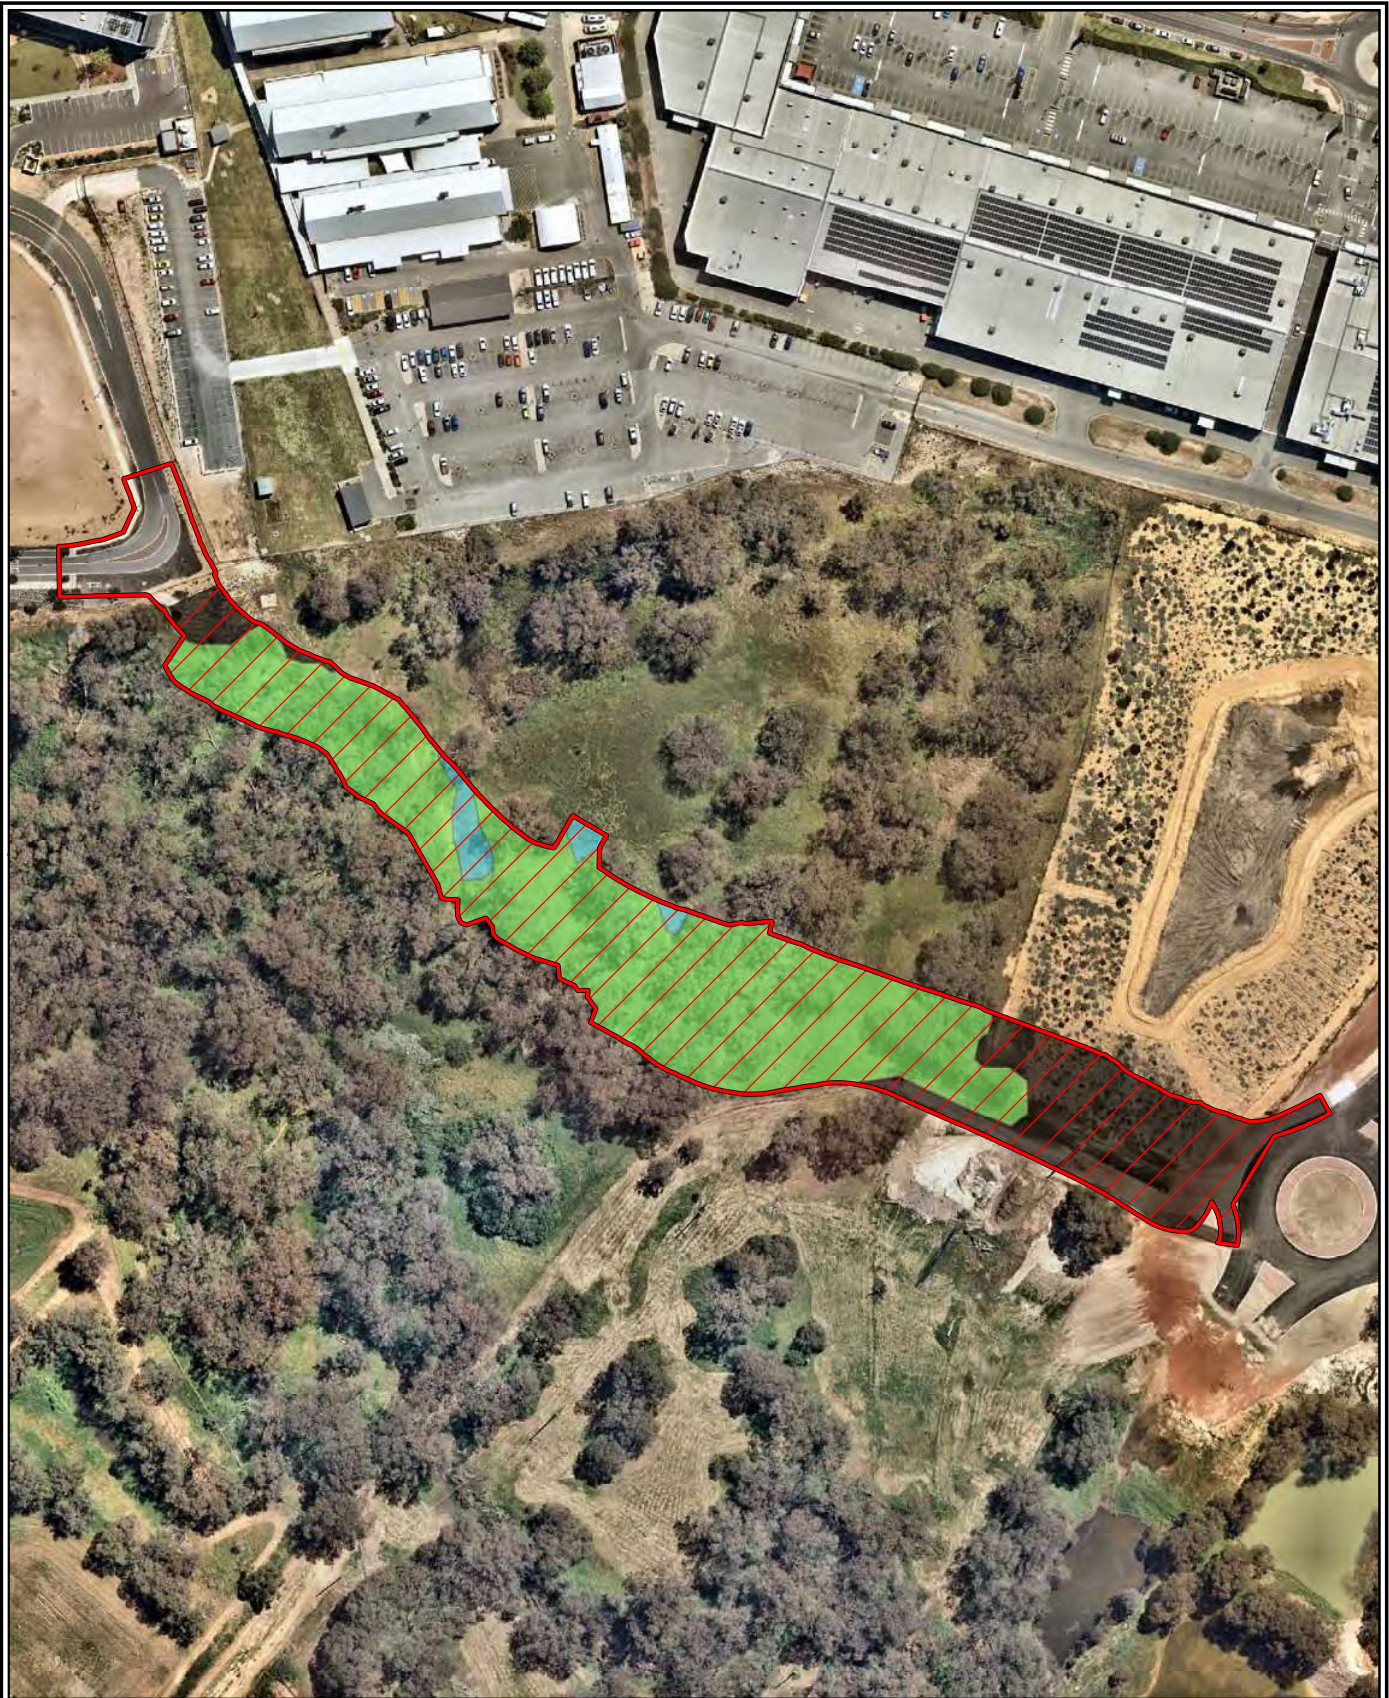
FIGURE 5

The potential for contaminated soils impacting flora and fauna at the site is low. The Helena River conservation category wetland contains some scattered mature trees and typical riparian vegetation. Vegetation within the proposed road reserve (Figure 5) is considered degraded, with several mature flooded gums (*E.Rudis*) and several weed species.

- Project area
- Vegetation type
 - VT1
 - VT2
 - Cleared
- Vegetation condition
 - Completely degraded

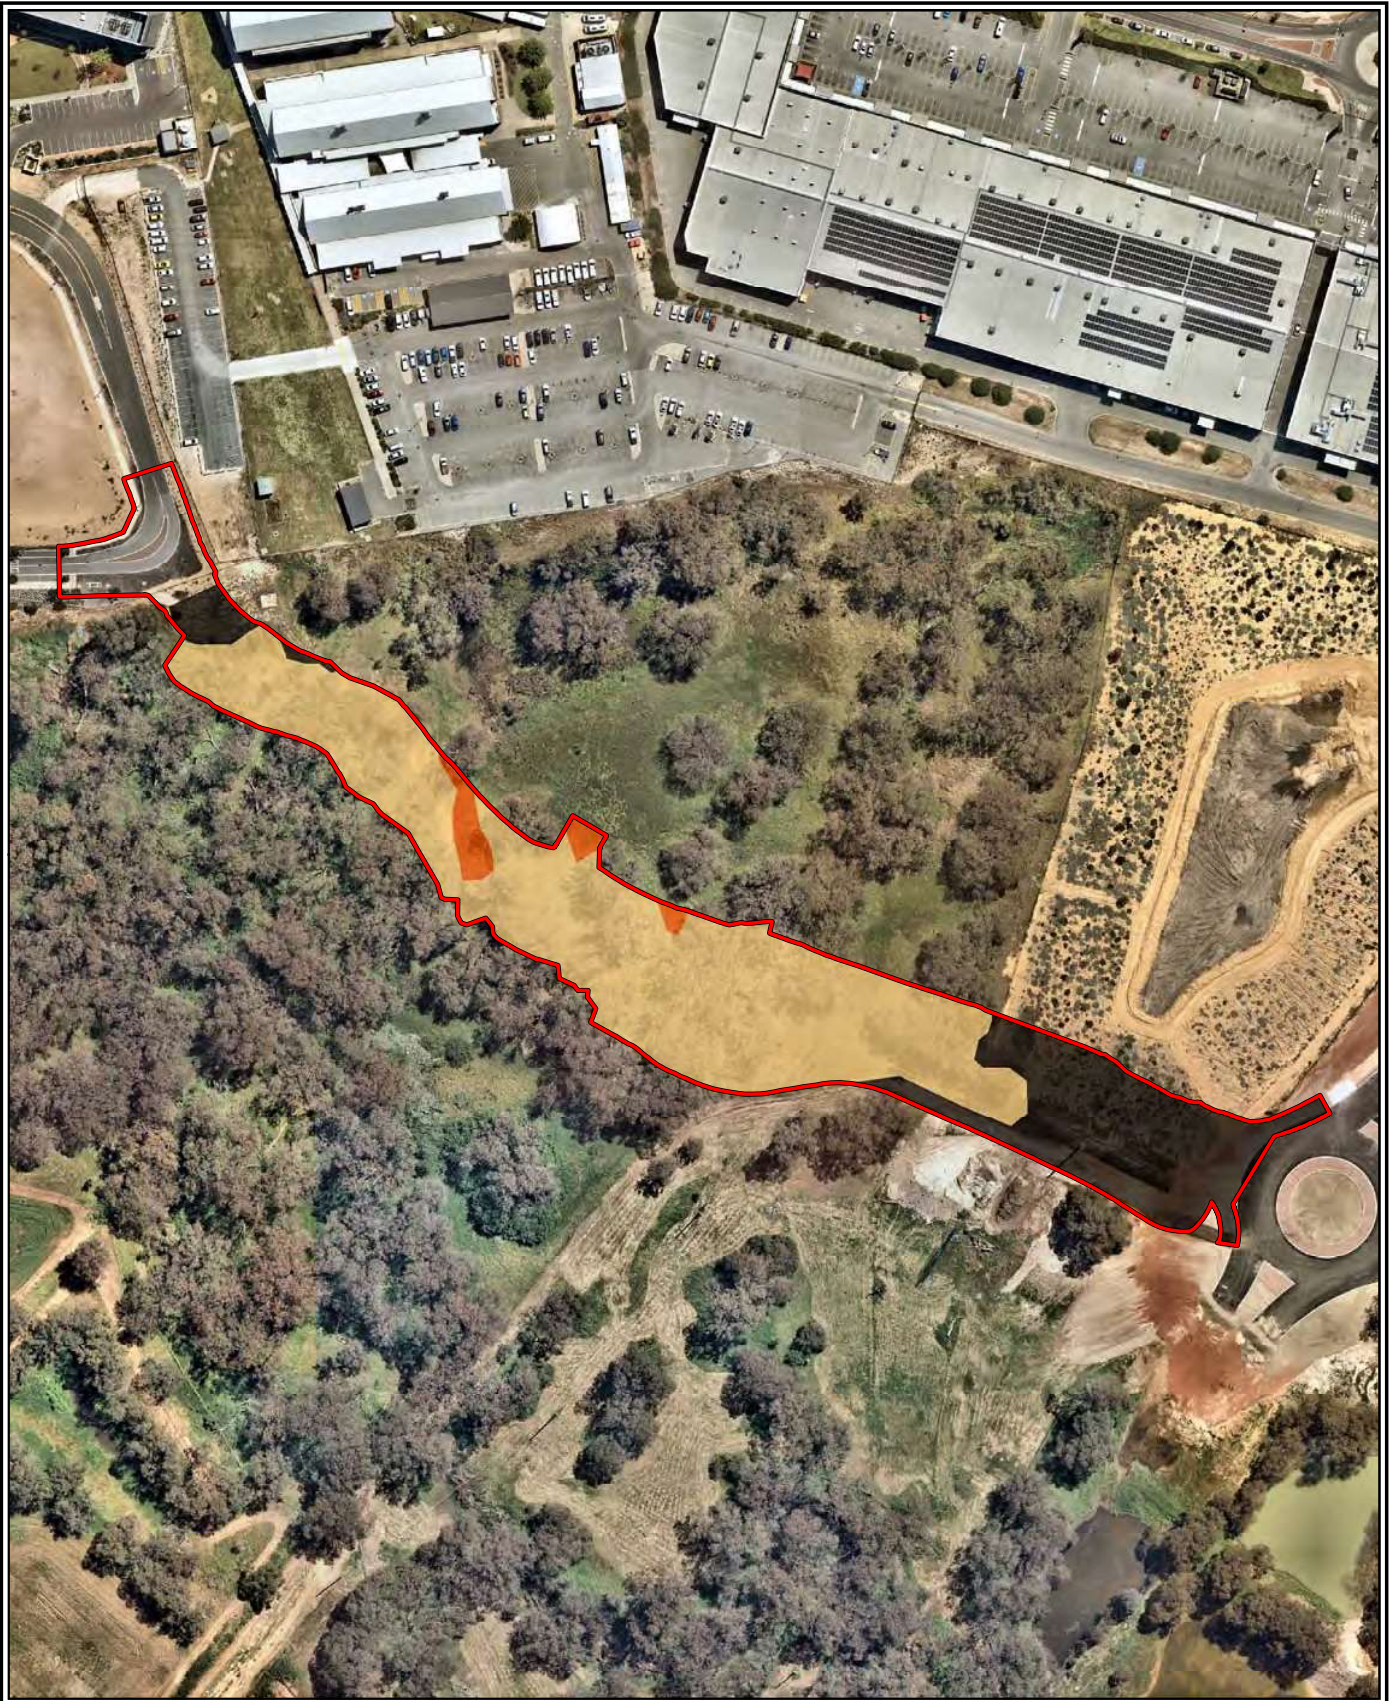
FIGURE 6

The mature trees were surveyed for their potential as foraging and nesting habitat by Carnaby Black Cockatoos (Figure 6). The habitat was mapped as either Nil, Very Poor or Moderate-Good for Carnaby Black Cockatoos. A separate report is under preparation with respect to cockatoo habitat impacts and a clearing permit has been applied for.

- Project area
- Black Cockatoo habitat
- Moderate-Good (CBC only)
- Very poor (CBC only)
- Nil

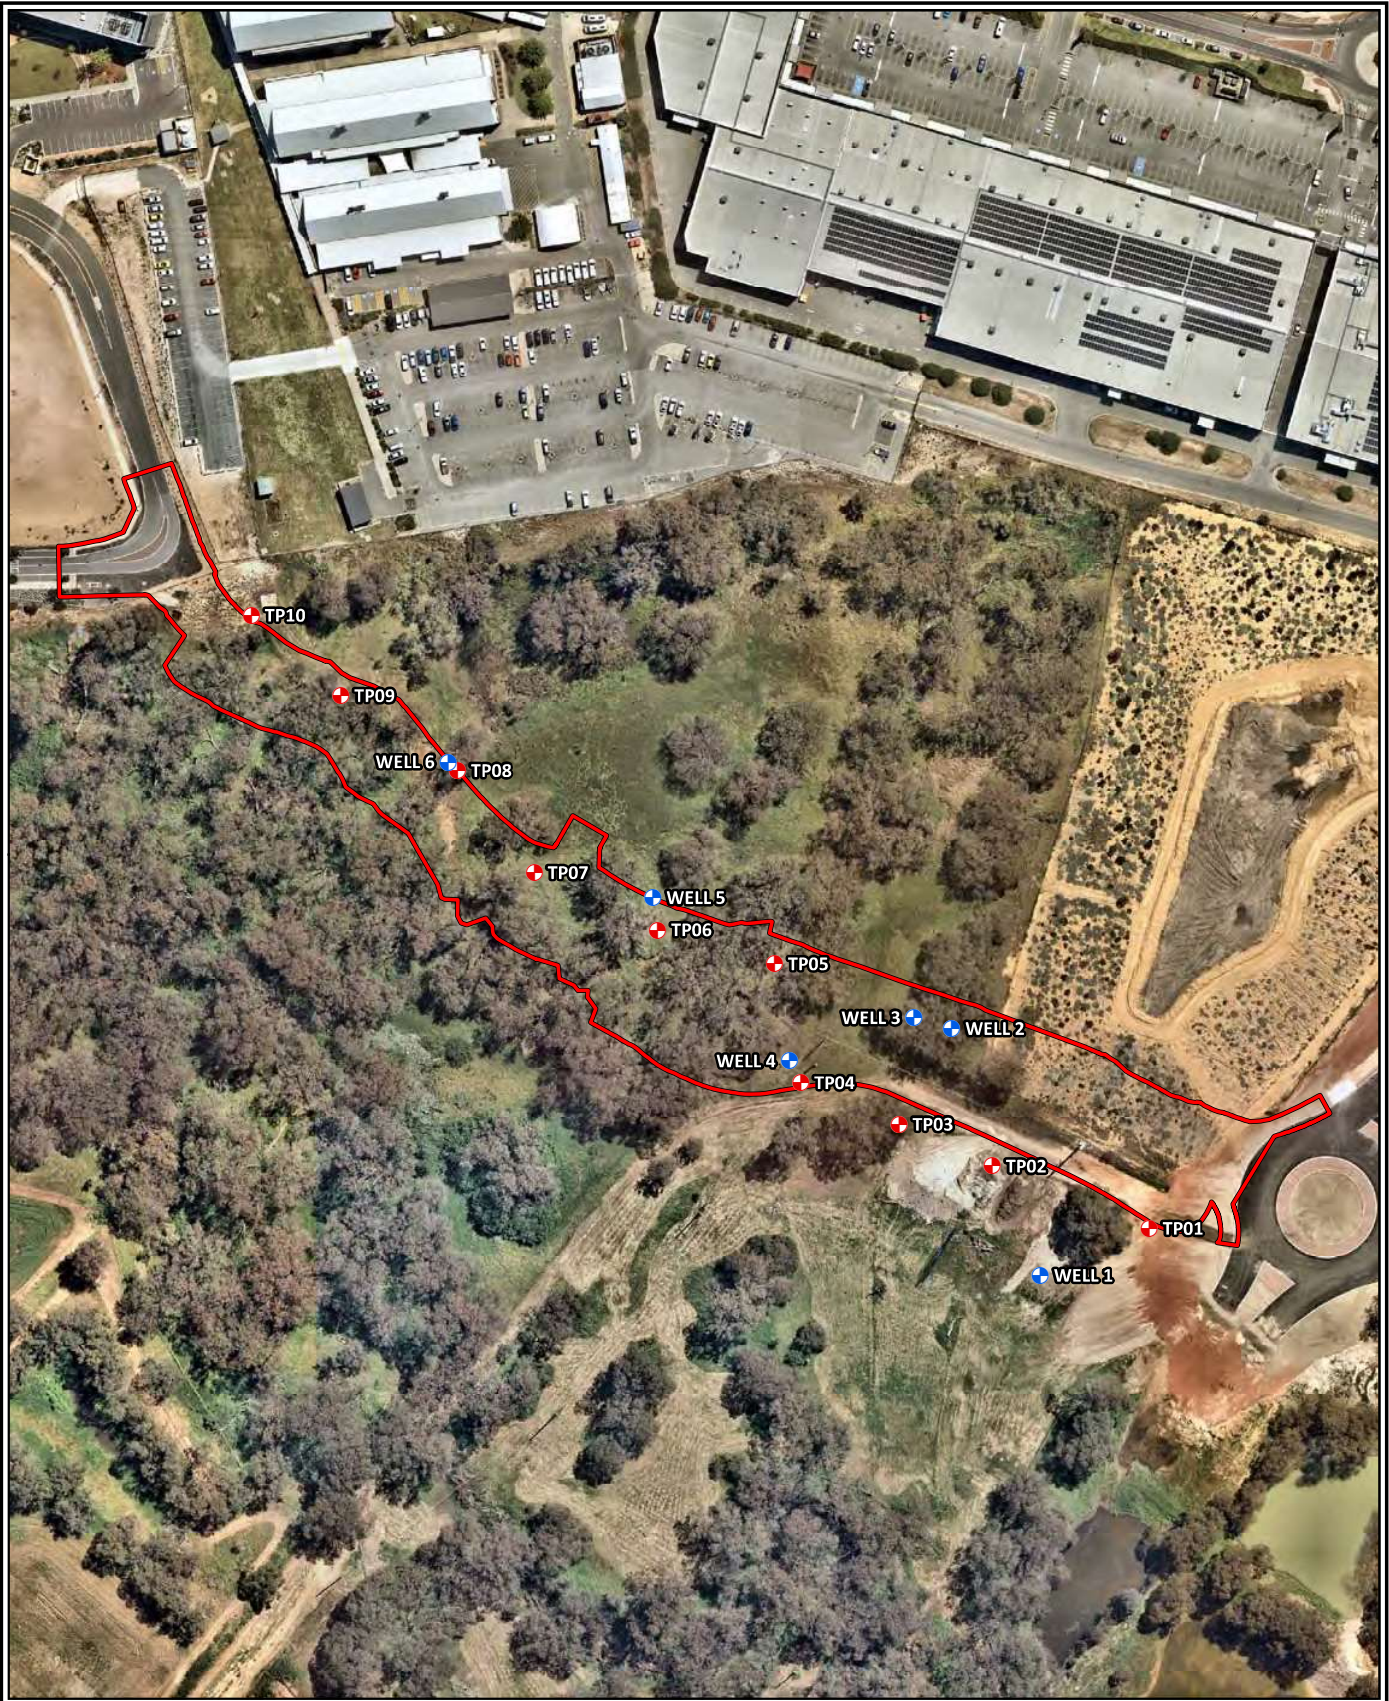
Strategen-JBS&G inspected the test pits for the presence of ACM fragments in accordance with the methodology outlined in Department of Health (DoH 2009). Minor amounts of ACM were identified in the soil stockpiles south of the proposed road alignment opposite the Western paddock (see test pit location TP02). 10L samples of soil were collected and sieved at test pit locations TP01 and TP02 (Figure 7).

- Project area
- + Monitoring well
- + Test pit

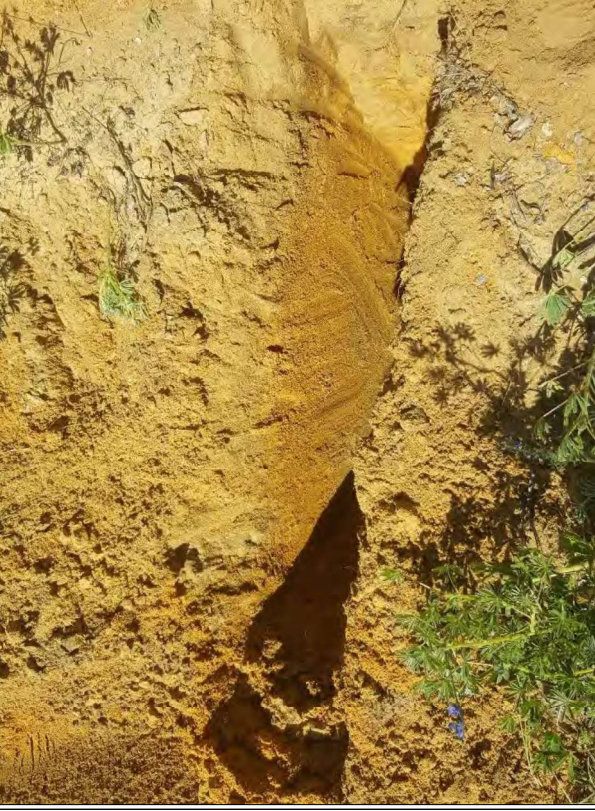
ASBESTOS IMPACTED SOIL STOCKPILE NEAR TP02

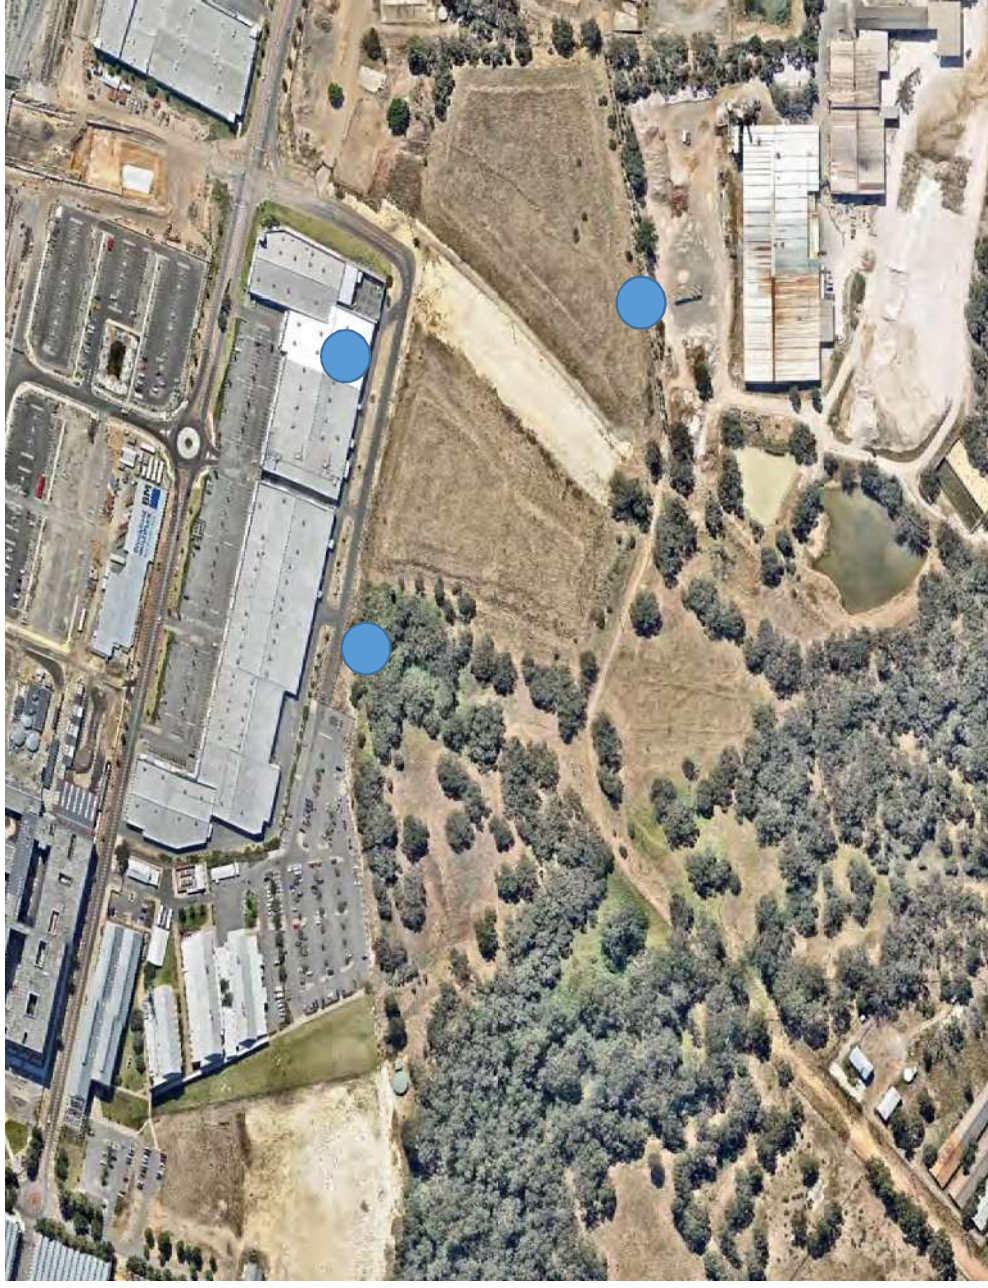
Asbestos and PM₁₀ Monitoring Location
