Application for a Native Vegetation Clearing Permit for Golden Hind, Hornet and Pegasus Projects

Evolution Mining (Evolution) is proposing to commence mining of the Golden Hind, Hornet and Pegasus deposits as part of the existing Mungari Gold Operations (MGO).

The total disturbance envelope comprises land within mining tenements M15/669, M15/993 and M16/309 and miscellaneous tenement L16/104. This application proposes a total allowable clearing area of **650 ha**.

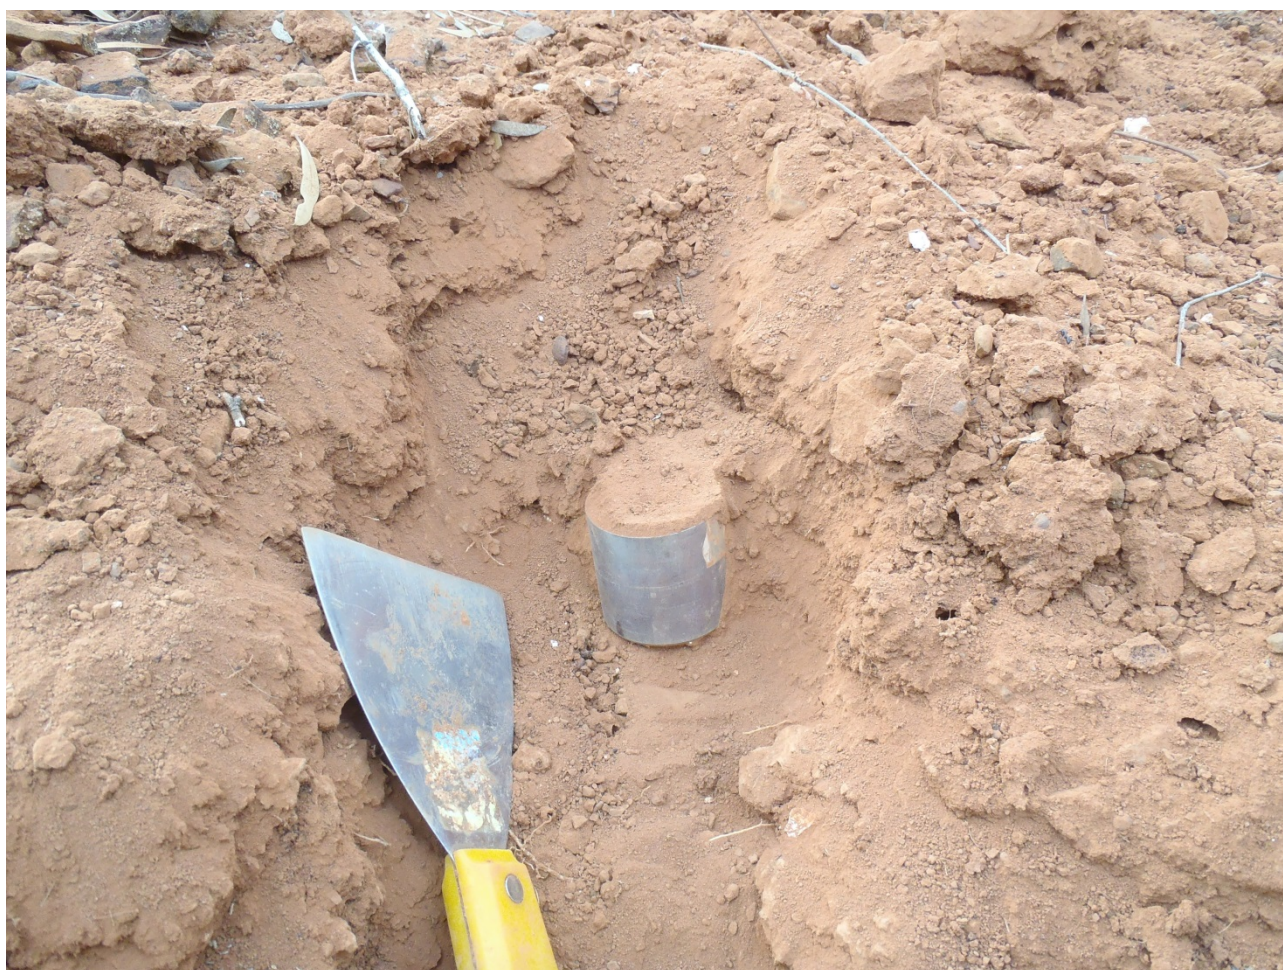
Plate 3.1: Collection of *in situ* soil profile cores in the field.

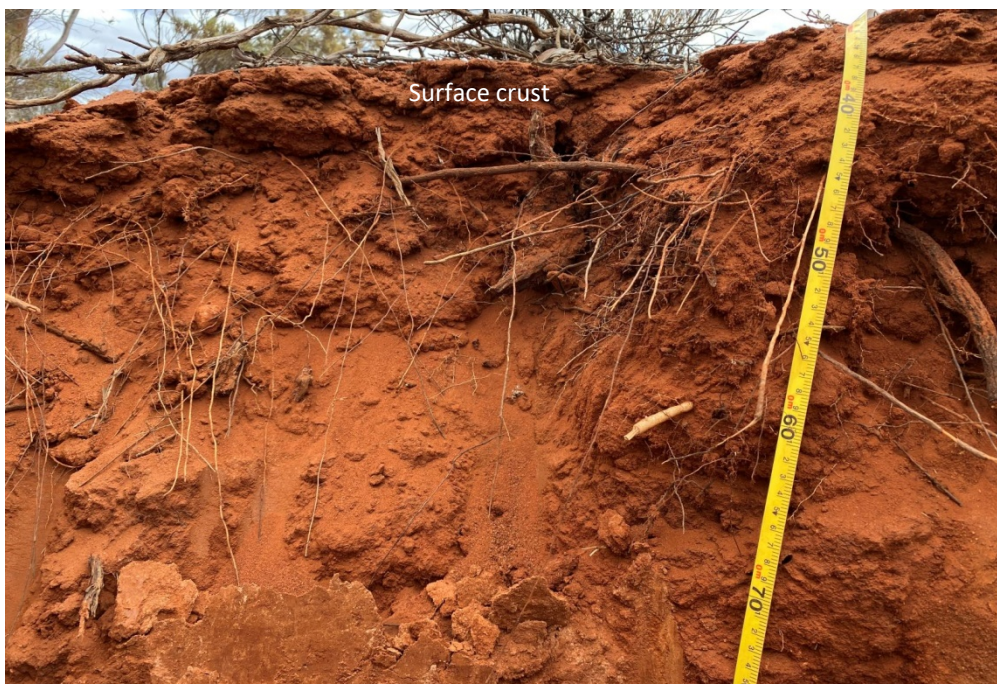
Plate 4.1: Surface crust and abrupt boundary between surface sand and underlying loam

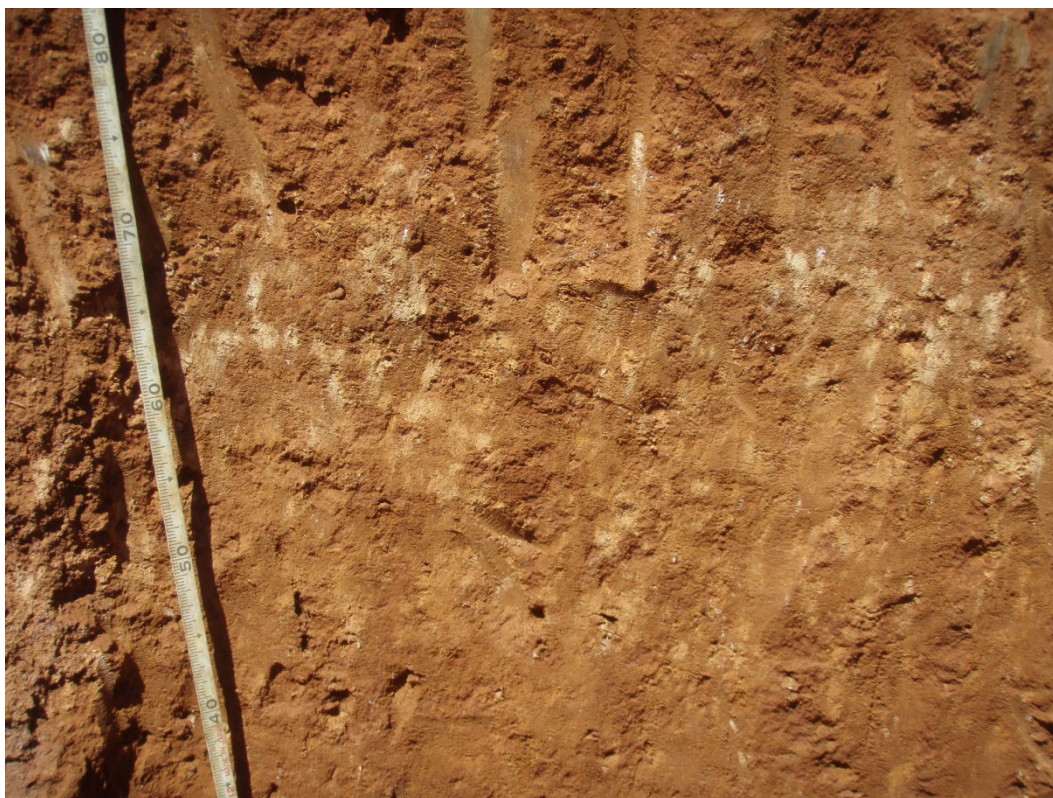
Plate 4.2: Calcareous nodules formed in the lower profile.

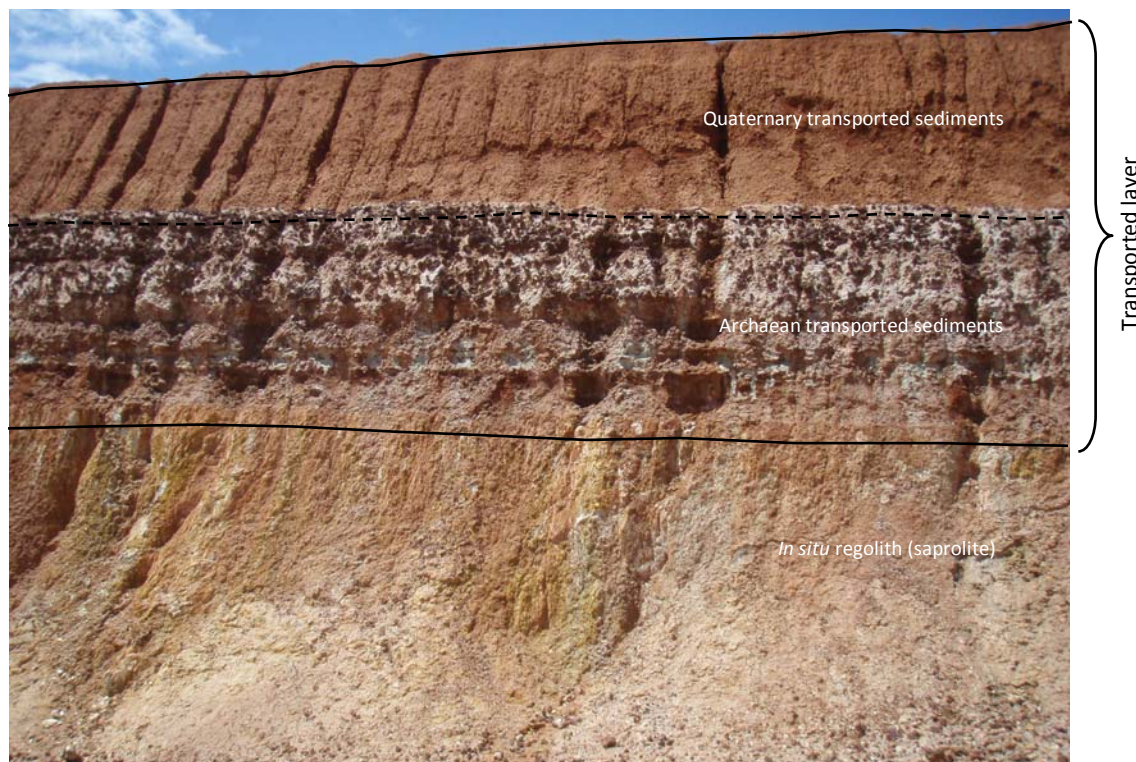
Plate 2.1: Transported alluvial cover overlying saprolite at the adjacent Rubicon minepit. The upper surficial soil profile at the Hornet deposit is likely to be similar to that observed in the Rubicon minepit given its close proximity.

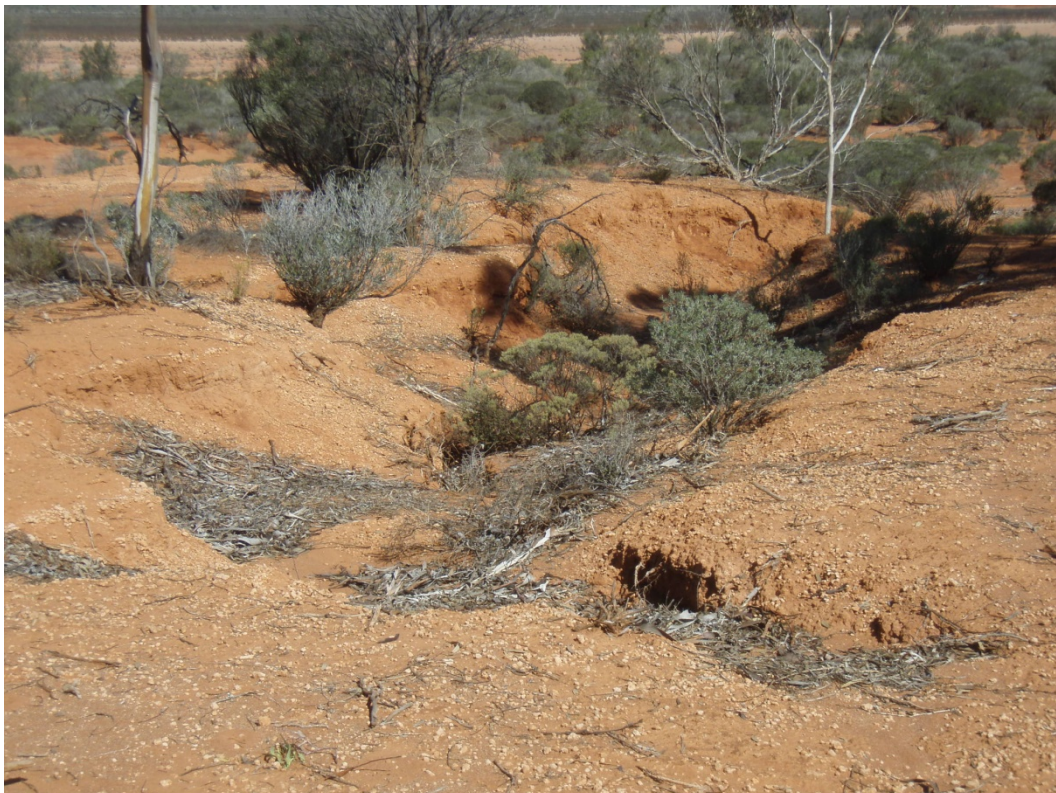
Plate 4.13: Etching and subsequent formation of large gullies through the accumulation of surface water.

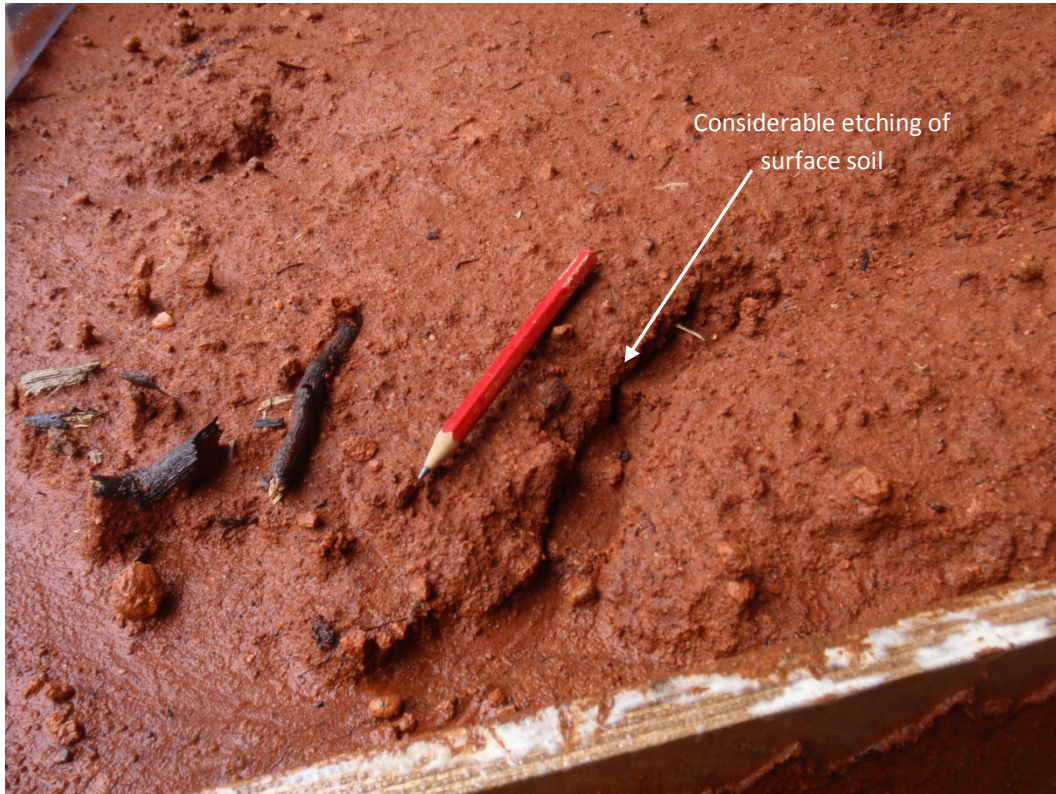
Plate 4.16: Response of the Hornet surface to applied rainfall at a slope angle of 15°.

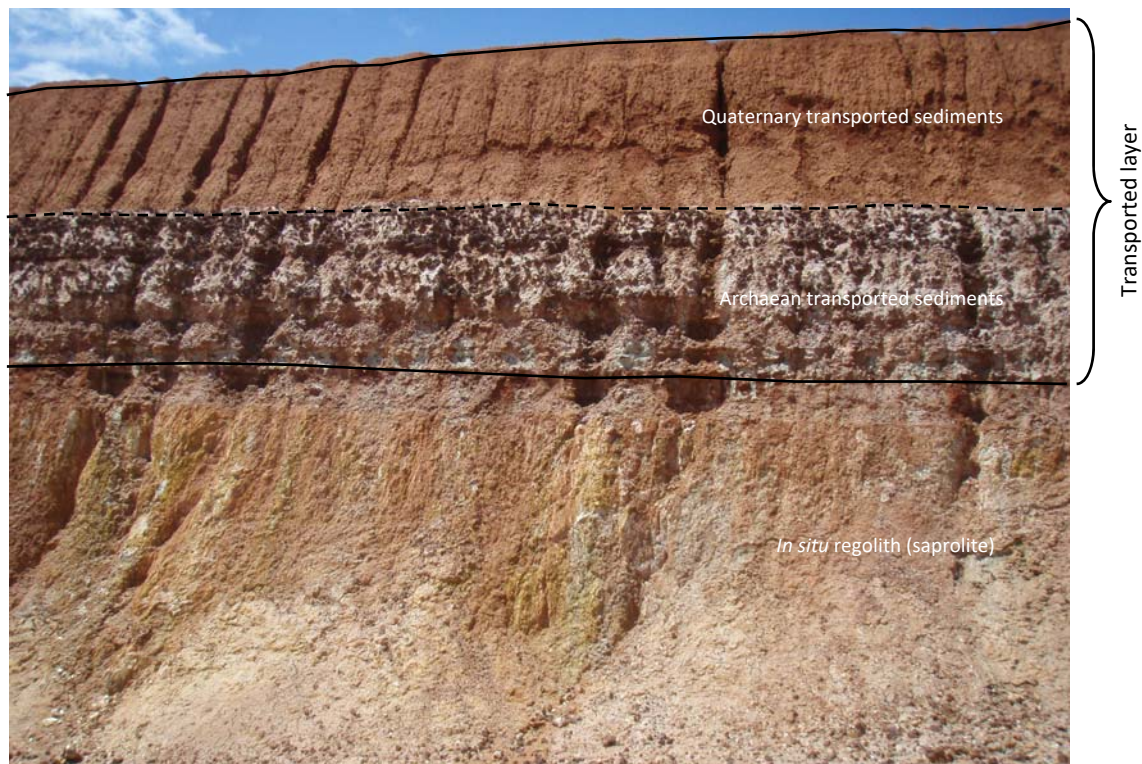
Plate 2.1: Transported alluvial cover overlying saprolite at the adjacent Rubicon mine pit. The upper surficial soil profile at the Pegasus Deposit is likely to be similar to that observed in the Rubicon mine pit given its close proximity.

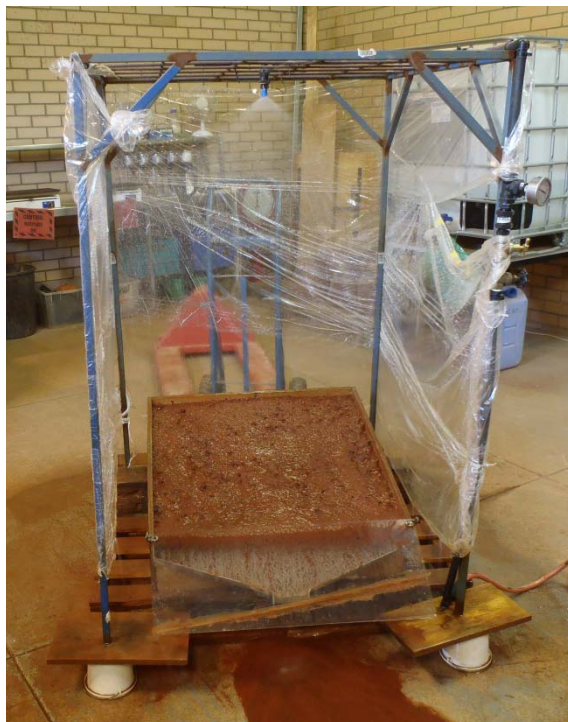
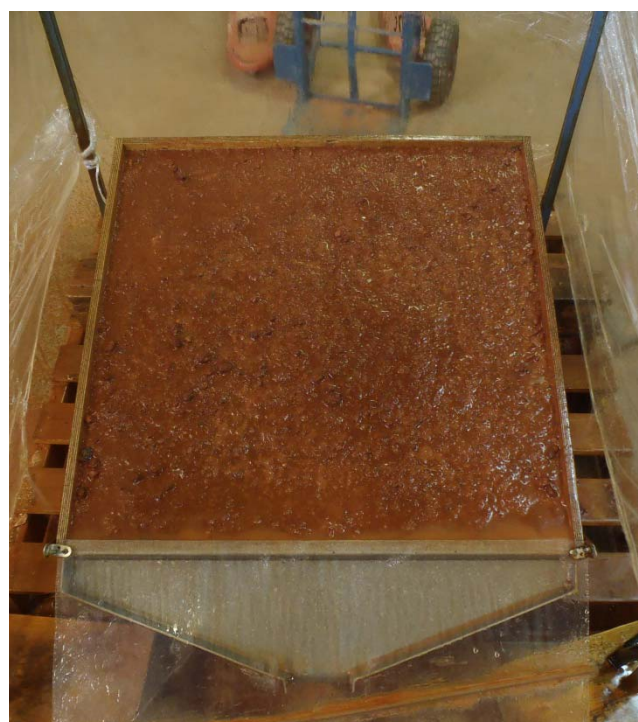
Plate 3.3: Laboratory rainfall simulator.

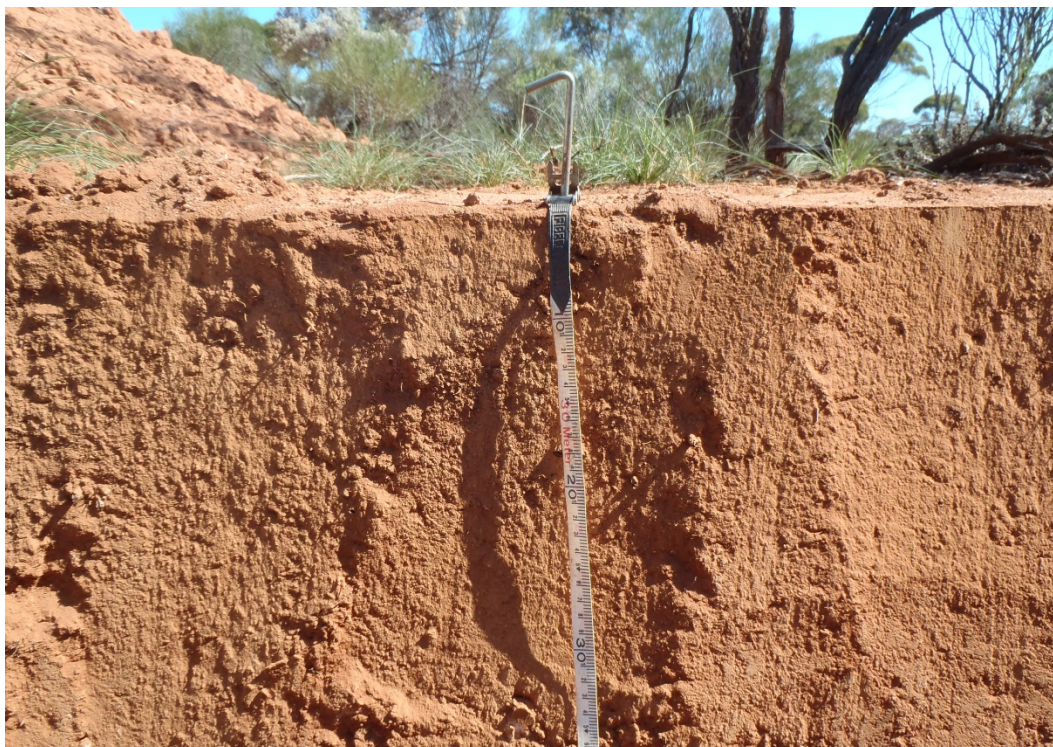
Plate 4.1: Poor topsoil development across the Project Area.

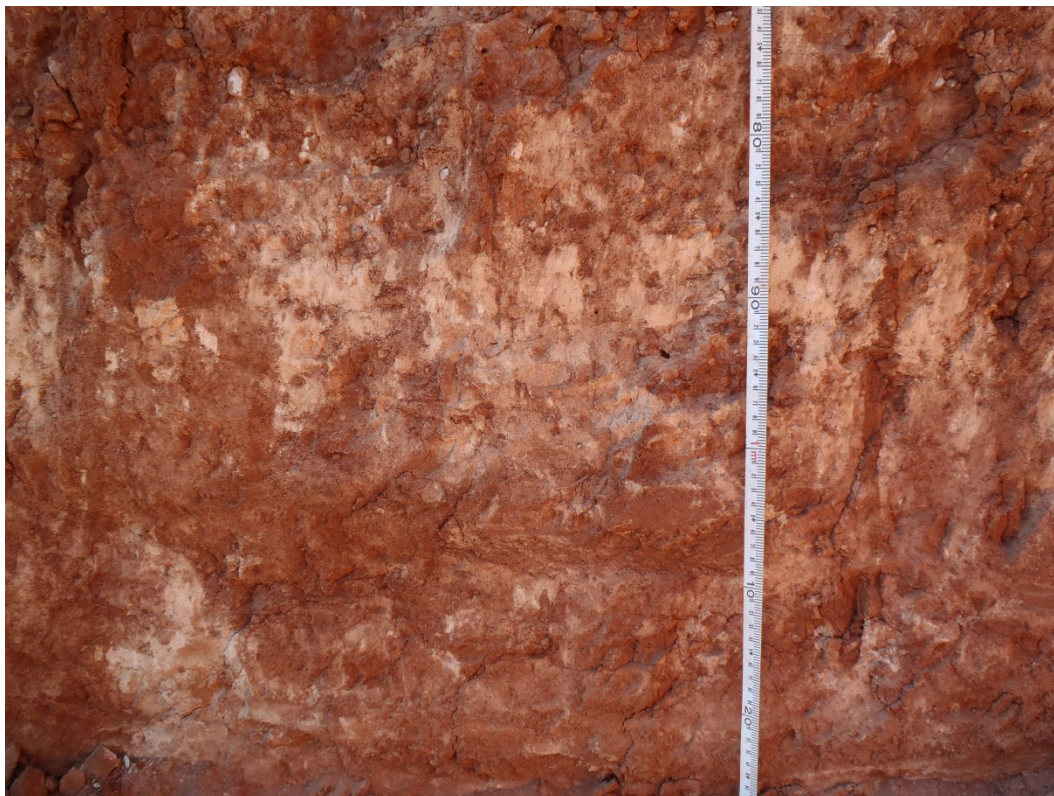
Plate 4.2: Calcareous mottling occurring at 40 – 70 cm due to evaporation concentration of soluble salts.

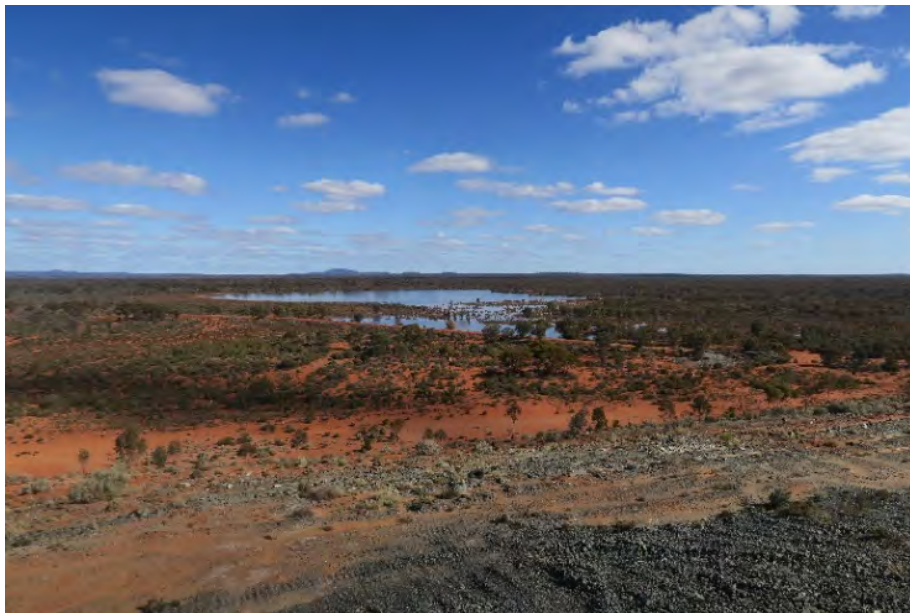
Initially, flows in excess of the dam storage capacity mainly bypassed the dam and continued into Kopai Lake. Only a portion of the flood flows overspilled through the Kundana area. After breaching in 1992 floods, the dam was repaired and slightly raised, blocking a greater proportion of flow, and diverting it via natural flood overflow routes through the Kundana mine area – protection levees were required to be put in place to protect the mine site. The largest flood flows mostly drain to Kopai Lake.

Picture 1 - View of Bullock Hole Dam from Raleigh Waste Dump

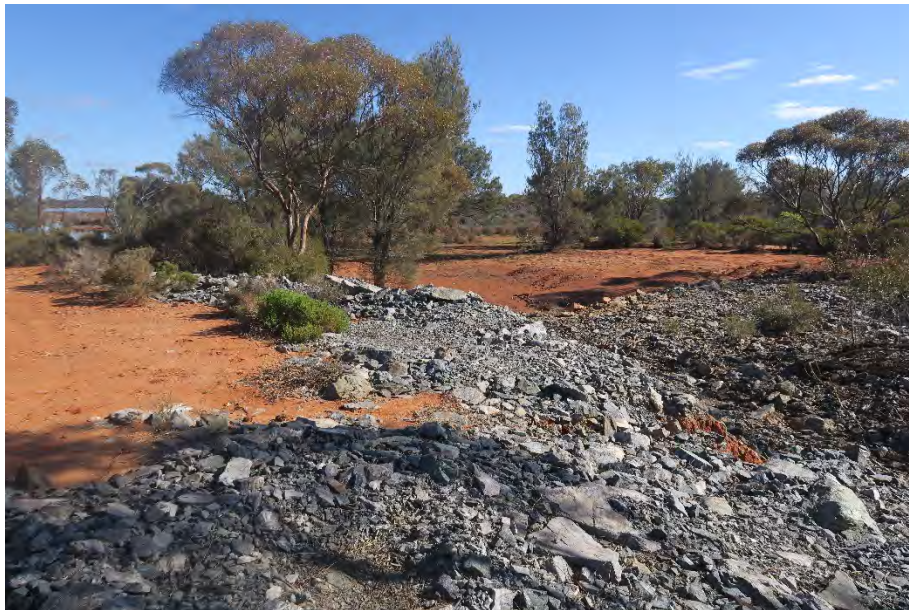
- Bullock Hole Dam blocks off the flow and directs it through the mine. A rock lined overflow on the northern side of the dam allows some flow through during higher flood events (i.e. greater than 10-year). The Raleigh and Moonbeam Pits are located on higher ground to the east of Bullock Hole Dam, and are protected from flooding by the Raleigh Waste Dump

Picture 2 - Bullock Hole Dam Overflow Channel

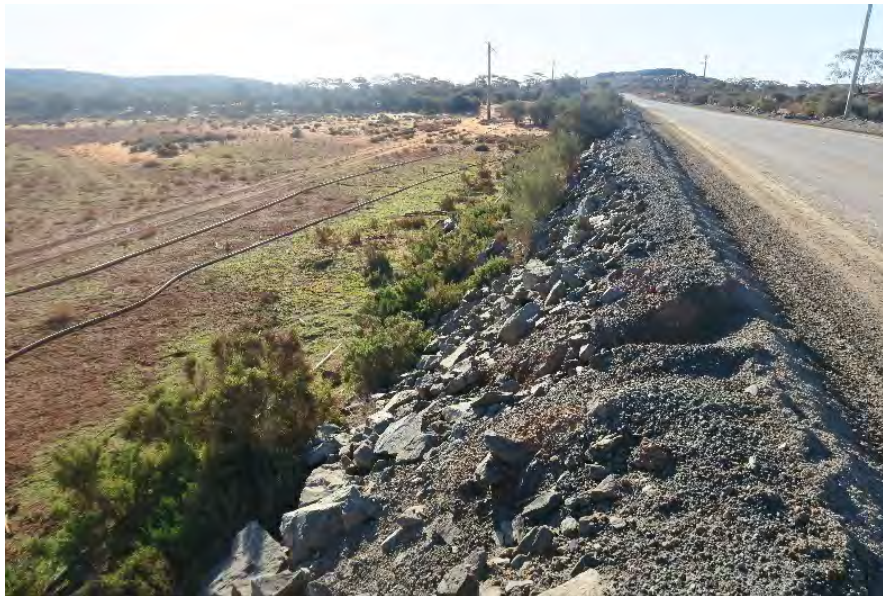
The mine site access causeway runs across Kopai Lake (refer Figure C) and is susceptible to flooding during larger rainfall events. The effect of Bullock Hole Dam on Kopai Lake flood levels has been investigated by modelling the site with and without the dam in place as shown in Table 1 below.

Picture 4 - Causeway across Kopai Lake
