# Clearing Permit

## Coronation Road

### SLK 11.47 to 11.62

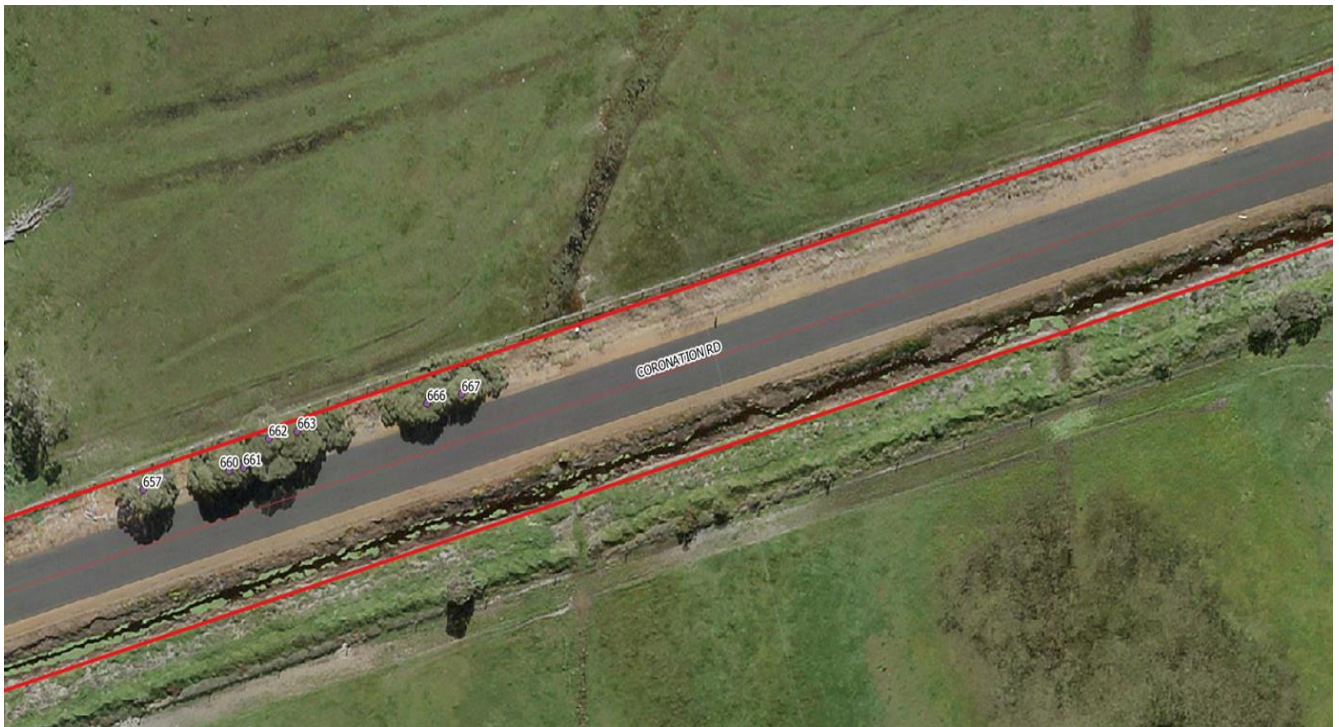
*\* The Map above shows Coronation Road running in an East/ West direction, with the nearest crossroad being Coles Road.*

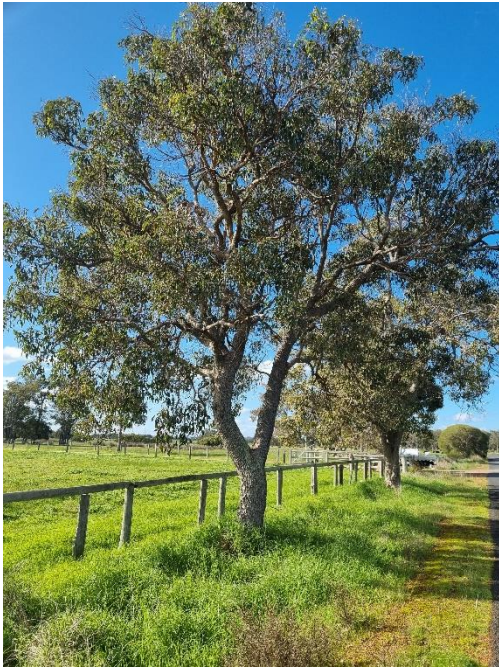
Tree ID	Description	Trunk (m)	Canopy (m)	Pruning/ Removal	Observations
305	<i>Corymbia Calophylla</i>	1.48	8	Removal	No visible signs of nesting or hollows.

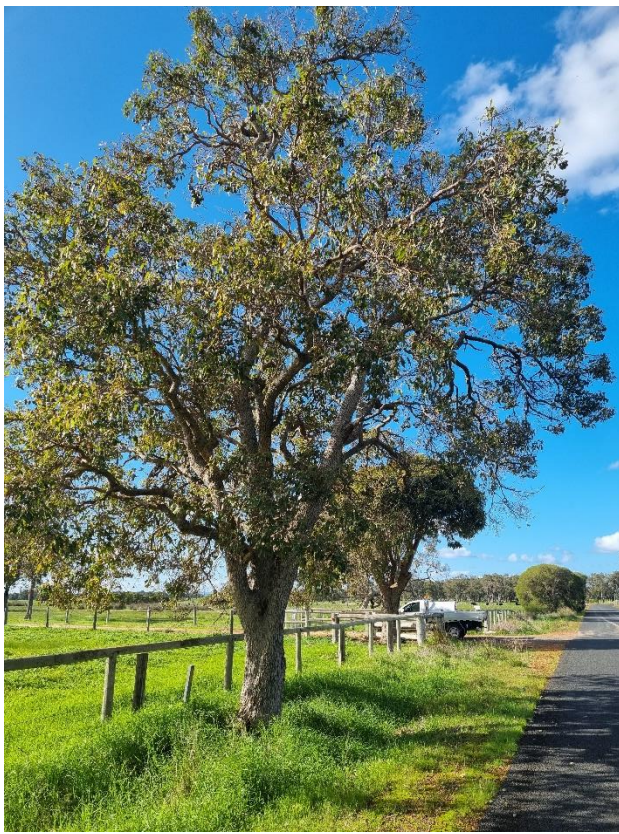
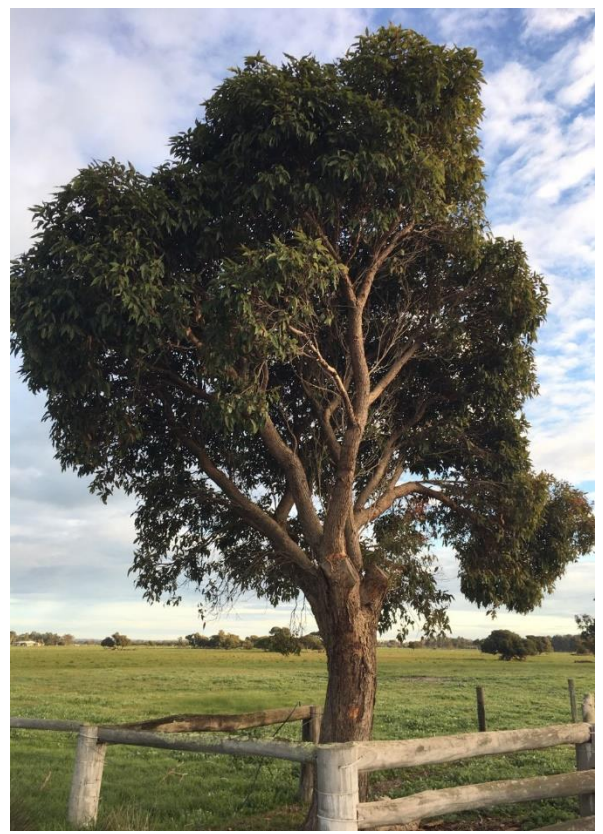
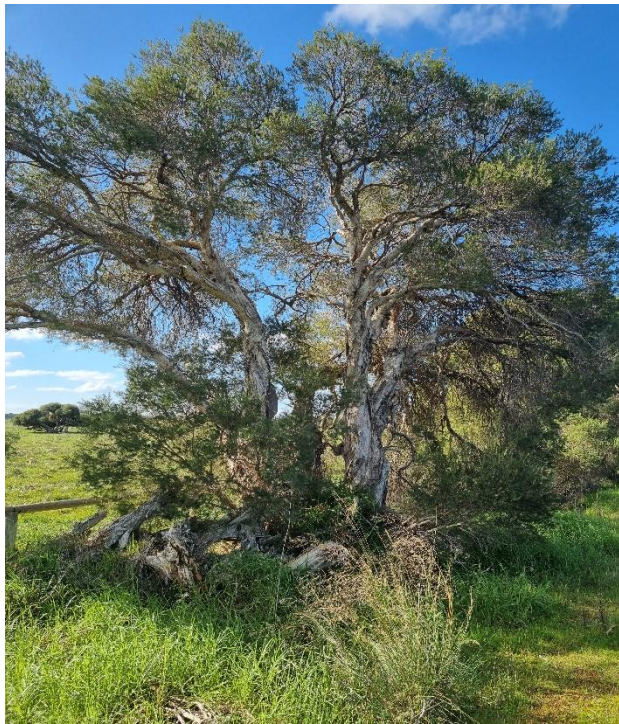
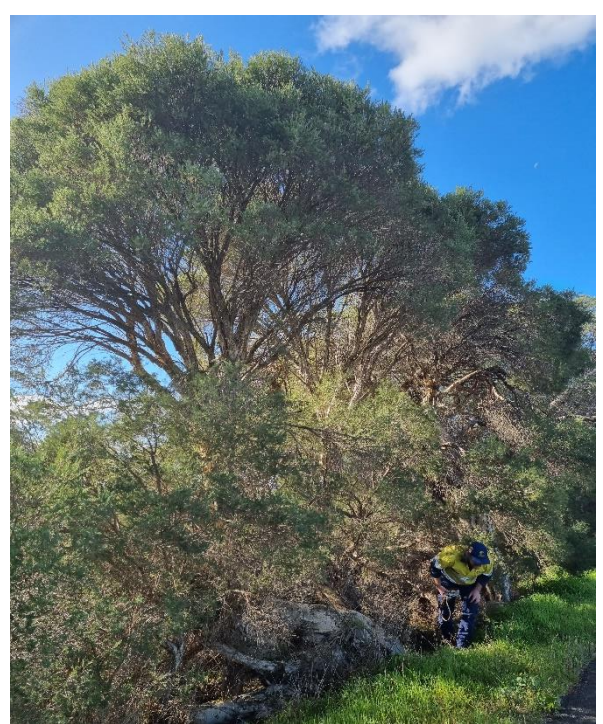
Tree ID	Description	Trunk (m)	Canopy (m)	Pruning/ Removal	Observations
304	<i>Corymbia Calophylla</i>	1.9	9	Removal	No visible signs of nesting or hollows.
N/A	<i>Corymbia Calophylla</i>	1.8	9	Removal	No visible signs of nesting or hollows. Within 1184 Coronation Road
657	<i>Melaleuca Raphiophylla</i>	3m	4	Removal	No Visible signs of nesting or hollows.
660	<i>Melaleuca Raphiophylla</i>	3.5m	6	Removal	No Visible signs of nesting or hollows.

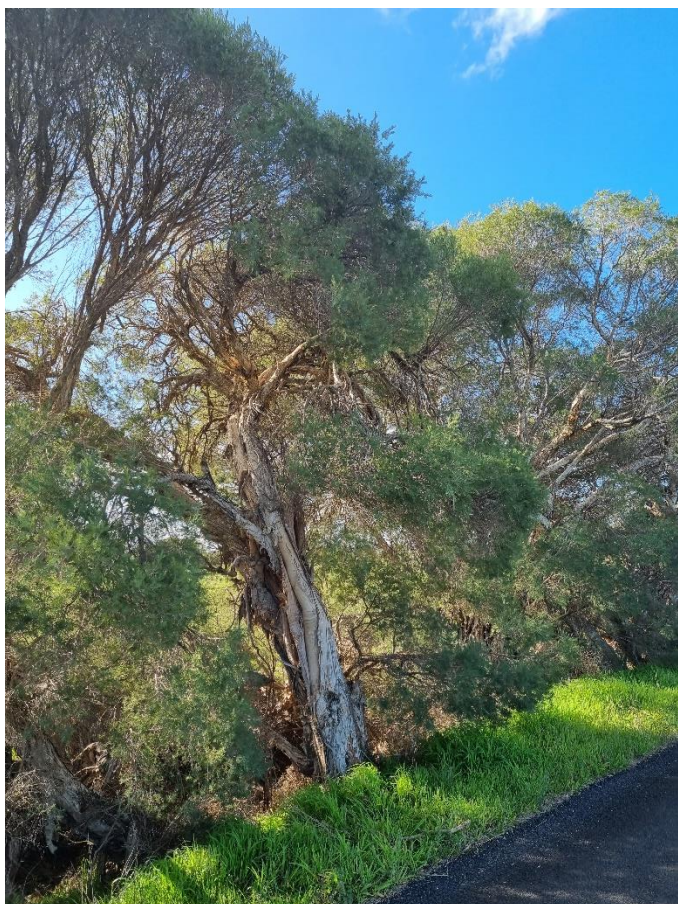
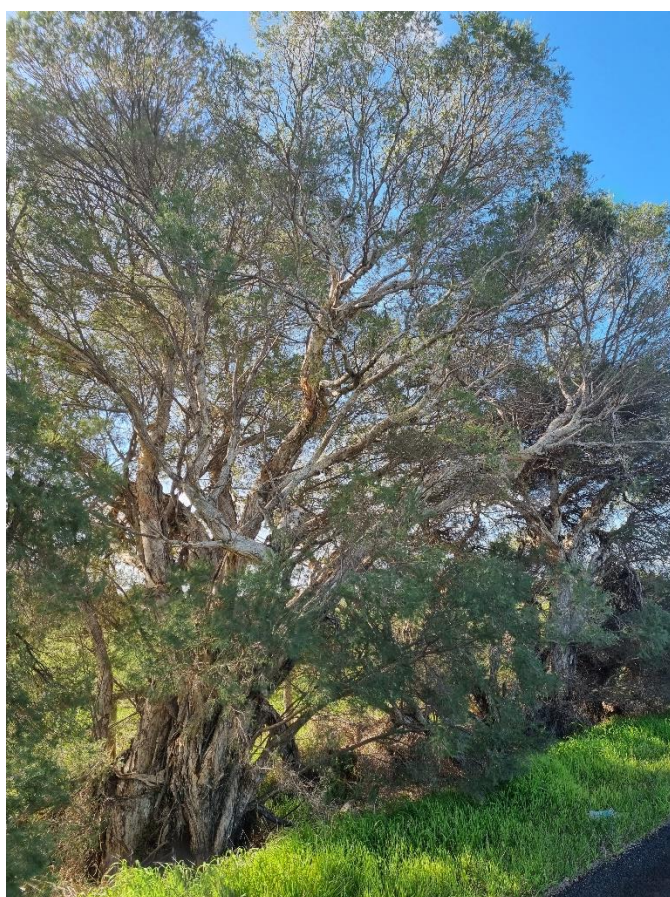
Tree ID	Description	Trunk (m)	Canopy (m)	Pruning/ Removal	Observations
661	<i>Melaleuca Raphiophylla</i>	3	6	Removal	No visible signs of nesting or hollows.
662	<i>Melaleuca Raphiophylla</i>	1.3	5	Removal	No visible signs of nesting or hollows.

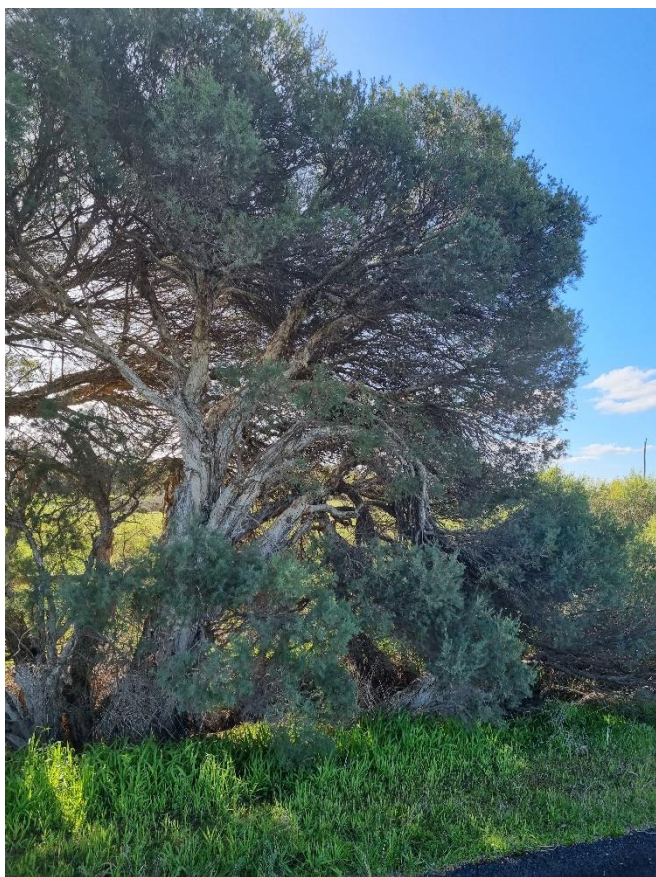
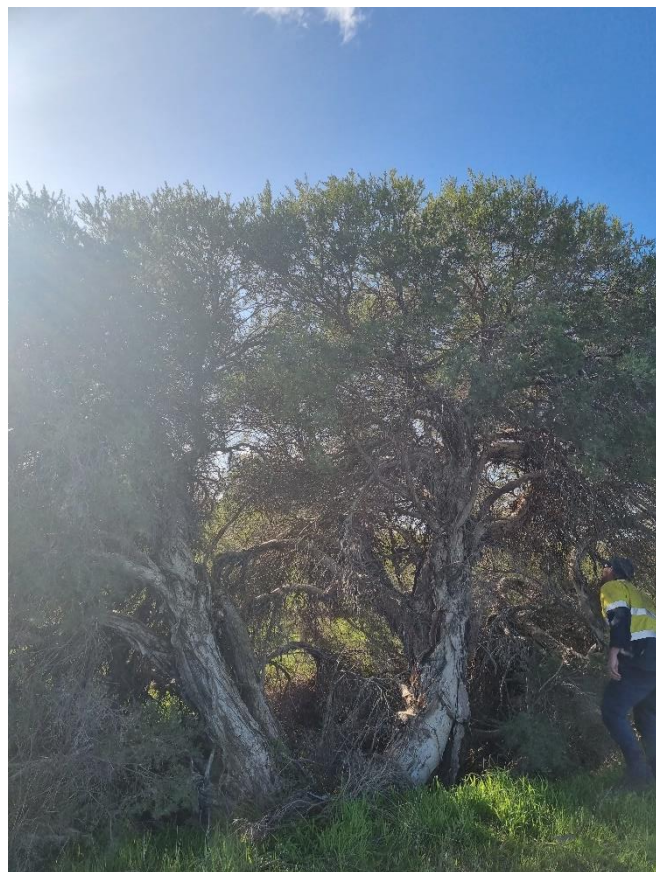
Tree ID	Description	Trunk (m)	Canopy (m)	Pruning/ Removal	Observations
663	<i>Melaleuca Raphiophylla</i>	1.6	7	Removal	No visible signs of nesting or hollows.
666	<i>Melaleuca Raphiophylla</i>	1.4	5.5	Removal	No visible signs of nesting or hollows.

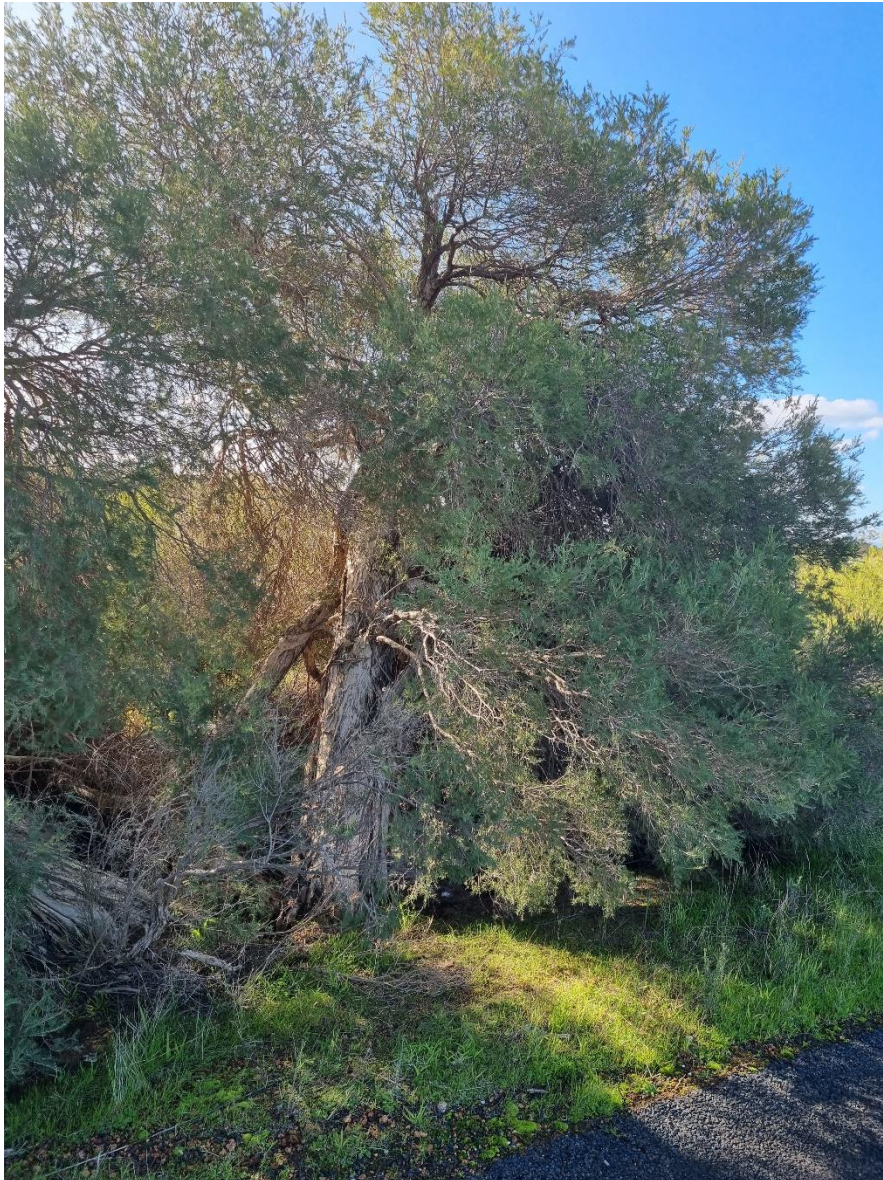
Tree ID	Description	Trunk (m)	Canopy (m)	Pruning/ Removal	Observations
667	Melaleuca Raphiophylla	1.5	5	Removal	No visible signs of nesting or hollows.
