MCPL Reference: MHE2101/026/21

IMPACT FOOTPRINT ASSESSMENT, FLAT ROCKS WIND FARM, KOJONUP WA.

Appendix A: Photographic Record of Proposed Flat Rocks Wind Farm Turbine Cable Impacts, March 2022

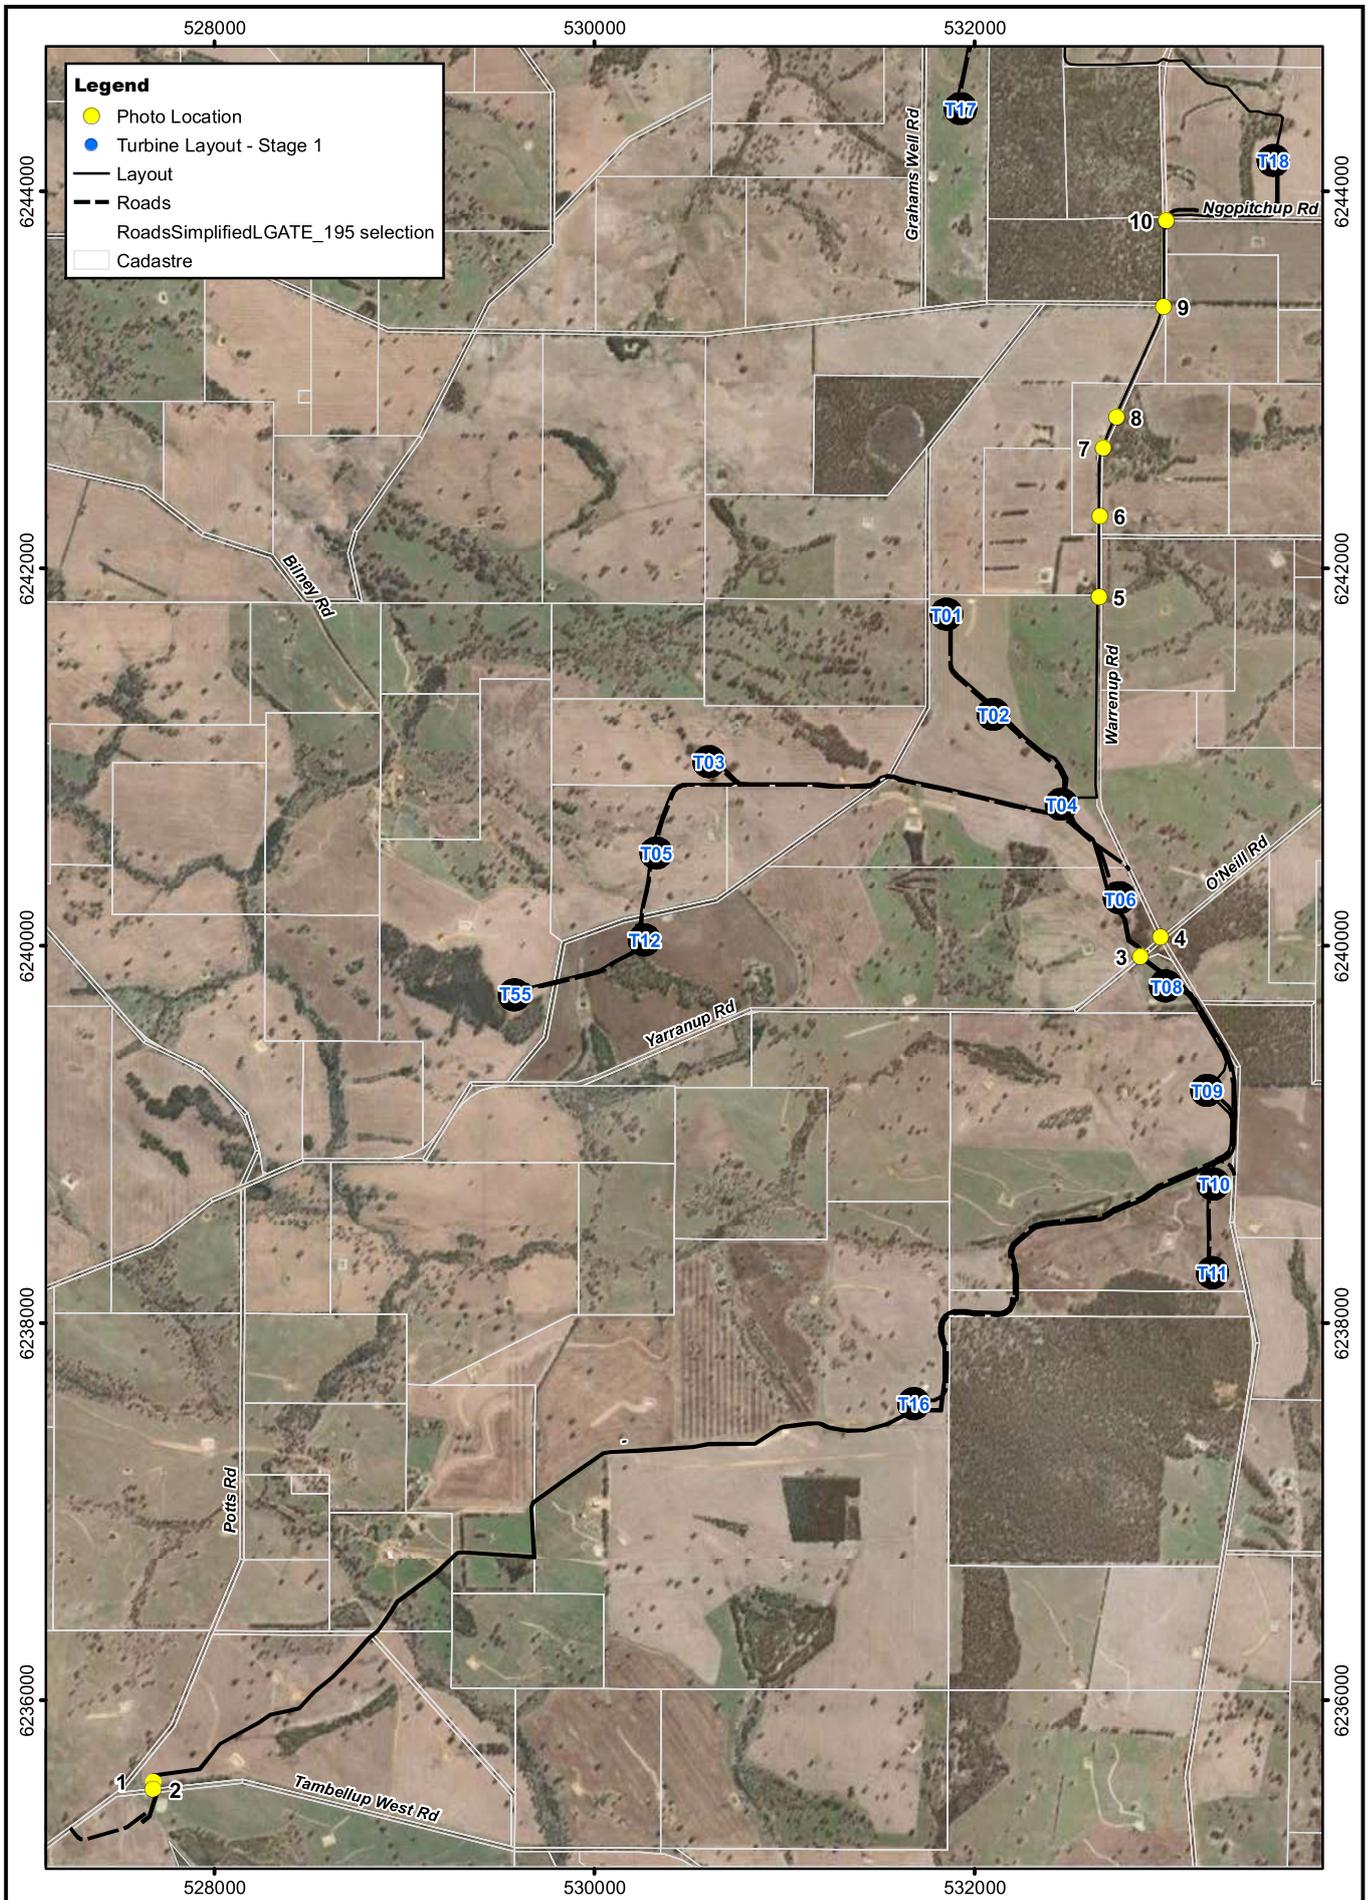
Moonies Hill Energy Pty Ltd
Photo Locations

Figure 1: Overview of Proposed alignment with Photo Location Point (1 to 10 inclusive)

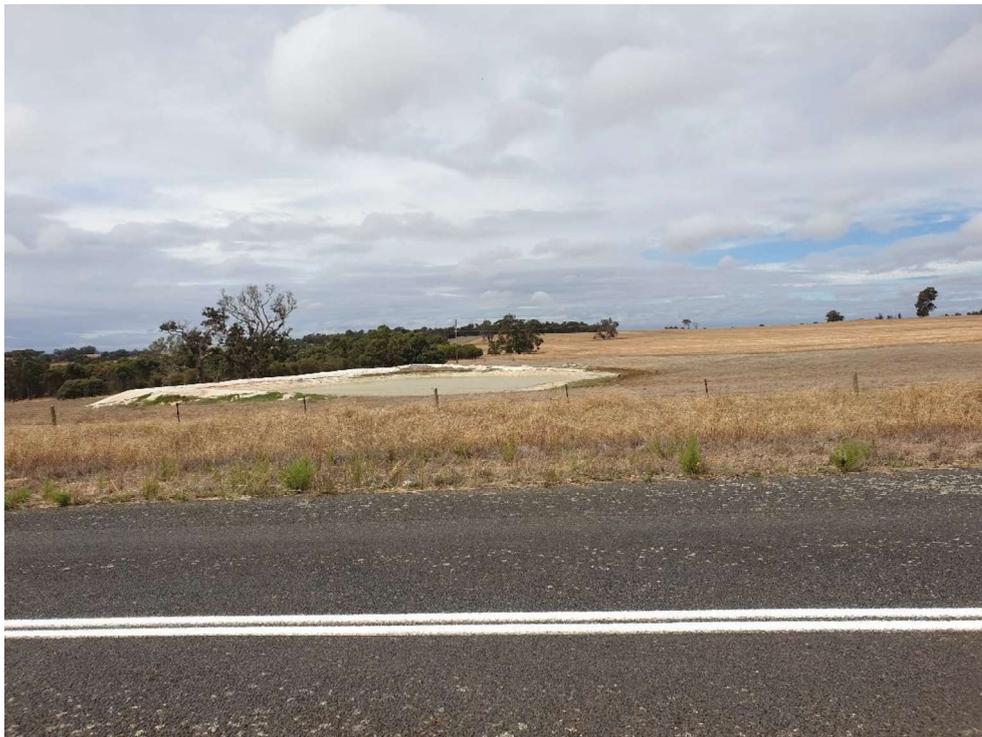
Photo 1 Location 1: Looking south at crossing of cable of West Tambellup Road to Substation. Note only introduced grasses and **Dittrichia graveolens* (Stinkwort) and cleared paddocks south of road.

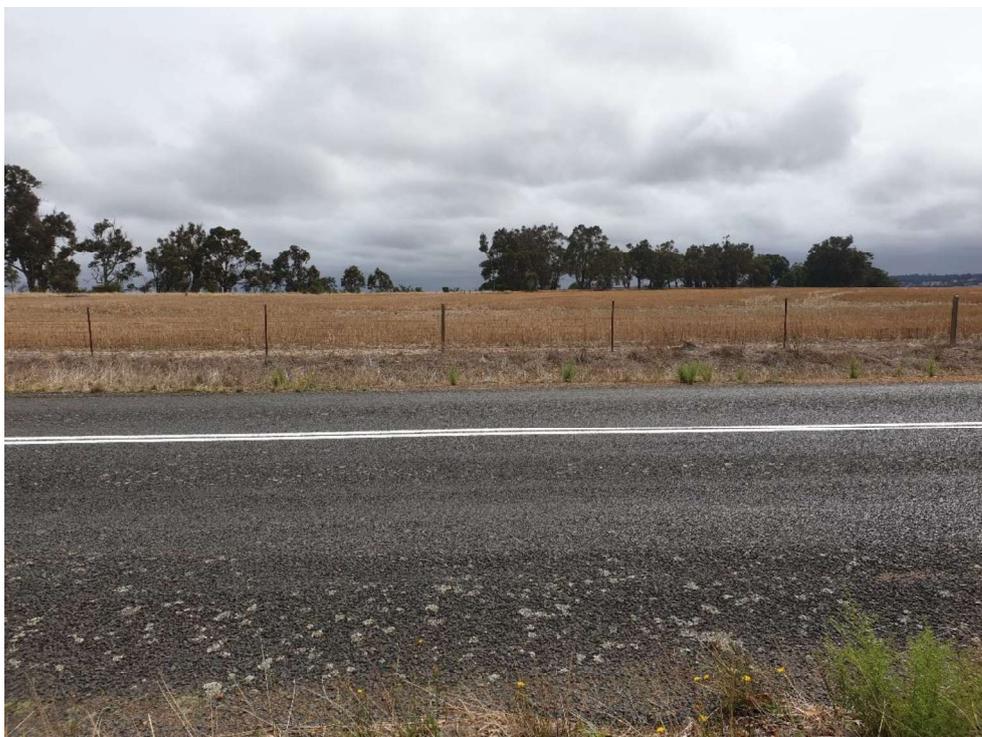
Photo 2 Location 2: Looking south at crossing of cable of West Tambellup Road to Substation. Note only introduced grasses and **Dittrichia graveolens* (Stinkwort) and cleared paddocks south of road.

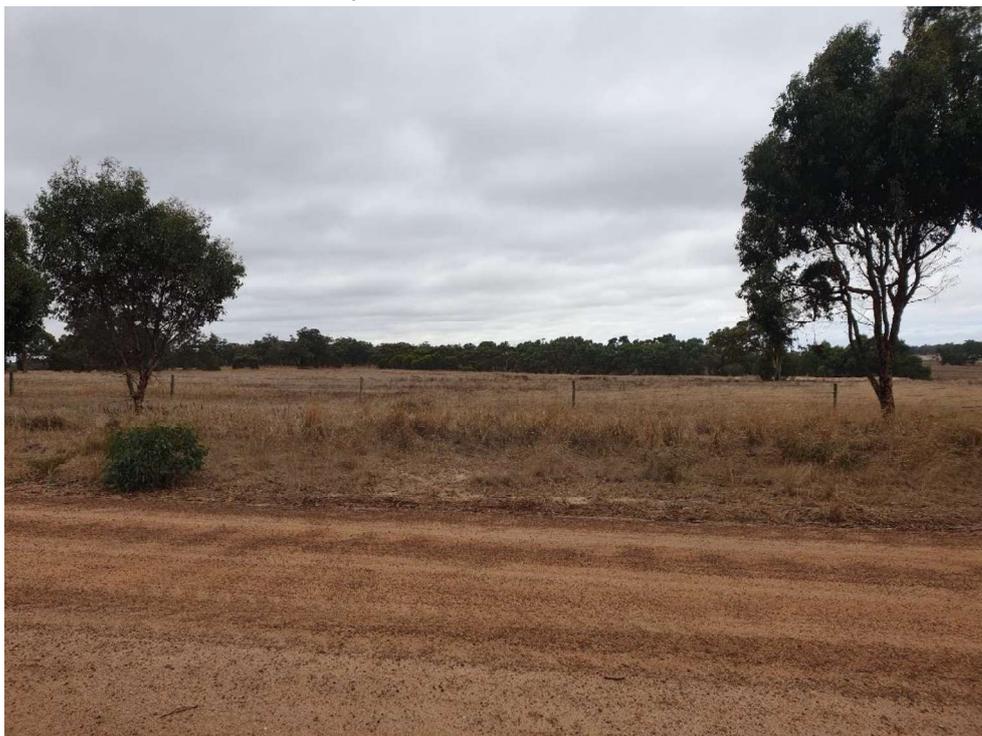
Photo 3 Location 3: Looking southeast at crossing of Yarranup Road. Note only introduced grasses and occasional *Acacia pulchella* and cleared paddocks south of road. Crossing of cable as proposed avoids the Wandoo (*Eucalyptus wandoo*) trees.

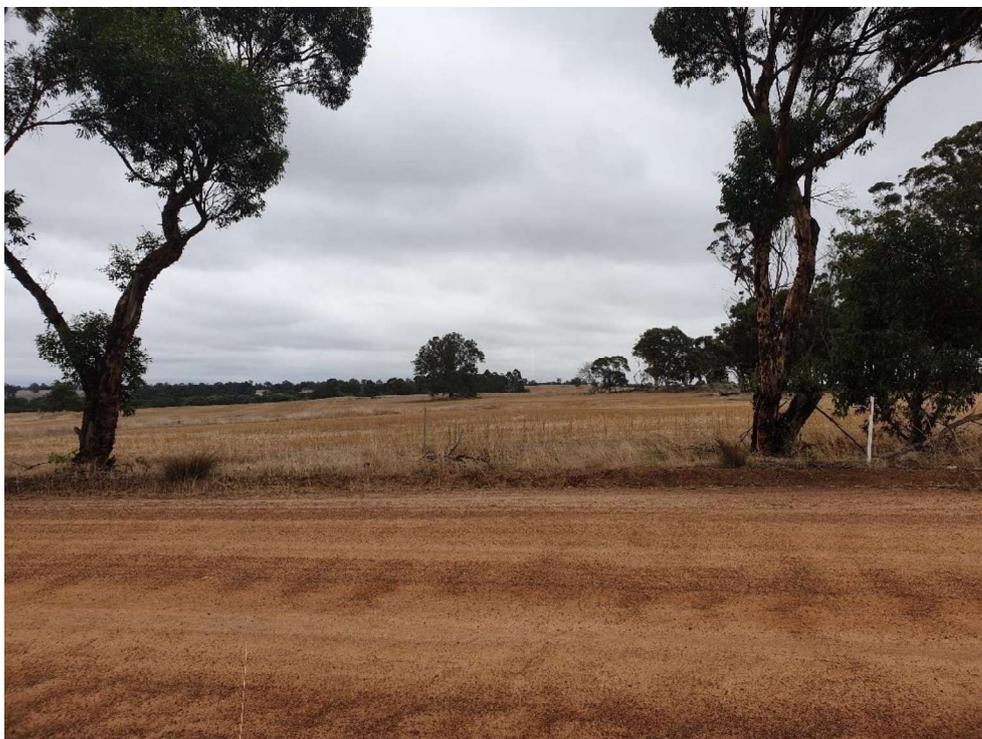
Photo 4 Location 3: Looking northwards at crossing of Yarranup Road. Note only introduced grasses and cleared paddocks north of road. Crossing of cable as proposed avoids the Wandoo (*Eucalyptus wandoo*) trees which occur as isolated trees on narrow road verge.

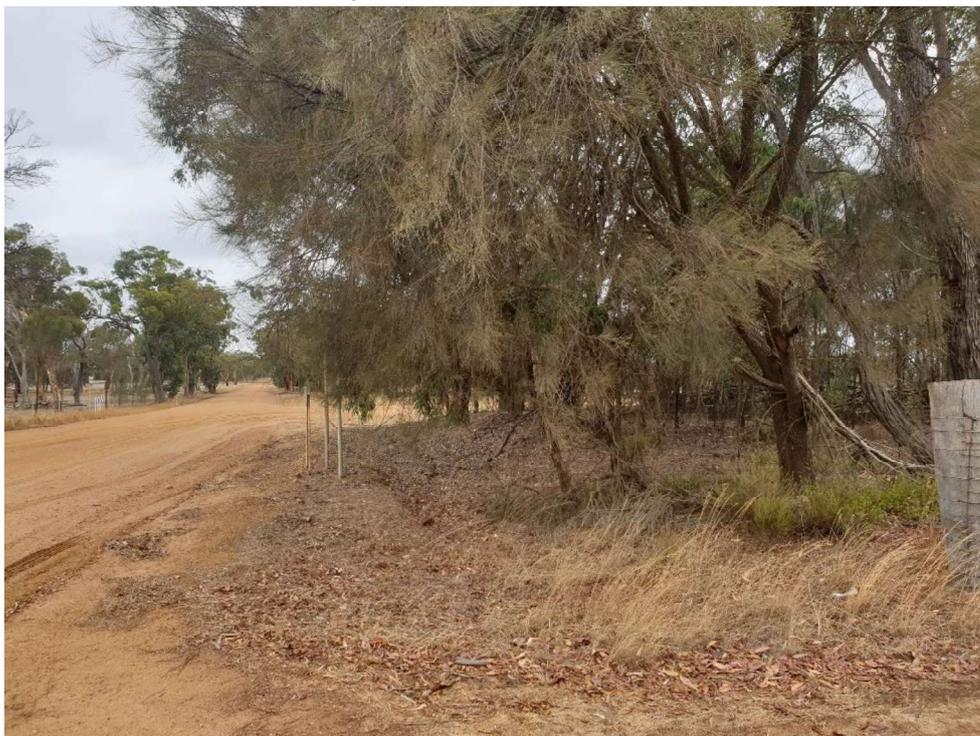
Photo 5 Location 4: Near Corner of Yarranup Road and Warrenup Road looking east along Yarranup road past cross intersection. Note only introduced grasses and cleared paddocks north of road. Stand of mixed aged Sheoak (so preference to cut across paddock south of this site where less vegetation). Suggested to avoid stands and head through paddock between T08 and T06 within cleared paddocks.

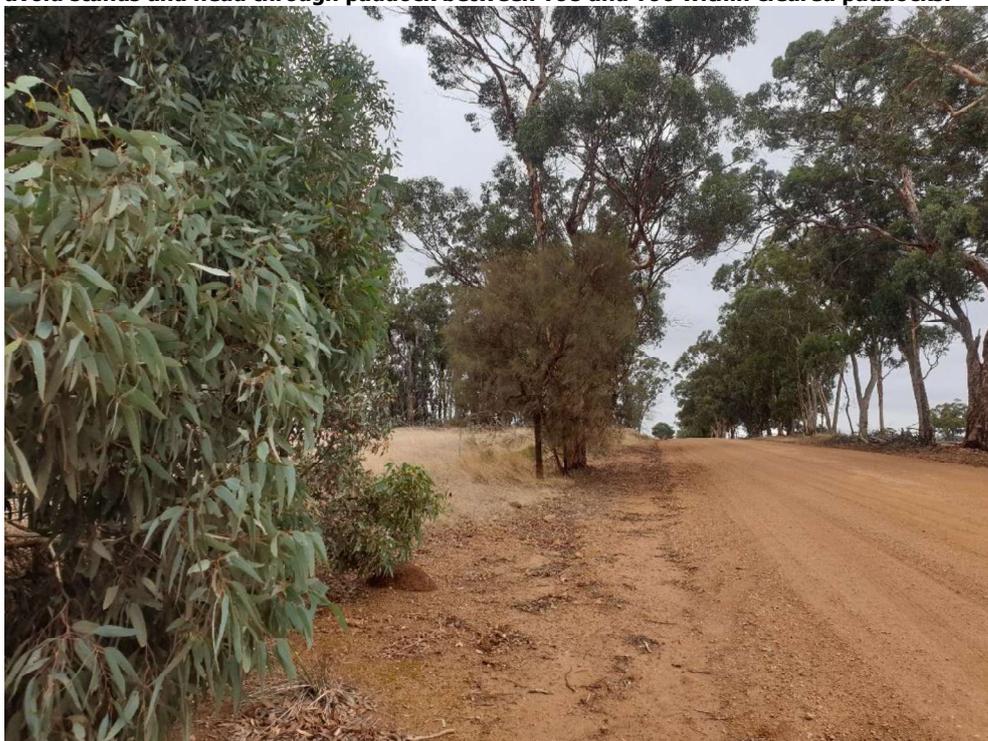
Photo 6 Location 4: Near Corner of Yarranup Road and Warrenup Road looking north along Warrenup Road with narrow stands of Eucalyptus wandoo and occasional Sheoak (near gravel pit and cleared paddocks). Note only introduced grasses and cleared paddocks north of road. Suggested to avoid stands and head through paddock between T08 and T06 within cleared paddocks.

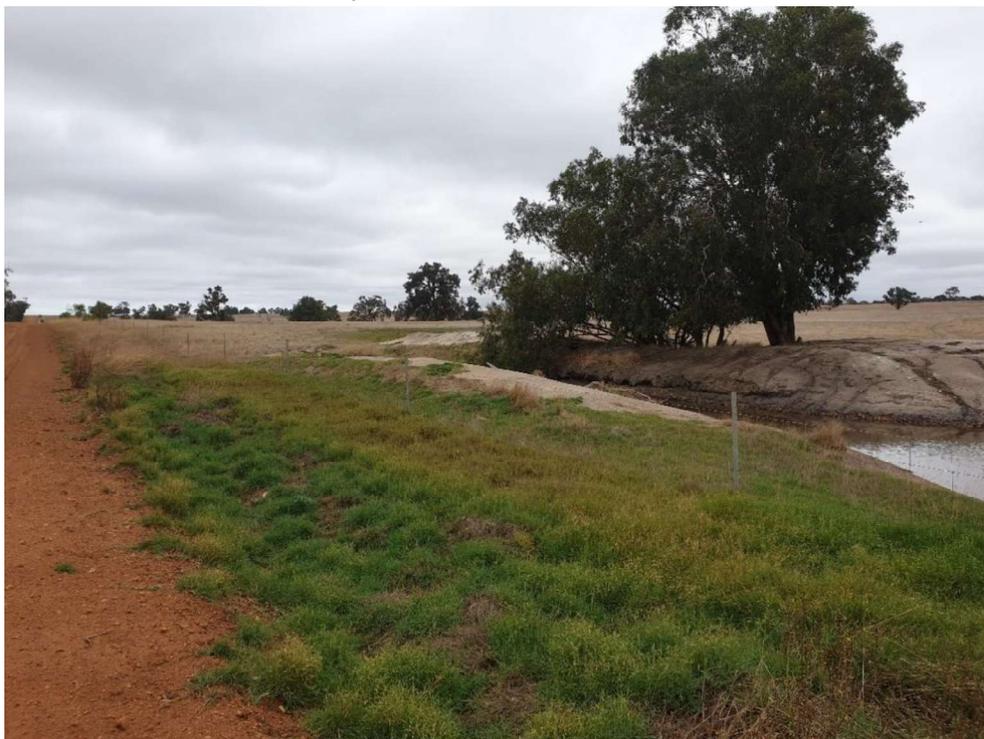
Photo 7 Location 5: Near Dam to west of Warrenup Road on western road verge (looking south) as less vegetation between Locations 5 and 6, only occasional Jam (*Acacia acuminata*), Sheoak and *Corymbia calophylla* (Marri) and Wandoo. Cable to be located on western side of Warrenup Road.

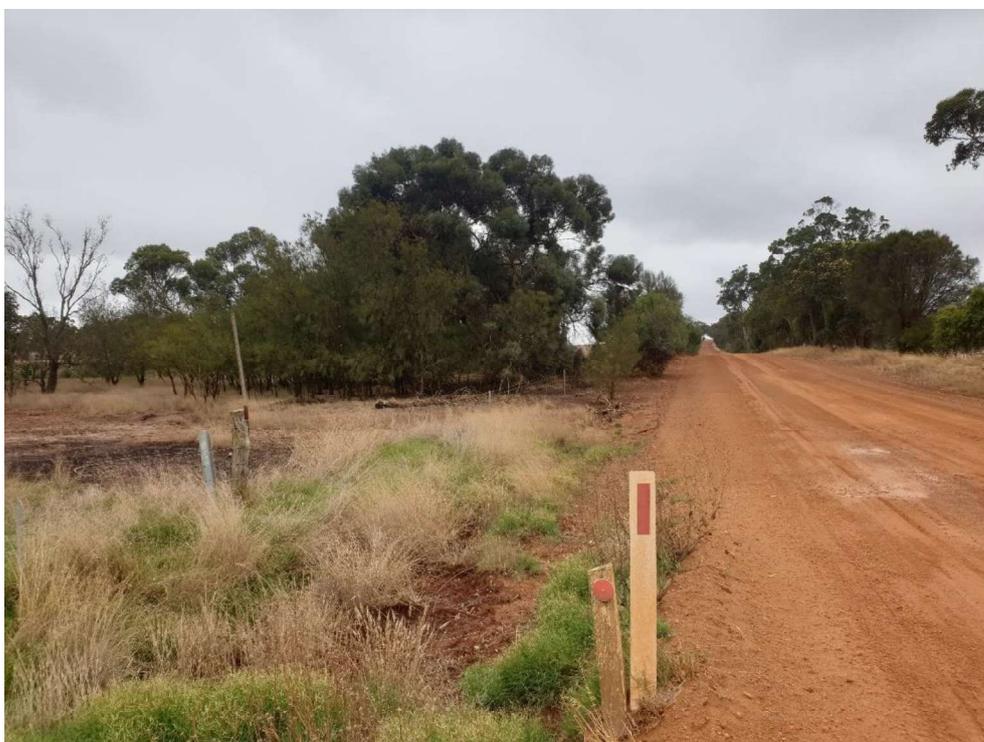
Photo 8 Location 5: Near Dam to west of Warrenup Road on western road verge (looking north) as less vegetation between Locations 5 and 6, only occasional Jam (*Acacia acuminata*), *Acacia microbotrya*, Sheoak and *Corymbia calophylla* (Marri) and Wandoo. Cable to be located on western side of Warrenup Road.

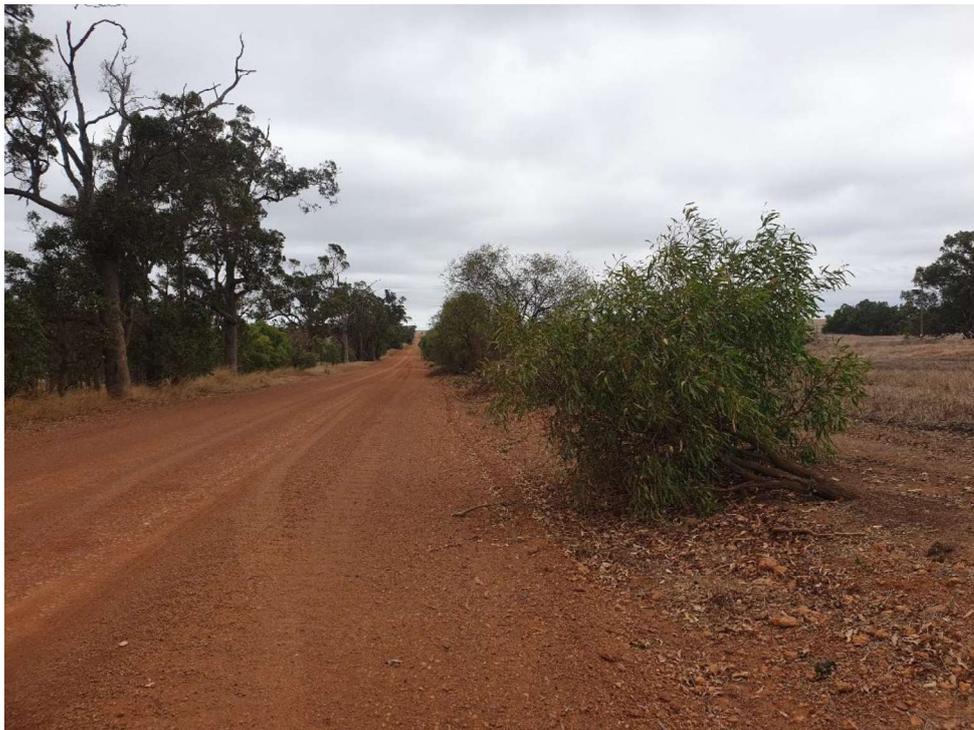
Photo 9 Location 6: Looking south to less vegetation on western side of Warrenup Road road verge (only occasional Jam (*Acacia acuminata*), *Acacia microbotrya*, Sheoak and *Corymbia calophylla* (Marri) and Wandoo. Eastern side greater growth of trees. Cable to be located on western side of Warrenup Road.

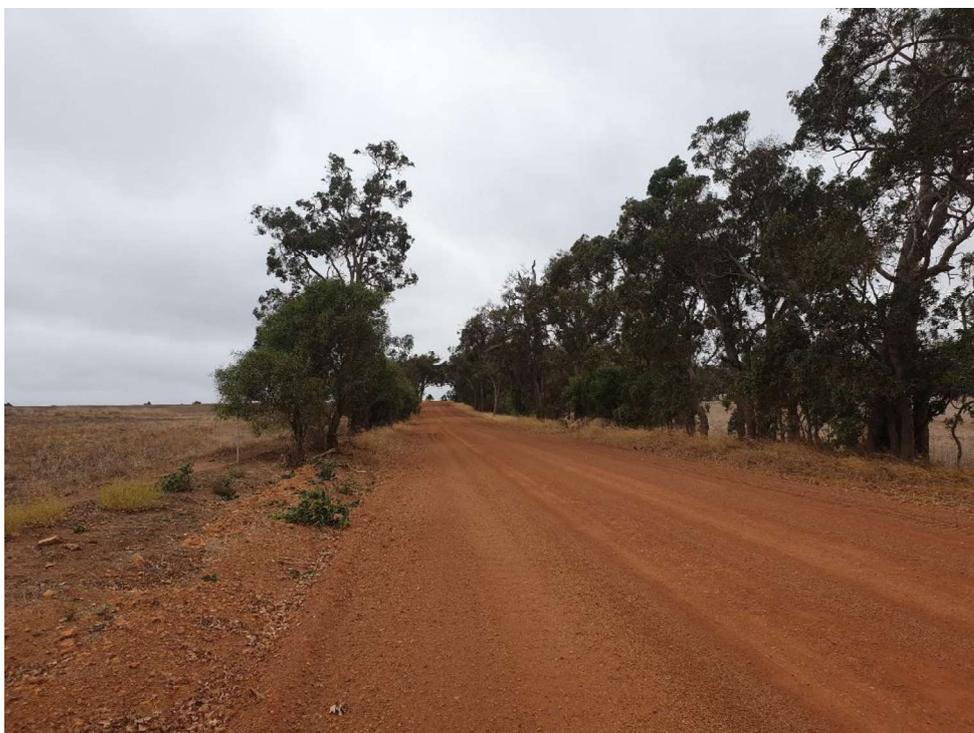
Photo 10 Location 6: Looking north to less vegetation on western side of Warrenup Road road verge (only occasional Jam (*Acacia acuminata*), *Acacia microbotrya*, Sheoak and *Corymbia calophylla* (Marri) and Wandoo. Eastern side greater growth of trees. Cable to be located on western side of Warrenup Road.

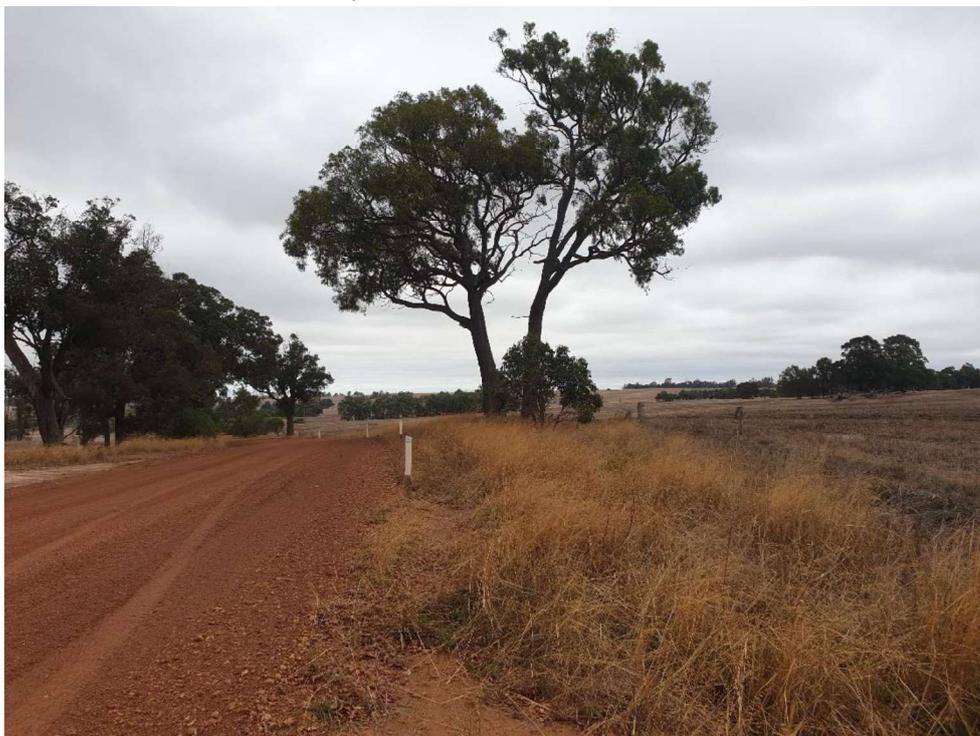
Photo 11 Location 7: Looking south to bend in Warrenup Road with less vegetation on western side of Warrenup Road verge; only occasional tree. Western road verge very narrow in width and degraded. Cable to be located on western side of Warrenup Road.

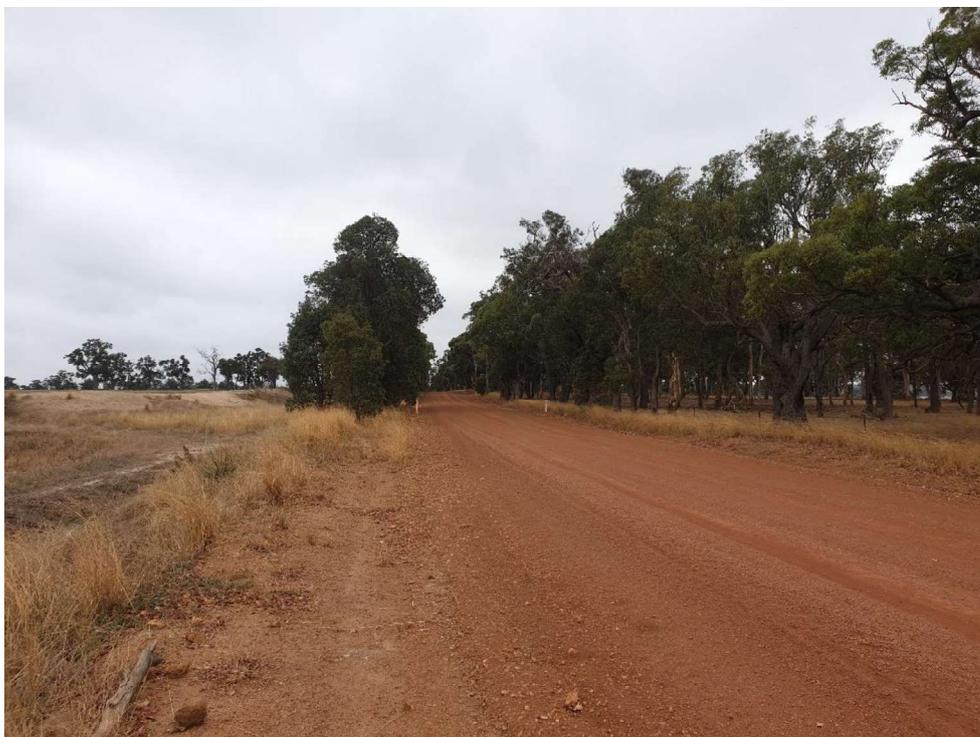
Photo 12 Location 8: Looking north with proposed cable route on western side in narrow road verge, mostly planted trees. Eastern road verge abuts a woodland with maintained canopy cover, although heavily disturbed understorey due to grazing and farming infrastructure. Cable to be located on western side of Warrenup Road.

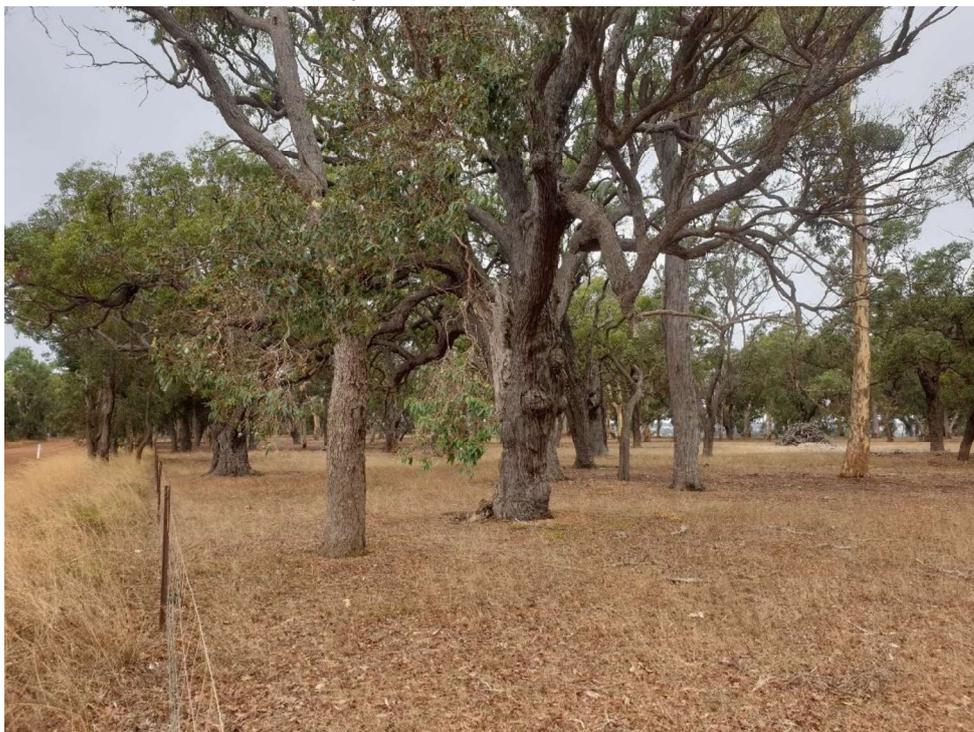
The WA Wheatbelt Woodlands ecological community is a woodland in which the trees typically are spaced and the canopy is relatively open. The understorey is highly variable in structure and composition. There can be localised variation in vegetation structure as a consequence of disturbance, for instance fire, or change in site characteristics that allows for gaps in tree canopy cover, a higher density of trees e.g. dense sapling regrowth, or change in the nature of the understorey (DAWE 2015). The minimum patch size of woodland required is 2 hectares with a condition rating of Pristine/Excellent/Very good (DAWE 2015). As indicated in Photo 13 in Appendix A most remnant areas are degraded as a result of grazing activities.

Photo 13 Location 8: Looking north along eastern road verged into open woodland of Jarrah and Wandoo over grazed paddocks. Area being avoided as proposed alignment on western side of Warrenup Road and hence tree canopy maintained on eastern side. Cable to be located on western side of Warrenup Road.

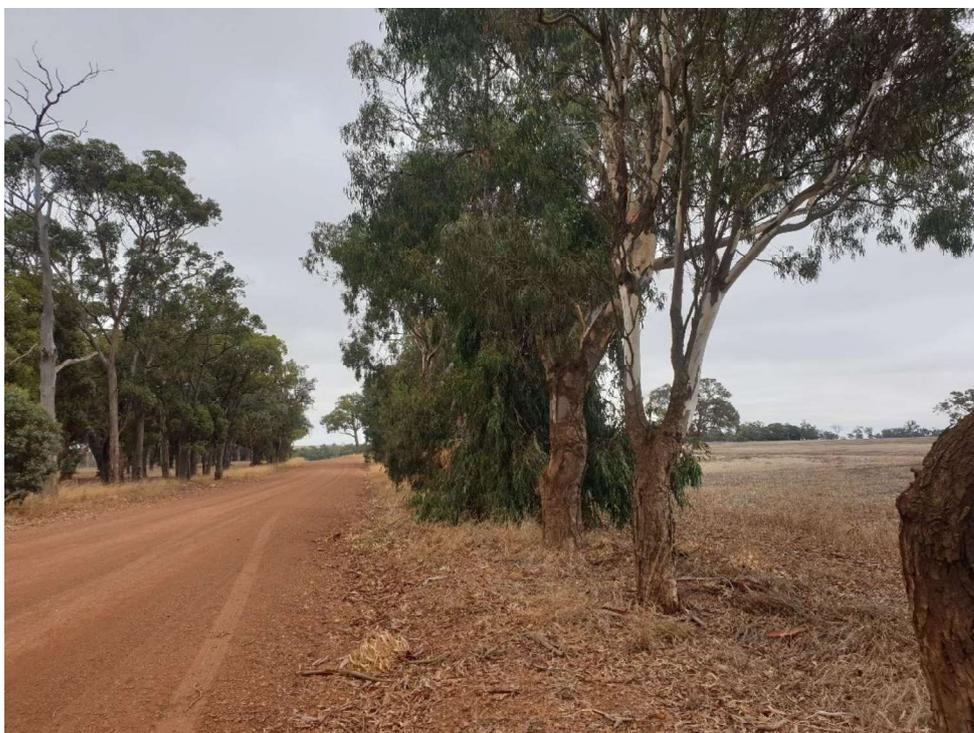
Photo 14 Location 8: Looking south along Warrenup Road with less vegetation on western side of Warrenup Road verge; only occasional planted trees (even aged and known by locals to be planted). Western road verge very narrow in width and degraded. Cable to be located on western side of Warrenup Road.

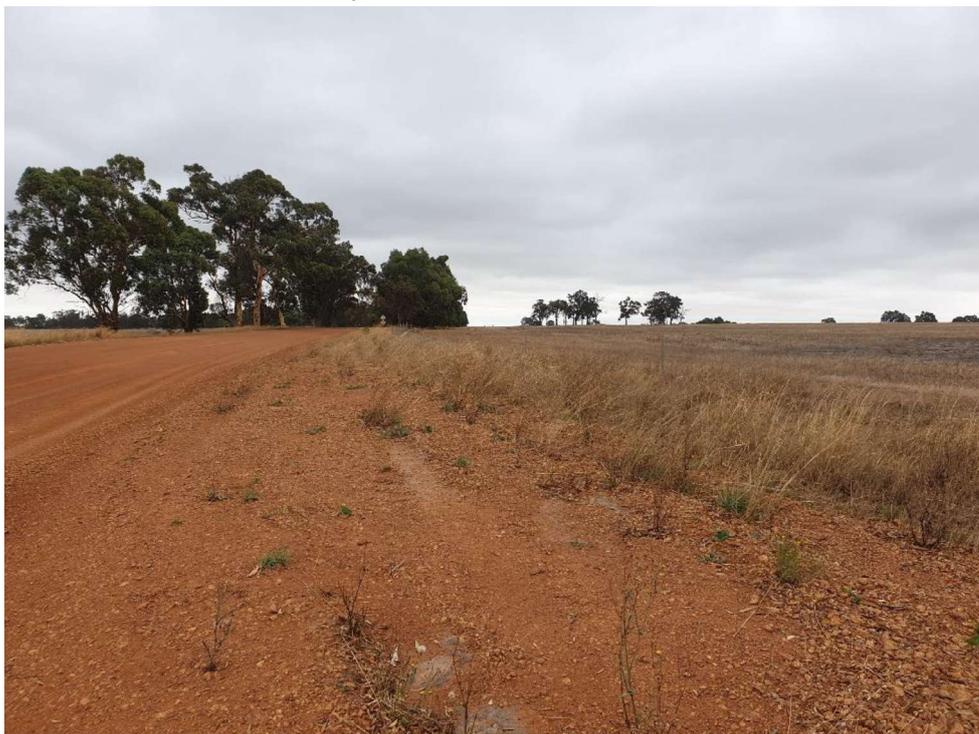
Photo 15 Location 9: Looking South along western side of Warrenup Road road verge where cable will be located; very disturbed and narrow verge prior to road corner and crossing (next two photographs). Cable to be located on western side of Warrenup Road.

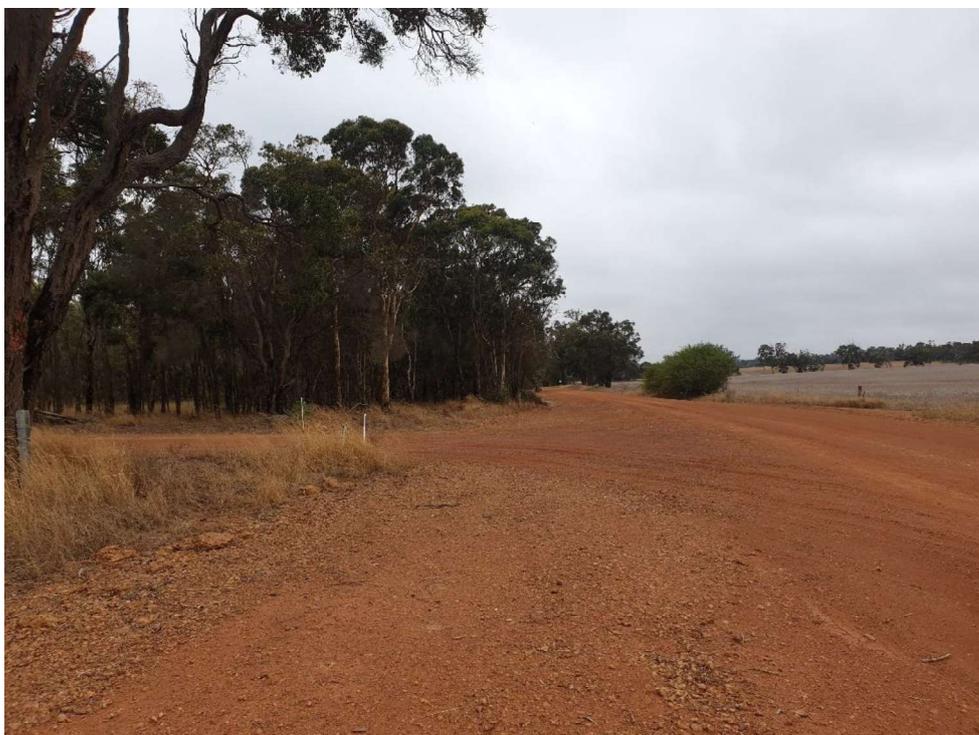
Photo 16 Location 9: Looking north along Warrenup Road where Cable will be crossing from western side to eastern side; only occasional Eucalypt seedlings, mostly introduced grasses on narrow road verge on eastern side looking north. Thus avoiding the remnant trees on the eastern side between locations 9 and 10 to the western side of Warrenup Road.

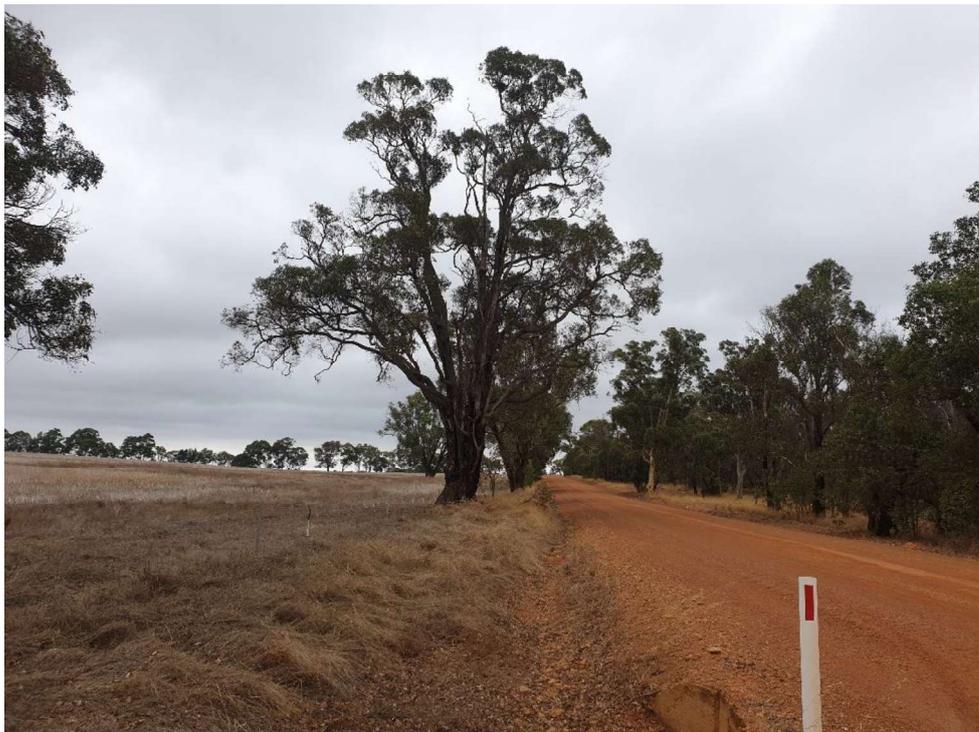
Photo 17 Location 10: Looking south from intersection of Warrenup Road and Ngopitchup Road to less vegetation on eastern side of Warrenup Road road verge, only occasional *Corymbia calophylla* (Marri). Western side greater growth of trees. Cable to be located on eastern side of Warrenup Road.

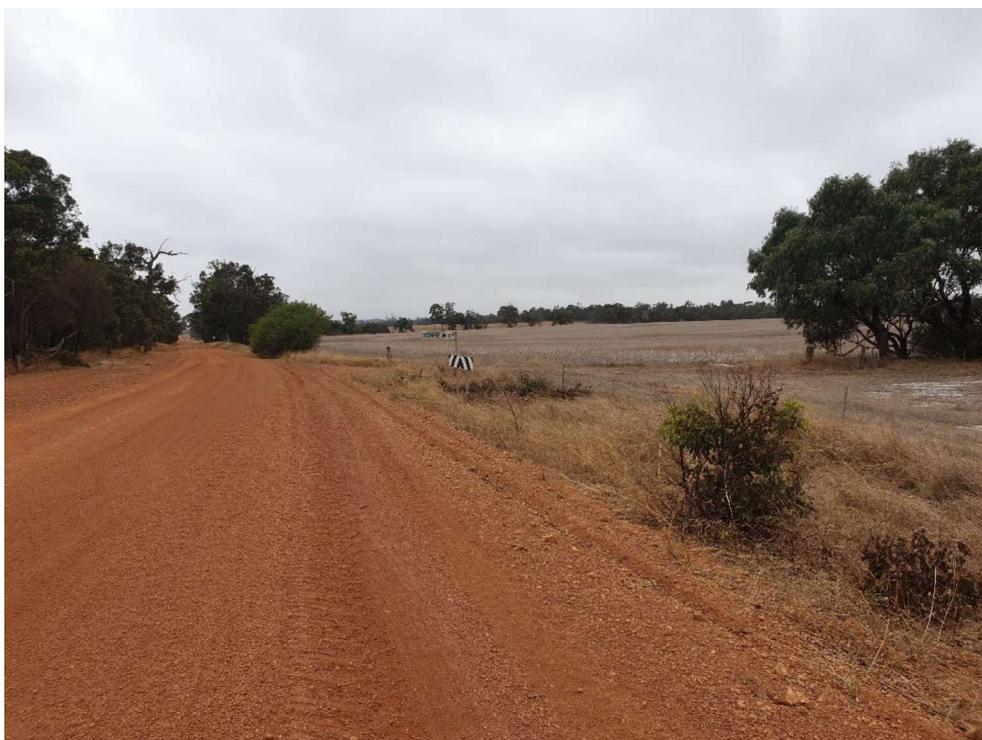
Photo 18 Location 10: Looking north over intersection of Warrenup Road and Ngopitchup Road showing only occasional tree seedling on eastern side of Warrenup Road in foreground and then into paddock as in next photograph. Cable to be located on eastern side of Warrenup Road and crossing northwards into paddock past Ngopitchup Road.

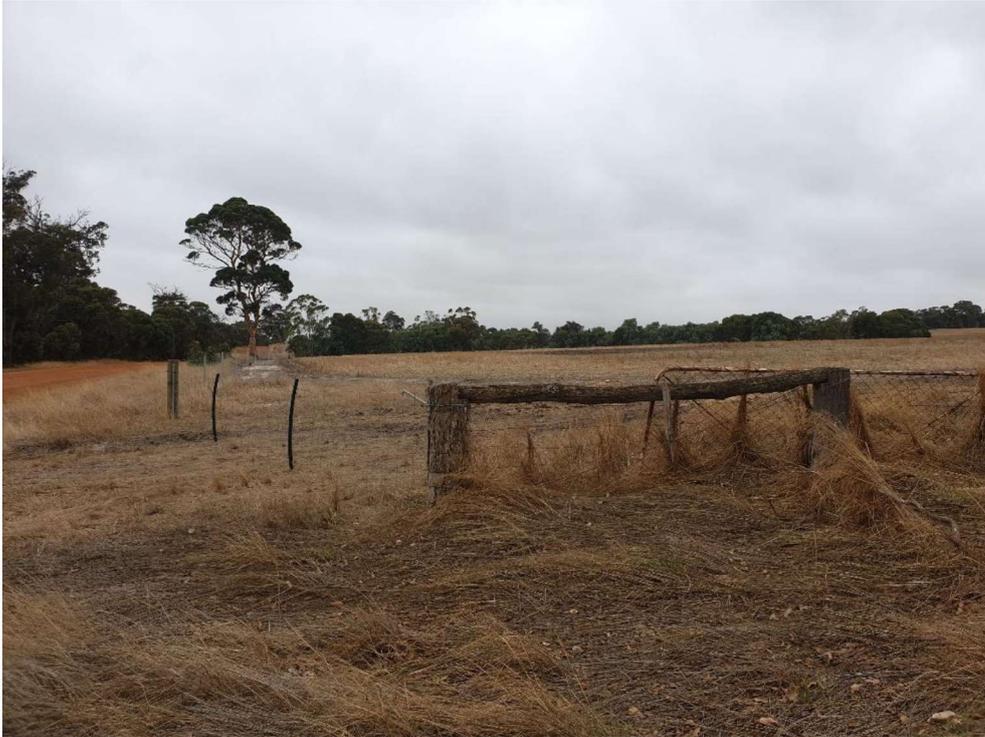
Photo 19 Location 10: Looking north from intersection of Warrenup Road and Ngopitchup Road to cleared paddocks towards T18 on private property through cleared paddocks. Cable to be located on eastern side of Warrenup Road and crossing northwards into paddock north of Ngoptichup Road and east of Warrenup Road.
