July 19 2022

Dr Sarah Rankin
Moonies Hill Energy Pty Ltd

IMPACT FOOTPRINT ASSESSMENT OF TRACK ESTABLISHMENT ON FLAT ROCKS WIND FARM, KOJONUP WA.

Table 1: Clearing sites identified by Umwelt and Enel Green Power and Photographs with assessments by Mattiske June 2022

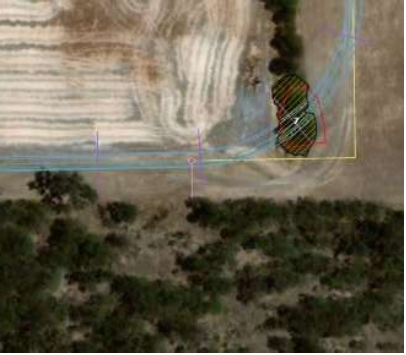
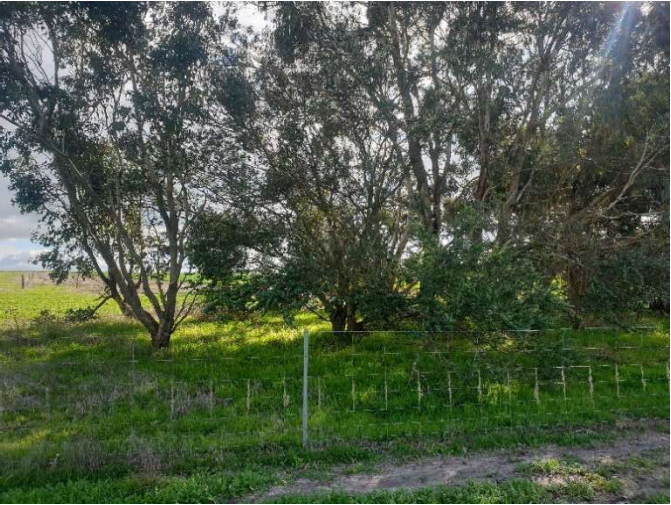
<p>Site 7</p> <p>Clear (permit required)</p>
Photograph June 2022 (Mattiske)	Mattiske Summary

<p>Site 7: This area supported a series of planted trees and as such only several planted trees will be impacted by widening the access track to the left of the trees in the photograph.</p> <p>Located at: Easting 532399 : Northing 6244887</p> <p>Looking west to northwest over corner of a strip of planted trees of <i>Eucalyptus</i> species (including <i>Eucalyptus rudis</i> and <i>Eucalyptus wandoo</i>), planted shrubs and introduced grasses and herbs. These trees are surrounded by paddocks that have been actively used for agricultural purposes.</p> <p>No sign of native fauna activity, although birds may forage at times.</p>

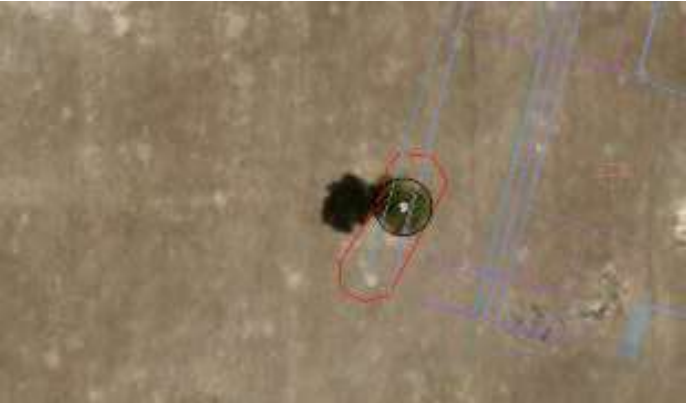
<p>Site 9</p> <p>Clear (Exempt – isolated paddock tree)</p>	
<p>No Photograph Taken by Mattiske in June 2022 as clearing is exempt as isolated paddock trees.</p>	<p>No inspection of Sites 8 and 9 undertaken as clearing is exempt as isolated paddock trees. Assessed in December 2021 by Mattiske Consulting Pty Ltd (January 2022)</p>

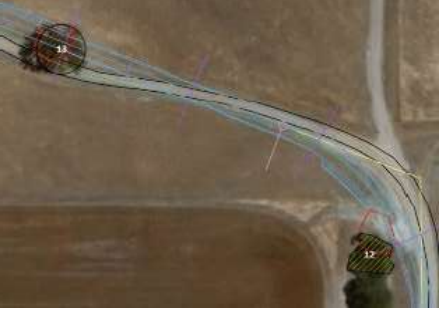
<p>Site 13</p> <p>Clear (Exempt – isolated paddock tree)</p>
<p>Photograph June 2022 (Mattiske)</p>	<p>Mattiske Summary</p>
<p>No Photograph Taken by Mattiske in June 2022 as clearing is exempt as isolated paddock trees.</p>	<p>No inspection of Site 13 undertaken as clearing is exempt as isolated paddock trees (see isolated tree in paddock beyond fence next to track). Assessed in December 2021 (Mattiske Consulting Pty Ltd January 2022).</p> <p>Located at: Easting 532354 : Northing 6246175</p>

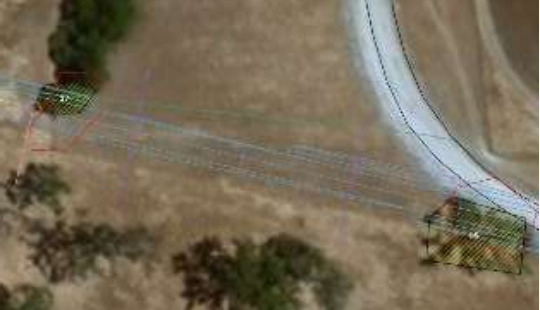
<p>Site 16 & 17</p> <p>Clear (permit required)</p>
<p>Photograph June 2022 (Mattiske)</p>	<p>Mattiske Summary</p>

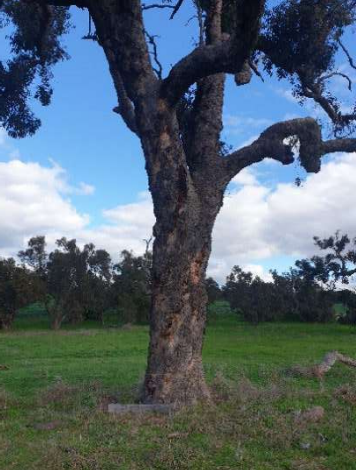
<p>Site 16: This area supported an isolated Marri (<i>Corymbia calophylla</i>) tree in a paddock and should be exempt from clearing application as isolated paddock tree.</p> <p>Located at: Easting 531879 : Northing 6246358</p> <p>No sign of native fauna activity, although birds may forage at times. No obvious hollow or nesting activity in the tree.</p>

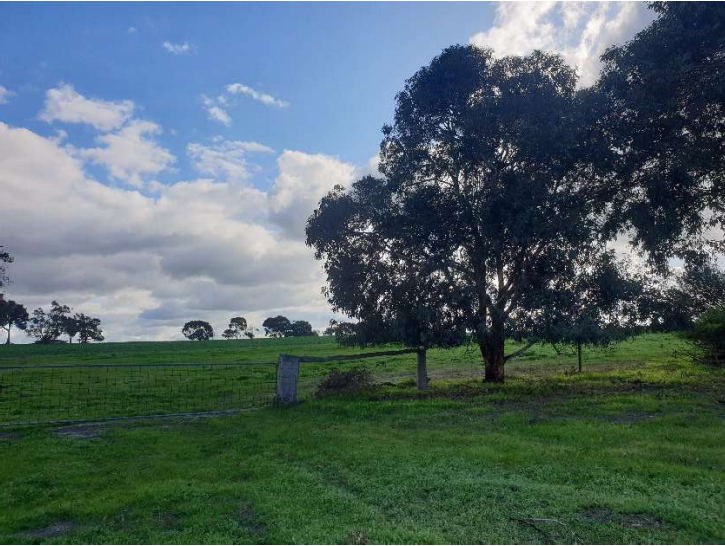
<p>Site 17: This area supported an isolated Wandoo tree that has been planted on the edge of the paddock near the gate. This will only entail the removal of one planted tree.</p> <p>Located at: Easting 531793 : Northing 6246373</p> <p>Looking to planted <i>Eucalyptus wandoo</i> over introduced grasses and herbs in the paddocks that have been actively used for agricultural purposes.</p> <p>No sign of native fauna activity, although birds may forage at times.</p>

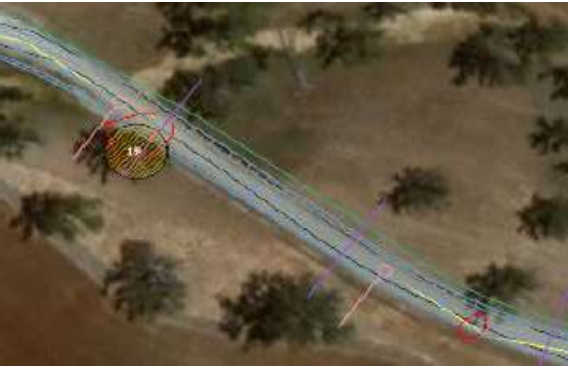
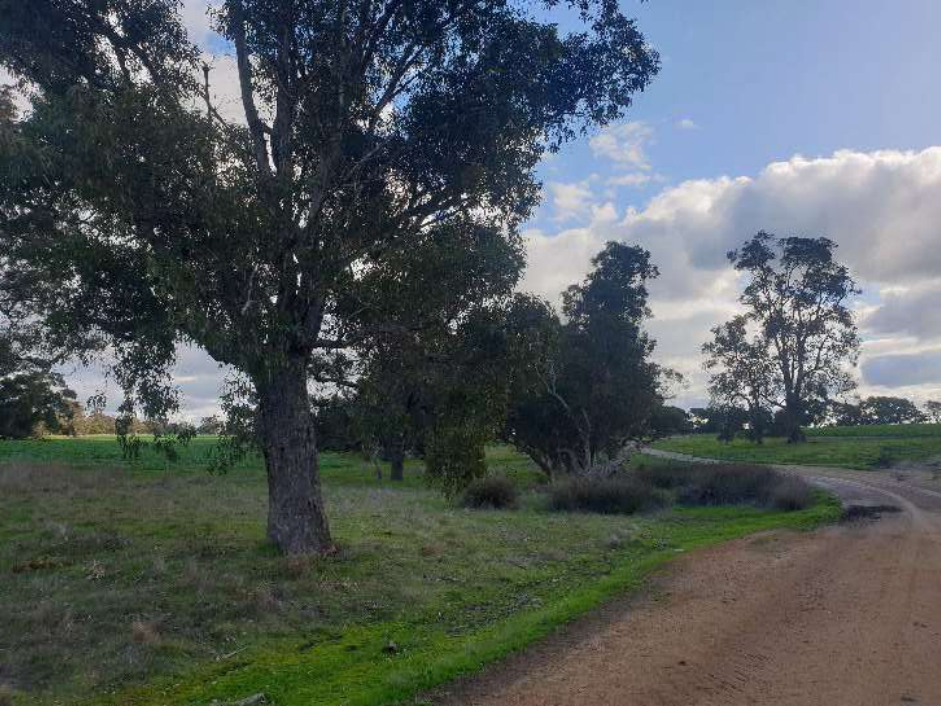
<p>Site 19</p> <p>Clear (permit required)</p>

<p>Site 19: This area supported isolated Flooded trees and a patch of Juncus that occurs on the fringes of the track in a moist to damp section of the track. Several Melaleuca trees also occur on the fringes of the Juncus. The majority of the understorey consists of introduced grasses and herbs due to agricultural activities in the area.</p> <p>Located at: Easting 532309 : Northing 6246300</p> <p>No sign of native fauna activity, although birds may forage at times.</p>

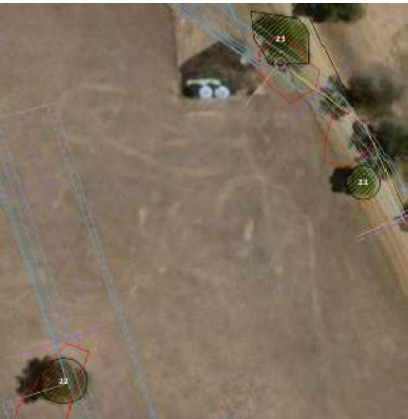
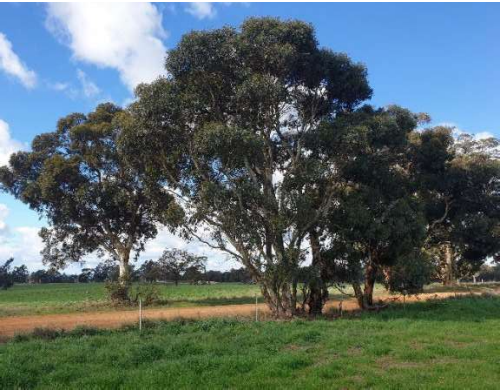
<p>Site 21: This area supports 3 Wandoo and 1 Jarrah tree on narrow road verge (<2m wide) over understorey of introduced grasses and herbs due to agricultural activities in the area. Trees relatively immature and some coppicing.</p> <p>Located at: Easting 532770 : Northing 6240436</p> <p>No sign of native fauna activity, although birds may forage at times.</p>

<p>Site 21 & 22</p> <p>21 – Clear (permit required)</p> <p>22 – Clear (Exempt; structure or isolated paddock tree)</p>
<p>Photograph June 2022 (Mattiske)</p>	<p>Mattiske Summary</p>
<p>No Photograph Taken by Mattiske in June 2022 as clearing is exempt as isolated paddock trees.</p>	<p>No inspection of site 22 undertaken as tree occurs as paddock trees. See earlier assessment in December 2021 (Mattiske Consulting Pty Ltd, January 2022).</p>

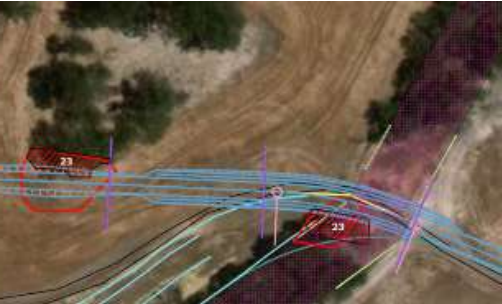
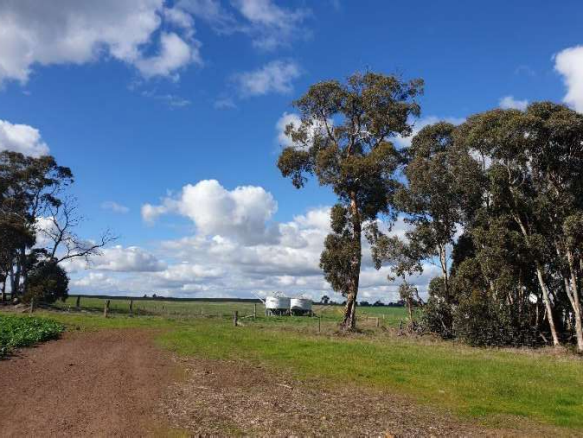
<p>Site 23: This area supports stands of Wandoo either side of the gate in the centre of the photograph. These trees occur on a historical stock route/road reserve that is fenced along most of the alignment. The access track is intended to pass through the area near the current gate and at the most the single Wandoo which occurs as a separated tree from the other trees may need to be removed. The following photos occur on the fringes of a Canola crop with several pockets of Eucalyptus wandoo on low ridges, with the potential need to possibly clear a few trees on the edges of the patches of Wandoo.</p> <p>Located at: Easting 531512: Northing 6240909</p> <p>No sign of native fauna activity, although birds forage at times. And the stands of trees in the fenced off stock route provide shelter for smaller ground dwelling animals.</p>

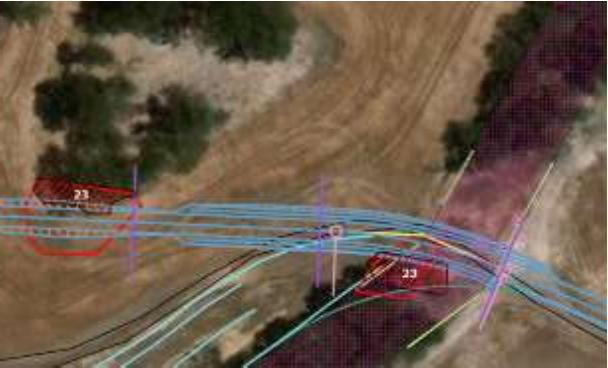
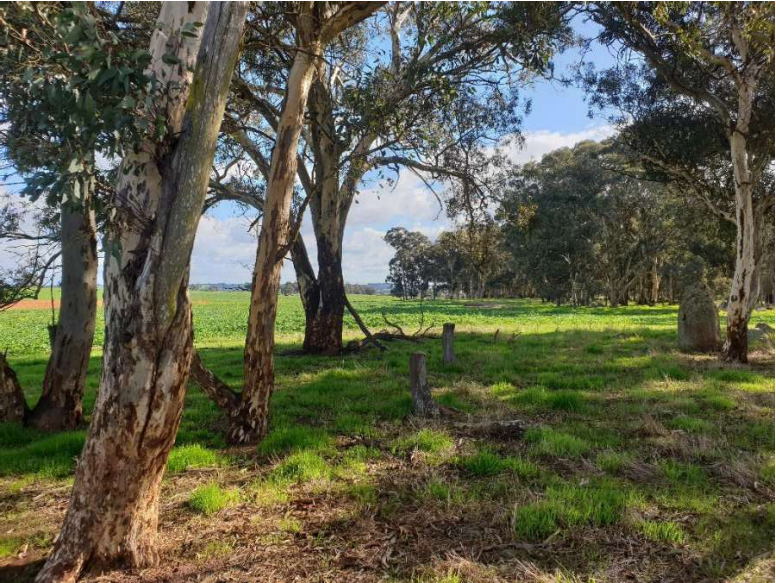
<p>Site 23</p>

<p>The photo to the left was taken just north of Site 23 on the fringes of a Canola crop with several pockets of Eucalyptus wandoo on low ridges, with the potential need to possibly clear a few trees on the edges of the patches of Wandoo (in the foreground of the photo and a few trees on the western fringe of the patch of Wandoos in the background of the photo).</p> <p>Located at: Easting 531510 : Northing 6240949</p> <p>No sign of native fauna activity, although birds forage at times. Note some outcropping and patchy open trees of Wandoo over introduced species and herbs.</p>

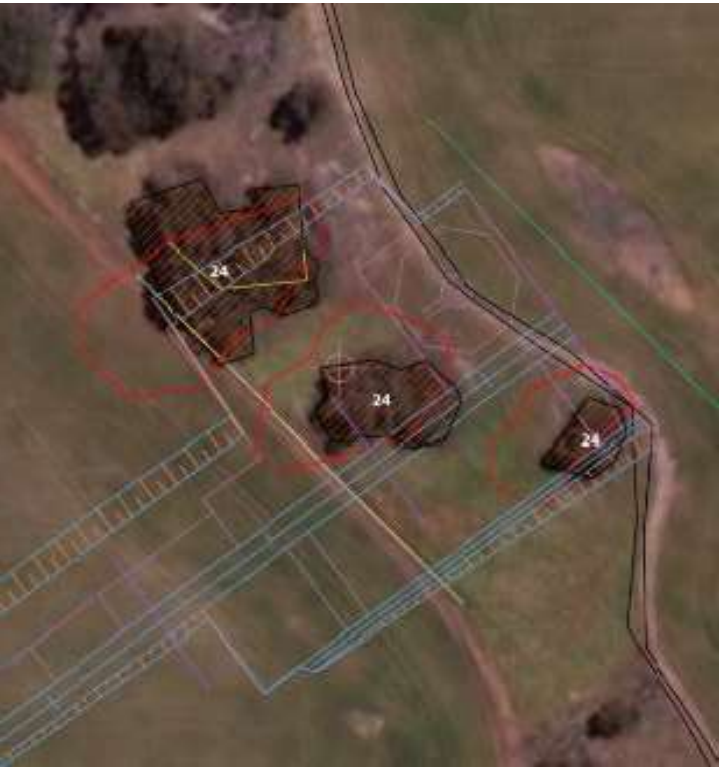
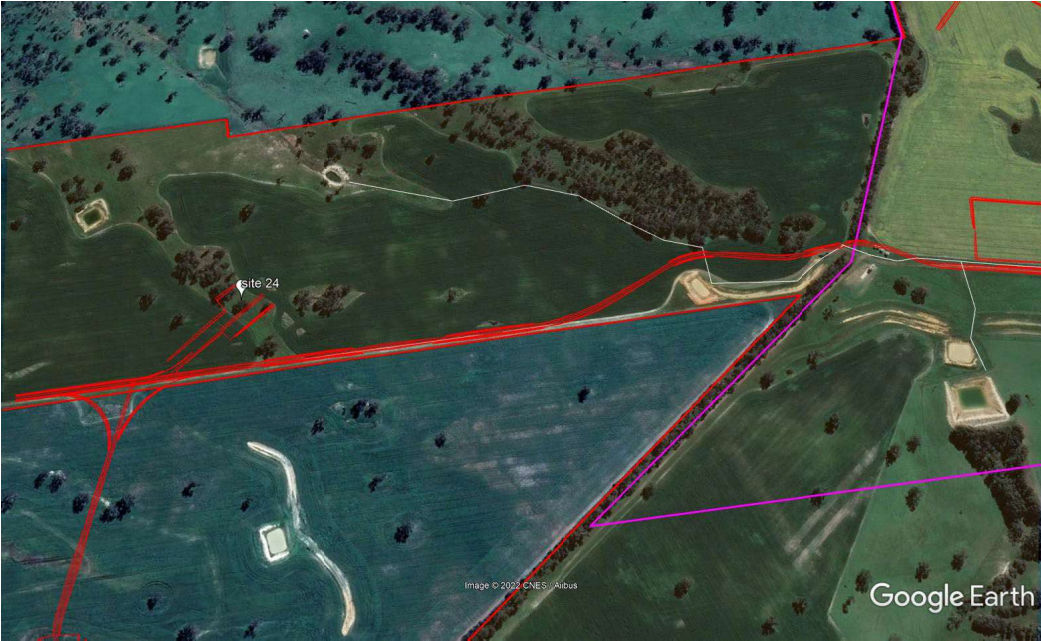
<p>Site 24</p> <p>Clear (exempt – structure)</p>

<p>Site 24: This area occurs west of Site 23 in the previous photograph. This area supports several isolated paddock trees and will support structures in the current agricultural paddock.</p> <p>Located west of Site 23.</p> <p>Clearing for necessary structures are exempt.</p>

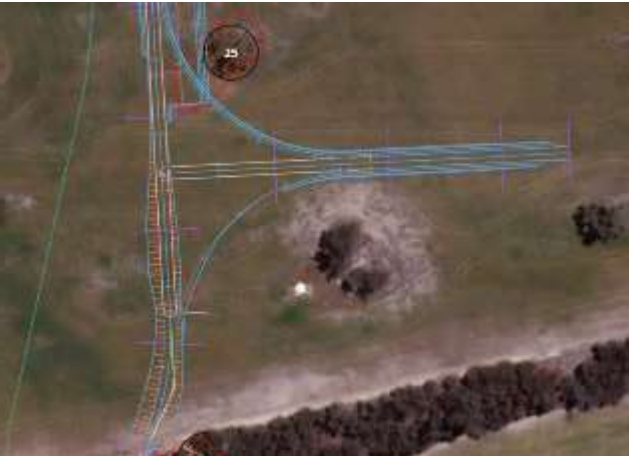
<p>The photograph shows an aerial view of a rural landscape. A road or path runs vertically on the left side. A tree is circled in red and labeled '25'. The surrounding area is a mix of green grass and brownish soil, with some other trees visible in the distance.</p>	<p>Site 25</p> <p>Clear (Exempt – isolated paddock tree)</p>
<p>Photograph June 2022 (Mattiske)</p>	<p>Mattiske Summary</p>
<p>No photograph taken.</p>	<p>Site 25: This is an isolated paddock trees over introduced grasses and herbs in current agricultural paddock.</p> <p>Clearing is exempt for isolated paddock tree.</p>

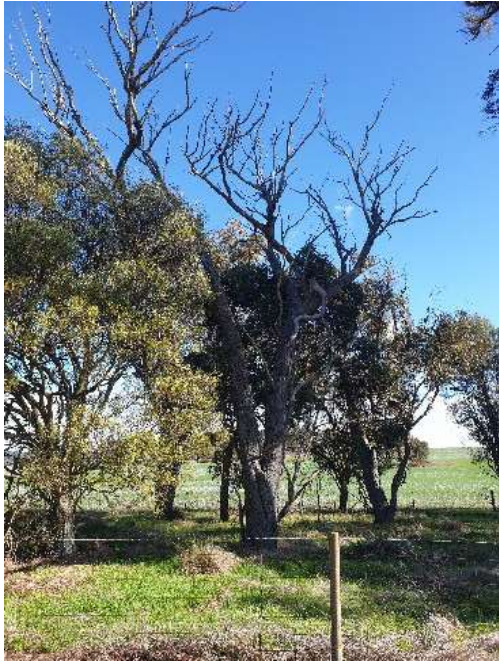
Actions
 	<p>Site 29</p> <p>Clear (permit required – road reserve)</p> <p>Note – same road reserve as 27 above. Need to include in permit from council.</p>
<p>Photograph June 2022 (Mattiske)</p>	<p>Mattiske Summary</p>
 	<p>Site 29: In this area the old stock route/road reserve has been fenced and supports stands of Jarrah and Wandoo in the main. There are several sections of the road reserve that occur in this area that could be crossed with minimal impacts to the trees and understorey. There is an occasional <i>Xanthorrhoea</i> (grass tree), a few Jams (<i>Acacia acuminata</i>) <i>Lomandra</i> plants but generally the native understorey is absent.</p> <p>Clearing should be located in the more open areas to the north of the dam and wetter soils in the paddock to the east. There is a few gaps and one area supporting a dead Jarrah tree that could be removed. Permit will be required from Council as Road reserve.</p> <p>Located at: Easting 529808 : Northing 6239951</p>

<p>The photograph shows a landscape with several trees. One prominent tree in the center is dead, with bare, dark branches reaching upwards against a clear blue sky. To its left and right are other trees with green and yellowish foliage. The ground is covered with a mix of green grass and brown, dry vegetation. A wooden fence post is visible in the foreground on the left side.</p>	<p>Site 29: Photograph of dead Jarrah near more open area with Jam (<i>Acacia acuminata</i>) over introduced grasses and herbs on old stock route/road reserve.</p>

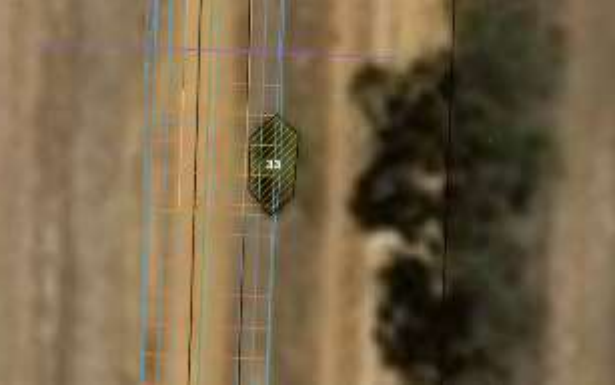
<p>Site 33</p> <p>Clear (permit required)</p>
<p>Photograph June 2022 (Mattiske)</p>	<p>Mattiske Summary</p>
 	<p>Site 33: Looking south from Site 33 in open area south of the few Jarrah trees on the fringes of the road within the narrow (<2m) road verge. There are a few Jarrah trees that may require removal within the eastern road verge. The remainder the vegetation consists of introduced grasses and herbs in degraded road verges.</p> <p>Located at: Easting 533365 : Northing 6238820</p> <p>No sign of native fauna activity, although birds may forage at times.</p>

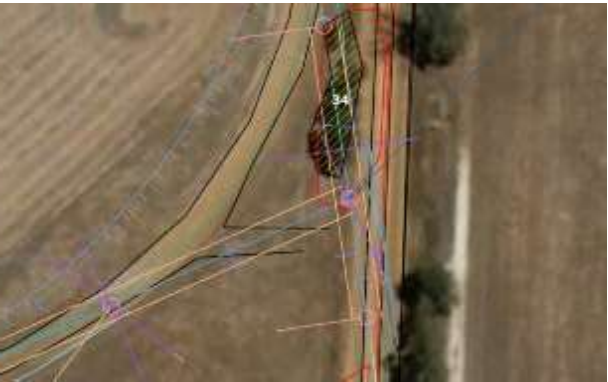
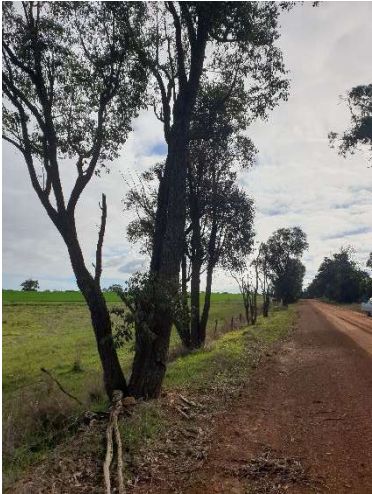
<p>Site 34</p> <p>Clear (permit required)</p>
<p>Photograph June 2022 (Mattiske)</p>	<p>Mattiske Summary</p>

<p>Site 34: Looking north in open area with a few Jarrah trees on the fringes of the road within the narrow (<2m) road verge. There are a few Jarrah trees that may require removal within the eastern road verge. The remainder the vegetation consists of introduced grasses and herbs in degraded road verges.</p> <p>Located at: Easting 533365 : Northing 6238820</p> <p>No sign of native fauna activity, although birds may forage at times.</p>

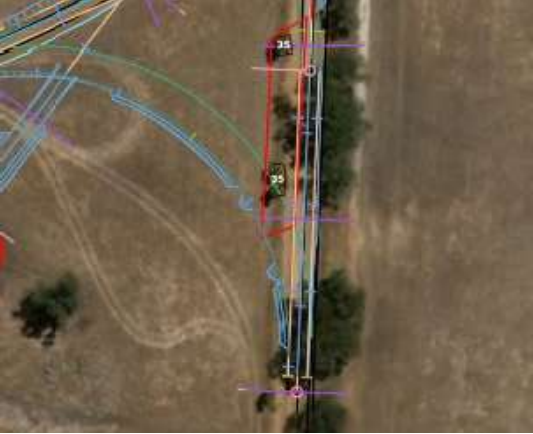
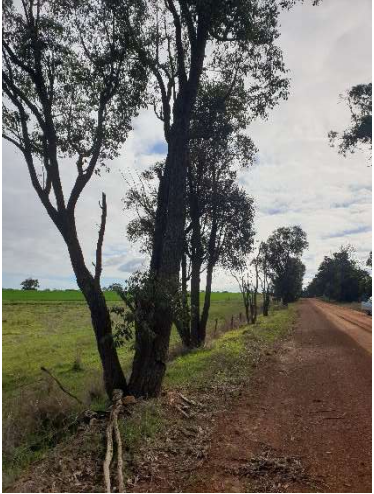
<p>Site 35</p> <p>Clear (permit required)</p>
<p>Photograph June 2022 (Mattiske)</p>	<p>Mattiske Summary</p>

<p>Site 35: Looking north in open area with a few Jarrah and Marri trees on the fringes of the road within the narrow (<2m) road verge. There are a few trees that may require removal within the eastern road verge. The remainder the vegetation consists of introduced grasses and herbs in degraded road verges. The trees on the northern section of the photograph beyond Site 34 are associated with Site 35.</p> <p>Located at: Easting 533368 : Northing 6238889</p> <p>No sign of native fauna activity, although birds may forage at times.</p>

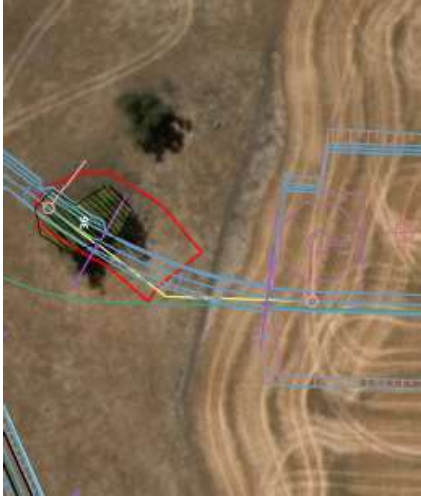
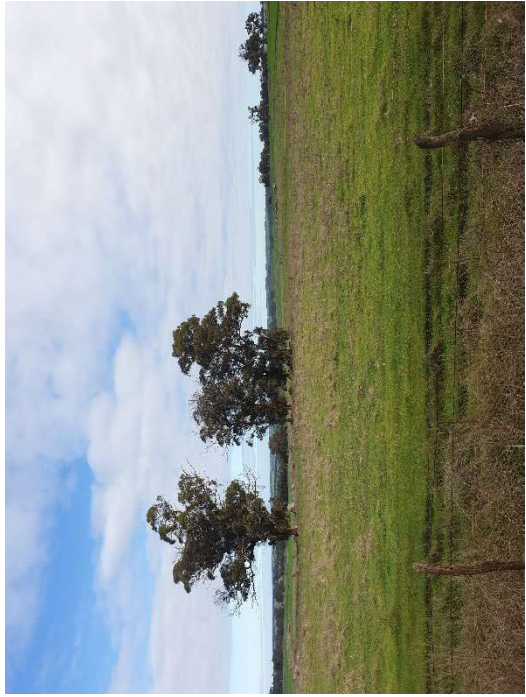
Actions	
<p>Site 36</p> <p>Clear (permit required)</p>	<p>Mattiske Summary</p> <p>Site 36: Looking west into a few isolated paddock trees over pasture. The trees occur as several isolated paddock trees and therefore should be exempt from clearing permits. It should be feasible to avoid these trees through as small design change.</p> <p>Located at: Easting 533300 : Northing 6238820</p> <p>No sign of native fauna activity, although birds may forage at times.</p>
<p>Photograph June 2022 (Mattiske)</p>

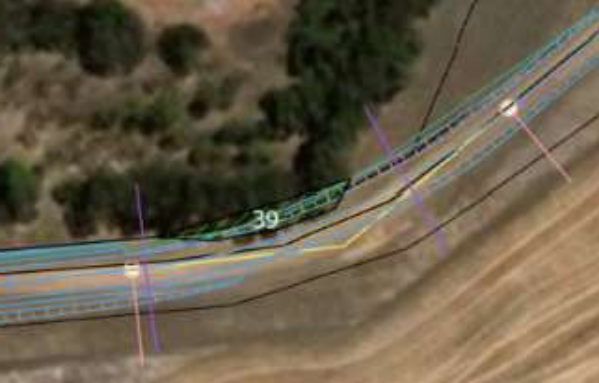
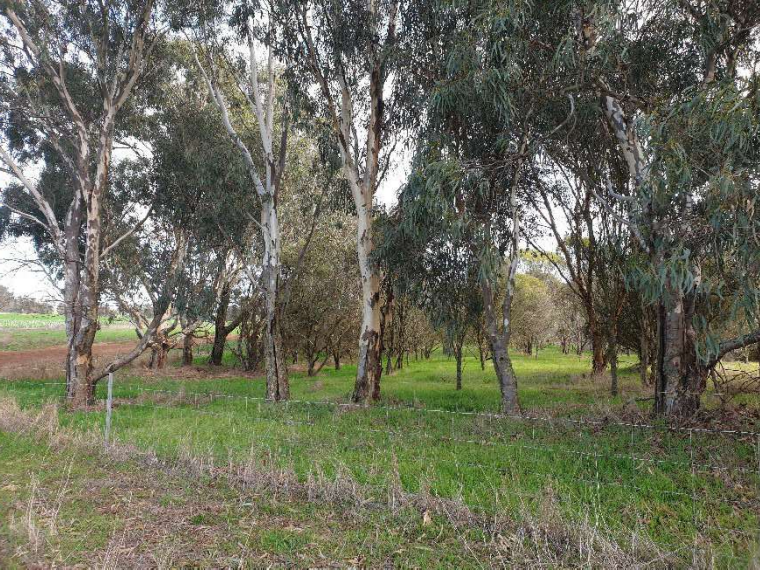
<p>Site 39</p> <p>Clear (permit required)</p>
<p>Photograph June 2022 (Mattiske)</p>	<p>Mattiske Summary</p>

<p>Site 39: There is a need to clear some of the planted trees in the rehabilitation area to enable a straightening of the track. There is a mixture of <i>Eucalyptus wandoo</i>, Jam (<i>Acacia acuminata</i>), <i>Melaleuca raphiophylla</i> over introduced grasses and herbs. Possibly 15 planted trees and some 20 saplings.</p> <p>Located at: Easting 533697 : Northing 6238583</p> <p>No sign of native fauna activity, although birds may forage at times.</p>

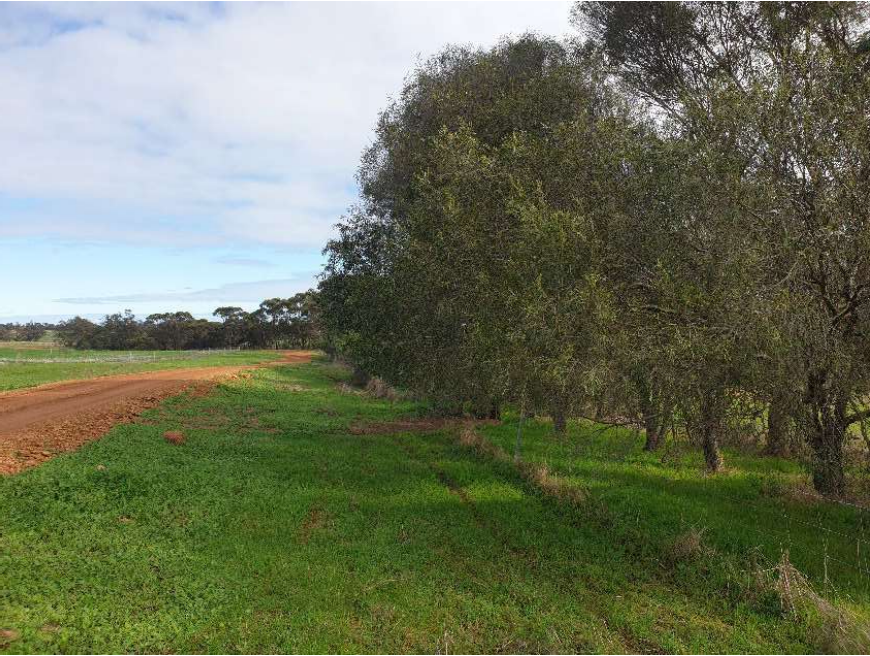
<p>Site 41: There is a need to clear some of the planted trees in the rehabilitation area to enable a straightening of the track. There is a mixture of planted <i>Melaleuca raphiophylla</i> and <i>Acacia acuminata</i> over introduced grasses and herbs. Possibly 15 to 20 trees.</p> <p>Located at: Easting 532485 : Northing 6238545</p> <p>No sign of native fauna activity, although birds may forage at times.</p> <p>There is a commitment to re-plant trees along this local watercourse where there is no planned disturbance.</p>

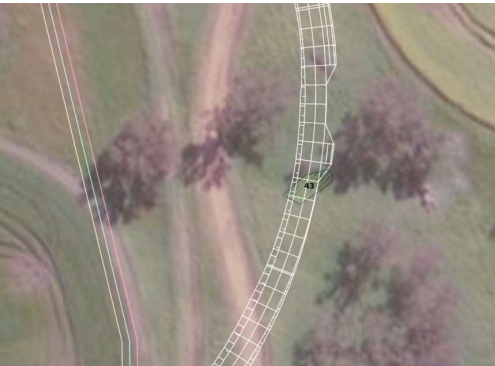
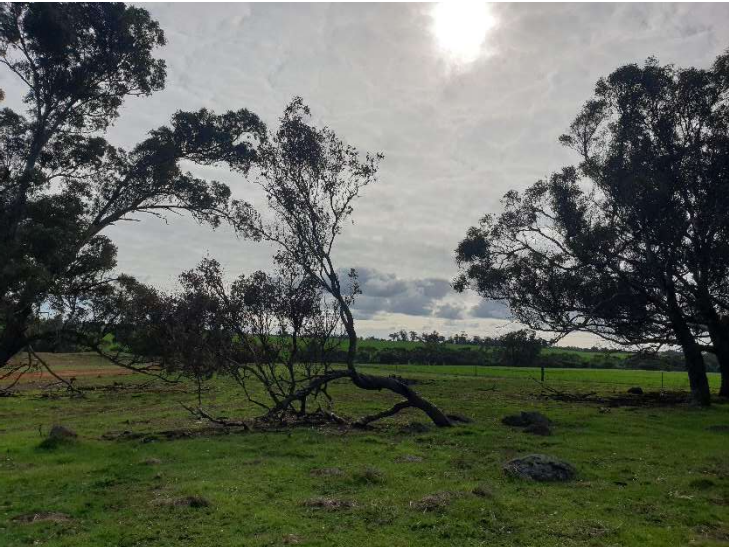
<p>Site 43</p> <p>Clear (permit required)</p>
<p>Photograph June 2022 (Mattiske)</p>	<p>Mattiske Summary</p>

<p>Site 43: There is a need to clear a gnarled old tree of <i>Eucalyptus rudis</i> in the alignment. This tree occurs as an isolated paddock tree. The tree also occurs in an area with exposed outcropping which may influence the alignment. There may also be a need to prune several branches on the adjacent larger trees which should not impact the condition of these trees.</p> <p>Located at: Easting 532218 : Northing 6238151</p> <p>No sign of native fauna activity, although birds may forage at times.</p>

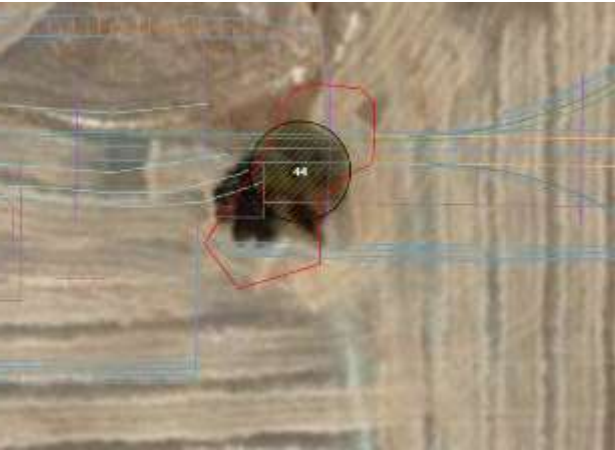
<p>Site 44</p> <p>Clear (exempt – isolated paddock tree).</p>
Photograph June 2022 (Mattiske)	Mattiske Summary
No Photograph Taken by Mattiske in June 2022.	No inspection undertaken as clearing is exempt for isolated paddock trees and structures. See earlier assessment in December 2021 (Mattiske Consulting Pty Ltd, January 2022).

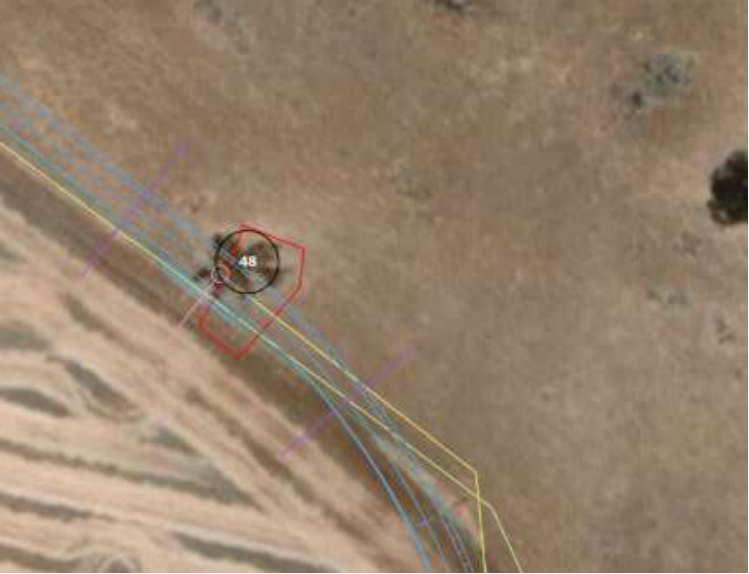
<p>Site 48</p> <p>Clear (exempt – isolated paddock tree, access track).</p>
Photograph June 2022 (Mattiske)	Mattiske Summary
<p>No Photograph Taken by Mattiske in June 2022.</p>	<p>No inspection undertaken as clearing is exempt for isolated paddock trees and structures. See earlier assessment in December 2021 (Mattiske Consulting Pty Ltd, January 2022).</p>

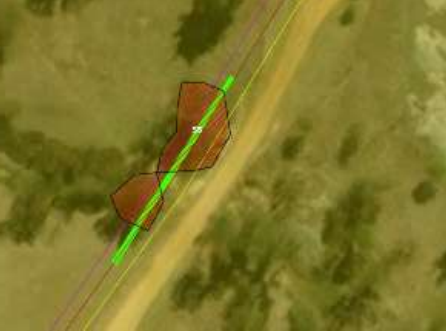
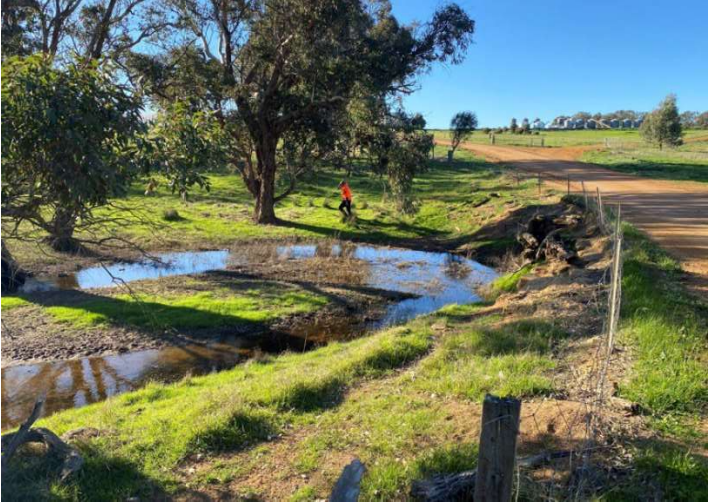
<p>Site 55/60</p> <p>The alignment occurs on the western side across the creek line.</p> <p>Only a couple of trees of <i>Eucalyptus rudis</i> and <i>Acacia acuminata</i> will require removal. The area is degraded and the understorey is dominated introduced grasses and herbs.</p> <p>Located at: Easting 528942 : Northing 6236492</p> <p>No sign of native fauna activity, although birds may forage at times.</p>

<p>Site 55/60</p> <p>Ground-truth vegetation extent and determine need for clearing, as a cleared area is immediately to west.</p>
<p>Photograph June 2022 (Mattiske)</p>	<p>Mattiske Summary</p>
