Cannington Swamp Threatened Ecological Community

Hydrological Study and Preliminary Management Plan

Prepared for the City of Canning

By Urbaqua

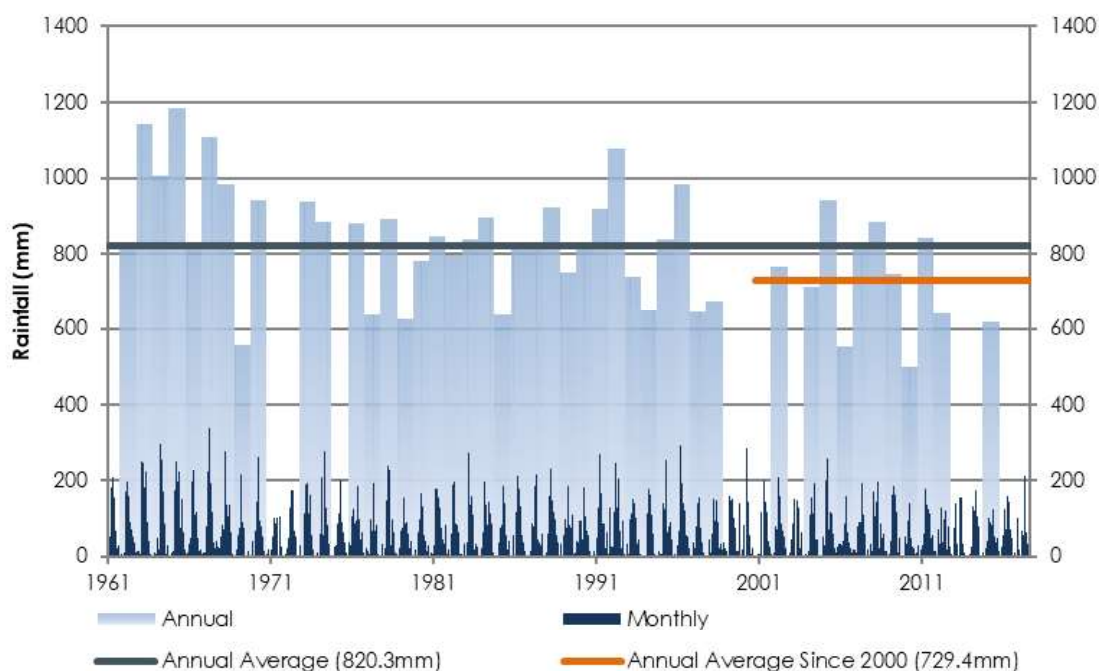
Figure 2a: Average annual and monthly climate data (station no. 9106) (BoM, 2018)

As demonstrated in Figure 2a, there is a variation in the annual totals, ranging between 499.6mm (2010) and 1,184mm (1965). The data indicates a decreasing trend in annual and winter rainfall totals, particularly since 2000 where the annual average rainfall has decreased from 820.3mm to 729.4mm (approximately 11.1% decrease).

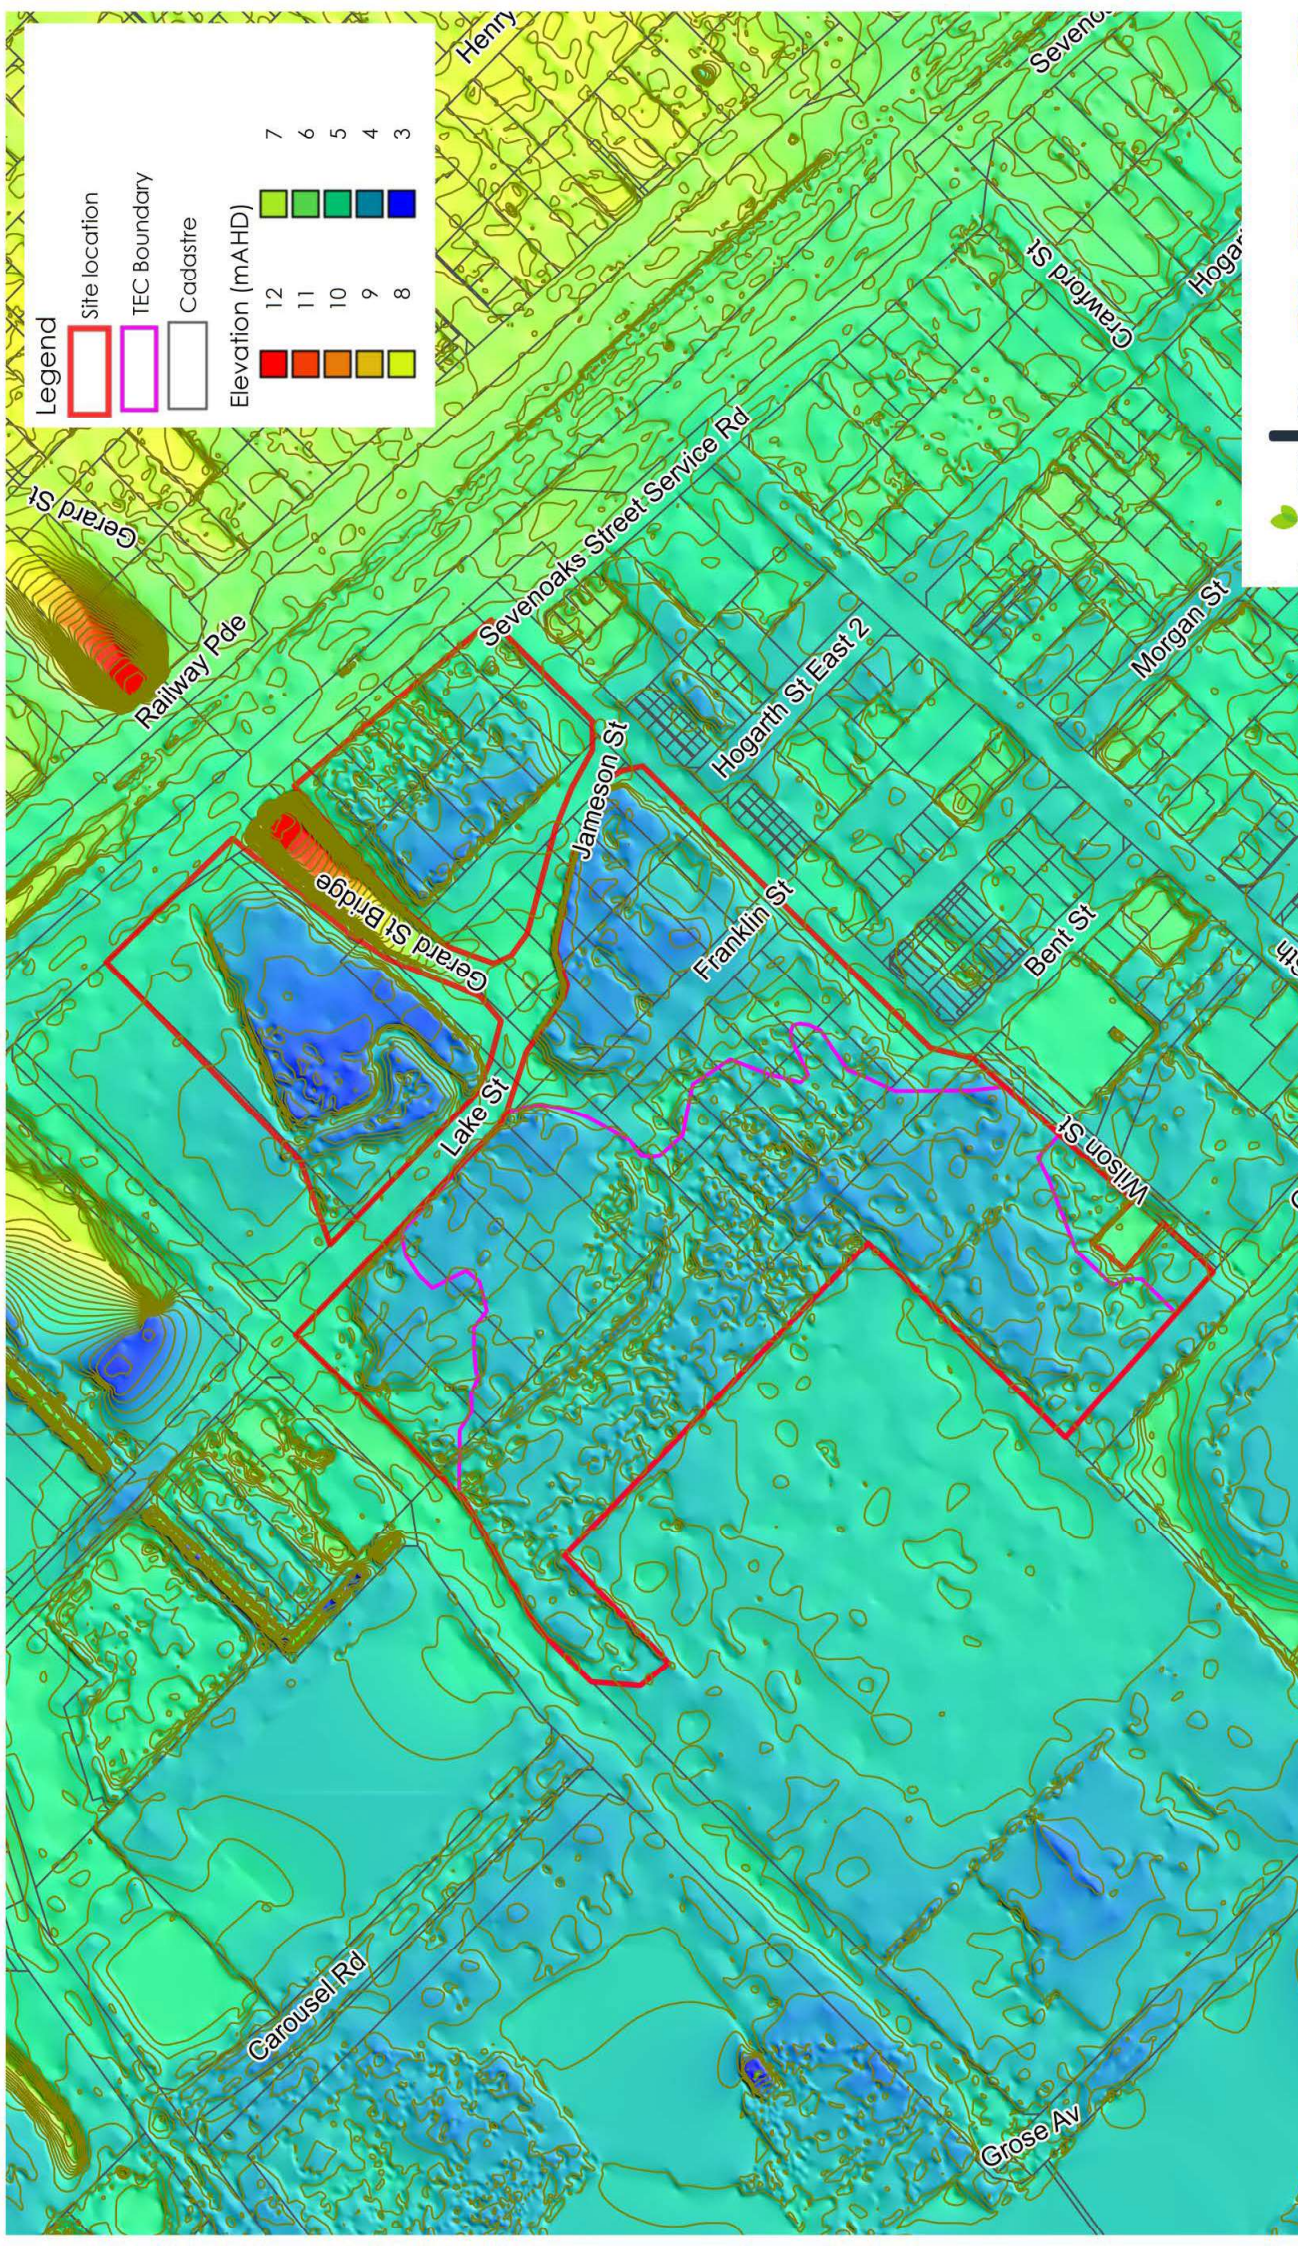
Western Power - Cannington Swamp Hydrological Study
 Figure 3 - Topography

The topography of Cannington Swamp varies from 3.2 mAHD to 5.3 mAHD (Figure 3). The elevations within the larger portion of the swamp (main area), which includes the CCW and TEC immediately adjacent to the Western Power Sub Station, varies between 3.5 mAHD and 5.1 mAHD. The other portions of the swamp located in the north east and east will be filled and developed as part of the Canning City Centre Activity Centre Plan. Existing roads and developed land surrounding the site has generally been filled with imported sand material to approximately 0.5m above natural surface.

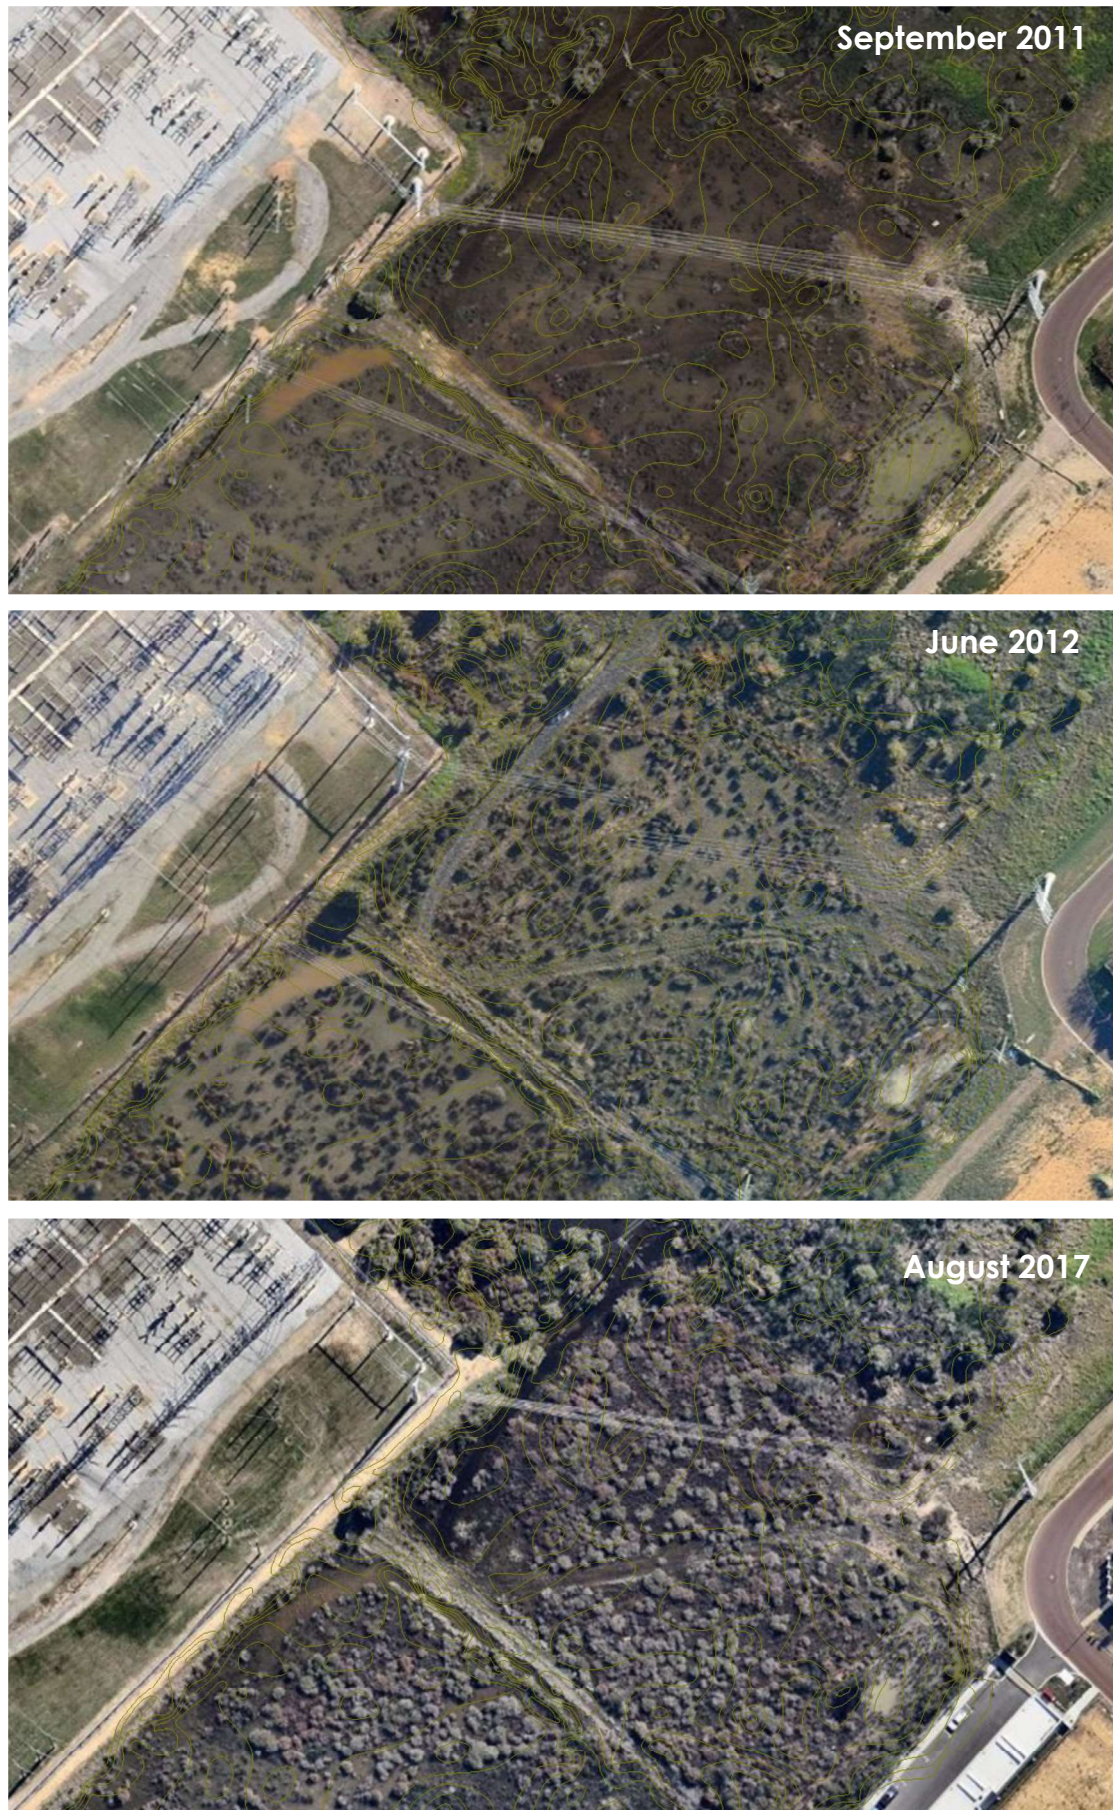
Figure 8: Aerial imagery review – observable inundation in selected years

It is noted that inundation in the wetland is often only observable in certain locations in aerial imagery such as cleared maintenance tracks and other more sparsely vegetated areas. Because these do not correspond to the lowest points on the site, inundation at levels lower than approximately 3.8mAHD cannot be observed by this method. Therefore, the observable hydroperiod is likely to be shorter than the actual hydroperiod. Observations of maximum water level are considered more reliable as it is generally possible to observe high water marks on exposed portions of the site that can be easily compared to LiDAR elevations.

This information has been used to review the extent and hydroperiod predicted by the model in these years and the results of this comparison are presented in Table 6. In general, the model predicts a longer hydroperiod than was observed, however this is expected given the difficulties associated with the observation method. The observed top water level is reproduced by the model reasonably accurately in all three years.

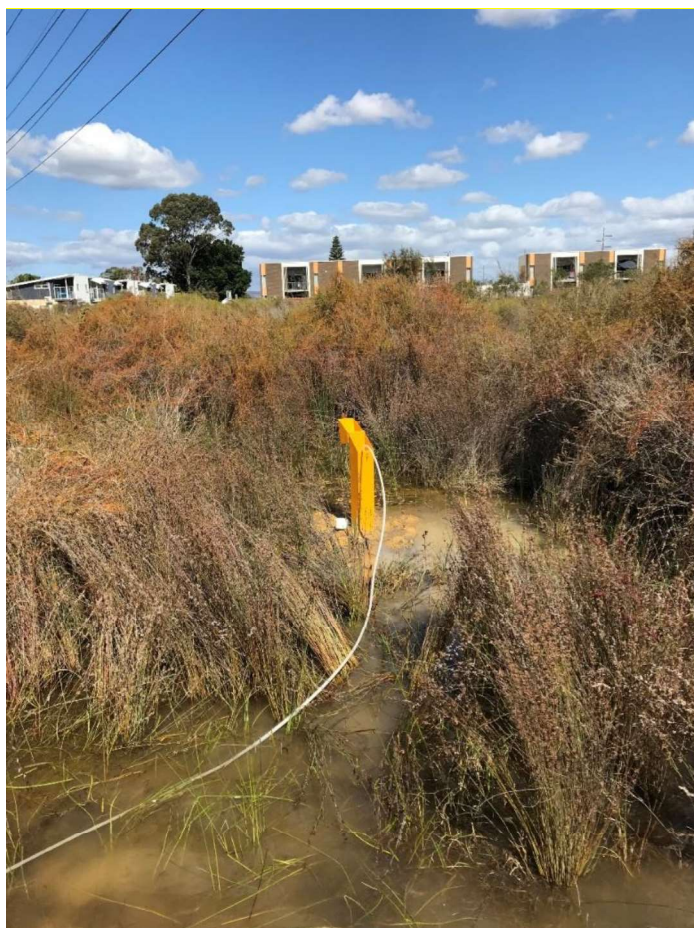
Figure 10: Inundation around bore CS-U3 (looking north-west)

As discussed in Section 2.4, a groundwater monitoring program and site inspection was undertaken by Urbaqua staff between July 2017 and June 2018. During August, September and October 2017, inundation was observed at some areas of the Swamp. Figure 10 illustrates the inundation around bore CS-U3 at the corner of the Western Power Sub Station in October 2017. The groundwater has been below the ground level at the other sampling bores during the monitoring period.

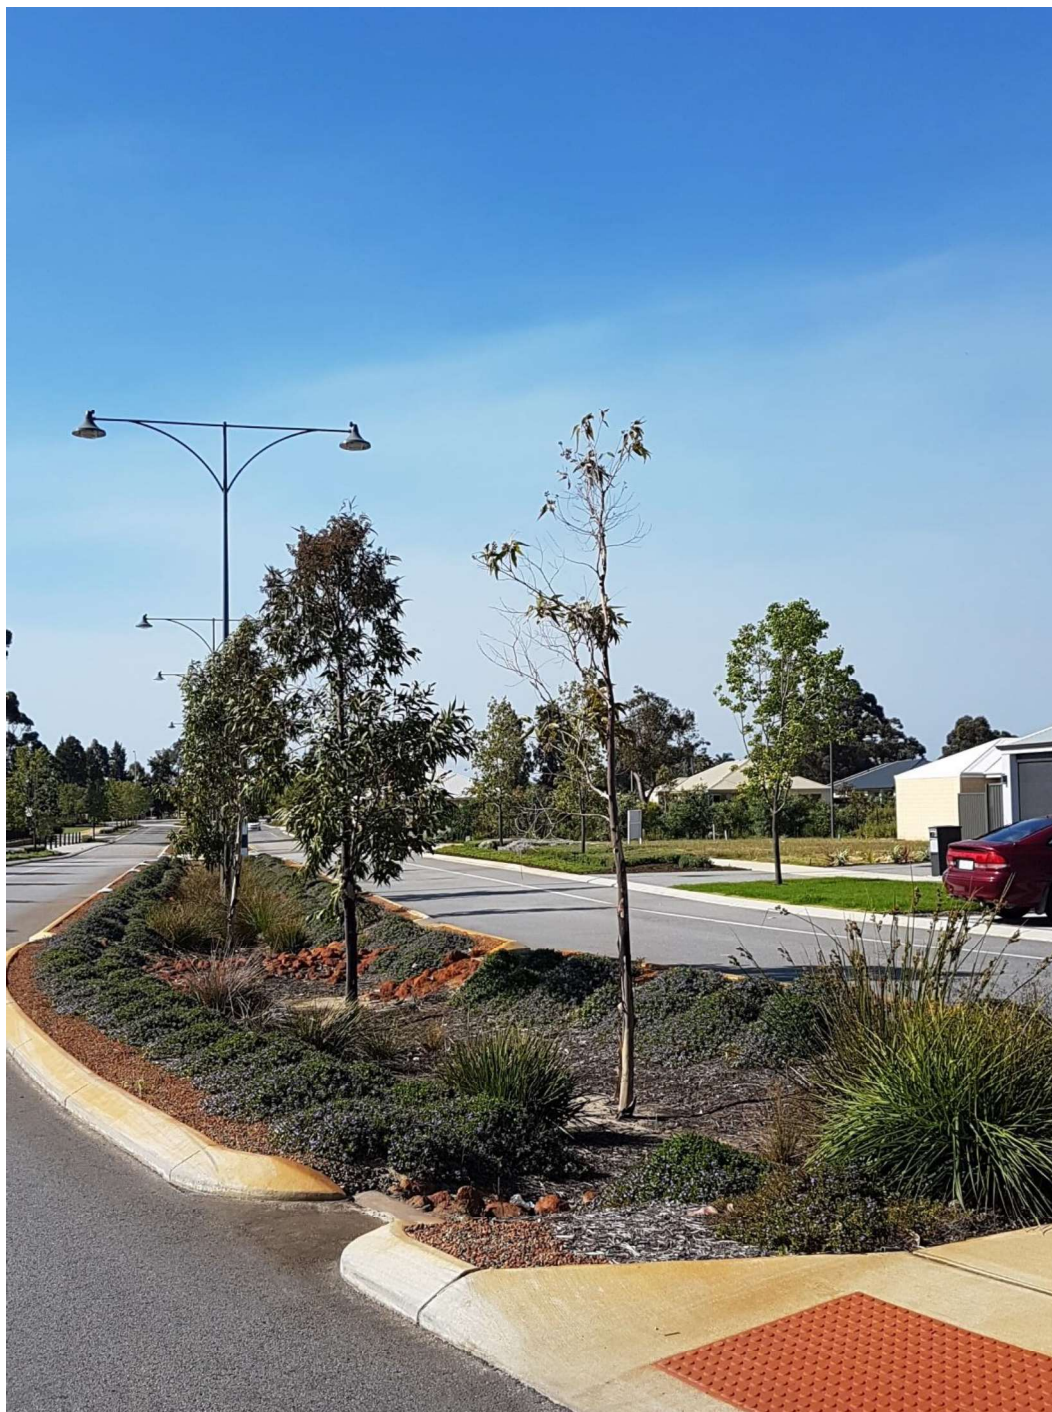
Figure 14: Example median swale arrangement

It is proposed that runoff generated by the first 15mm of rainfall onto the new road reserve will be managed in median swales within the road reserve (see example in Figure 14) while runoff from larger events will be conveyed directly into the existing downstream drainage system.

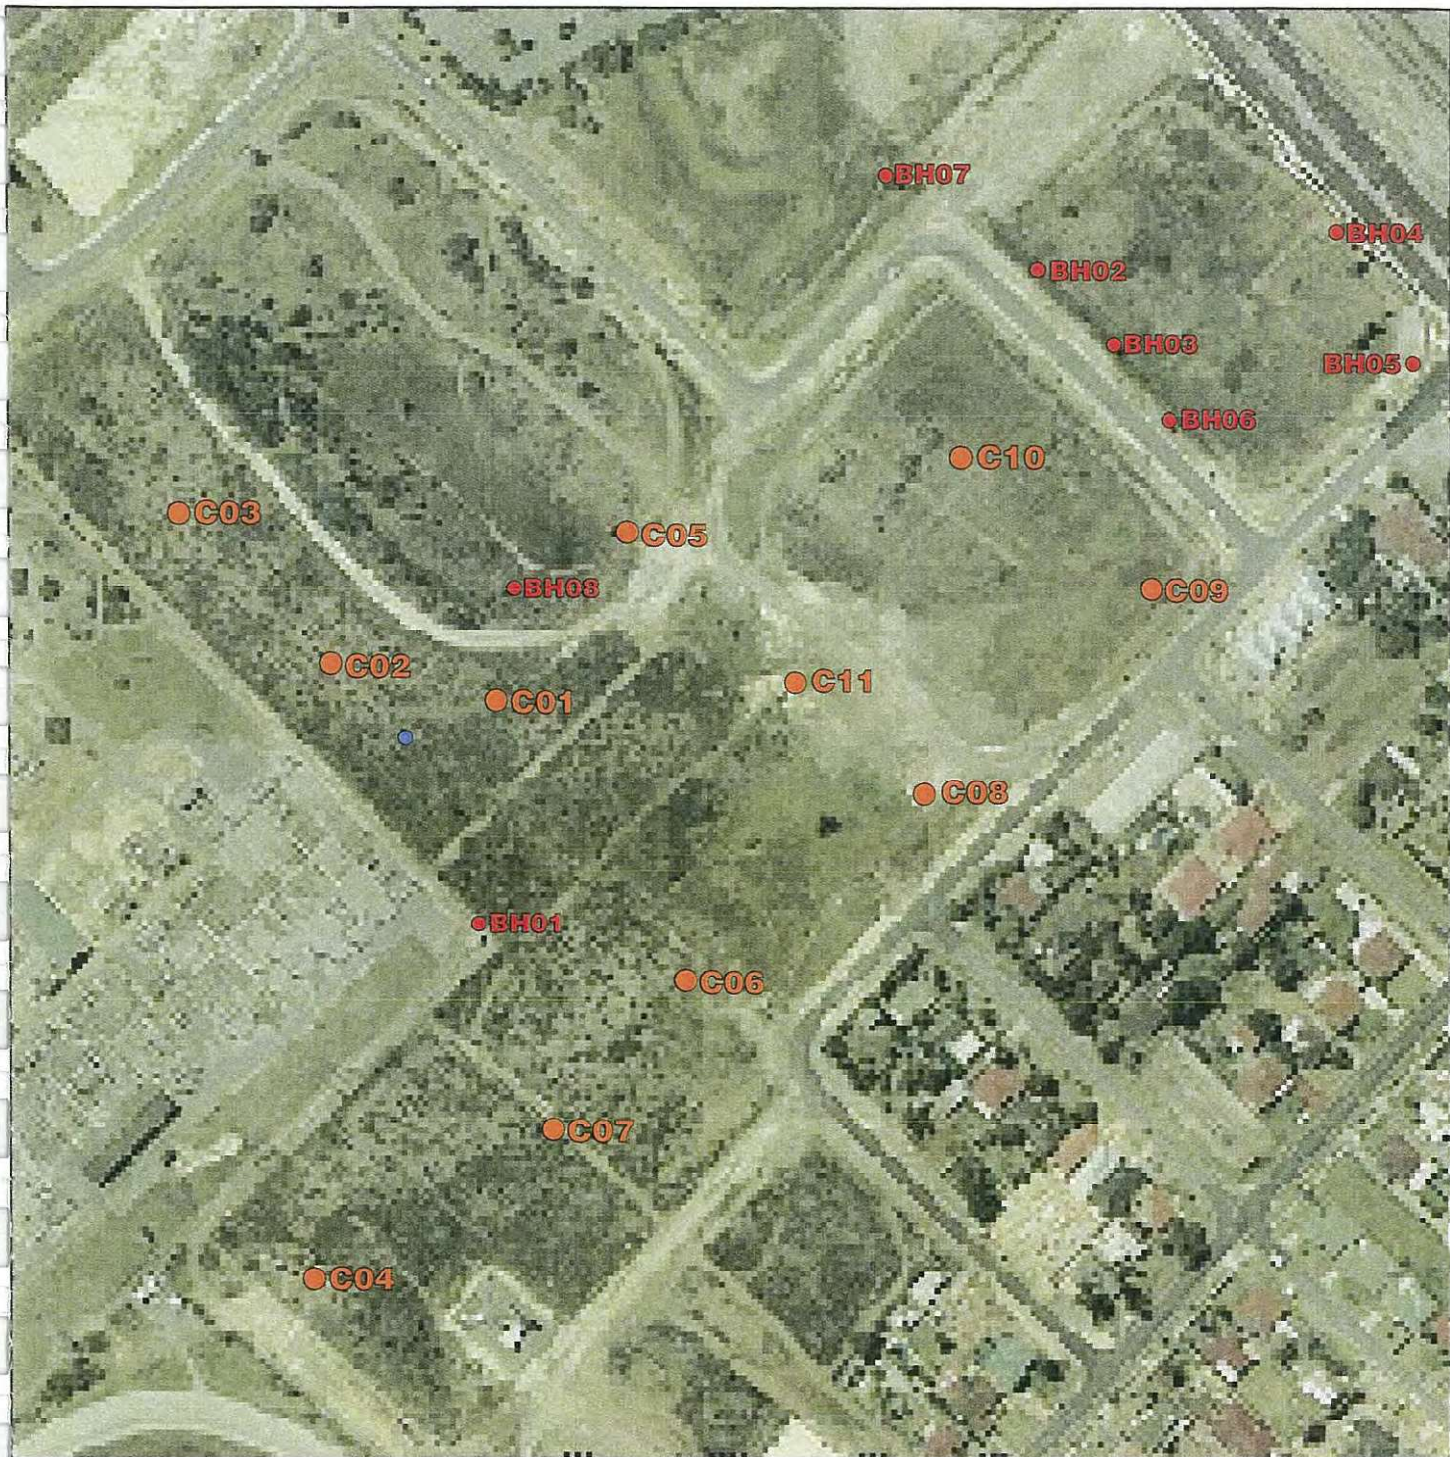
Figure 1
2142125A

Eleven bores were drilled using air-core methods to characterise the thickness of the clay layer and assist in creating a generalised map of the sites soils, geology and hydrogeology. Drilling was carried out using a truck-mounted air-core drill rig. Every effort was made to minimise vegetation disturbance and drill sites were located on access tracks and cleared areas. Soil bore cuttings were removed from undisturbed sites and piezometers were installed as temporary completions that can be removed by hand once the investigation and monitoring has been completed. Bore locations are shown in Figure 1.

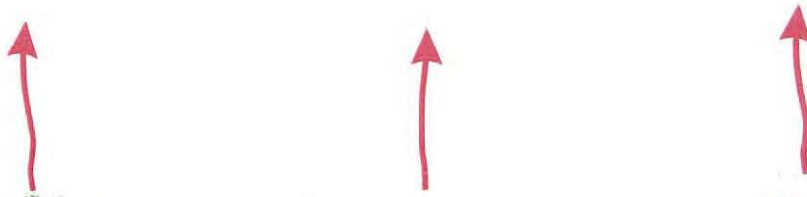
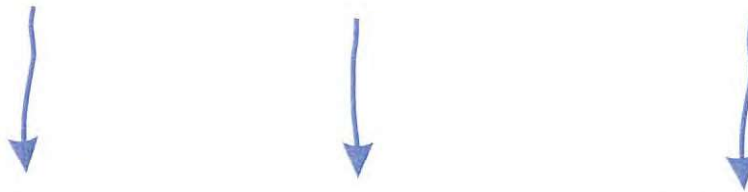
Figure 3
2142125A

Summer

Evaporation and Evapotranspiration

Surface Clay Drying

Winter

Direct Rainfall Recharge

Possible surface runoff from drainage features

Surface Clay Hydration

The presence of a dry section of the soil profile between 0.5 and 3.0mbgl in bores C01, 3, 4, 6, and 7 demonstrates the hydraulic isolation of surface water from groundwater. A schematic diagram of the Cannington Swamp hydrogeology is presented in Figure 3.
