**Varanus Island**

**Supporting documentation for a  
Clearing Permit (Purpose Permit) –  
Fire Risk Reduction and  
Maintenance Activities**

**Document No. EA-60-RI-180**

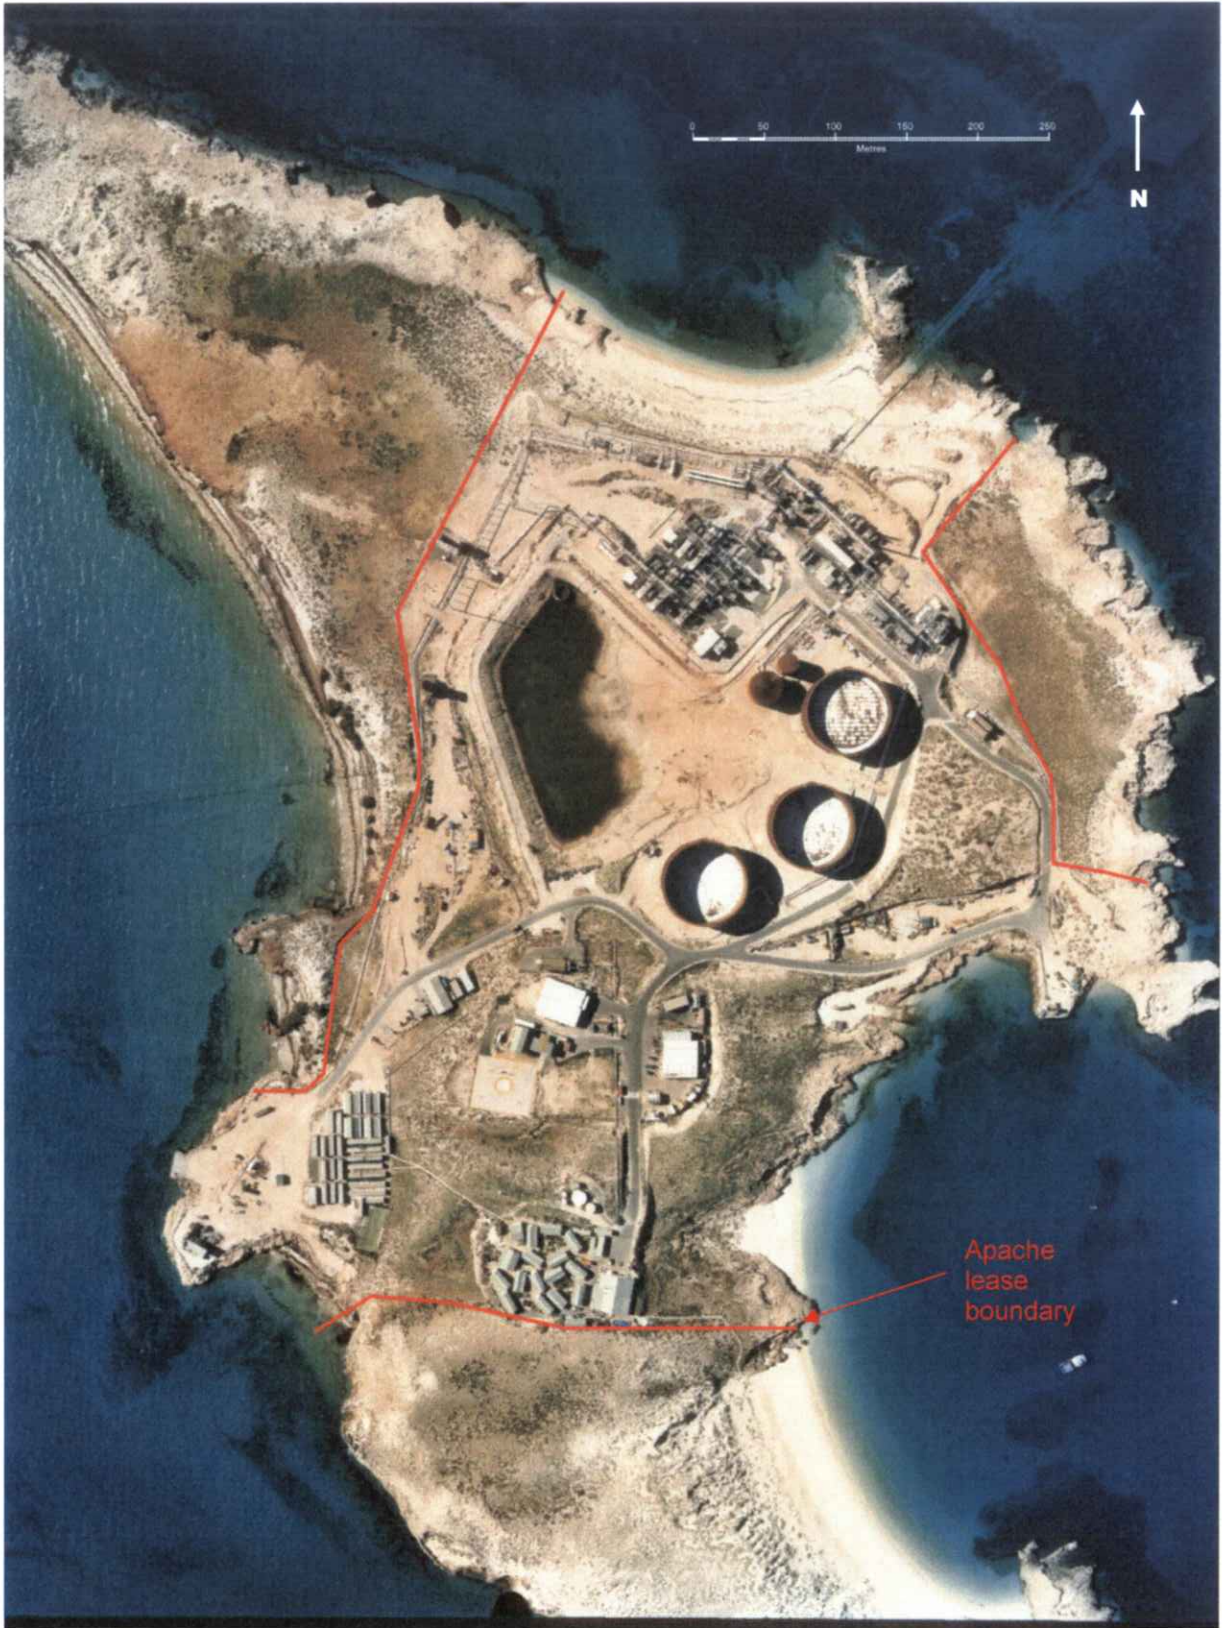
Figure 1. Apache's DCLM lease area on Varanus Island

As part of routine maintenance activities undertaken within its DCLM lease area on Varanus Island located in W.A. state waters (offshore permit TL/6), Apache Northwest Pty Ltd (Apache) may need to disturb or remove native vegetation in order to maintain existing cleared areas around dwellings and infrastructure and for fire hazard reduction. The DCLM lease area on Varanus Island is shown in Figure 1.

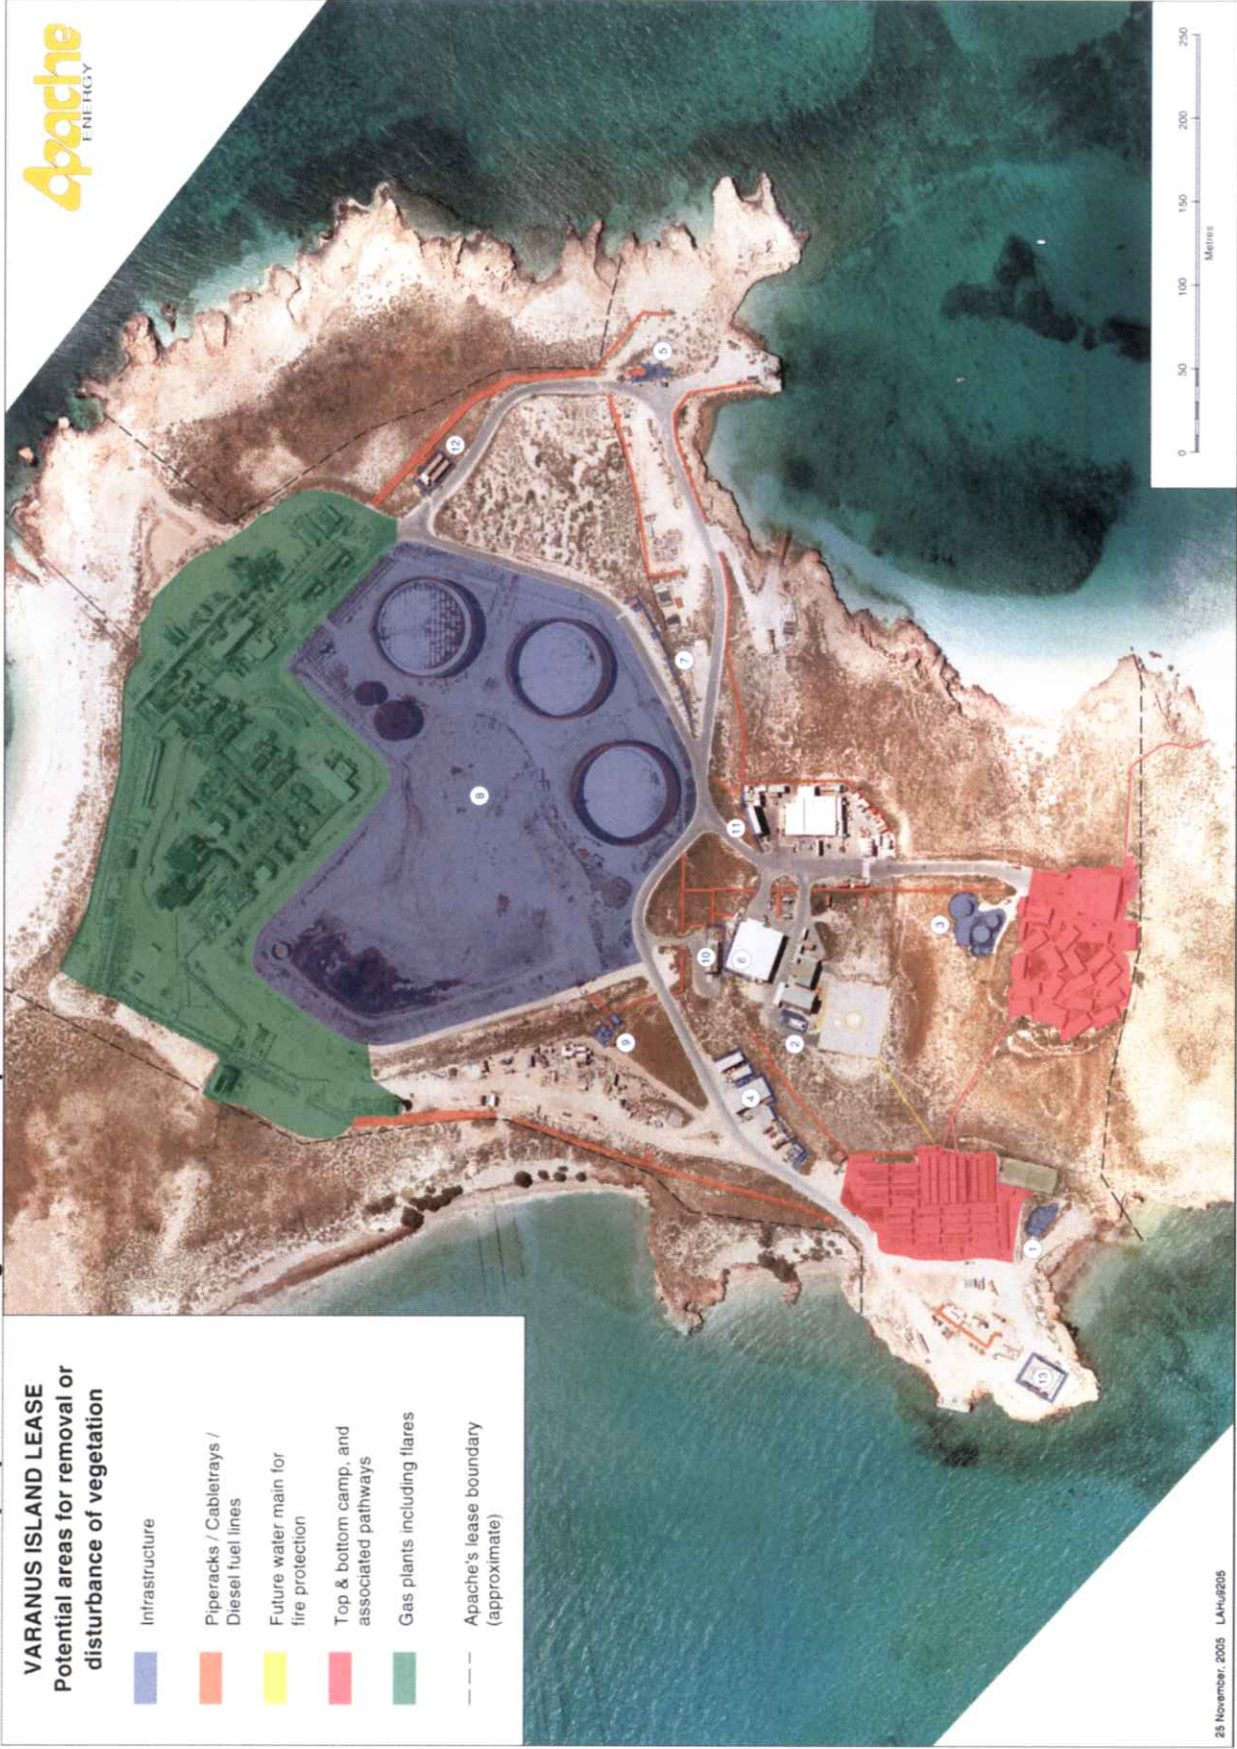
Figure 2. Location of proposed clearing areas with Apache's lease area on Varanus Island

The designated areas where the above activities would be carried out are described in Table 1 and displayed in Figure 2.

It is estimated that the total area covered by this permit application as outlined in Table 1 and Figure 2 is 9.86 ha, which represents 34% of the DCLM lease on Varanus Island. Note that the actual area of vegetation removal or disturbance within these designated areas per calendar year will be far less because

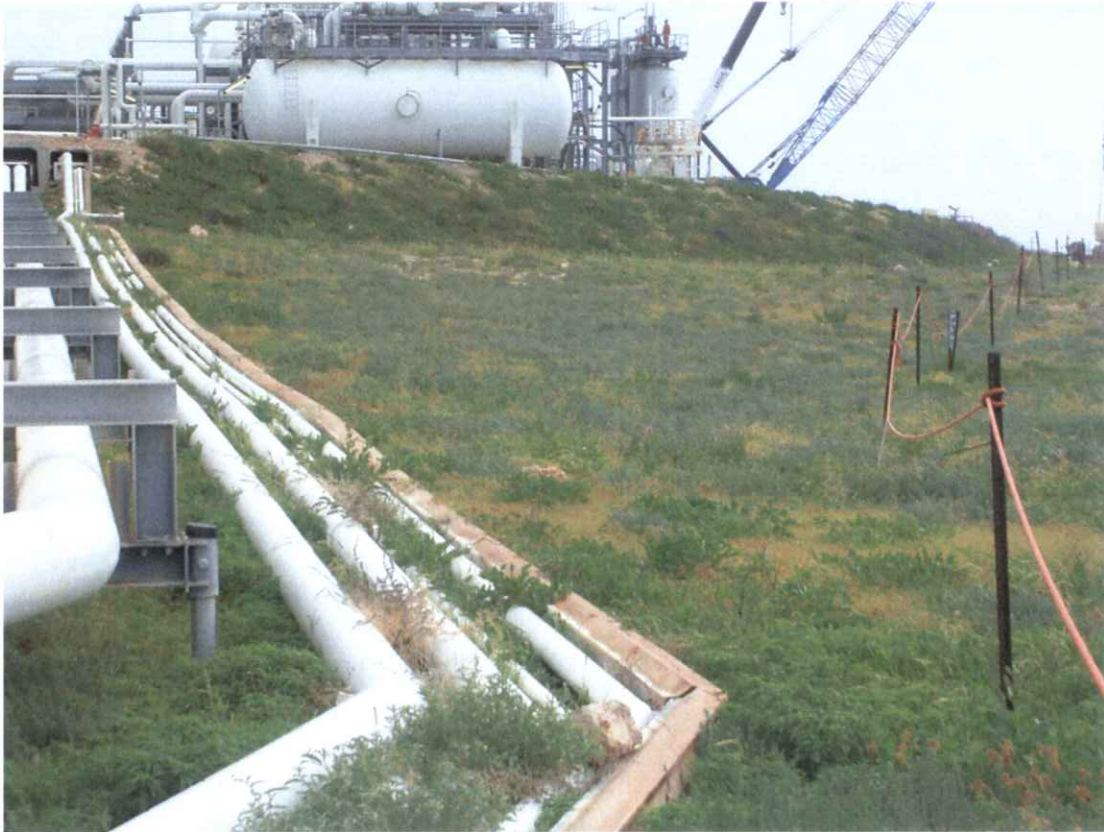
**Photo 1. Vegetation under pipelines and cable trays.**

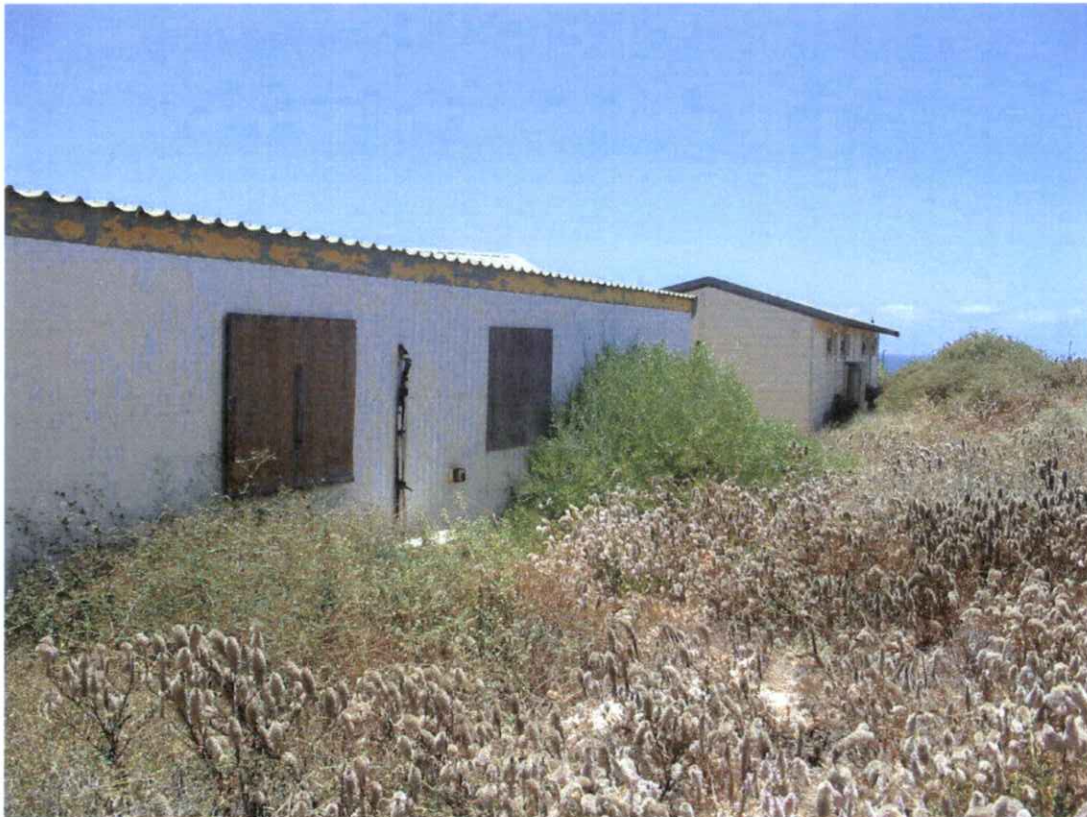
**Photo 2. Vegetation around base of accommodation units.**

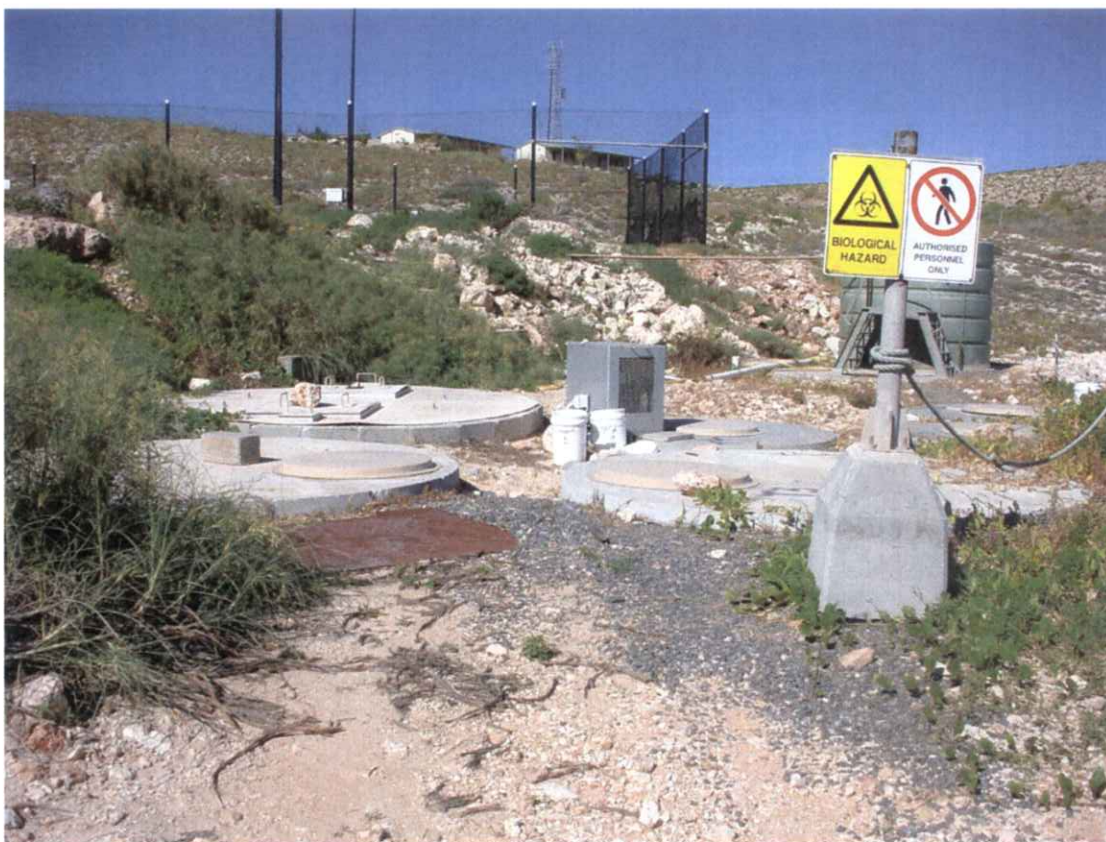
**Photo 3. Vegetation surrounding sewage farm tanks.**

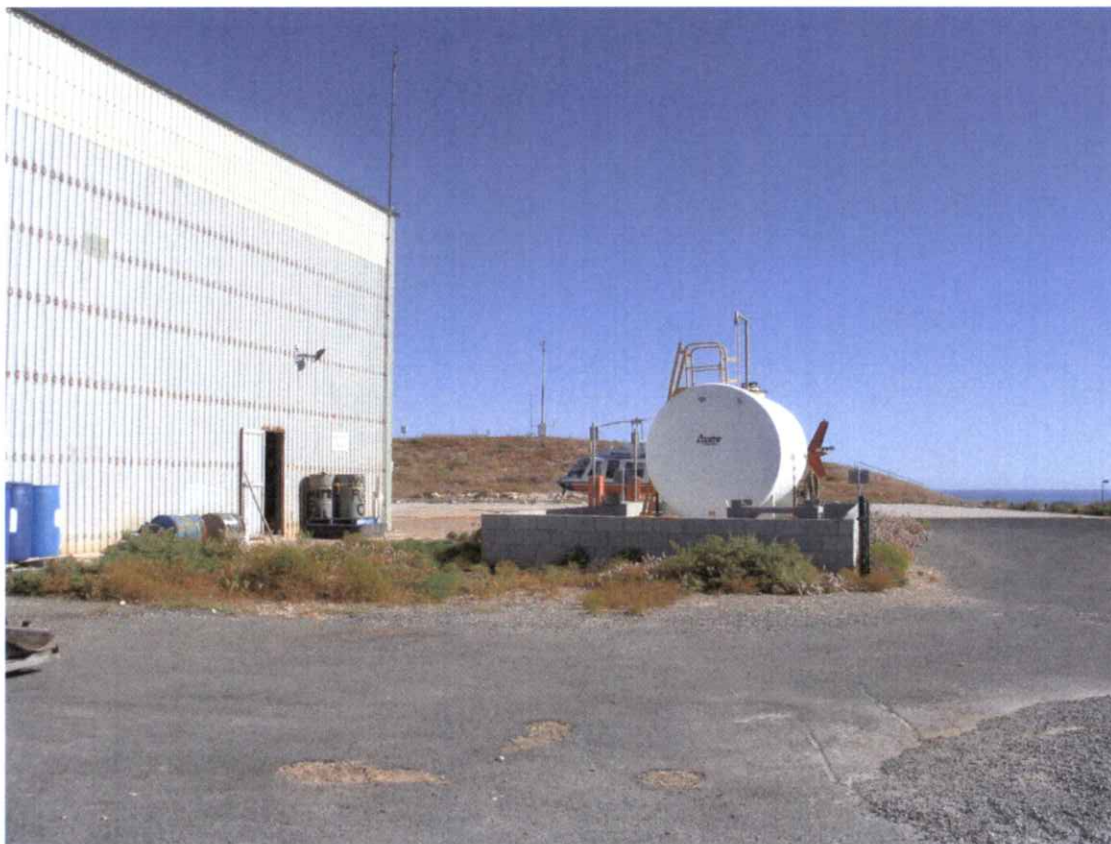
**Photo 4. Vegetation around the helicopter Jet Fuel tanks.**
