Environmental survey

Verge vegetation – 17 Burton Rd Darlington

5 January 2023

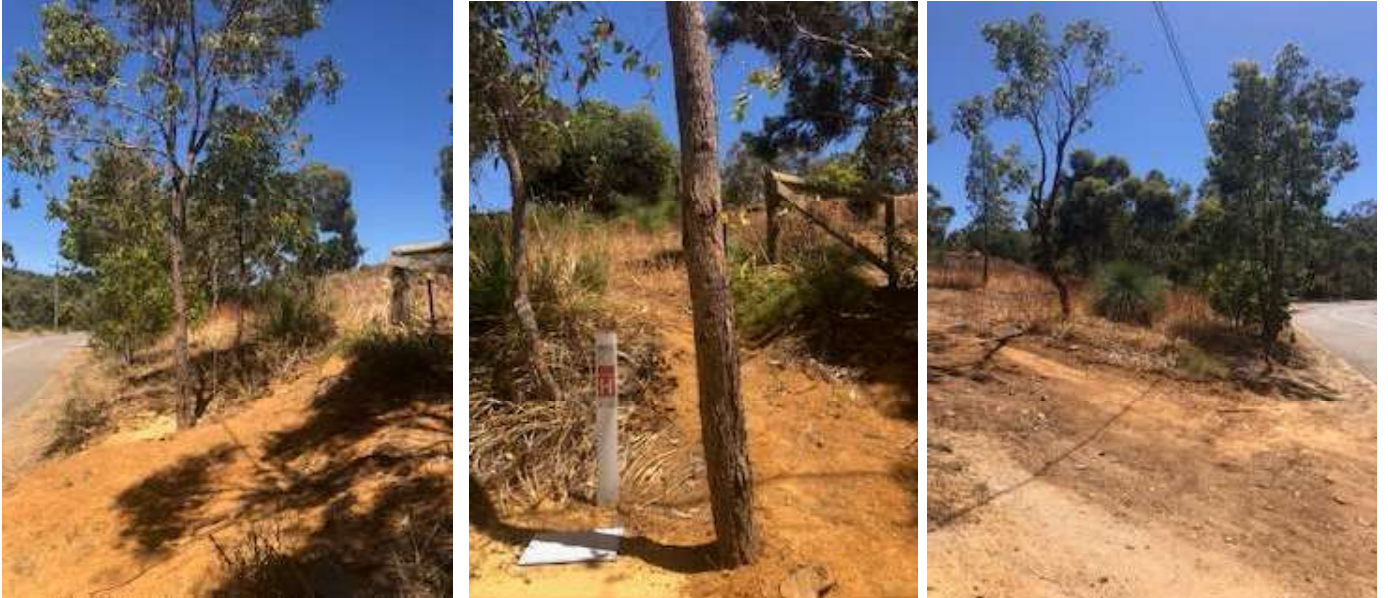
Photos 1-3 (above): Vegetation along the verge at 17 Burton Rd, Darlington. The area is dominated by watsonia weeds, with some small grass trees and *Corymbia calophylla* (Marri) saplings approximately 10-15cm DBH. No significant vegetation found within the clearing permit area and the alignment should be able to avoid the majority of native vegetation.

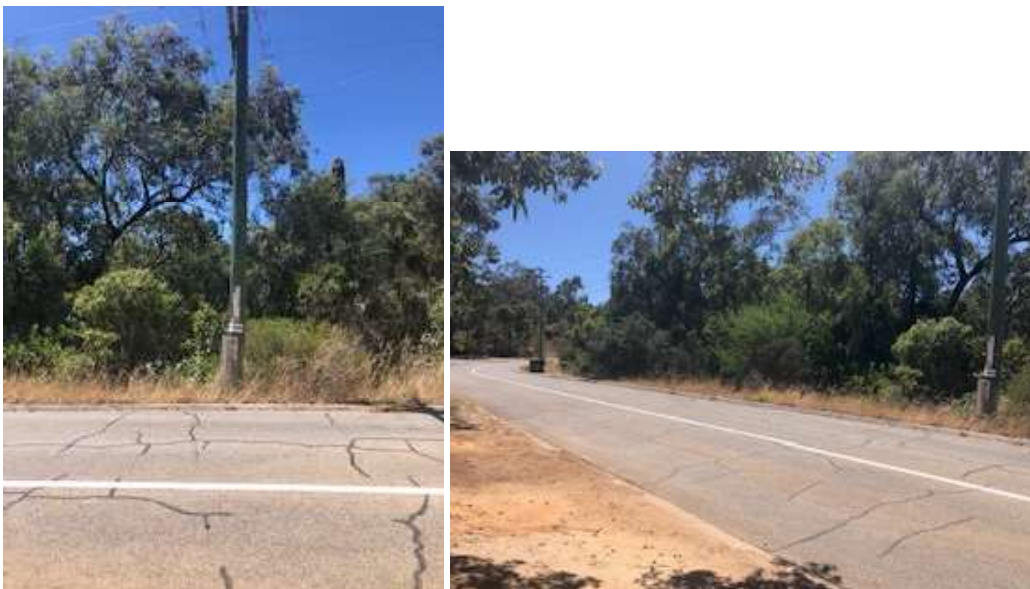
Photos 4 & 5 (above): Vegetation on the southern side of Burton Rd, surrounding power pole S186623. The vegetation that would be impacted by the clearing for the utility installation is weedy grasses, watsonia and polygala. No significant vegetation identified.
