Southern Site – Detail A -

Northern Site – Detail B -

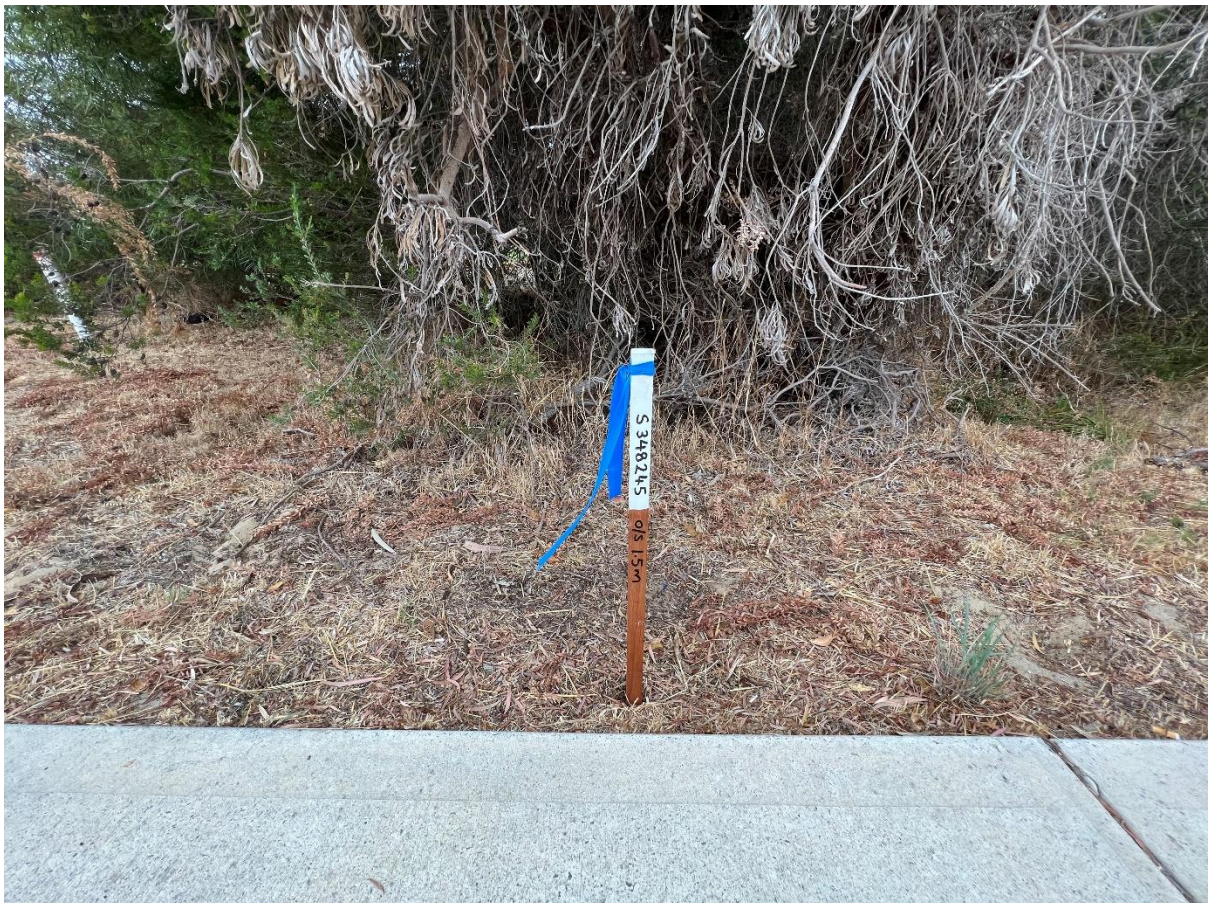
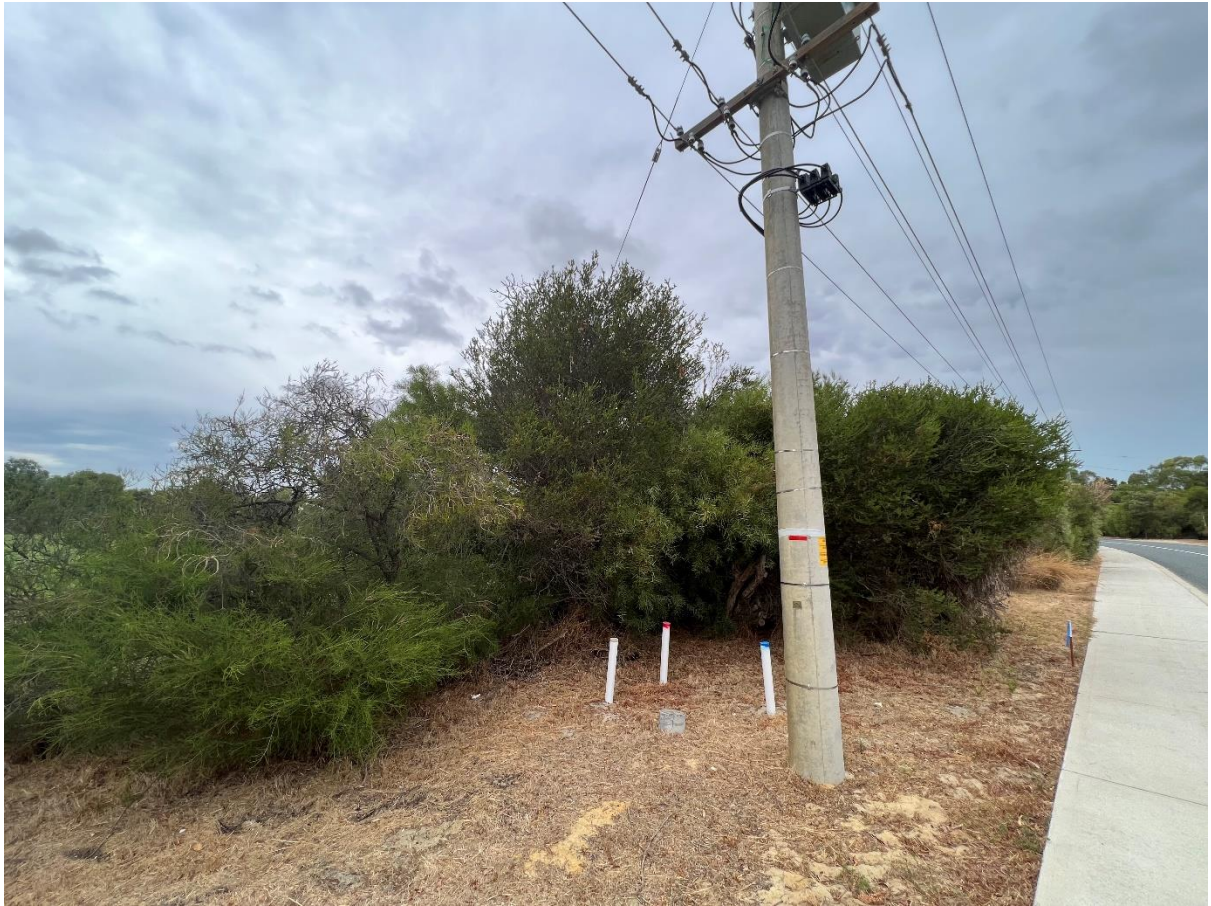
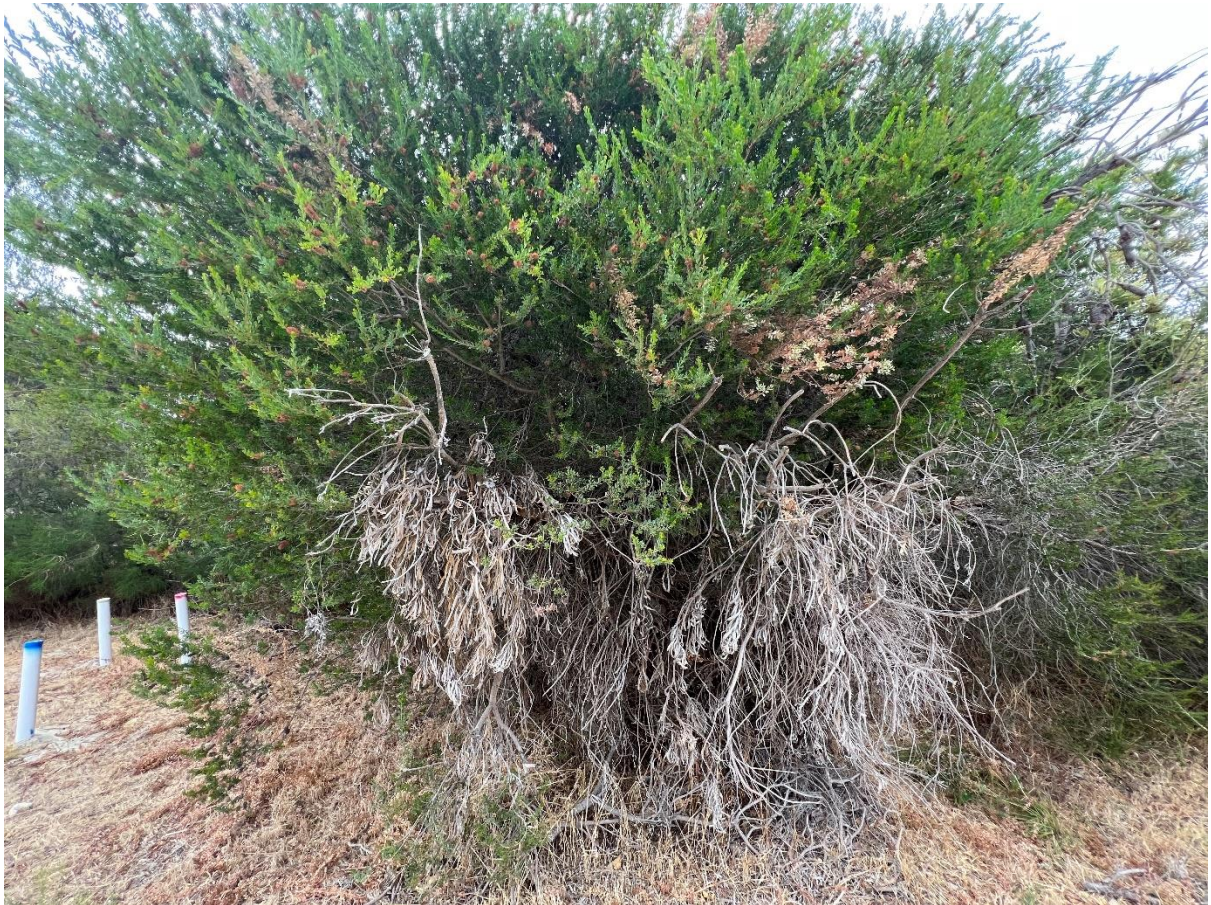
Photos (S348245):

Comments for S348245: Peg is offset by 1.5m. One tree (shown above) to be removed. Pruning to be done to provide access and allow easier removal of power pole guy-cable.

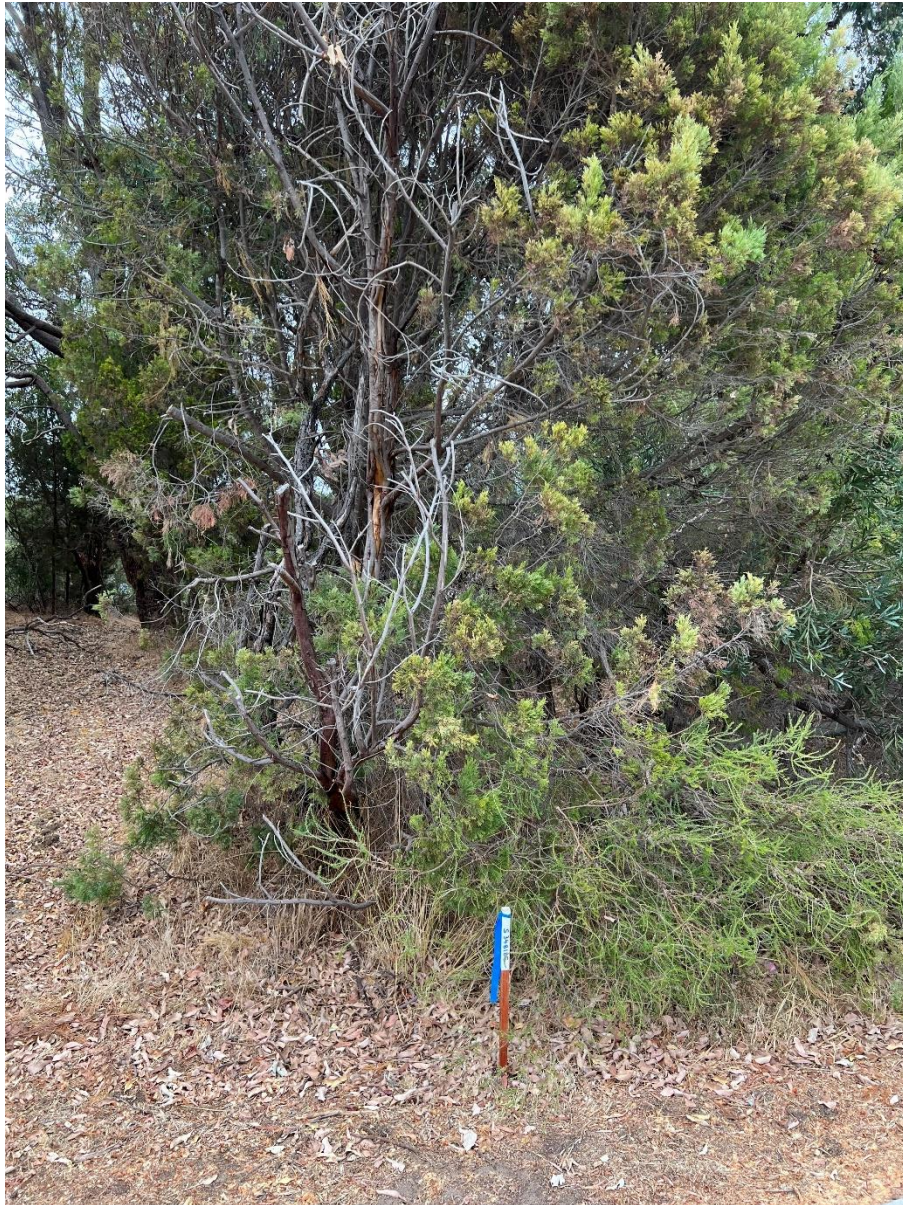
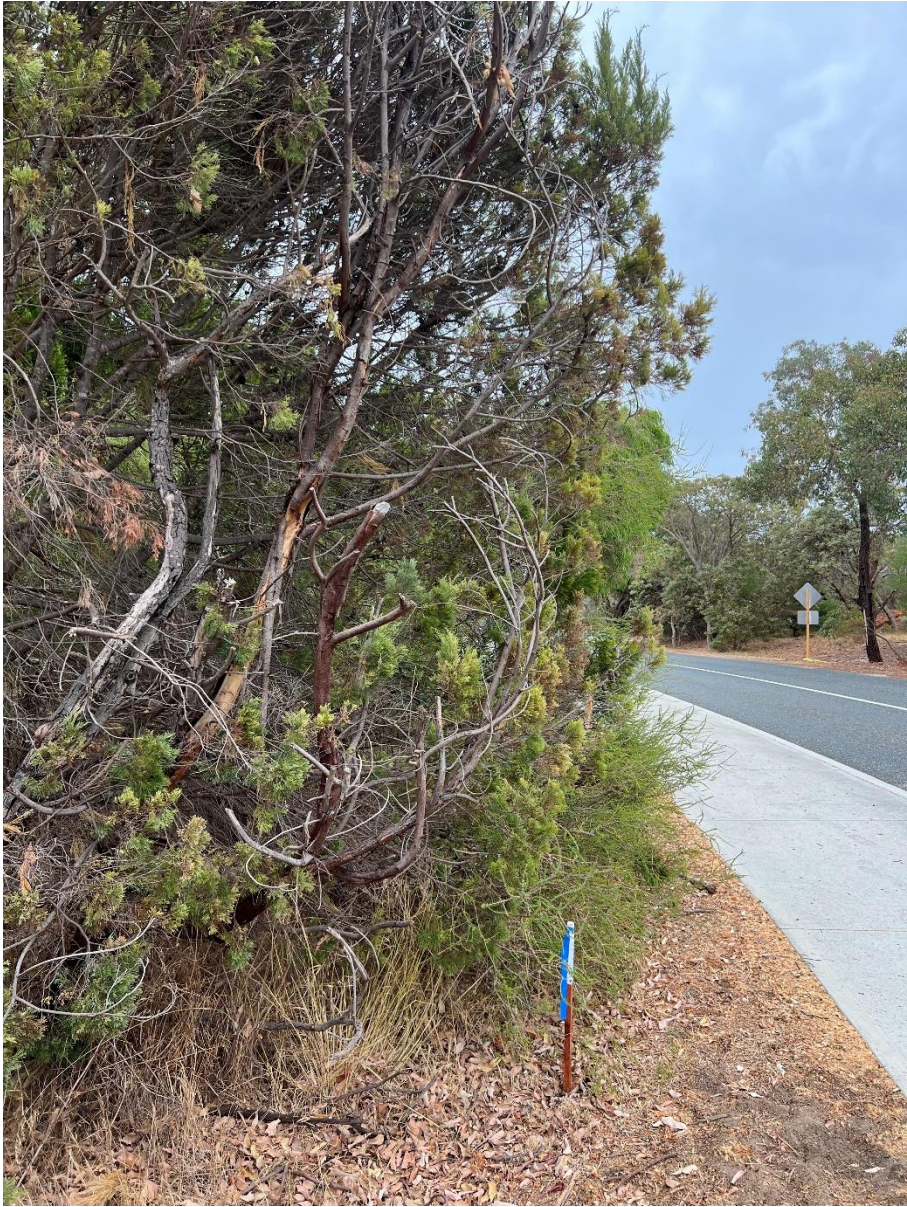
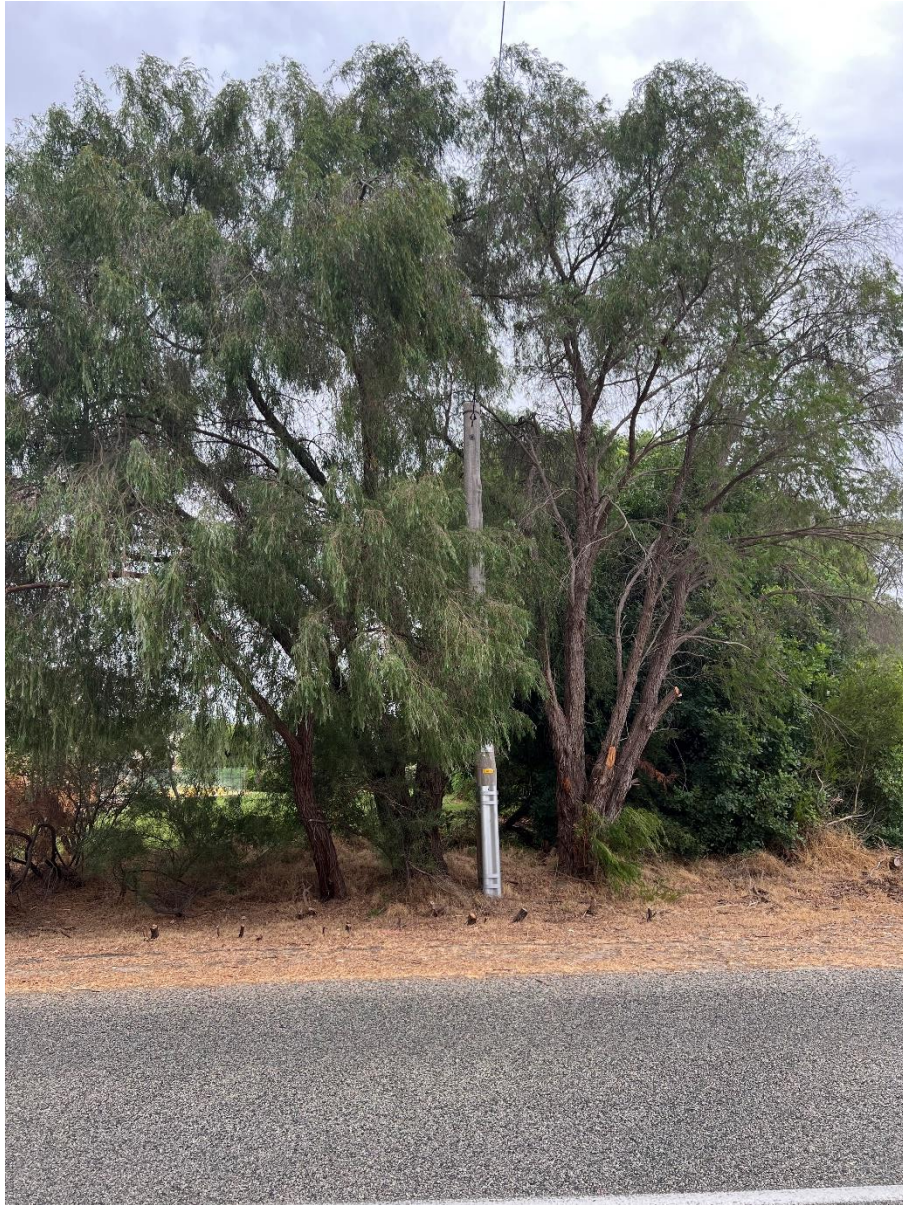
Photos (S348185):

Comments for S348185: Pruning of branches required behind peg location (pruning up to about 2m behind peg, full height). No pruning required for branches around stay-pole and guy-cable unless advised.
