# MEMORANDUM

## Albemarle Corporation

### Clearing Permit Referral: Picture Attachments

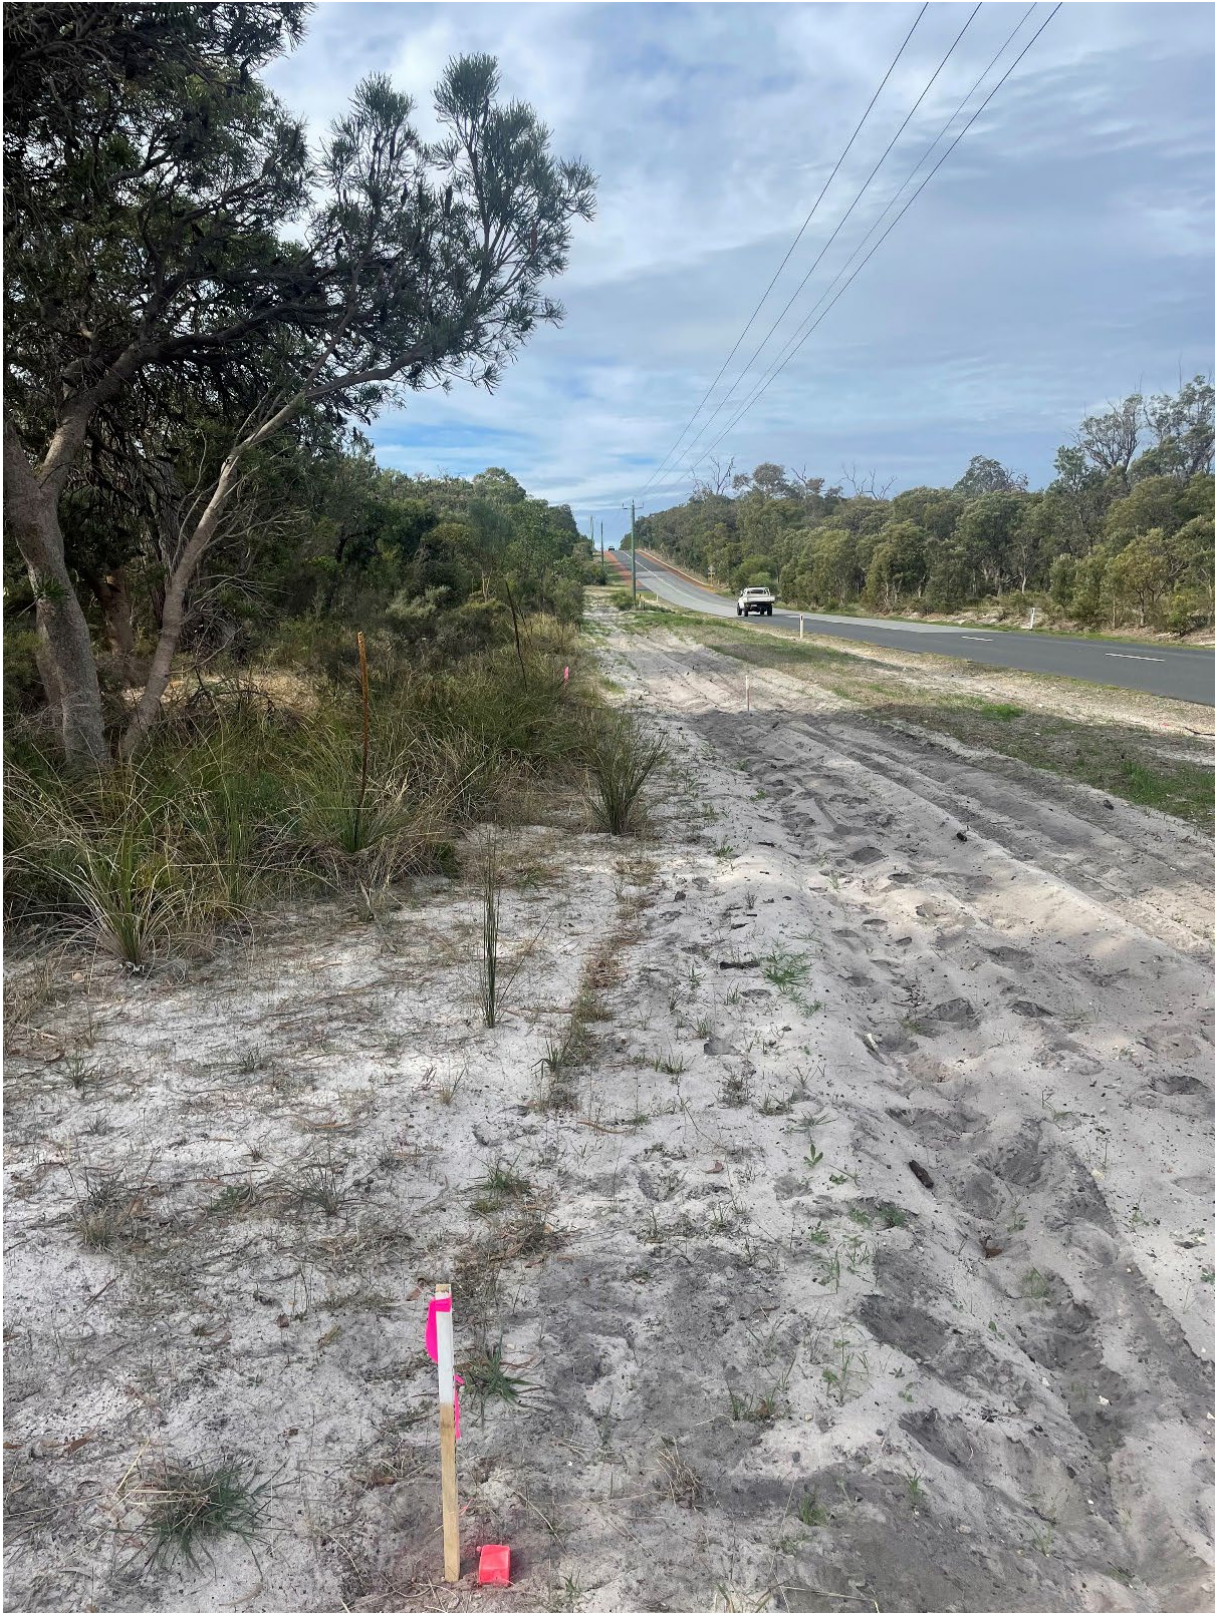
Almost all of Construction Area A has previously been cleared, however in Clearing Area 2 (Points E, F, G and H) there are some plants that may potentially be damaged. In Figure 1 below, the two pink markers indicate points E and F. Between these points there are several plants that may be incidentally damaged.

Figure 1: Vegetation within Clearing Area 2 at Construction Detail A (E to F)

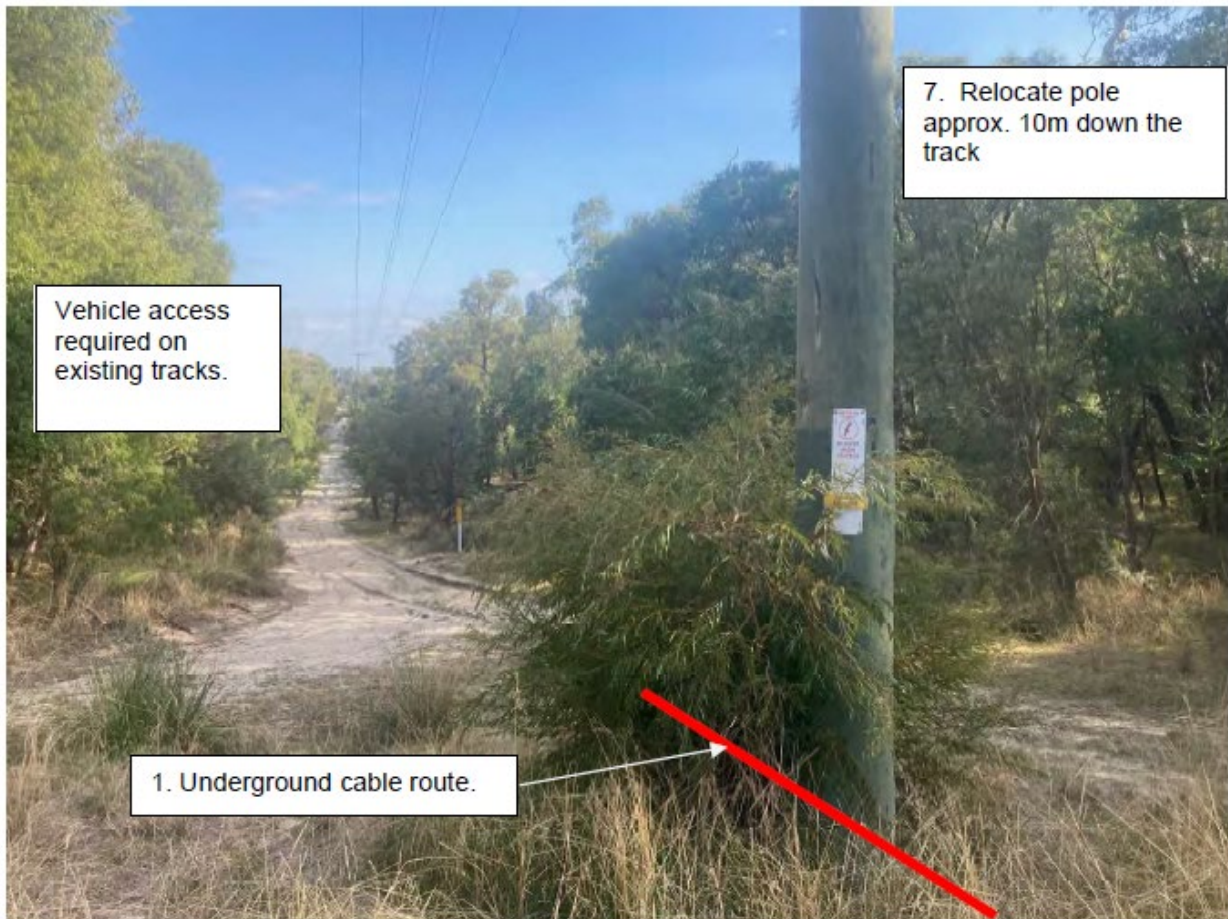
In Figure 2 below, works to remove and relocate pole S740403 may result in the damage or clearing of vegetation in close proximity. There are two individual plants located close to the pole that will likely be damaged.

Figure 2: Relocation of pole S740403 (currently 10m from J) in Construction Detail B (J to I)

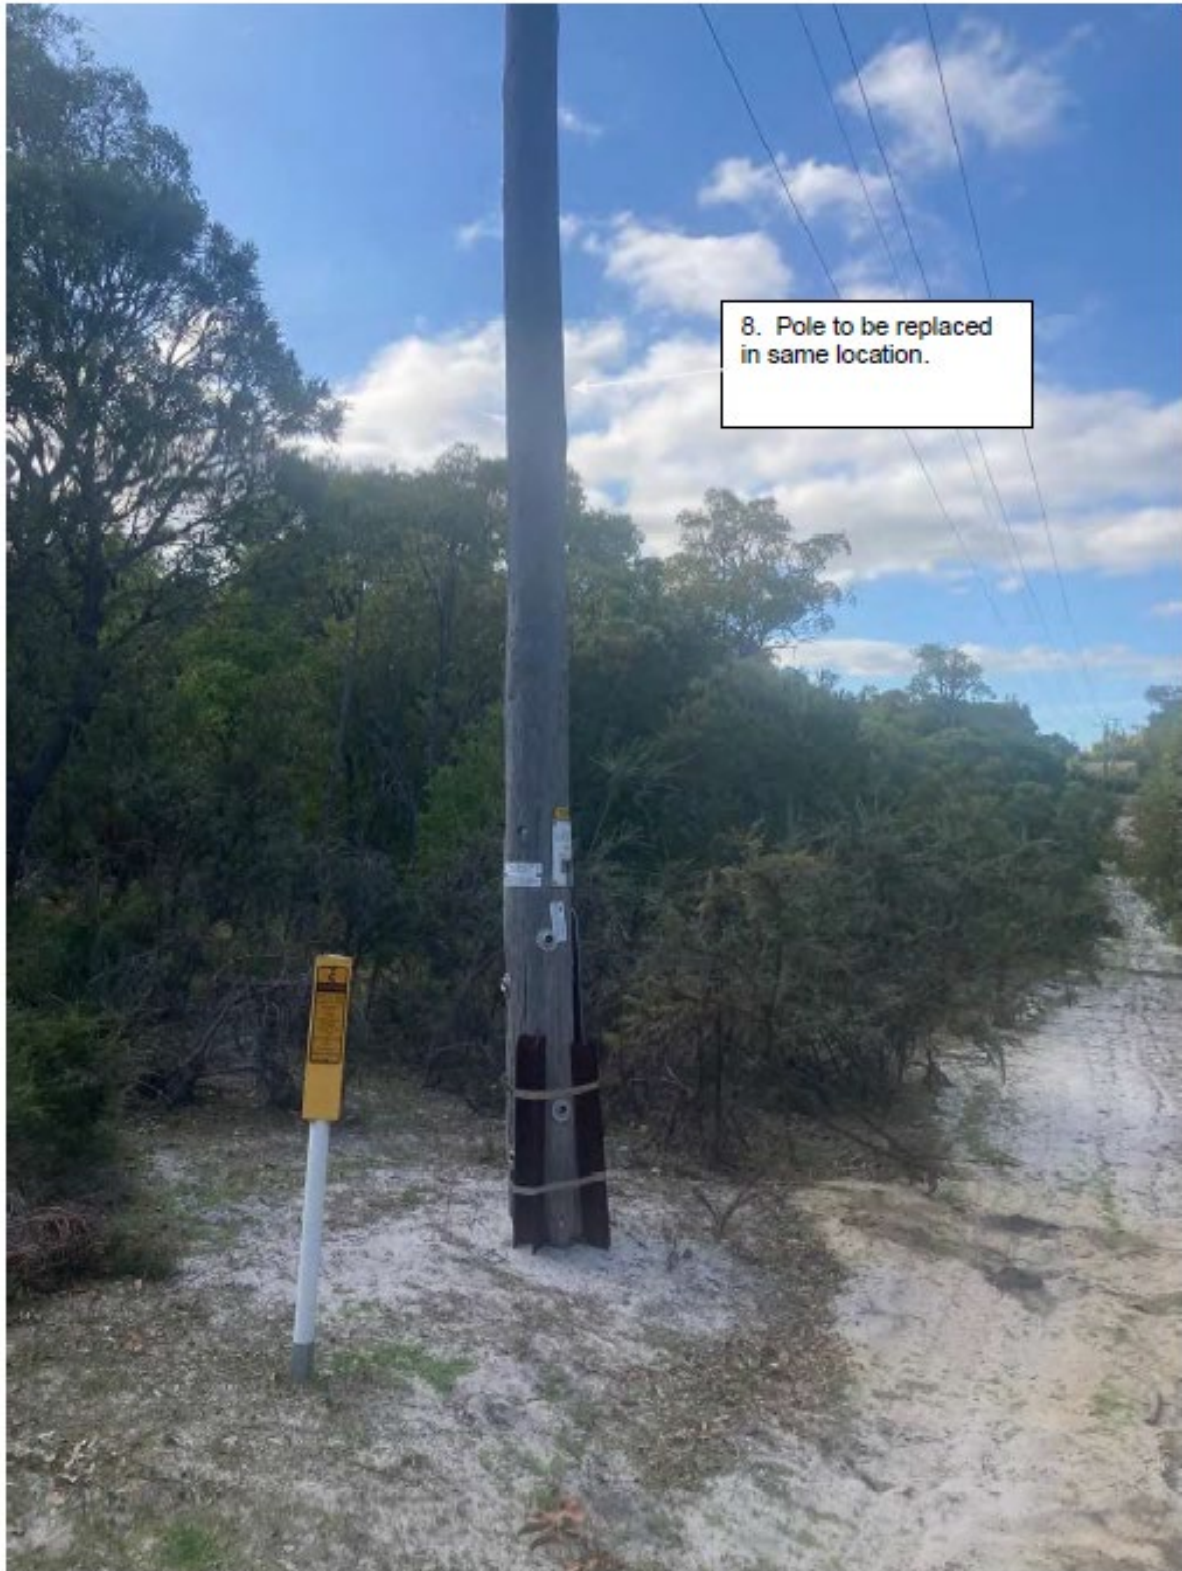
In Figure 3, works to remove and replace pole S740404 may require the pruning of nearby vegetation. It is possible that there will be incidental damage to nearby vegetation.

Figure 3: Pole S740404 to be replaced in its current location (10 m from I) in Construction Detail B (I to J)
