Kerosene Lane Native Vegetation Clearing Permit Referral: Supporting Information

1.0 Appreciation of the Scope

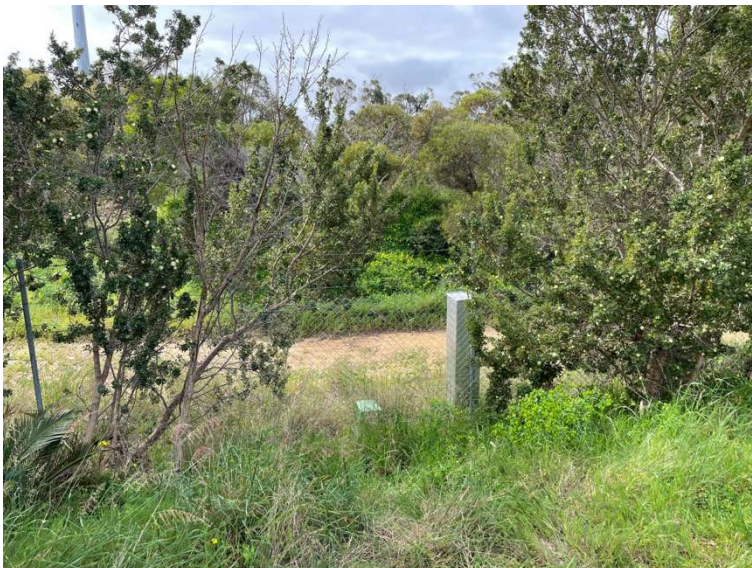
- Fig 1a and Fig 1b shows the location where the mini pillar will be upgraded to the Uni Pillar on the northern side of the road within the edge of Lot 800 adjacent to the road reserve; and
- Fig 2a and Fig 2b shows the location of the cable trenching on the southern side of the road within the road reserve to meet up with the existing pillar.

Fig 1a: Location of mini pillar to uni pillar upgrade on the edge of Lot 800.

1. Between one and three *Banksia sessilis* (Parrot bush) shrubs around the pillar upgrade on the northern side of the road; and
2. Seven individuals within the southern road reserve consisting of:
 - four *Macrozamia riedlei* (Zamia) cycads,
 - one *Hibbertia hypericoides* (Yellow Buttercups) shrub,
 - one almost dead *Jacksonia sternbergiana* (Stinkwood) shrub.
 - one *Ptilotus polystachyus* (Prince of Wales Feather) herb.

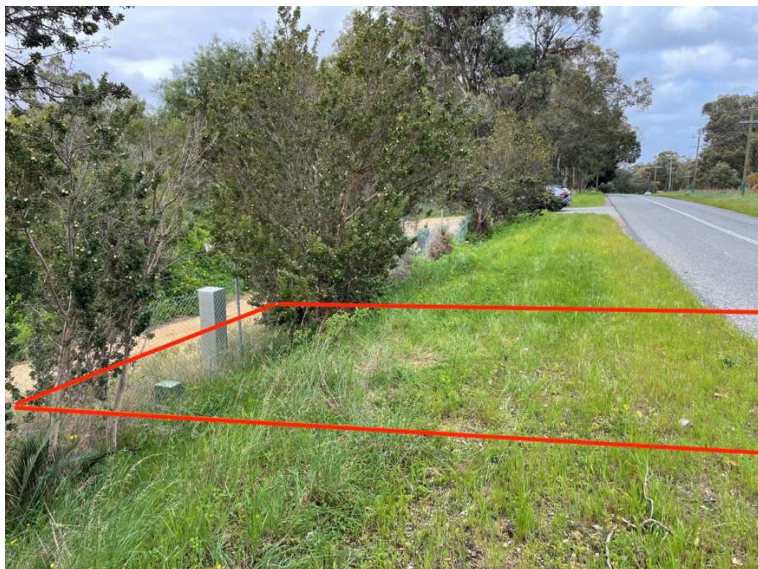
Fig 1b: Location of mini pillar to uni pillar upgrade on the edge of Lot 800 adjacent to the road reserve.
(Approximate boundary of indicative impact area marked in red).

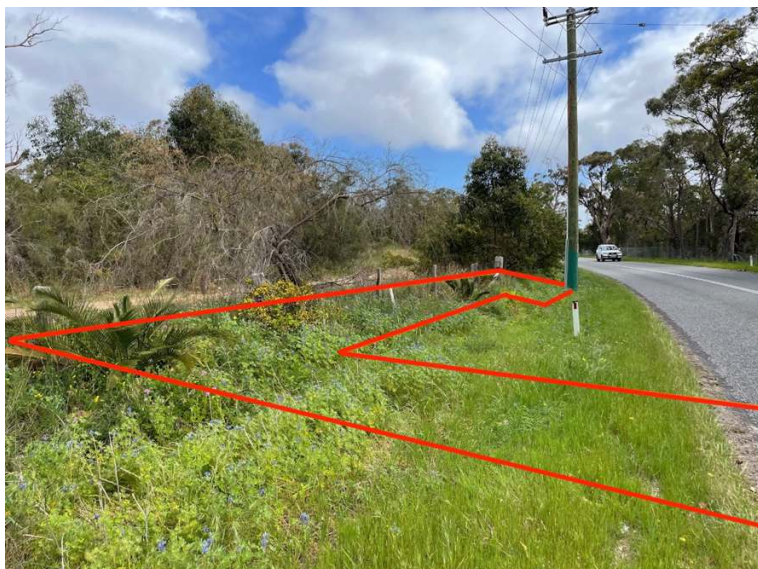
Fig 2a: Location of proposed trenching in the southern road reserve towards the proposed connection at existing power pole.
(photo taken facing west along Kerosene Lane).
(Approximate boundary of indicative impact area marked in red).

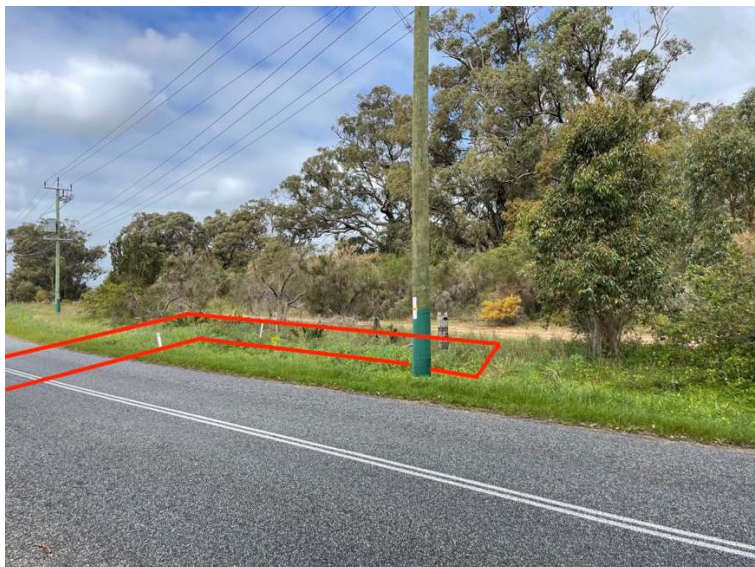
Fig 2b: Showing the same as Fig 2a but facing east along Kerosene Lane from existing power pole.
(Approximate boundary of indicative impact area marked in red).

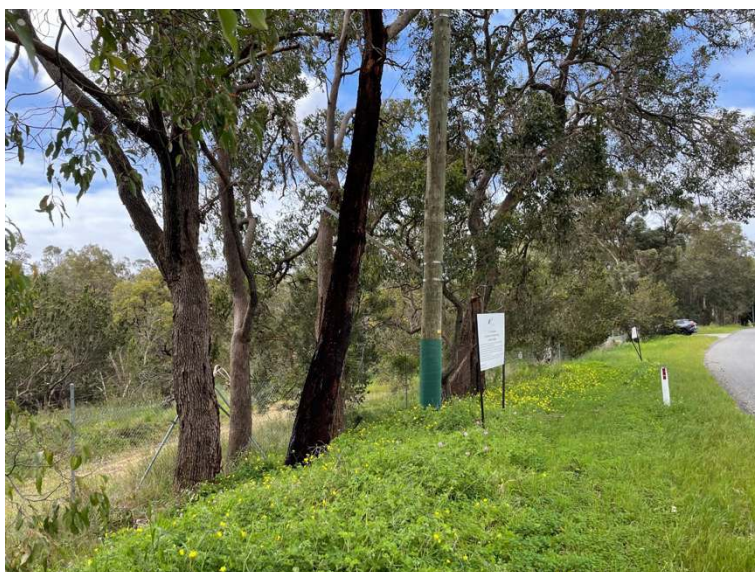
Fig 3a: Patch of Marri trees to the west of the proposed pole installation location.

The installation of the power pole upgrade and power cable will be constructed according to the scope and design plan of Western Power (Attachment 1). It is noted that the design for the cable laying utilises the southern road reserve rather than the northern road reserve, which means that impact to the patch of Marri trees to the west of the proposed pole installation location (Fig 3a and Fig 3b) is avoided.

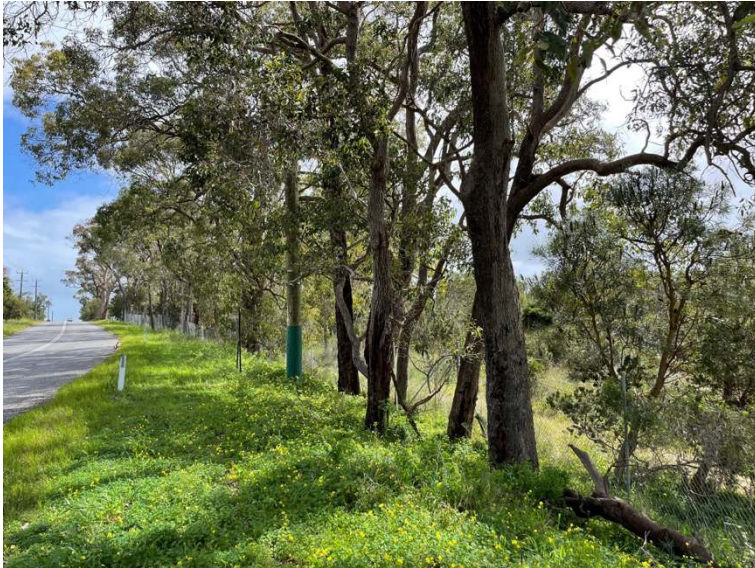
Fig 3b: Showing the same as Fig 3a from the opposite direction.
