Native Vegetation Clearing Referral – Site Inspection Report Sand Back Pass Pipeline and Pathway Upgrades

Report by –
Katherine Walkerden (BSc, MEnvSc) Environmental Officer

February 2024

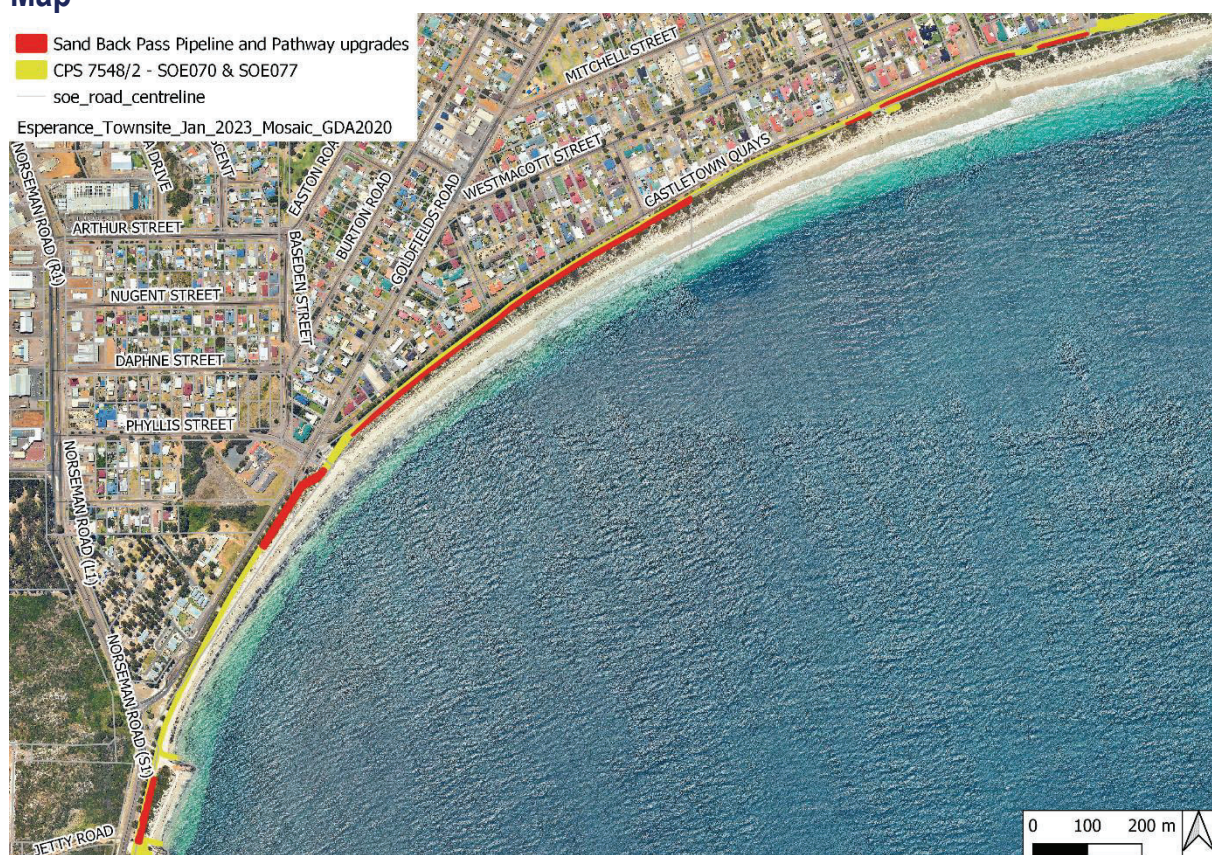
Figure 1. Location of Sand Back Pass Pipeline and Pathway Upgrades and previously approved CPS 7548/2 SOE070 and SOE077

The Shire of Esperance has proposed to clear 0.570 ha of vegetation within several reserves, for the purpose of sand pipeline and pedestrian path construction. This is located along Castletown foreshore, west of Bandy Creek, within the Esperance Townsite.

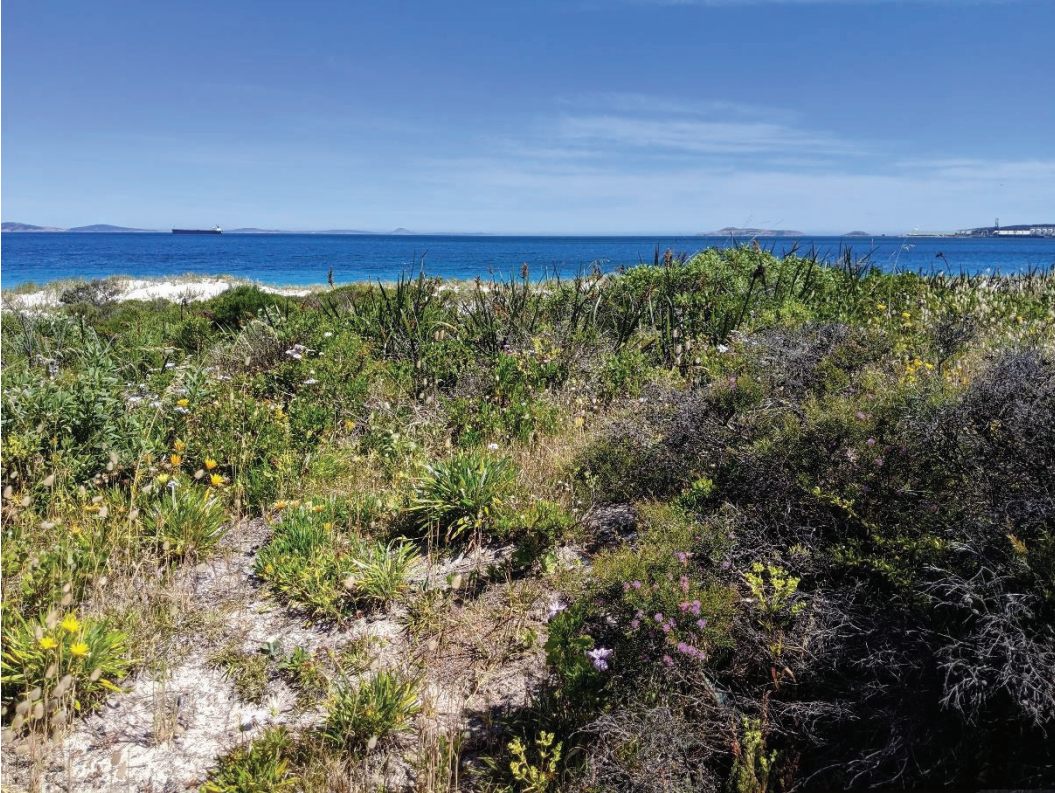
Figure 3. Photo of vegetation present within the project area. Taken at 400012m E 6255470m N GDA95 Zone 51, facing west. Taken by Katherine Walkerden on 16/11/2022.

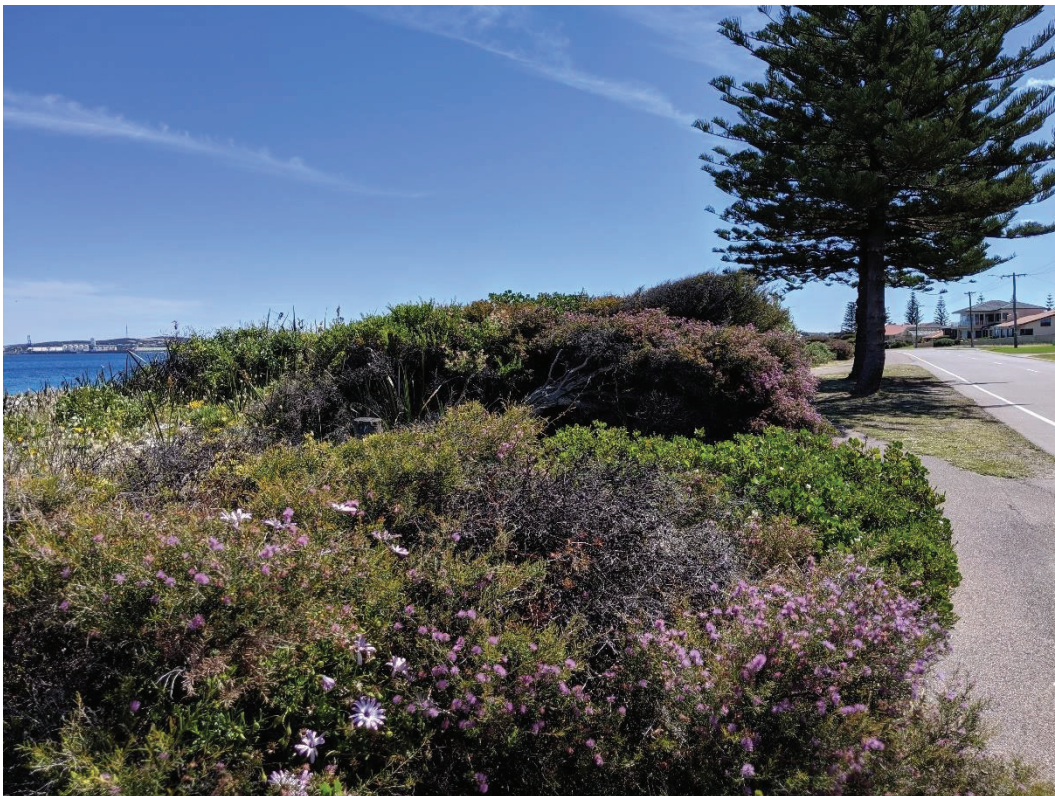
Figure 4. Photo of vegetation present within the project area. Taken at 399143m E 62550590m N GDA95 Zone 51, facing west. Taken by Katherine Walkerden on 16/11/2022.
