## OBSERVATION ON VEGETATION AT HANRAHAN RD WASTE FACILITY

A site visit was made to the Hanrahan Road Waste Facility on the 13<sup>th</sup> and 19<sup>th</sup> February 2024 by Green Skills Inc to document the native and introduced flora within three sites. All three sites have had significant disturbance associated with the adjoining landfill site and have a wide range of environmental weeds present with limited native vegetation occurring.

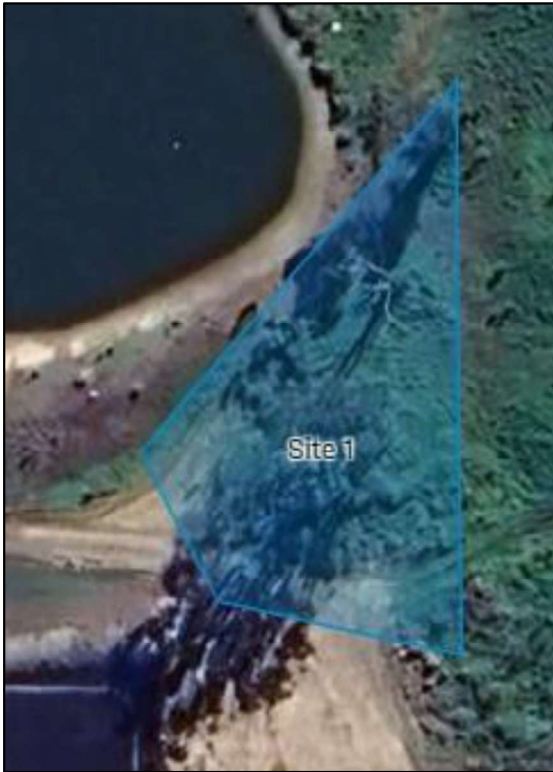
## SITE 1

**Condition** – Completely Degraded

**Vegetation** – stand of large non-local Eucalyptus species with one small Paperbark tree (*Melaleuca preissiana*) in the northern point of the site. Understory is a mix of environmental weeds dominated by Kikuyu (over 90%) and annual grasses.

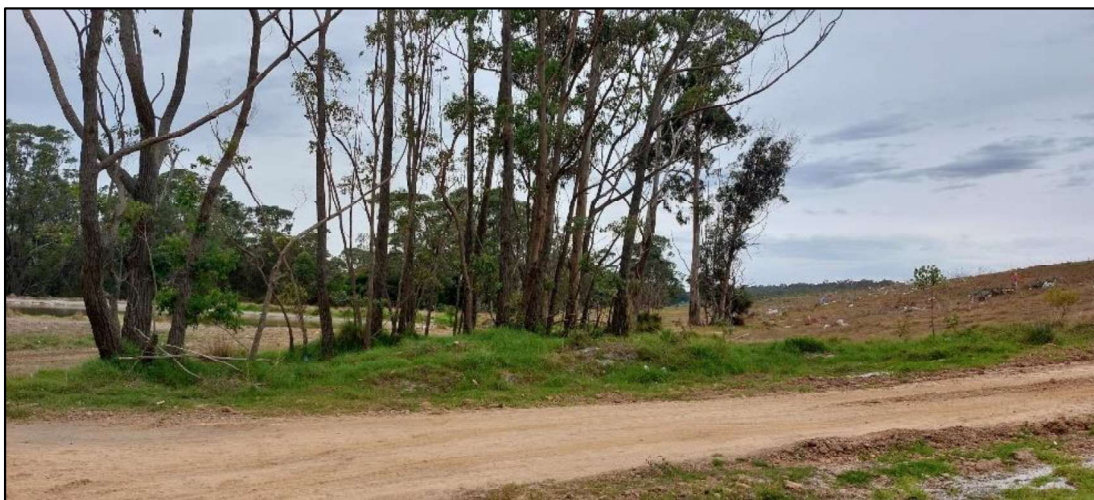
Photo 1: showing stand of non-local Eucalyptus trees and completely degraded understory in Site 1

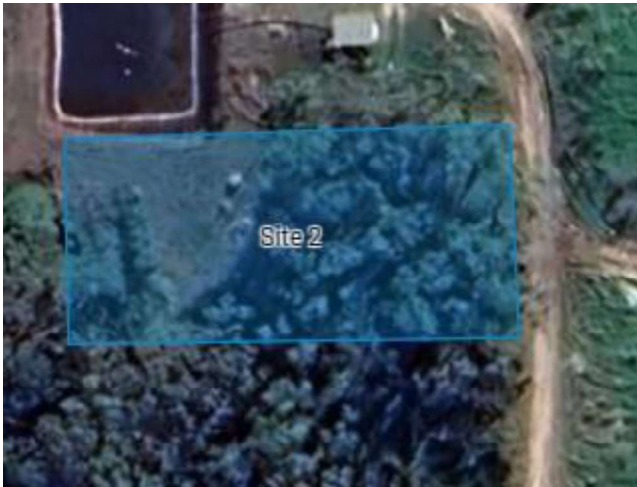
## SITE 2

**Condition** – Completely Degraded

**Vegetation** – dense stand of large non-local Eucalyptus species with one small Paperbark tree (*Melaleuca preissiana*) and five mature Wonnich (*Callistachys lanceolata*) scattered within the site. Understory is a mix of environmental weeds dominated by Kikuyu (over 90%) and annual grasses and the mid-story is dominated by Taylorina (*Psoralea pinnata*) shrubs.

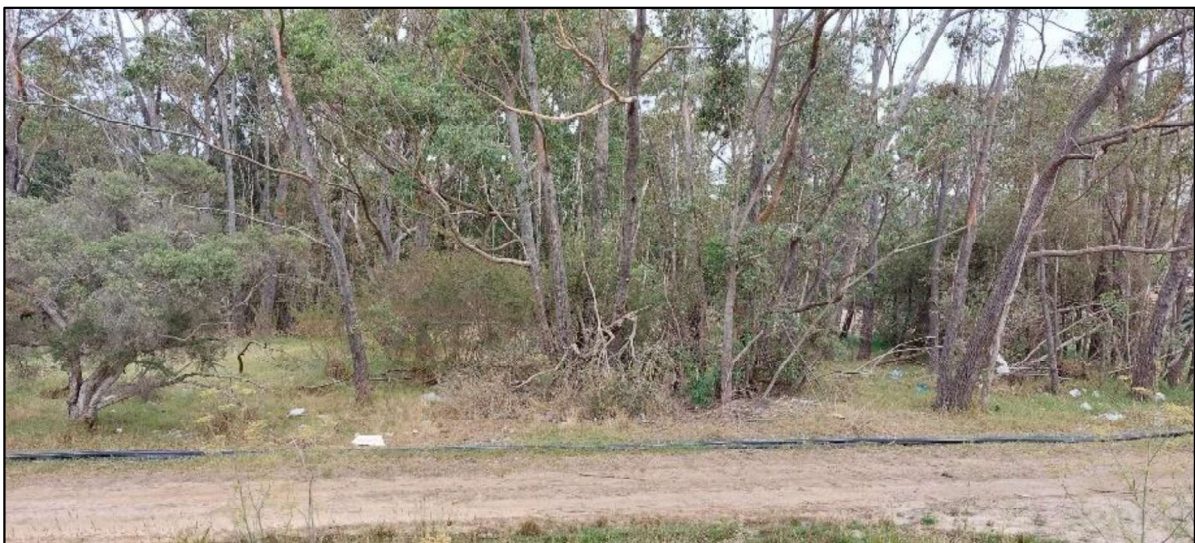
Photo 2: showing dense non-local Eucalyptus trees and Kikuyu understory in Site 2

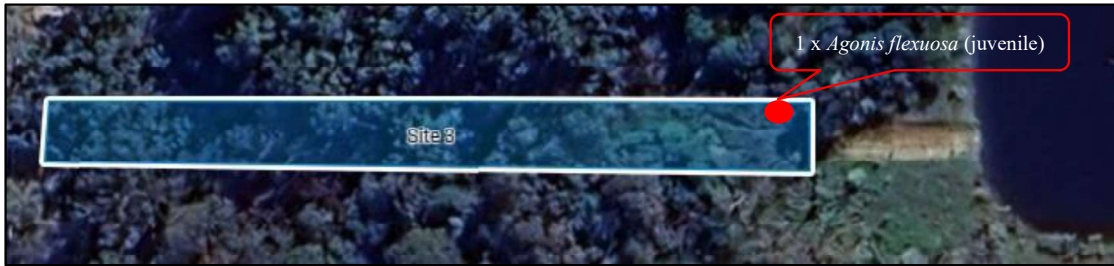
### SITE 3

**Condition** – Degraded

**Vegetation** – Dense to scattered large non-local Eucalyptus species with one Paperbark tree (*Melaleuca preissiana*) and eight mature Wonnich shrubs (*Callistachys lanceolata*) scattered within the site. The understory is a mix of native rushes including Bare Twig rush (approx. 60%) & Knotted Club rush (approx. 10%) and environmental weeds including Kikuyu, annual grasses, and Blackberry. The mid-story comprises scattered Taylorina and large Sydney Golden Wattle shrubs. There is one small juvenile (2.5m high) WA Peppermint (*Agonis flexuosa*) located just within the site near the existing rock/concrete spillway.

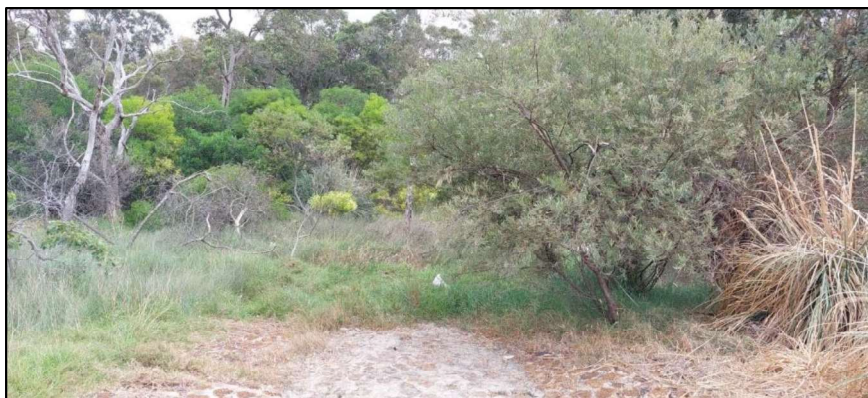
Photo 3: showing large Sydney Golden Wattle with non-local Eucalypts in the background in Site 3.
