RE – West Abbey, Busselton - Clearing Referral Application

PROJECT Coastal Dune Resilience - West Abbey

APPENDIX A – DUNE CONCEPTS

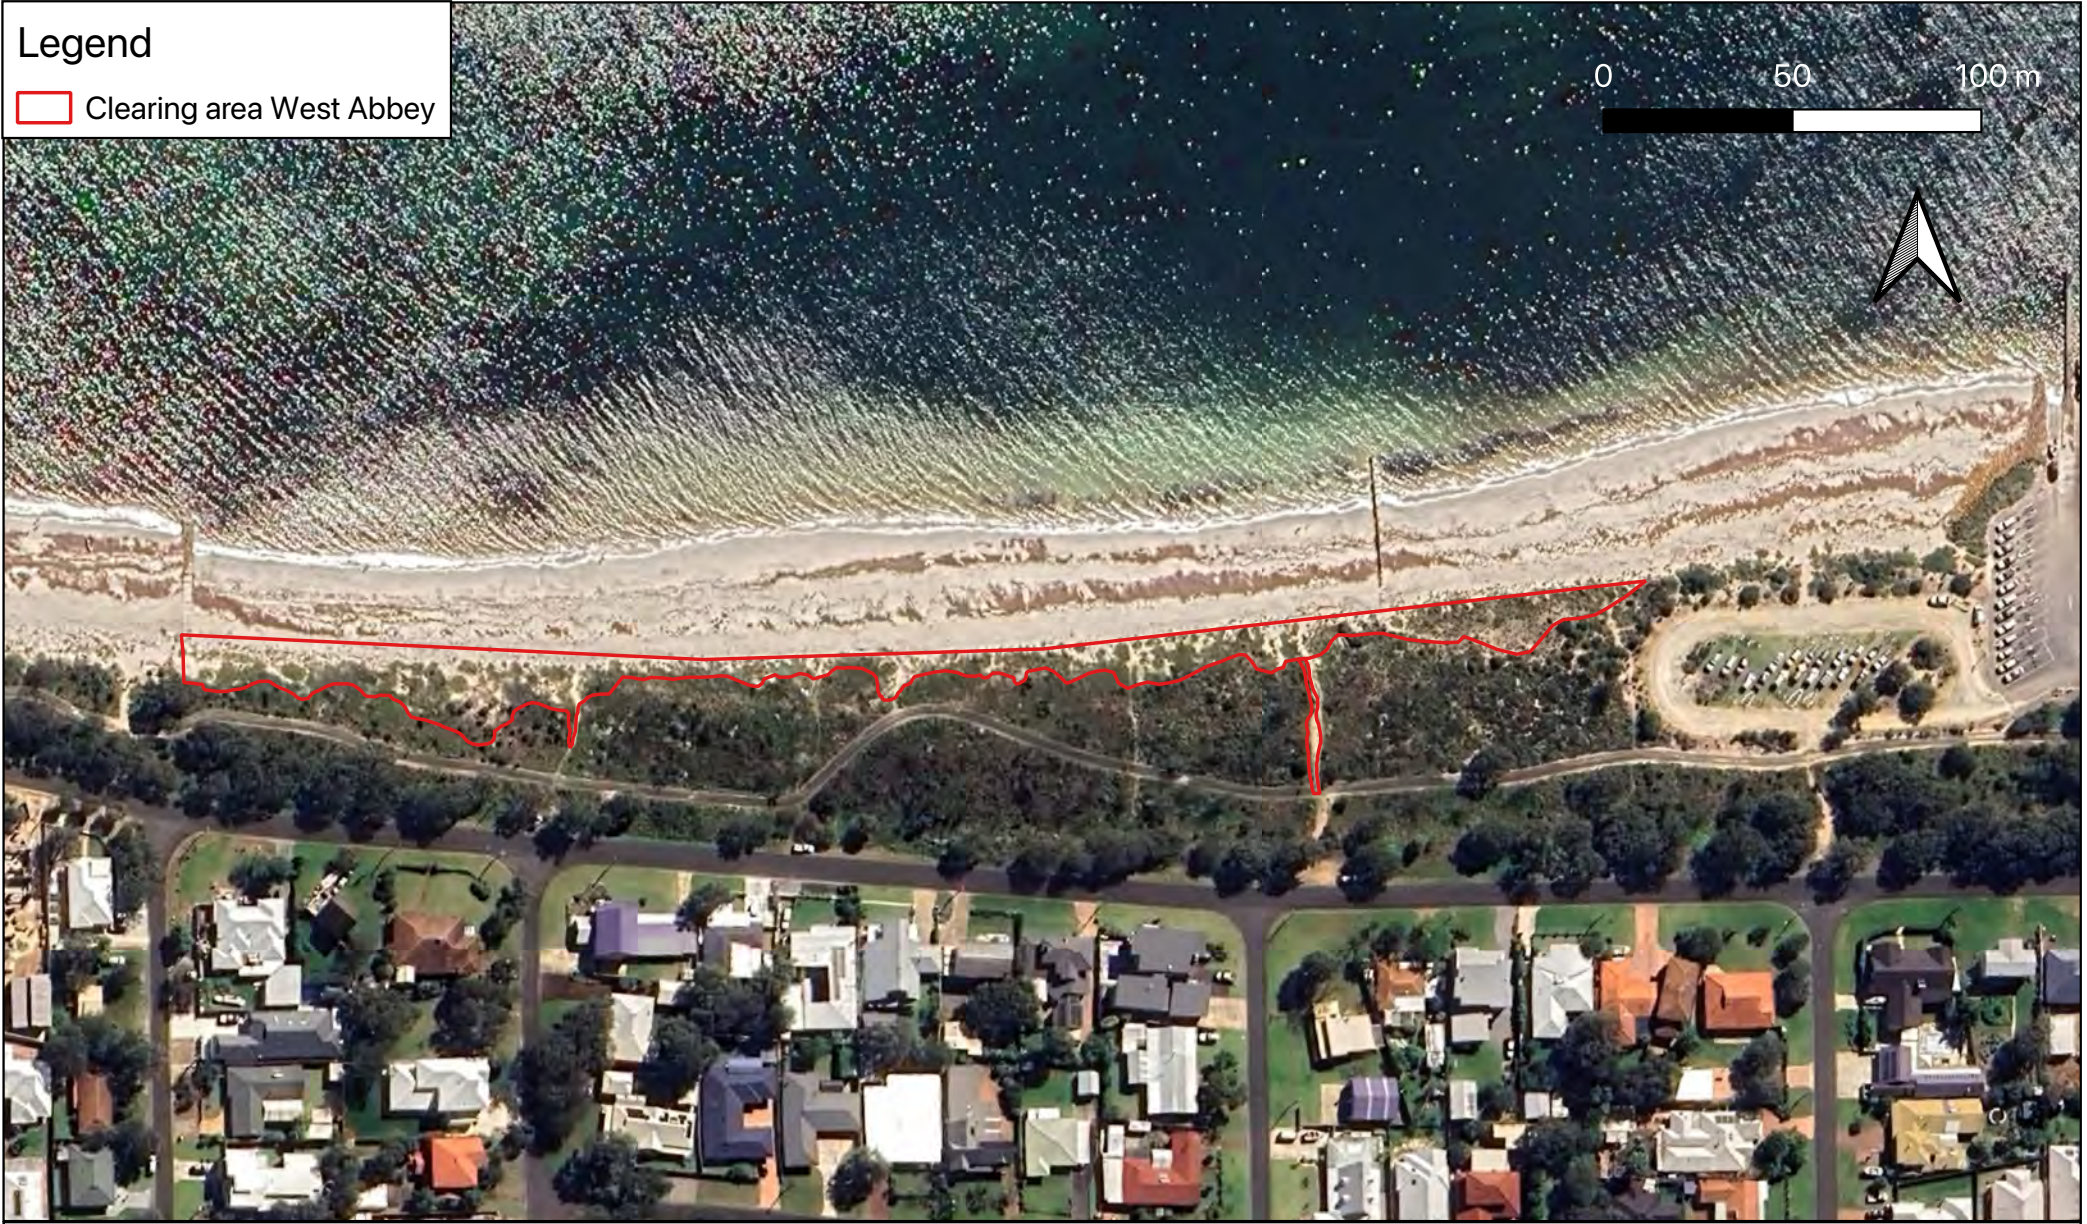
DRAWING TITLE Figure 1 - Clearing Area

Clearing area West Abbey

Please find herein information pertaining to a clearing referral application for a 0.39 hectare (ha) area at the West Abbey site (Lot 4532 on Deposited Plan 175255, Land ID Number: 3470935) on behalf of the City of Busselton (refer to **Figure 1**).

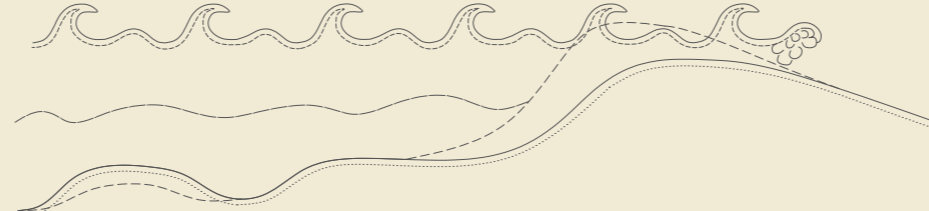
b DUNE OVERTOPPING

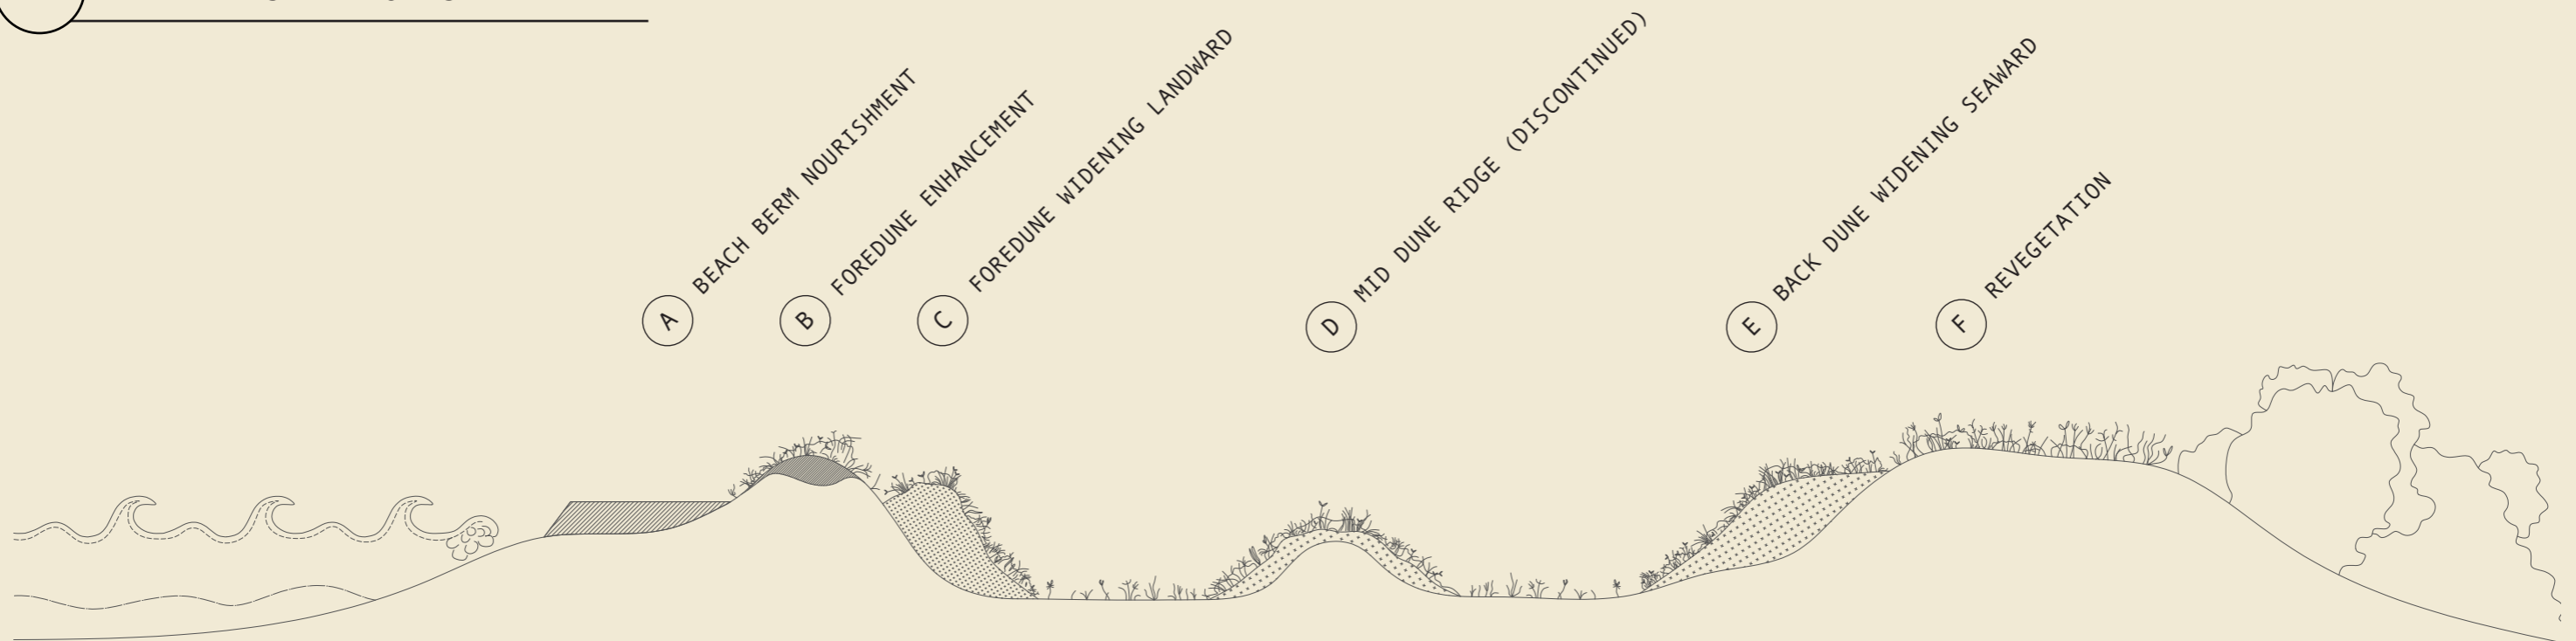
b AFTER SITE WORKS

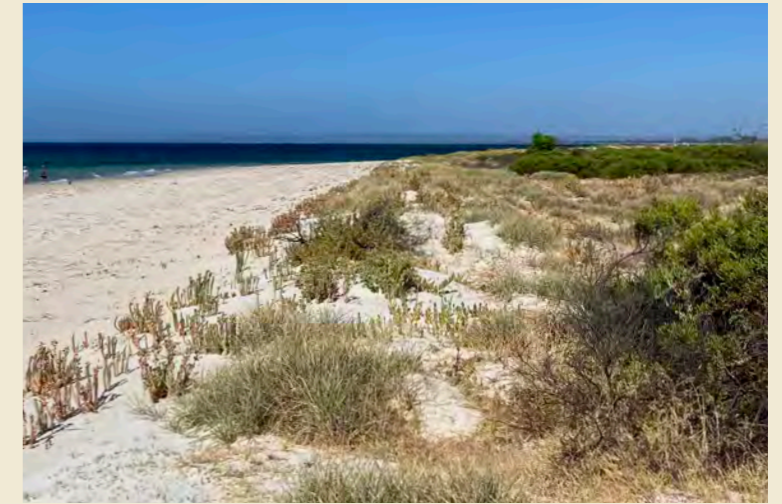
A BEACH BERM NOURISHMENT

-   Clearing
-   COIR Matting
-   Beach Sand
-   Imported Sand
-   Wrack
-   Vegetation

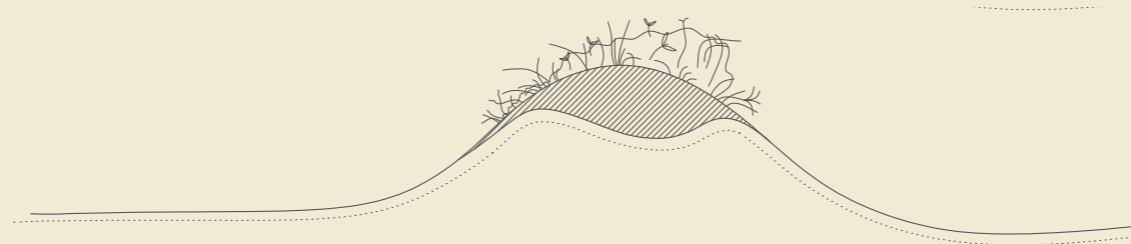
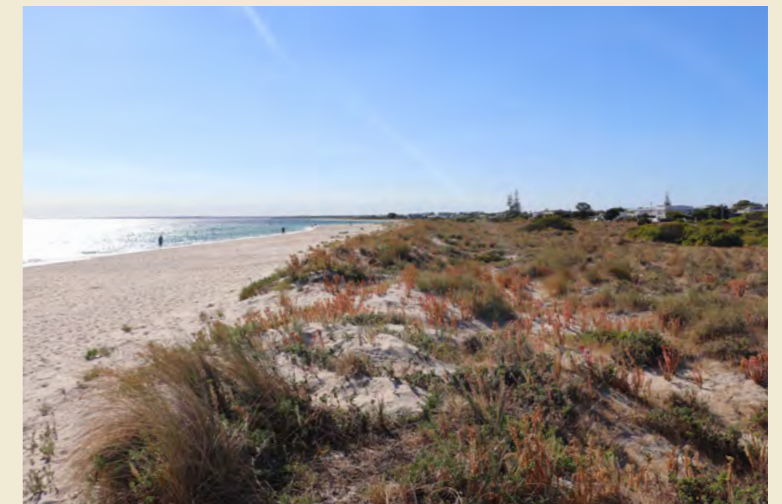
B FOREDUNE ENHANCEMENT

-   Clearing
-   COIR Matting
-   Beach Sand
-   Imported Sand
-   Wrack
-   Vegetation

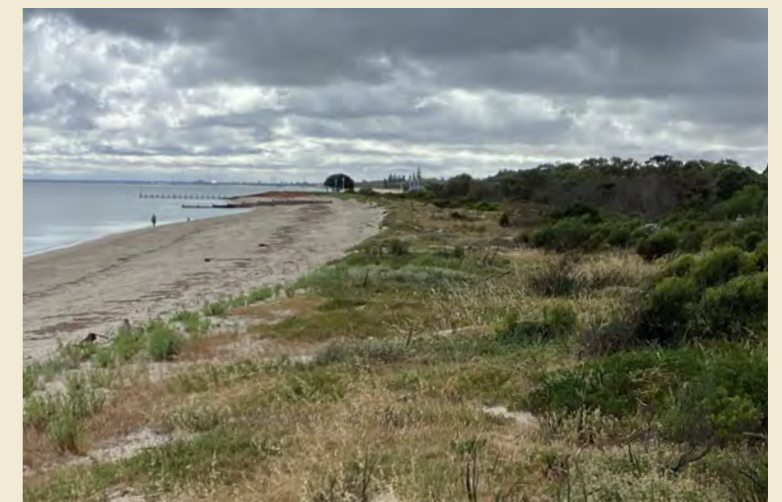
C FOREDUNE WIDENING LANDWARD

-   Clearing
-   COIR Matting
-   Beach Sand
-   Imported Sand
-   Wrack
-   Vegetation

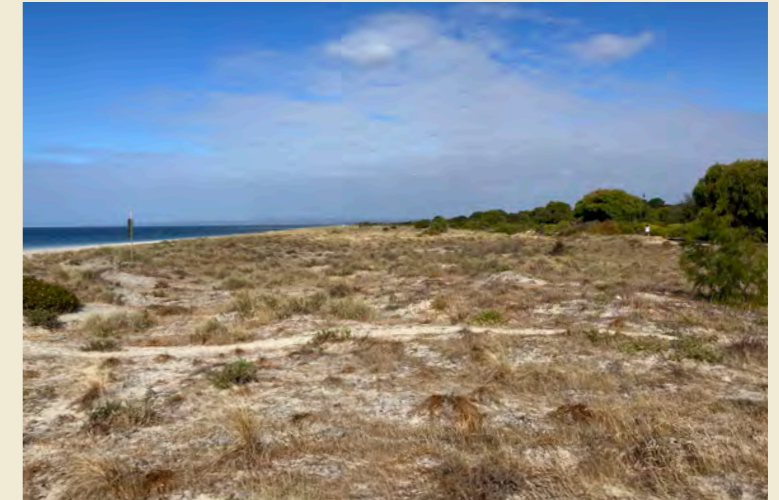
D MID DUNE RIDGE (DISCONTINUED)

-   Clearing
-   COIR Matting
-   Beach Sand
-

Imported Sand
-   Wrack
-   Vegetation

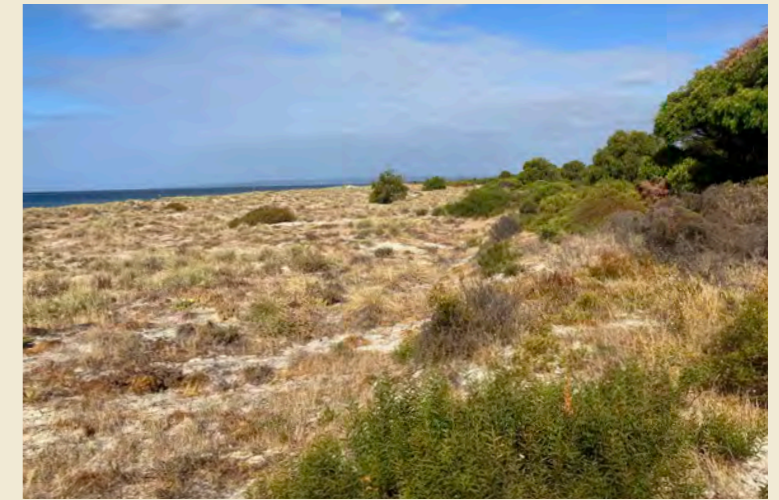
E BACK DUNE WIDENING SEAWARD

-   Clearing
-   COIR Matting
-   Beach Sand
-   Imported Sand
-   Wrack
-   Vegetation

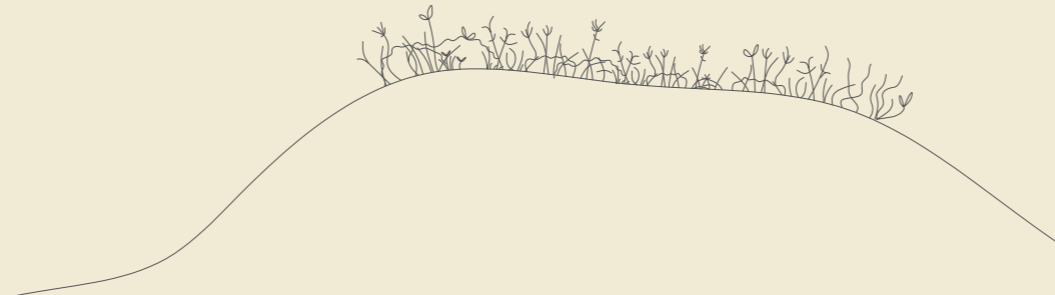
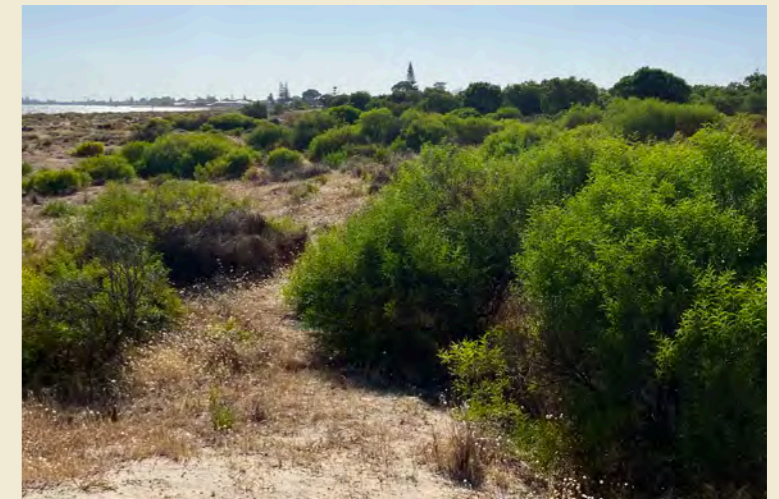
F REVEGETATION

-   Clearing
-   COIR Matting
-   Beach Sand
-

Imported Sand
-   Wrack
-   Vegetation

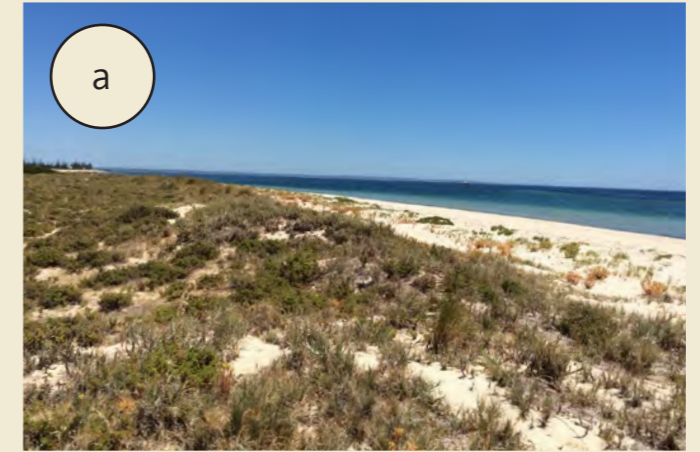
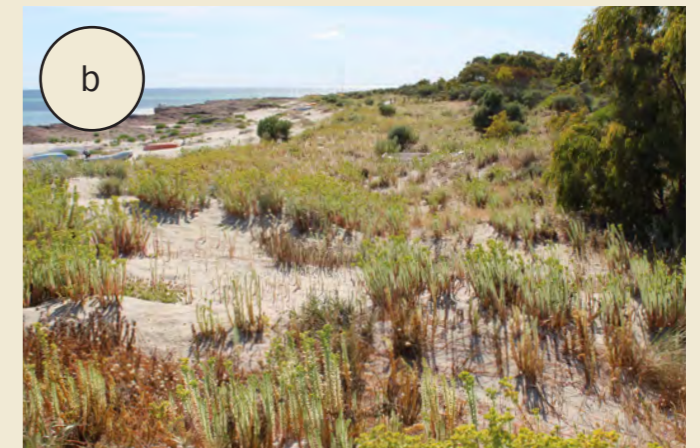
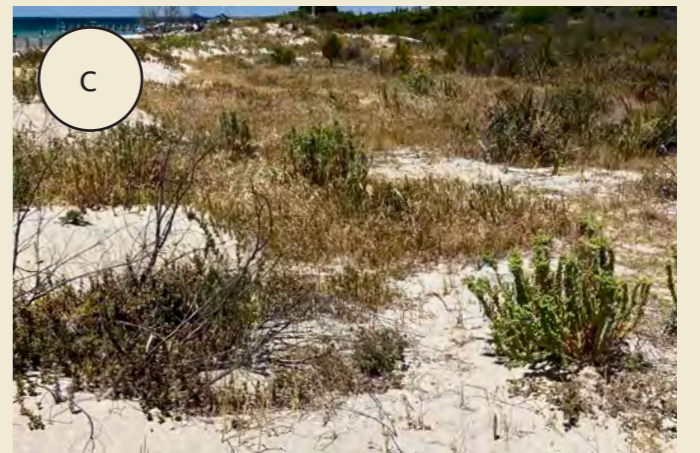
a LINEAR

b HUMMOCKY

c DISCRETE ECOLOGICAL
