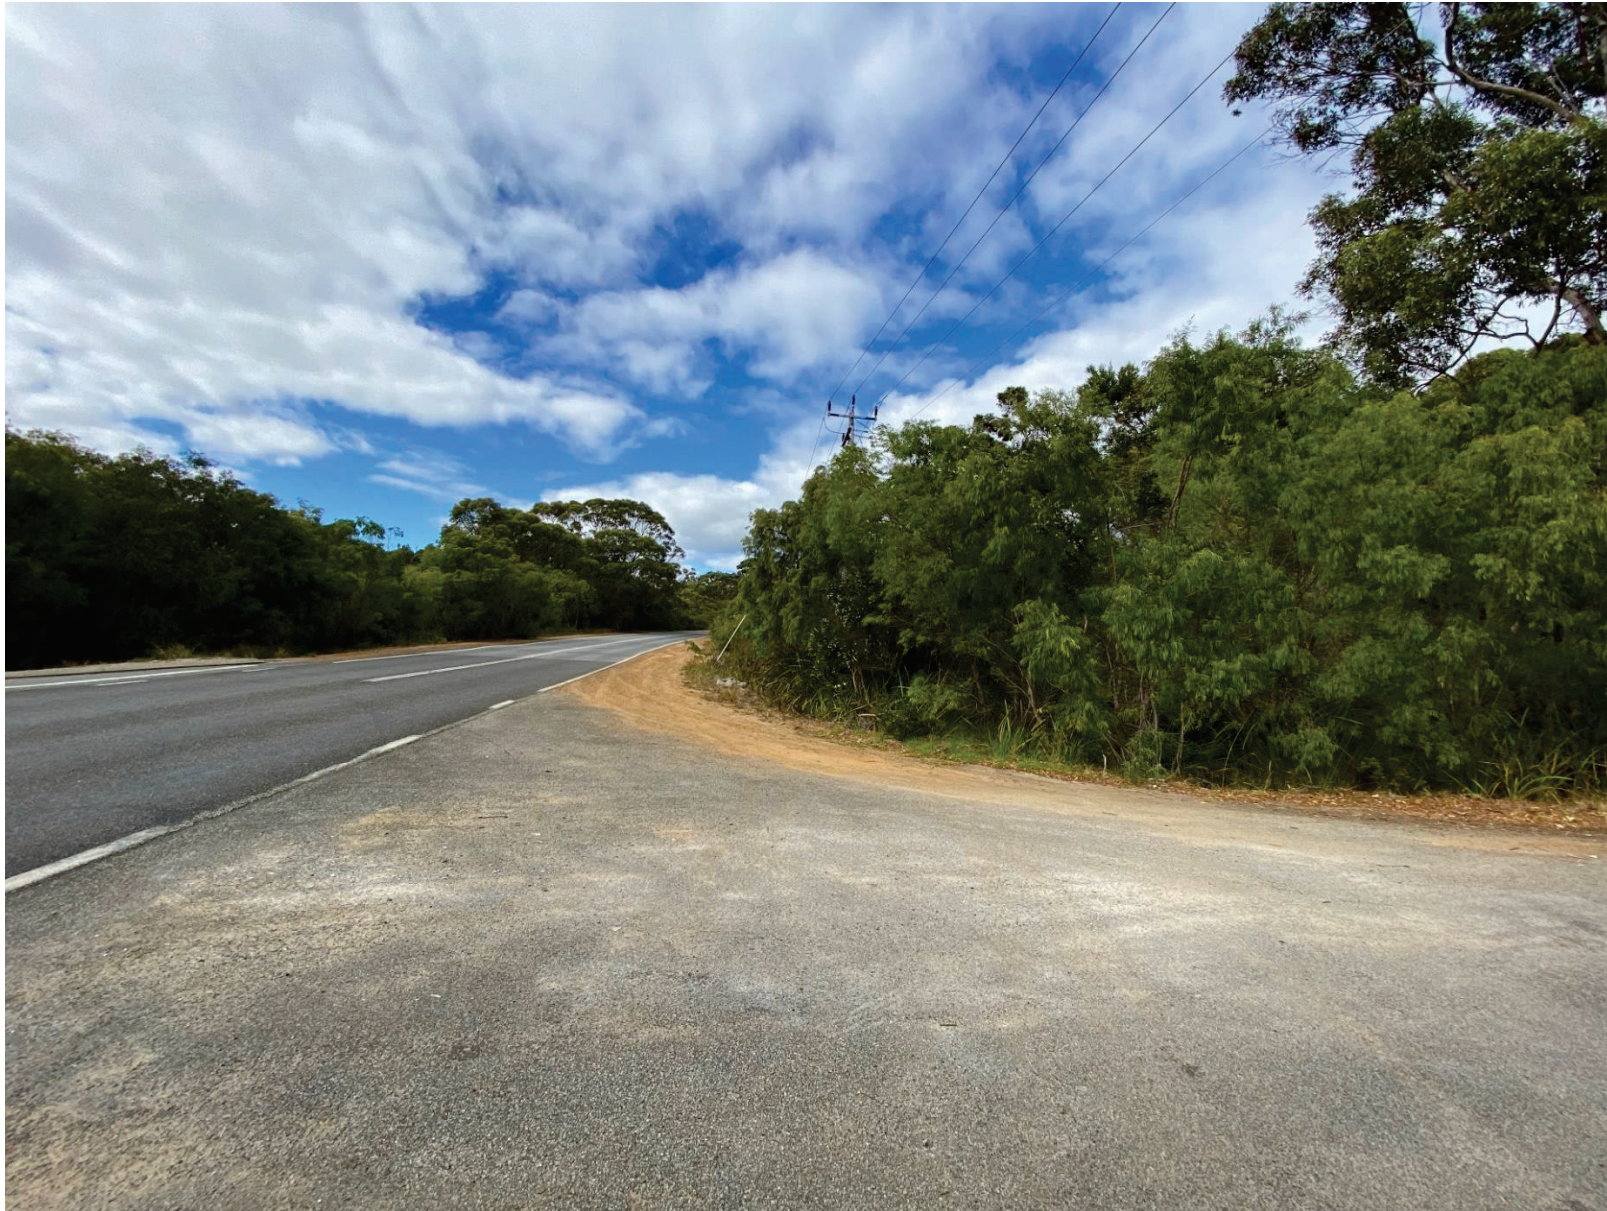
Looking SE from the crossover. Main species of plants are Peppermints, Woolly Bush and Sword Sedge. No possum dreys were seen and no large cockatoo trees within the area to be cleared. No records of TPFL, TEC or PEC.

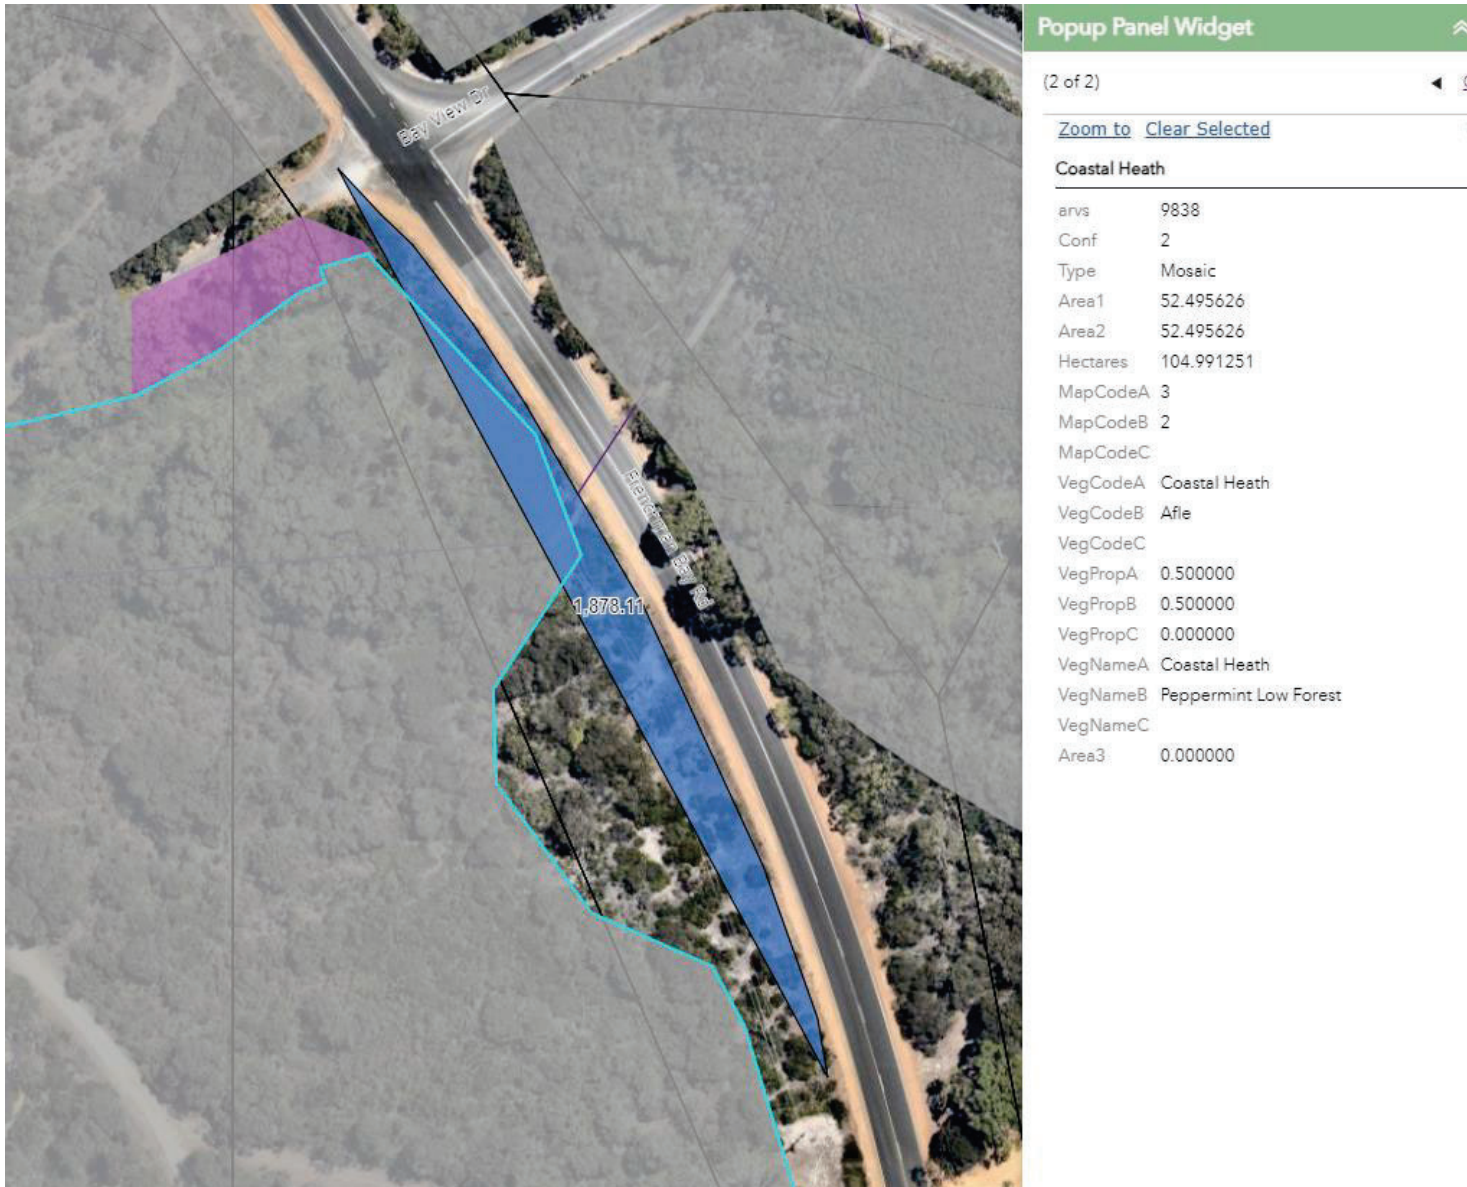
Some of the site is mapped as Peppermint Low Forest (Sandiford and Barret 2010). The remainder of the site is unmapped possibly due to Western Power having just maintained the area. The 2007 aerial does look a lot sparser.

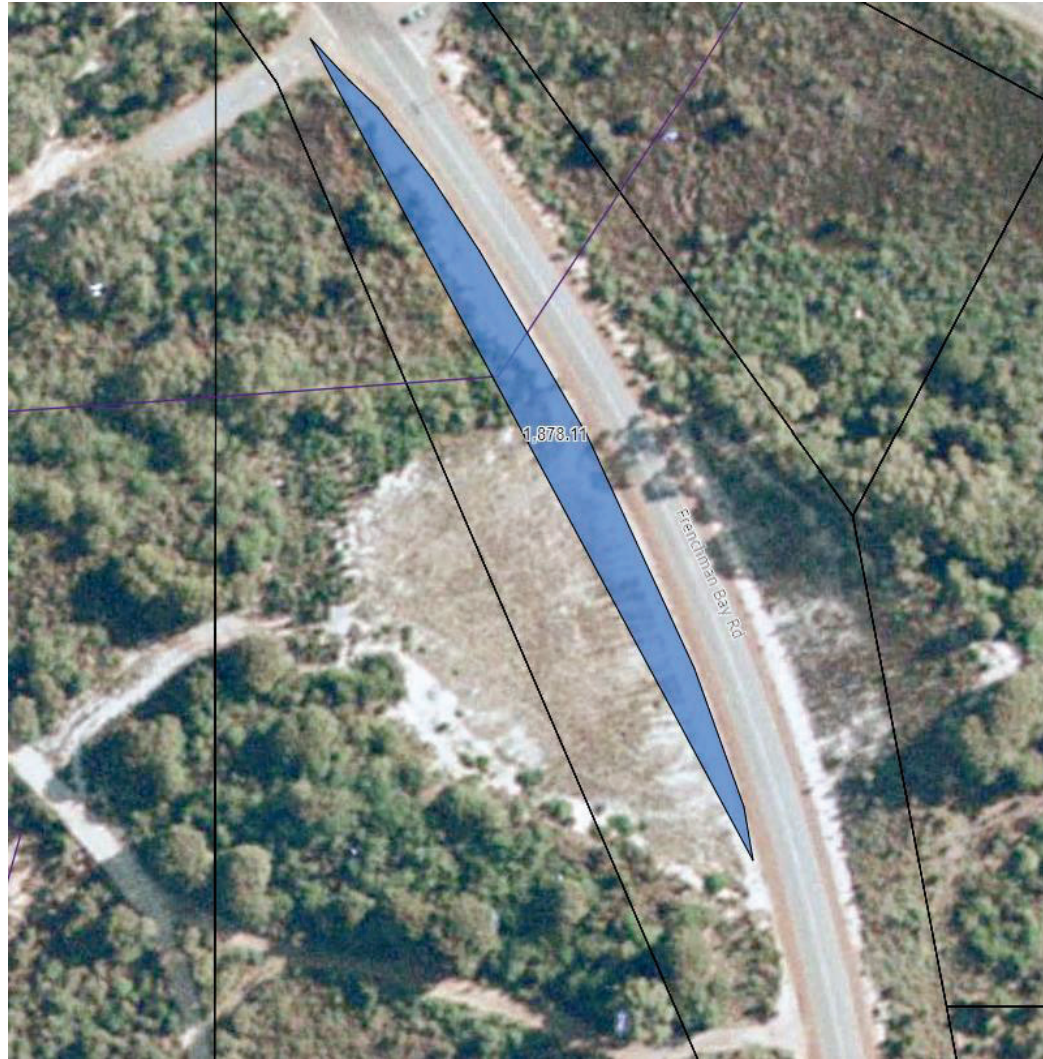
1988 aerial showing that most of the site was previously clear of vegetation.

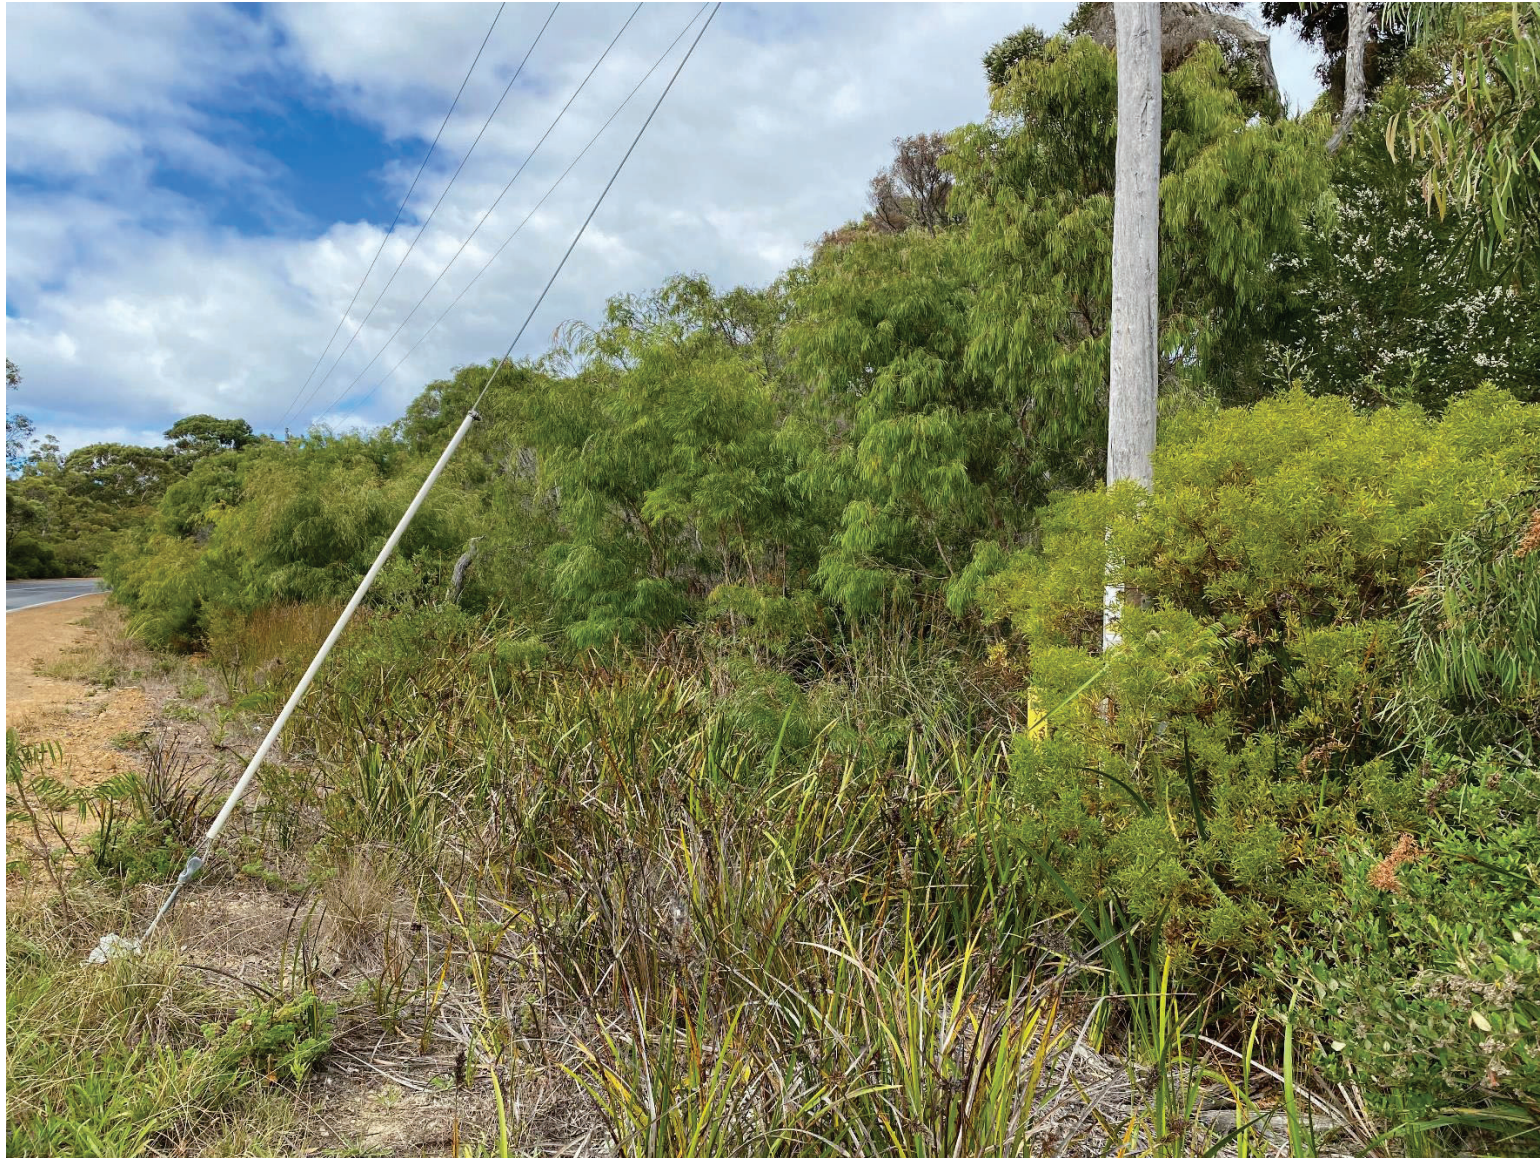
Looking SE from first power pole. This area is most likely regrowth from mulching works under the powerlines.
