Survey report of an Archaeological and Ethnographic Assessment for the Proposed Project Horizon Optic Fibre Cable Installation - Section T09 and T10, Western Australia, with the Ngoonooru Wajarri Traditional Owners

Proponent: Vocus Fibre Pty. Ltd.

Date: 28 June 2023

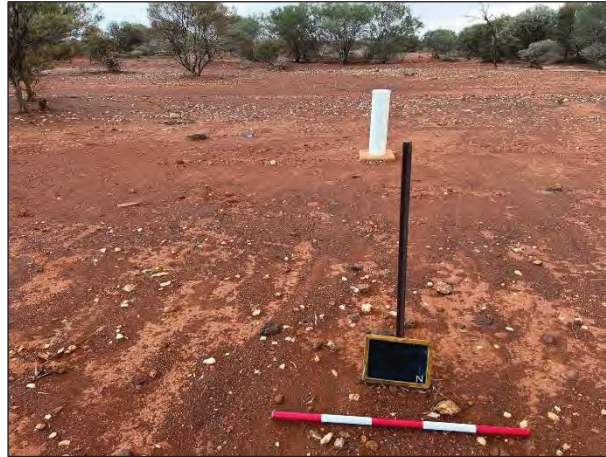
The GSV was generally considered very good (75% - 100%) for the majority of survey area 1.1, however, was noticeably reduced to 25% to 50% in the creek intersections of the proposed alignment and areas of vegetation. Disturbances within the proposed alignment that were noted included an old rail line, traffic and ground disturbance caused by the installation of a Telstra cable (Photograph 2).

Photograph 2 - Disturbance in survey area 1.1, facing South.

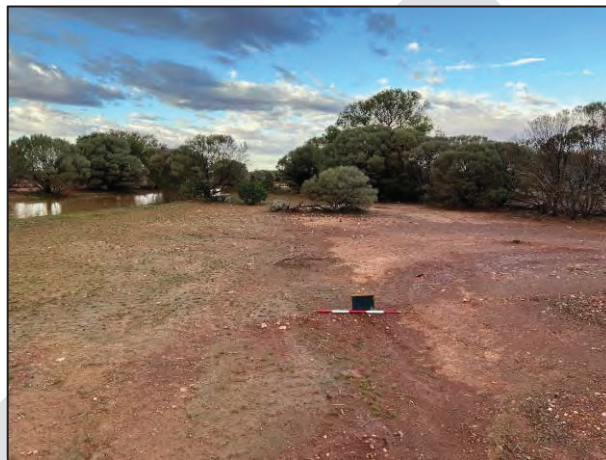
Photograph 3 - Aspect of survey area, showing significant topsoil modification resulting from an old road. E653966 N7064698. Facing Southwest.

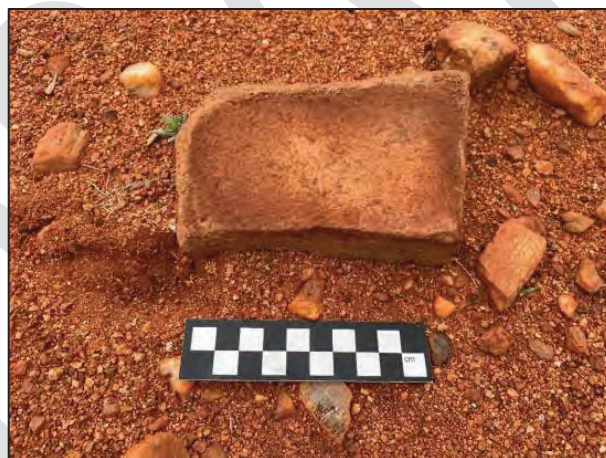
Photograph 4 - Grinding Stone in survey area 1.1.

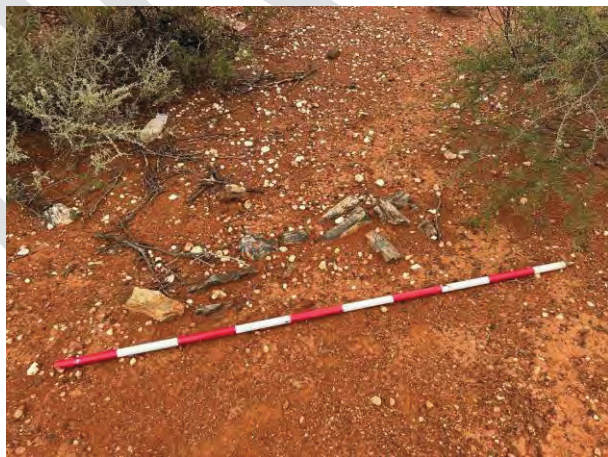
production of artefacts (see Photograph 7). An artefact scatter of the same raw material was identified immediately adjacent to this outcrop. Artefacts identified at 3.478km appear to have also been made from this parent outcrop.

Photograph 7 - Aspect of Banded Chert outcrop-quarry, associated with artefact scatter from the same raw material. E653193 N7063505. Facing Northwest.

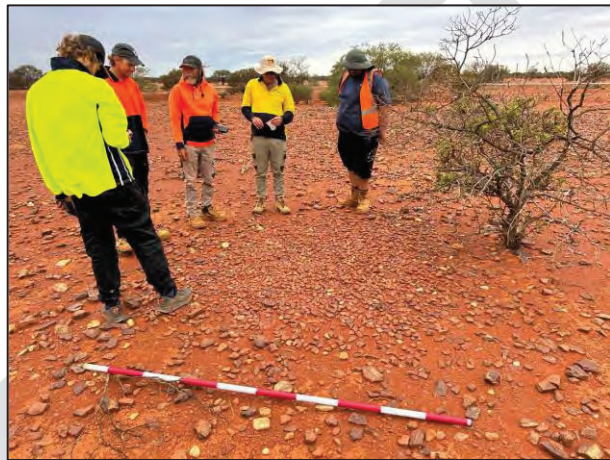
The locations of the intersecting tributaries of Garden Gully Creek displayed thicker sedimentary sand cover layers with fewer artefacts than previously surveyed areas. The northernmost 1.5 km of the surveyed area shows a higher presence of post-contact artefacts made from glass, metal, plastic, car parts. In general, post-contact landscape modifications are visible in the west of the alignment, where a Telstra cable has been previously installed, and East of the survey corridor, where the signs of modification by the early road and the present-day Great Northern Highway are evident. Still, areas where the *Wandri Barna* type landscape is relatively well preserved can be found within the proposed 30m corridor, especially on the interfluvial areas between the aforementioned ephemeral creeks. The latter stand, at this stage, as the main areas of ongoing erosion within the project alignment. During the survey, it was also possible to identify an old abandoned “nest” of a Western Pebble-mound mouse, or Ngadji (*Pseudomys chapmani*) (see Photograph 4).

*Photograph 9 - Abandoned "nest" of Western Pebble-mound mouse, or Ngadji (*Pseudomys chapmani*).
E653772 N7064468. Facing East.*

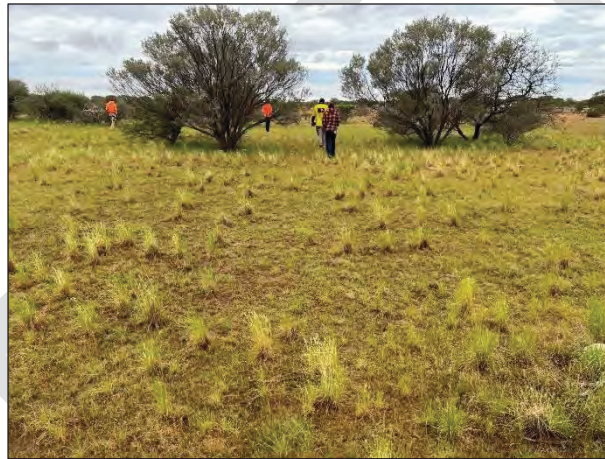
Photograph 10 - Impaired Ground Surface Visibility in Survey Area 2.1, facing North.

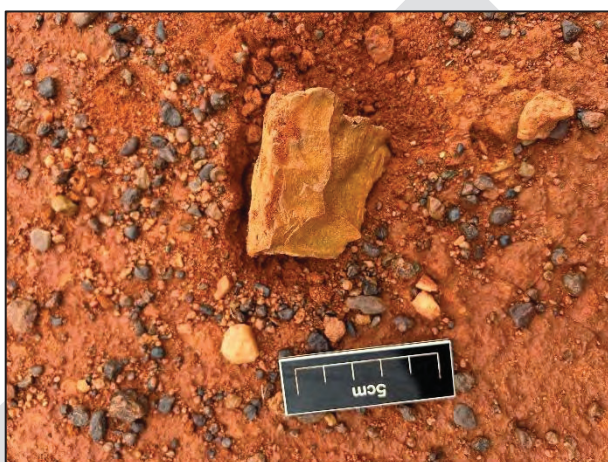
Photograph 12 - Core identified in survey area 2.1.

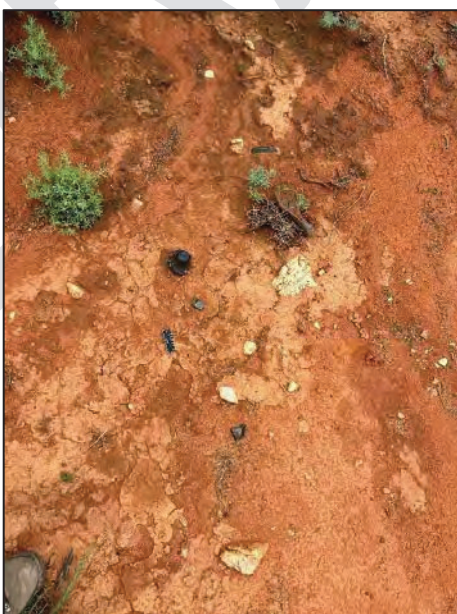
Photograph 13 – Artefact scatter made from bottled glass in survey area 2.1, Easting 657859 and Northing 7074604.

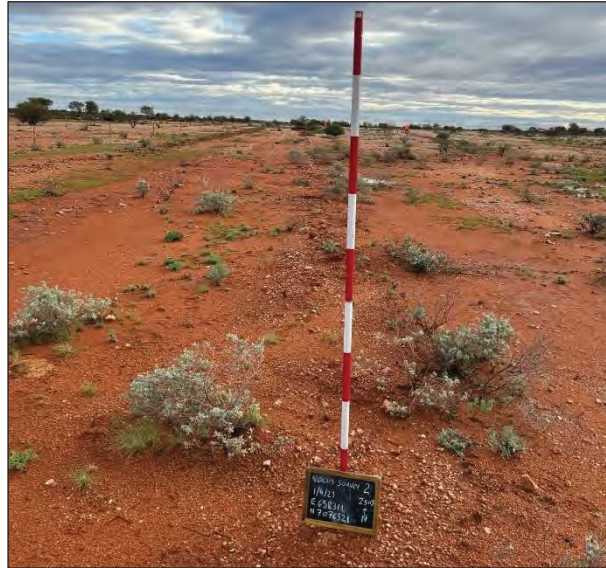
The topsoil in survey area 3.1 begins as a rocky surface with a high density of quartz fragments visible and minimal vegetation, providing very good ground surface visibility (see Photograph 17). Outcrops were identified north of this rocky surface. In the locations where the tributaries of Garden Gully Creek and the Yalga River cross the the proposed alignment there was an observed decrease in ground surface visibility owing to denser vegetation coverage (see Photograph 18).

Photograph 17 - Landscape of Survey Area 3, facing North.

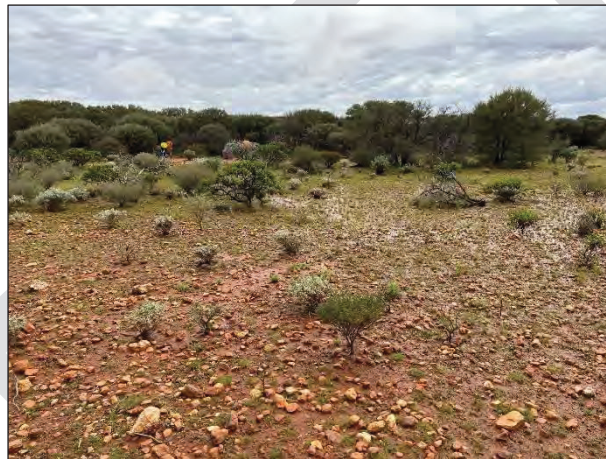
Photograph 18 - Area of low GSV. 658508E 7076954N. Facing North

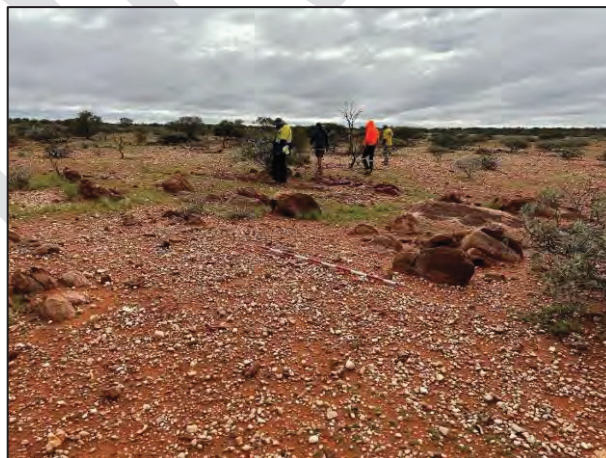
Photograph 19 - Granite outcrop in survey area 3.1. 658824E 7077591N. Facing Northeast.

A total of 425 artefacts were identified and recorded within survey area 3.1. Three granite outcrops were also recorded at the locations 658824E, 7077591N; 658499E, 7076930N and 659100E, 7078101N, whilst a quartz outcrop was identified at 659491E 7078953N in survey

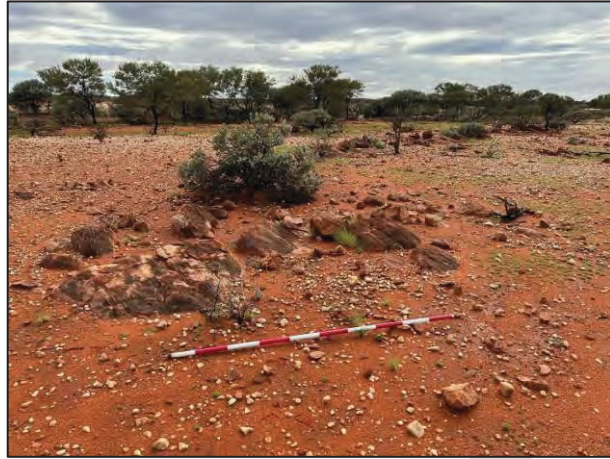
Photograph 20 - Linear granite outcrop and scatter in survey area 3.1. 658499E 7076930N. Facing Northeast.

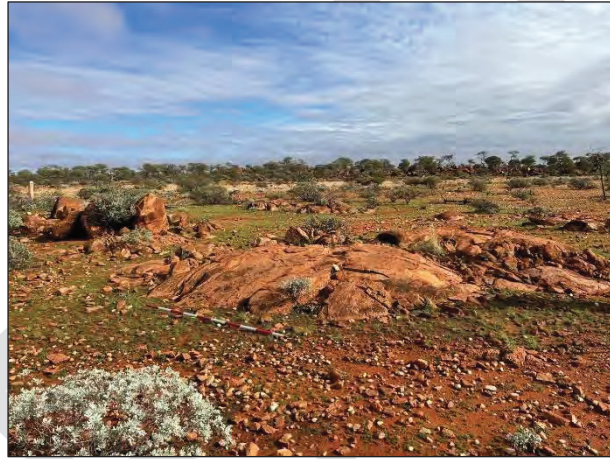
Photograph 21 - Granite outcrop and scatter in survey area 3.1. 659100E 7078101N. Facing Northeast.

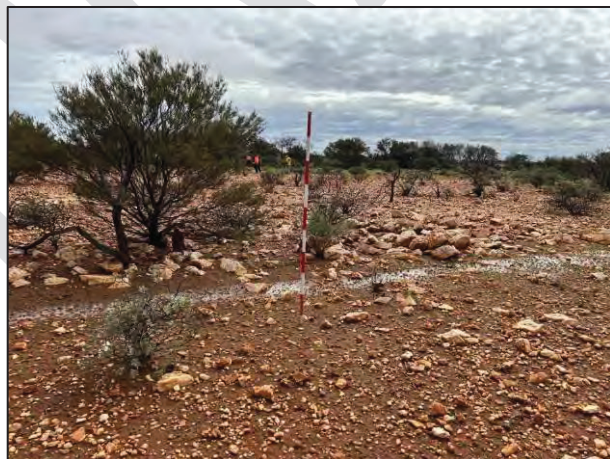
Photograph 22 - Quartz outcrop and scatter in survey area 3.1. 659491E 7078953N. Facing North.

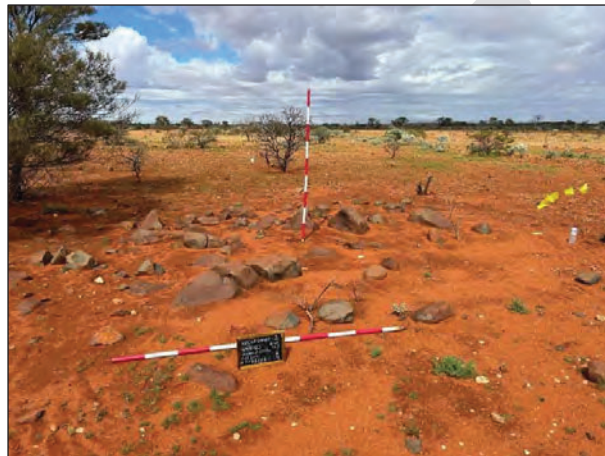
A total of 506 stone artefacts and one (1) quarry were identified in survey area 4.1. A basalt/greenstone outcrop showed profuse signs of exploitation for the production of artefacts (Photograph 30). This outcrop has been assessed as associated with a basalt and greenstone artefact scatter located North of the survey area near the outcrop (Photograph 30). The outcrop quarry is in clear association with a dense artefact scatter that spreads in a northern

direction along the proposed alignment. This is shown by the distribution of artefacts manufactured from the outcrop's greenish basalt that are easily identifiable on the surface. While this raw material dominates the sample of artefacts within the close vicinity of the outcrop, there are other raw materials represented, such as silcrete, chert, jasper, quartz, and "moss agate" from a known source located approximately 60 km to the west of the survey area, and includes some post-contact artefacts made from bottle glass. Examples of artefacts identified in survey area 4.1 are shown in photographs 31 to 36.

Photograph 30 - Basalt/greenstone outcrop/quarry identified in Survey Area 4.1. 662041E 7085664N. Facing Southwest.

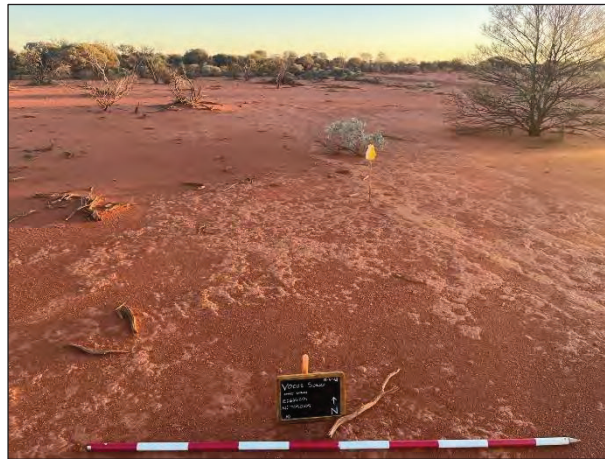
A total of 6,200 metres of the proposed alignment was surveyed on 18 April 2023, constituting survey area 5.1. The landform associated with survey area 5.1 is the continuation of the previous survey areas, including alluvial plains with low acacia woodland with grass cover. Ground surface visibility within survey area 5.1 varied between being very good (75% - 100%), whilst in areas of vegetation, ground surface visibility was reduced (~50%) (Photograph 37).

Photograph 37 - Landscape of Survey Area 5.1, facing North.

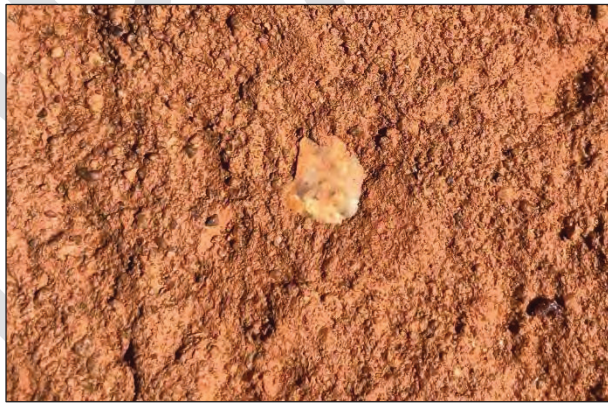
Flooding had moved some topsoils to expose coffee rock in sections, revealing artefacts embedded into exposed coffee rock running east/west approximately 15 metres wide, indicative of subsurface archaeology (Photograph 39).

Photograph 39 - Cultural Material Imbedded into Coffee Rock Survey Area 5.1.

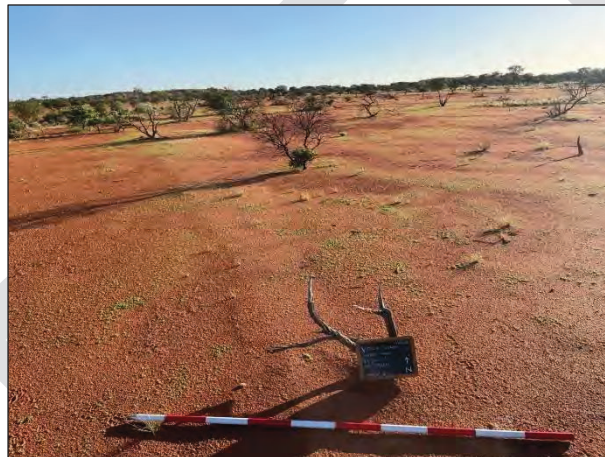
A total of 8,100 metres of the proposed alignment was surveyed on 19 April 2023, constituting survey area 6.1. The landform associated with survey area 6.1 is the continuation of the previous survey areas, including alluvial plains with low acacia woodland with grass cover. Survey area 6.1 contained areas of thick vegetation (grass, shrubs) which reduced ground surface visibility to 10-20% (Photographs 40, 41).

Photograph 40 - Landscape of Survey Area 6.1, facing North.

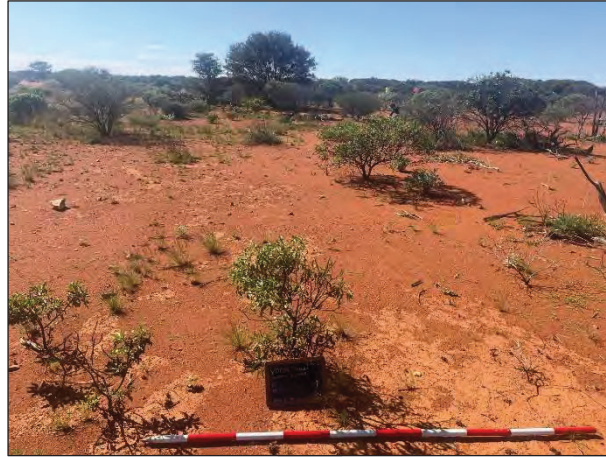
Photograph 42 - Artefact Scatter Survey Area 6.1, facing North.

Survey area 6.1 shows disturbances resulting from mining exploration, ripping, drilling, and grading of the ground (Photograph 42). A possible crystal quartz outcropping is located within

100m of GPS coordinates Zone 50 (GDA 94) Easting 668132 Northing 7100095 due to the high quantity of crystal quartz and Aboriginal cultural heritage artefacts made from it. A low density/isolated artefacts were also identified within survey area 6.1.

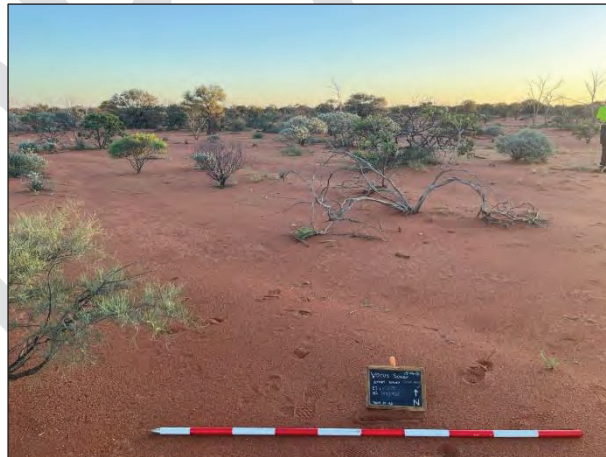
Photograph 43 - Landscape of Area 6.2, facing North.

Survey area 6.2 (Photograph 17) constitutes an additional area requested to be surveyed as a possible alternative route. Survey area 6.2 showed signs that this area had been disturbed by grading, rock deposition, and general road construction as it is located close to the highway, and the land had previously been used for a road (Photograph 43).

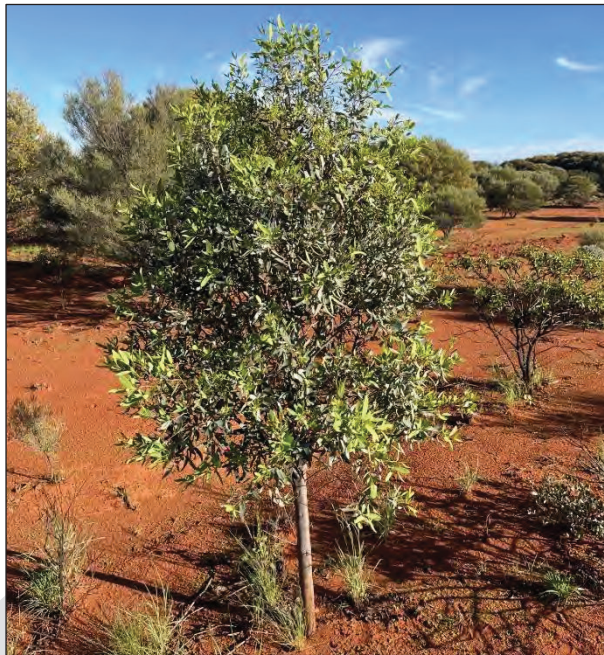
Photograph 45 - Native Plum/Cherry in Survey Area 7.1.

Survey area 7.1, surveyed on 20 April 2023, consists of floodplains with open, sparse scrub and begins with the continuation of the artefact scatter from Area 6.1. The artefact scatter reduces in density at GPS Coordinates Zone 50 (GDA 94) Easting 669522 Northing 7104128. Edible and medicinal trees, including native plum/cherry, cork trees, Maroon bush (Boogawee), and Water bush, are also present in this survey area (see Photograph 45).

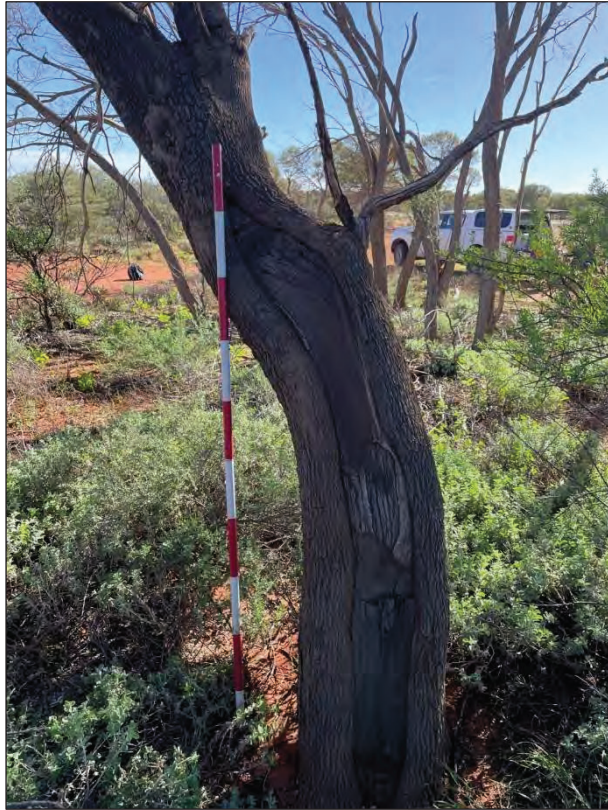
There is an area of high density of scar trees present in survey area 7.1, beginning with isolated finds at Zone 50 Easting (GDA 94) 669 519 Northing 7105979 and Easting 669519 Northing 7105975; with multiple scar trees present at Easting 669530 Northing 7106004 extending East as wide as the alignment allows. These scar trees continue through the alignment with the last recorded at GPS coordinates Zone 50 (GDA 94) Easting 669261 Northing 7109074; these are highly sensitive and require complete avoidance (Photographs 46, 47).

Photograph 46 - Culturally Modified Scar Tree in Survey Area 7.1.

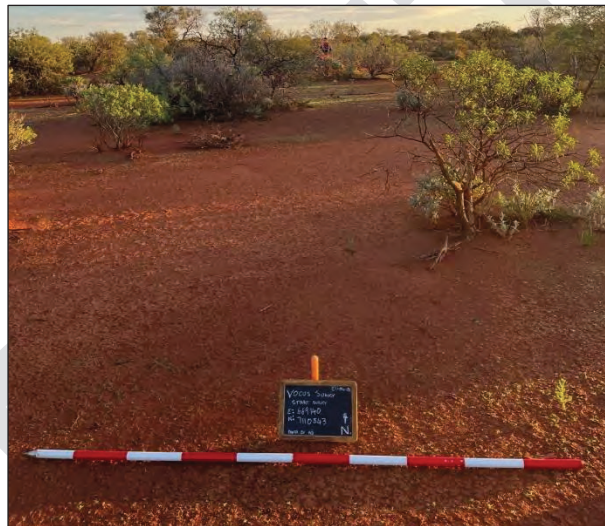
Photograph 48 - Landscape of Survey Area 8.1, facing North.

Survey area 8.1, surveyed on 21 April 2023, consists of alluvial plains with open, sparse scrub providing excellent ground surface visibility. The area contains a high density of artefacts on the ground surface as the alignment travels through the registered site Thirty Two Mile Well (Site ID: 6196) (see Photographs 49). The coordinates for the artefact scatter are Zone 50 (GDA 94) Easting 668807 Northing 7114189. This survey identified a higher density of artefacts outside the registered area to the south, east and north. The area appears to be used as a turning circle for cars and trucks; additionally, either side seems to have been deliberately cleared for a future road. South of the registered site contains low to medium-dense vegetation becoming more sparse towards the North. The further artefacts identified are considered to be a continuation of the registered site Thirty Two Mile Well - Site ID 6196.

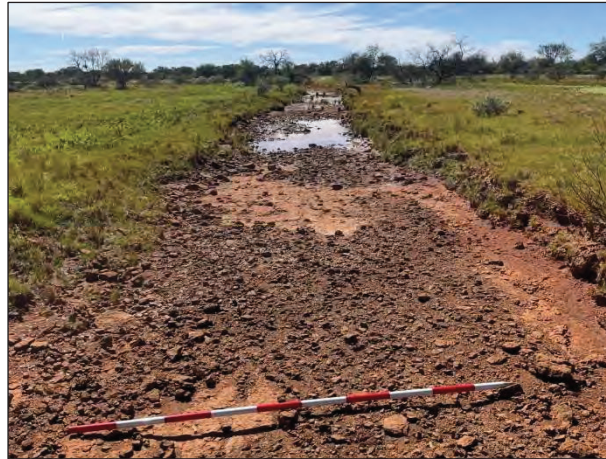
Photograph 50 - Yalgar Tributary in Survey Area 8.1, facing East.

A tributary of the Yalgarr River was recorded at coordinates Zone 50 (GDA 94) Easting 668859 Northing 7114850 within a terrace and floodplain landform where the stratigraphy of topsoil

deposits is visible within the tributary section (see Photographs 50, 51). A large chunk of source material recorded at Easting 668858 Northing 7114861 appears to have been flaked off to reach the high silica contents. Disturbance from the swale drain installation from the highway was found at Zone 50 (GDA 94) Easting 668663 Northing 7117179; no artefacts were found; however, they may still be present within the disturbance.

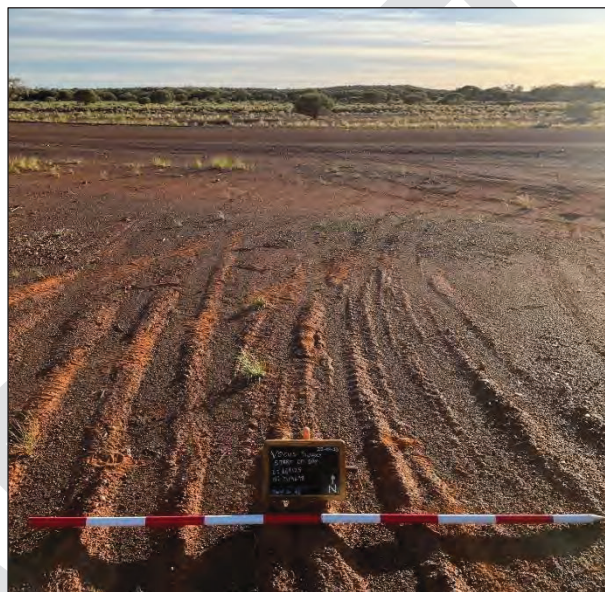
Photograph 52 - Landscape Photograph of Survey Area 9.1, facing North.

Survey area 9.1, surveyed on 22 April 2023, comprises sparse, open scrub within the terrace and floodplain landforms (see Photograph 52). An abandoned Western Pebble Mound mouse nest was recorded at Zone 50 (GDA 94) Easting 669500 Northing 7120226. The Area is disturbed at Zone 50 (GDA 94) Easting 671 466 Northing 7121361 by drainage works running East-West from the road; no artefacts were found but are possibly present within the disturbance. Survey area 9.1 was positioned too close to the Great Northern Highway, which resulted in the surveying being halted at Zone 50 (GDA 94) Easting 672584 Northing 7122215 to wait for alignment correction.

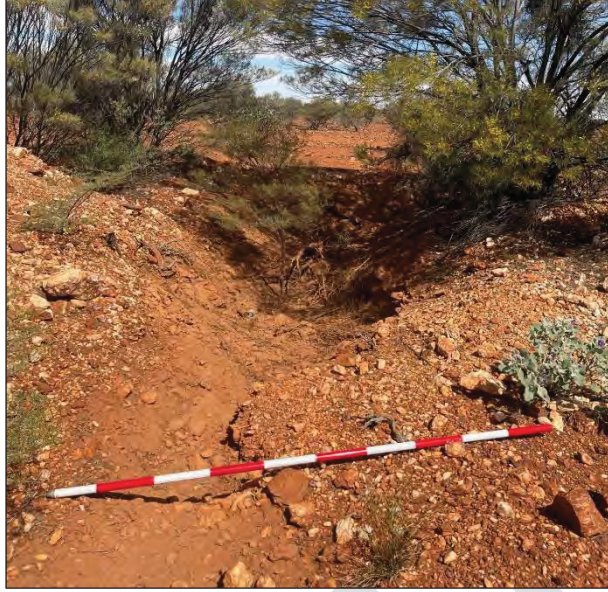
Survey area 9.2 begins at Zone 50 (GDA 94) Easting 681003 Northing 7129454; the area just north of the start point becomes a thick cover of Mulga trees (*Acacia aneura*). Termite mounds were recorded at Zone 50 (GDA 94) Easting 681408 Northing 7129865, which were not previously seen in the survey. The Telstra cable ground disturbance follows along the alignment's western boundary, and a reduction of artefact density is seen along the disturbance. Disturbance from a large mechanical gold mining pit and prospecting disrupts the northern section of area 9.2 (see Photograph 53).

Photograph 53 - Mechanical Gold Mining Disturbance in Survey Area 9.2, facing East.

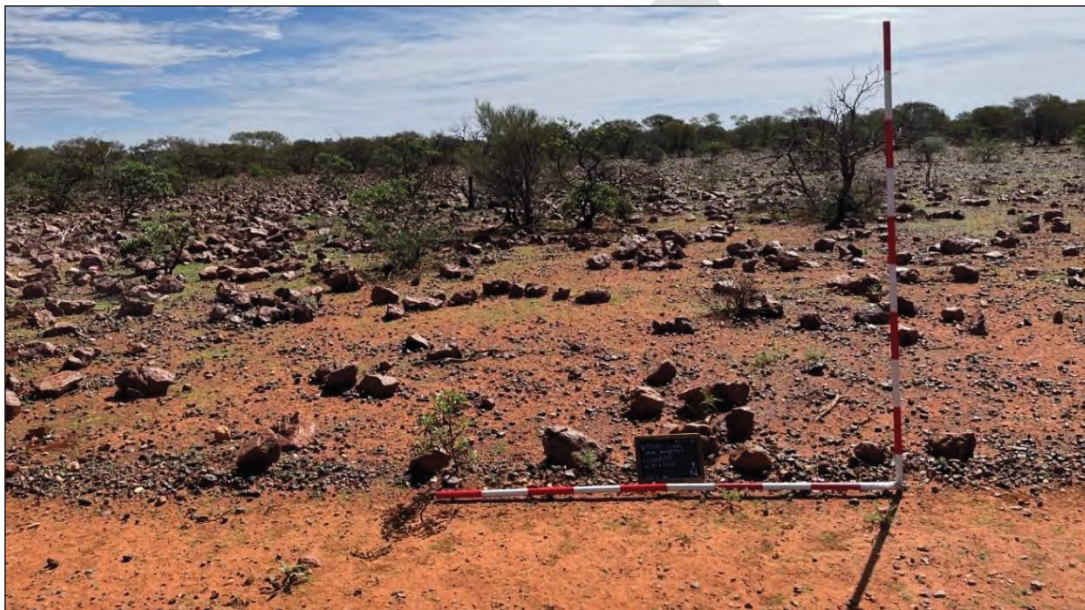
On 23 April 2023, the previous disruption from prospecting activities continued into survey area 10.1 with a rocky ground surface that appears to have been turned over and covered in small stones, making artefact identification difficult. The landform continues as alluvial plains vegetated by saltbush and blue bush with open scrub with excellent ground surface visibility. A possible stone arrangement was identified outside of the alignment at GPS coordinates Zone 50 (GDA 94) Easting 689535 Northing 7132502; potential regular stone alignments are visible in an area of extreme stone density, unusual from the surrounding environment (see Photograph 54).

Photograph 54 - Possible Stone Arrangement in Survey Area 10.1, facing North.

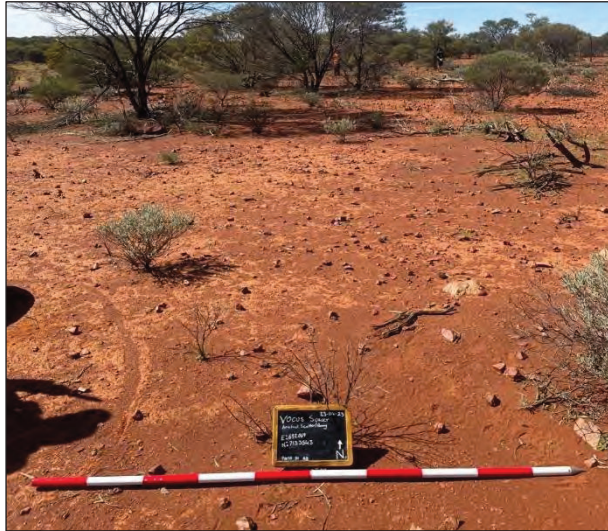
An artefact scatter of silcrete was identified at Zone 50 (GDA 94) Easting 692069 Northing 7133543, containing a high density of flakes and the potential for subsurface material (see Photograph 55). The current alignment runs through the artefact scatter and would damage the surface and subsurface material; avoidance is recommended.

Photograph 55 - Artefact Scatter in Survey Area 10.1, facing North.

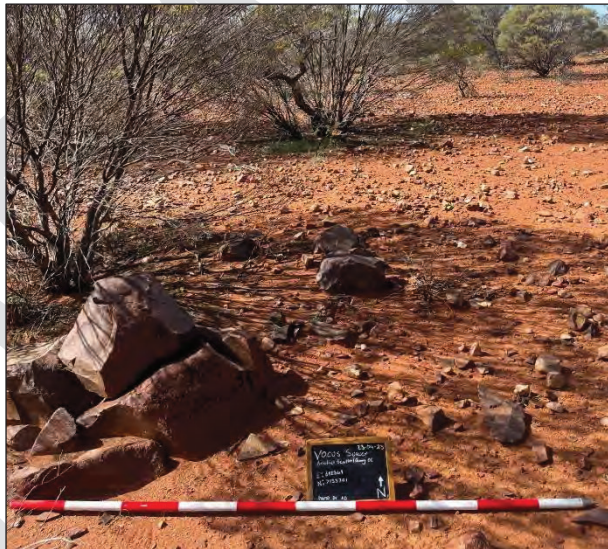
Another artefact scatter was recorded in survey area 10.1, made up of quartzite with evidence of source material collecting present; the location of this scatter is Zone 50 (GDA 94) Easting 692349 Northing 7133701 (see Photograph 56).

Photograph 56 - Quartzite Artefact Scatter in Survey Area Ten (10), facing North.

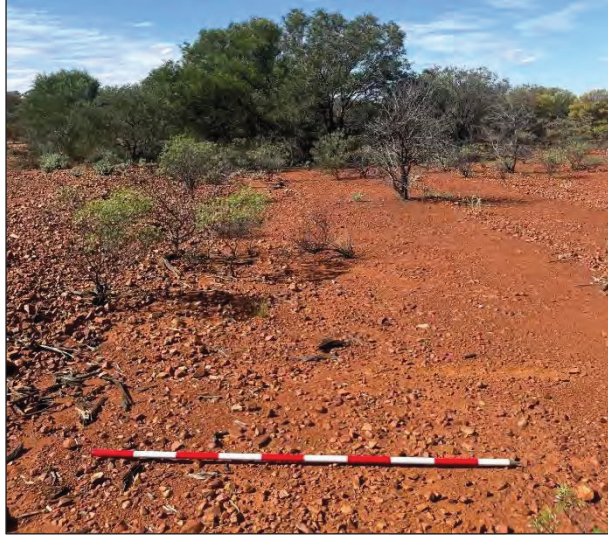
Photograph 57 - End of Survey Area 10.1, Northern Boundary of Alignment, facing North.

The end of survey area 10.1 marked the Northernmost point of the alignment (see Photograph 31).

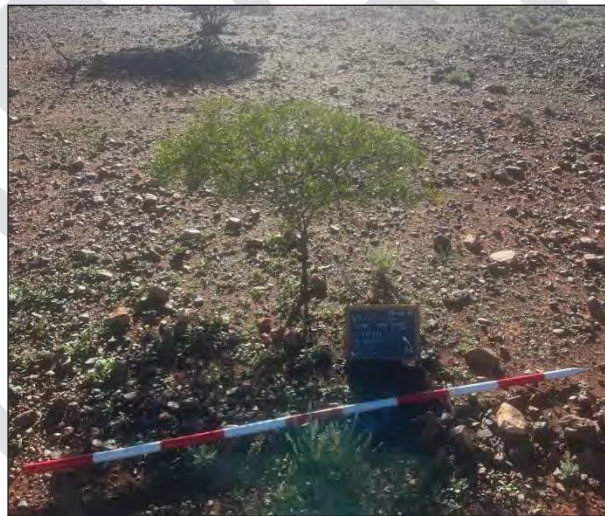
Photograph 58 - Landscape of Survey Area 11.2, facing Northeast.

Survey area 11.2 alignment was moved approximately 65m off the road and began as flat open plains with moderate rock cover and sparse open scrub and Mulga vegetation and is transected by small tributaries (see Photograph 58). The primary raw materials found include chert, quartz, and silcrete, with some quartzite present. Roughly a kilometre to the North, grading and clearing disturbance was identified, with raw materials showing signs of machine damage. The ground surface visibility was generally excellent, with small areas of increased vegetation and grass cover reducing ground surface visibility. The remainder of survey area 11.2 continued as flat plains with sparse vegetation, an area of increased tree cover and a large creek were recorded towards the north (see Photograph 59).

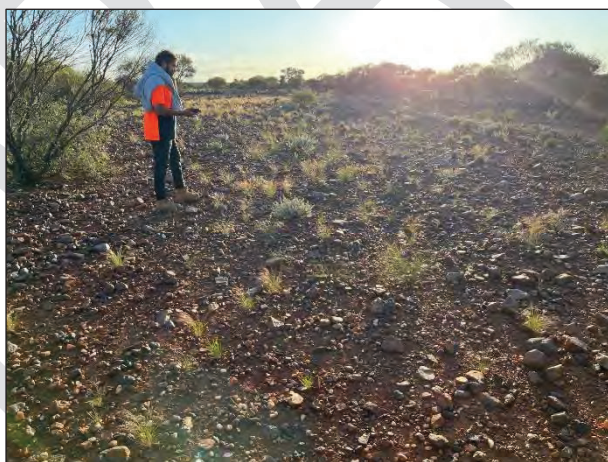
Photograph 60 - Landscape of Survey Area 12.1, facing Northeast.

Survey area 12.1, surveyed on 5 May 2023, is an approximately 5,000m stretch continuing from survey area 11.2 with flat plains and sparse open scrub; several bush tucker species were identified, including Kogla vines (bush bananas) and Kgulu vine (wild sweet potato). At GPS coordinates Zone 50 (GDA 94) Easting 677729 Northing 7126260, the ground surface changed with a 90% increase in rock cover (see Photograph 60).

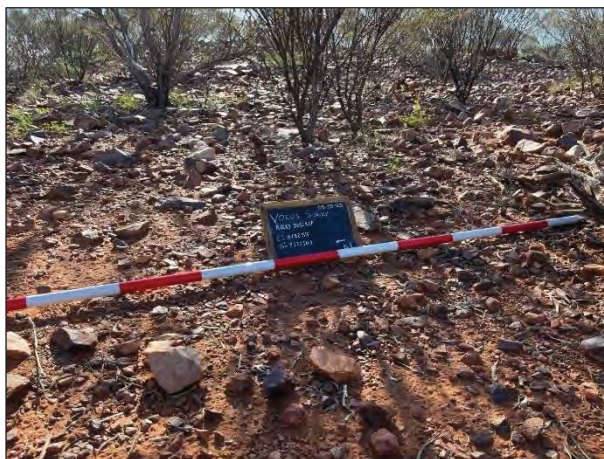
Photograph 61 - Rocky Outcrop in Survey Area 12.1, facing East.

The alignment crossed the eastern fence line; therefore, the survey line was adjusted to keep a 25m buffer from the fence. A rocky outcrop was surveyed towards the north of area 12.1, with an extent of 100 square meters (see Photograph 35). The rock consisted of large basalt chunks; however, very minimal cultural material was identified on the landform. Grading and vegetation clearing disturbance was recorded at GPS coordinates Zone 50 (GDA 94) Easting 673078 Northing 7122609; however, artefacts could still be recorded within the disturbance.

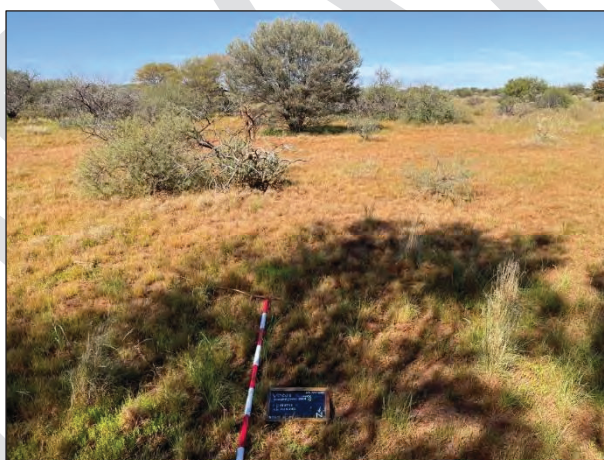
Photograph 62 - Landscape of Survey Area 12.2, facing South.

Survey area 12.2 covered an approximately 2,000m section, beginning with a ground cover of dense grass, resulting in poor ground surface visibility caused due to the lower elevation of the area as a floodplain (see Photograph 62). The southern section of this area became flat plains with very sparse scrub and no grass cover. This section increased artefact density mainly from chert and silcrete, which can be explained as it runs through the Thirty Two Mile Well registered site.

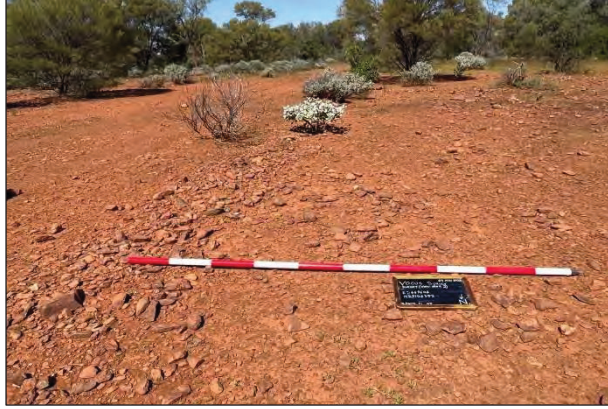
Photograph 63 - Landscape of Survey Area 12.3, facing South.

Survey area 12.3 consists of approximately 1,500m of flat alluvial plains, Mulga woodland and excellent Ground Surface Visibility; however, the disturbance was more evident through pieces of road base, glass, and ceramic insulators. Cultural material in the form of silcrete and chert artefacts were found, as well as knapped glass which may suggest a post-contact site (see Photograph 63).
