## Details of proposed vegetation clearing - Mounts Bay Road fenceline – Kings Park and Botanic Garden

Vegetation clearance works are needed to be undertaken along the 12 kJ rock catch fencing on Mounts Bay Road, Kings Park. There are two sections of rock catch fencing along Mounts Bay Road:

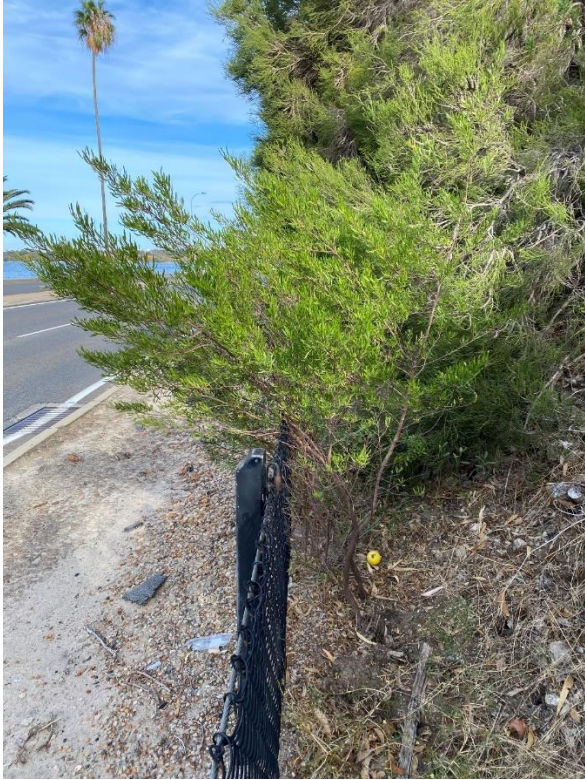
*Dodonaea hackettiana*

(-31.9716751, 115.8327225) *Dodonaea hackettiana* 1m height alive growing through fence. Will need removal to repair fence. Full removal.

(-31.9721080, 115.8314411) *Dodonaea hackettiana* 2m height dead. Leaning will collapse on fence. Full removal.

(-31.9722414, 115.8305412) *Dodonaea hackettiana* 2m height dead on fence. Full removal.

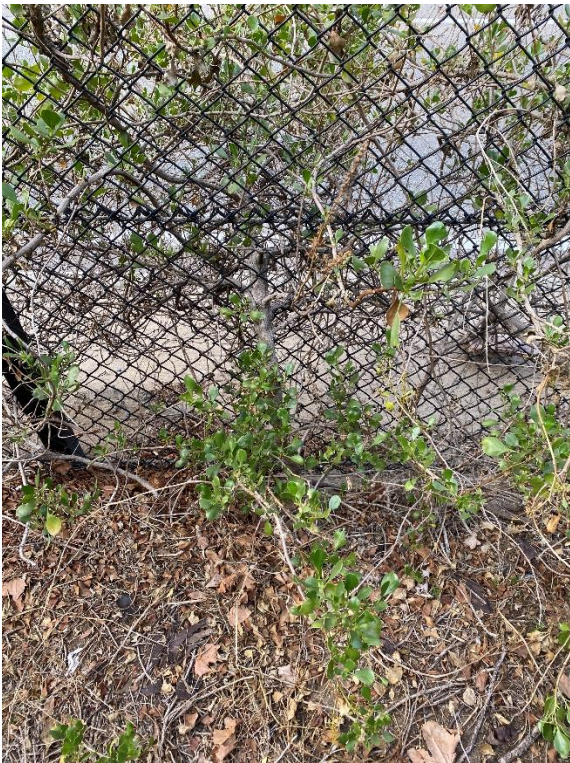
*Scaevola crassifolia* (several locations)

(-31.9696475, 115.8358385) *Scaevola crassifolia* 1m height alive. Growing through fence. Likely to re-shoot. Full removal.

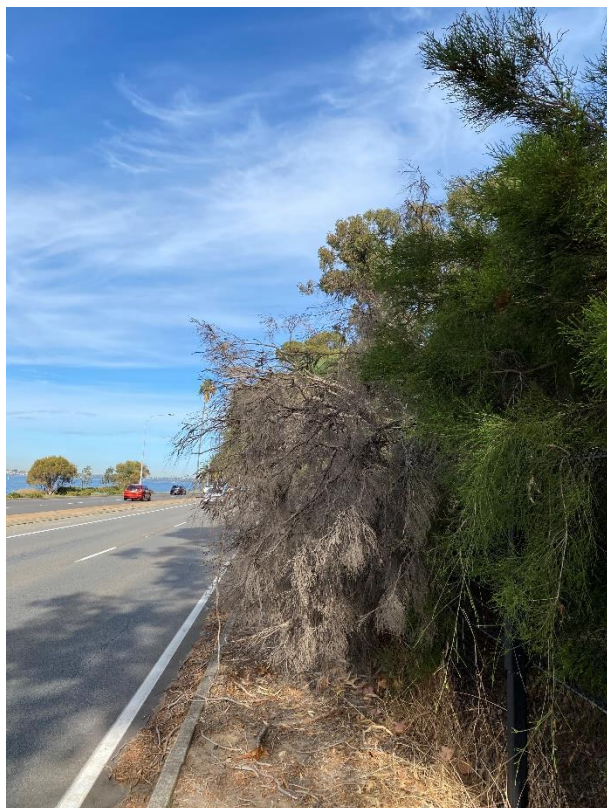
*Melaleuca huegelii*

(-31.9700232, 115.8345923) *Melaleuca huegelii* 1m height alive on fence. Full removal.

(-31.9699438, 115.8348076) *Melaleuca huegelii* 4m height alive. Collapsed on fence. Root failure. Full removal.

(-31.9670609, 115.8388892) *Melaleuca huegelii* 7m height dead collapsed on fence. Full removal.

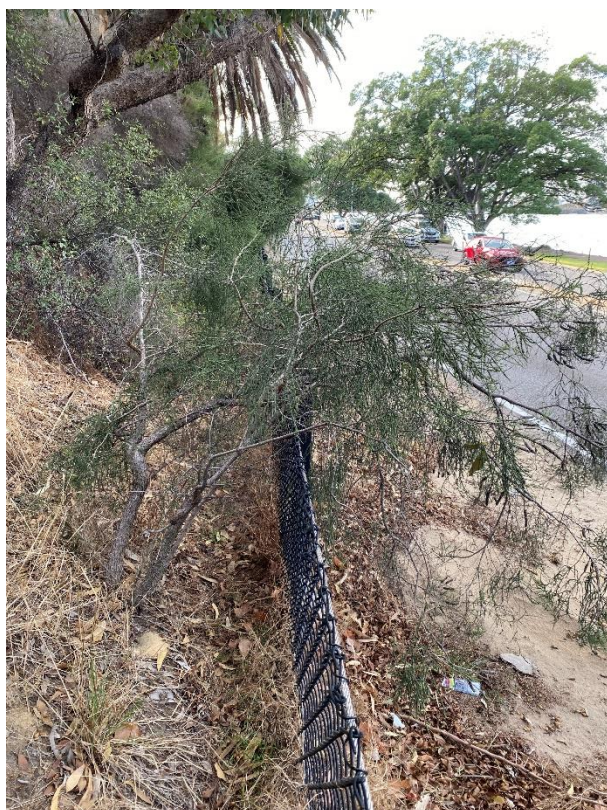
*Melaleuca huegelii*

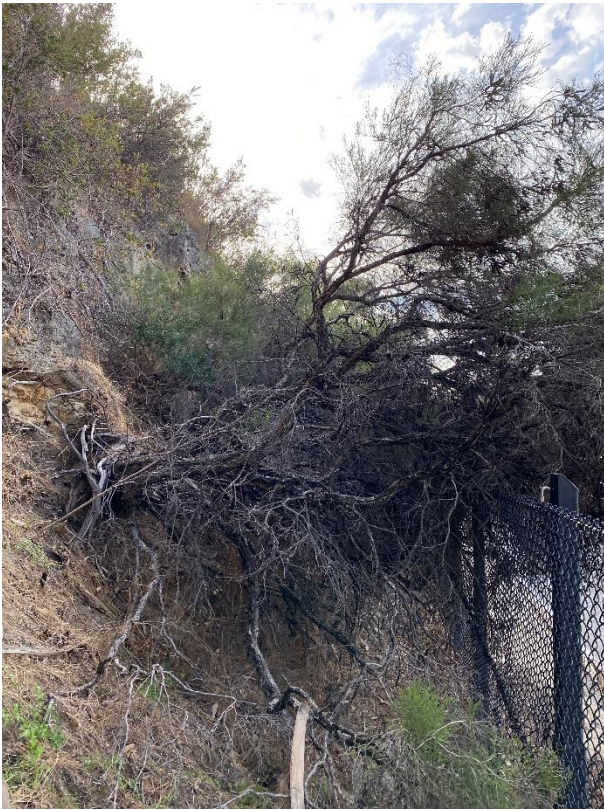
*Melaleuca huegelii*

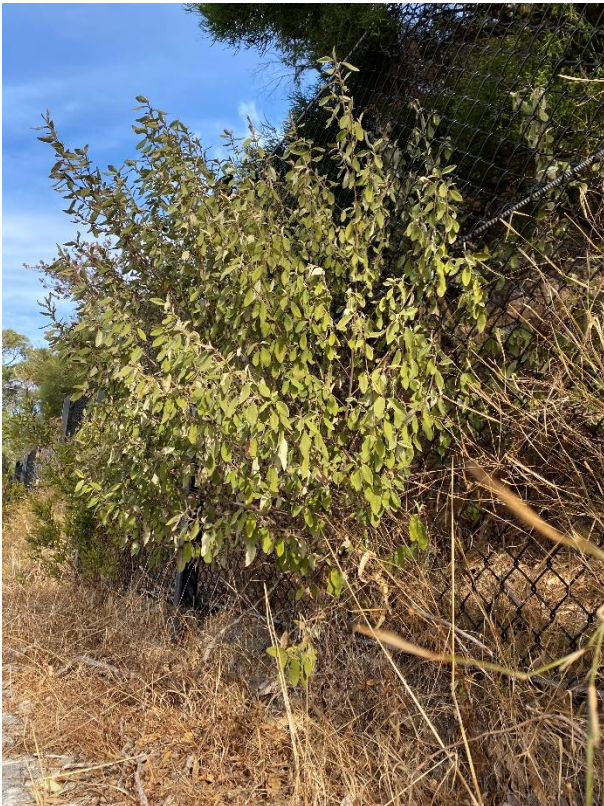
*Spyridium globulosum*

(-31.9665281, 115.8392724) *Spyridium globulosum* 1m height alive. Growing through fence. Full removal.
