Alexandra Bridge Foreshore Management Plan
For Shire of Augusta Margaret River

Vicki Winfield & Associates Pty Ltd

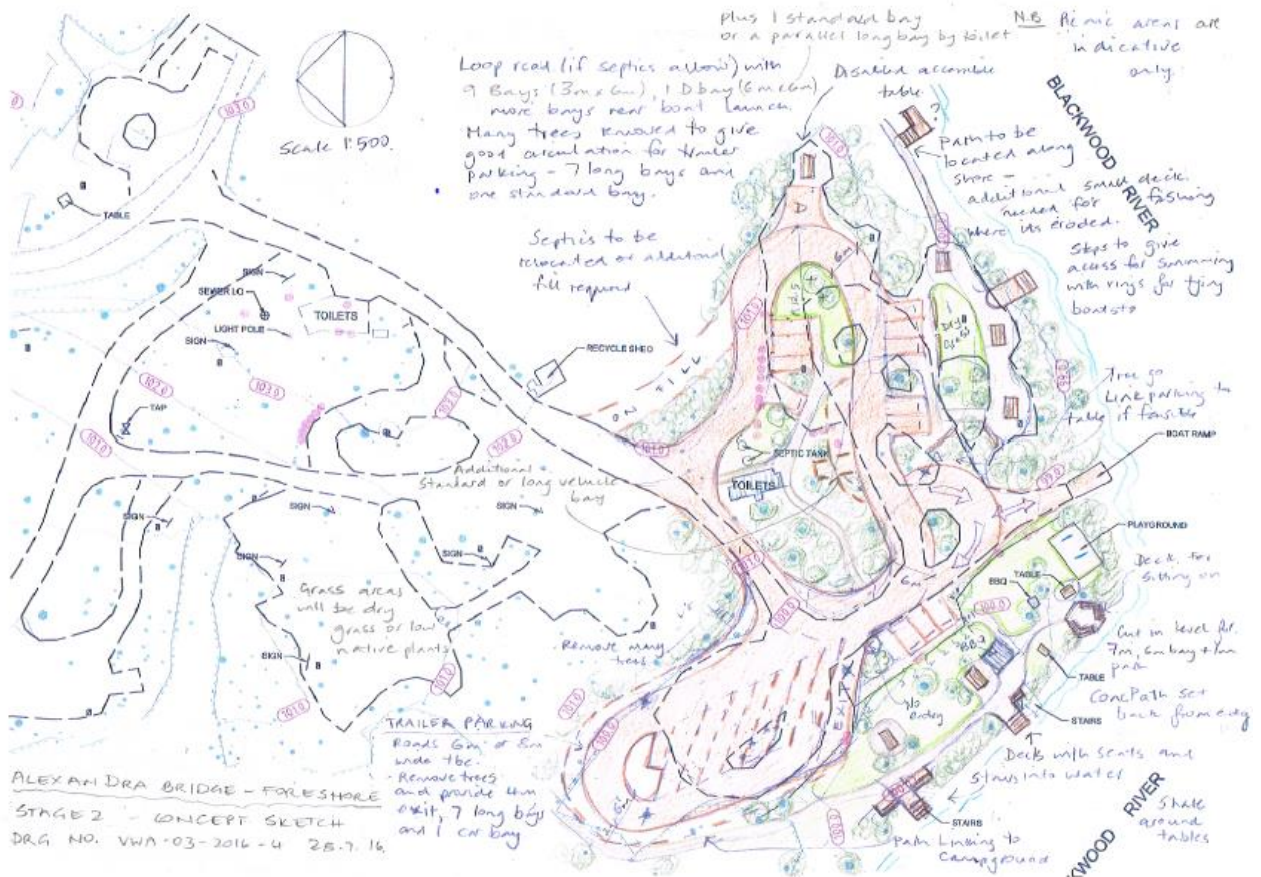
Alexandra Bridge Foreshore - Concept Design as at 2016

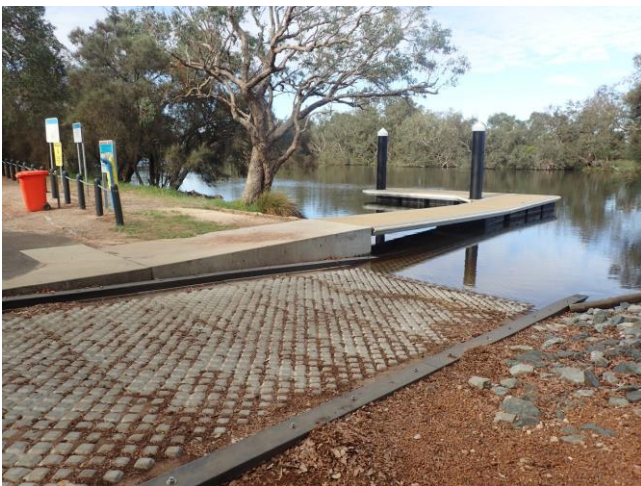
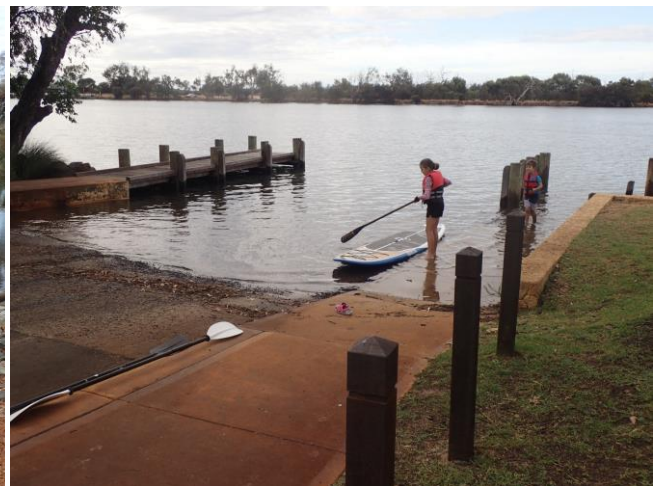
L: Eastwell Road boat ramp

R: Boat Ramp at Pratt Road with platform (where children standing)

- Riverside structures that may be relevant / suitable for Alexandra Bridge can be found along the Collie River at Riviera Way in the City of Bunbury, Pratt Road in the Shire of Dardanup and Eastwell Road (the Elbow) in the Shire of Harvey. The total costings for removal of the existing ramp, installation of new ramp and finger jetty at the Elbow was just under \$400,000.³

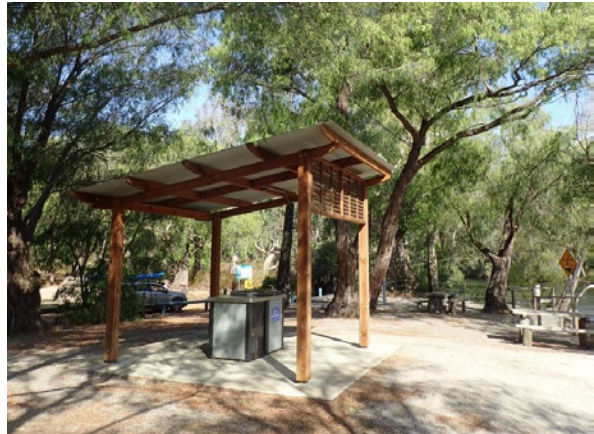
R: BBQ Shelter

BBQ Shelter – A Landmark Peninsula shelter (4m x 4m and Woodland Grey roof colour) with a gas BBQ and solar powered ignition system is set on the foreshore near the swimming area. A smaller shelter (3m x 3m) in the same style and colour is used for interpretation and camper’s registration at the main entry point on Clarke Road.

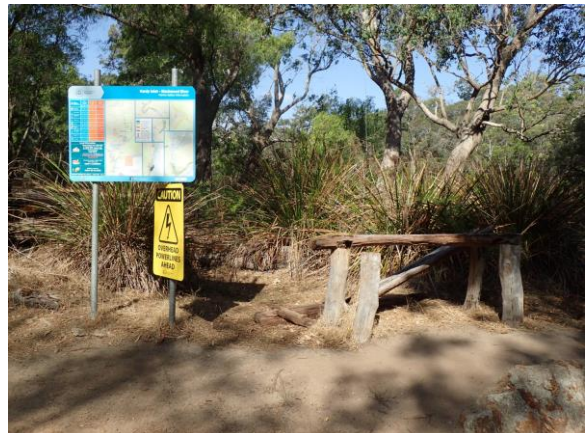
R: Disintegrating fish cleaning table

Fish Cleaning Table – the timber fish cleaning table by the boat ramp is falling apart.

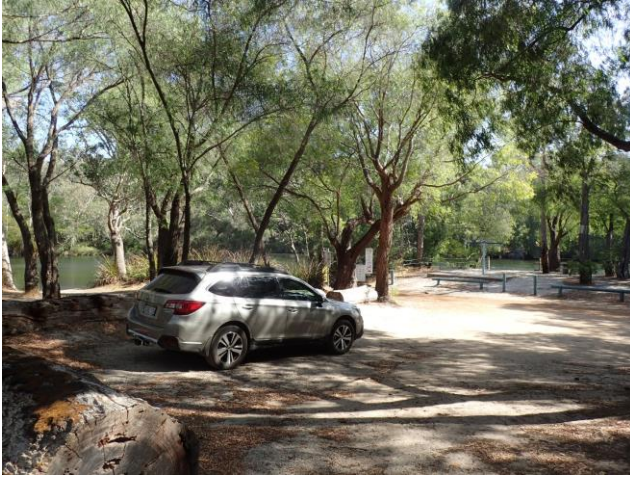
L: Varied vehicle barriers - logs and pine bollards and railings

Vehicle barriers - Varied pine bollards and railings are used within the site and post and wire fencing protects revegetation areas on the foreshore. Also very large tree logs have been used to define the car parking area.

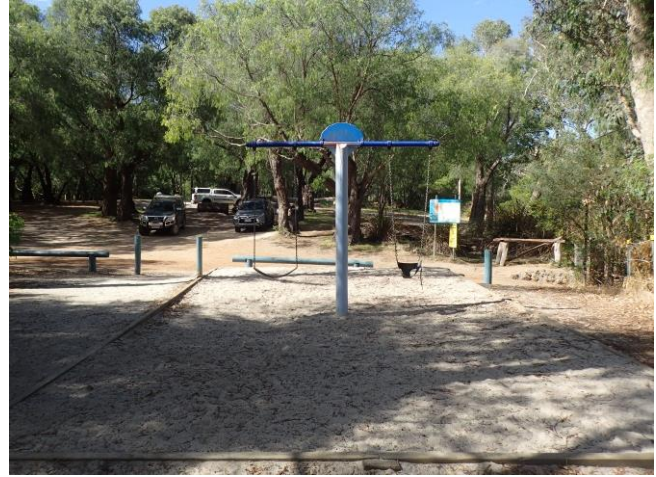
R: Existing swing

Swings – a swing structure is set in an area of sand for soft fall. It is old and to be replaced, the replacement swing set has already been purchased.

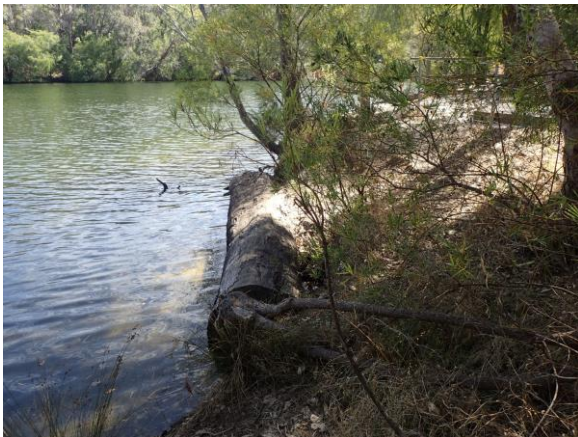
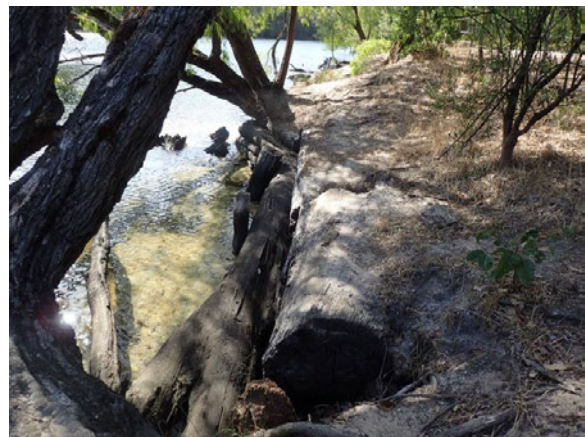
L: Log with no scouring at toe or behind log, gentle bank and fence R: Log with second log for toe scouring

- There are some reasonable examples of successful use of logs for stabilisation see photos below. So this could be used elsewhere but considerations should be - toe scouring (should be prevented), material behind the logs will need retaining (geofabric should be used), the bank should be sloped (1:3 would take up too much space, 1:1 is adequate) and fencing for public access control.

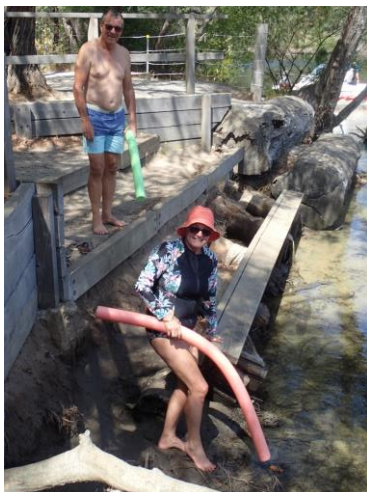
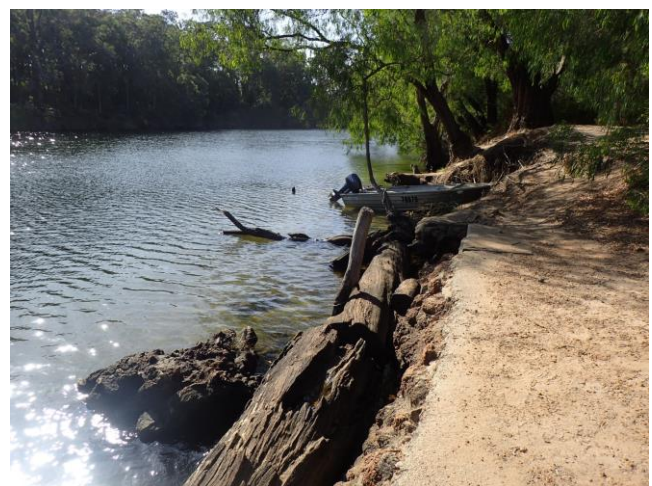
- River access structures require immediate maintenance in places (see below)

L: Undercut toe of access structure is hazardous for pedestrians R: Undercut cemented rock wall with void

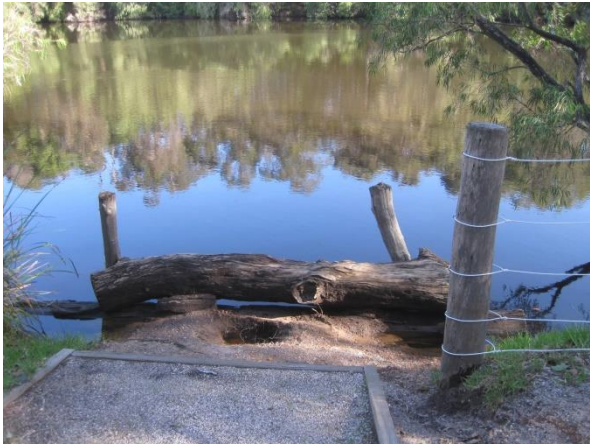
- New river access structures require careful design. Compacted gravel steps with timber supports work reasonably well up slope but had typically failed in the lower more dynamic sections near the river interface.

L: Toe of steps in 2016

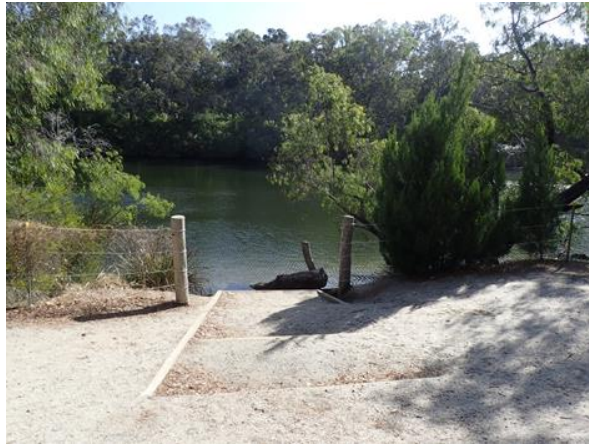
Toe of same steps in 2020 – log has moved.

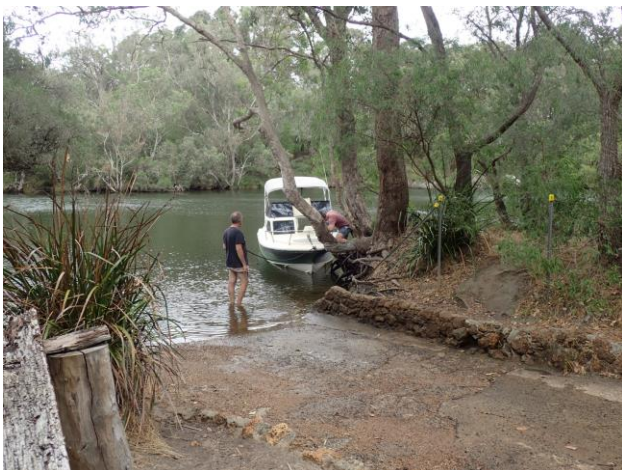
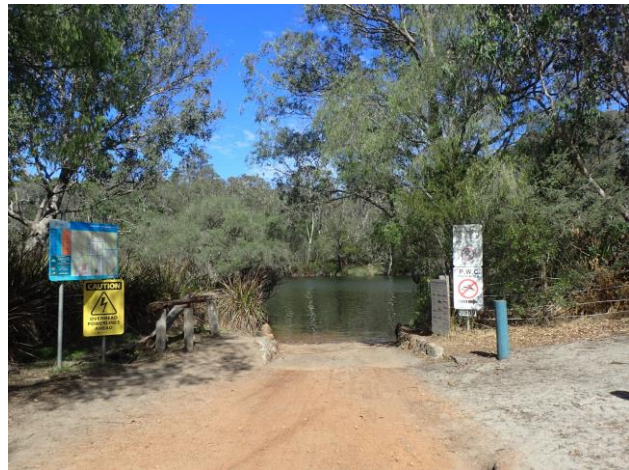
- The boat ramp is an older 'low key' structure that is fit for purpose with reasonable maintenance. Any upgrades should consider widening the ramp to 4m (currently approx. 3.5m), straightening, inclusion of a floating finger jetty to improve amenity and safety of access to vessels and assist with adjacent bank stabilisation (undercut trees).

L: problems getting on and off boats and bank erosion R: Narrow ramp, hard for backing, worn edges

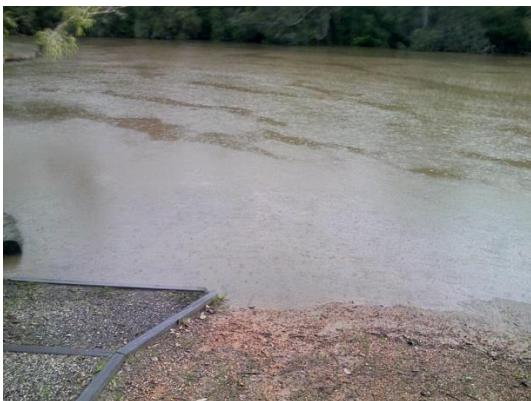
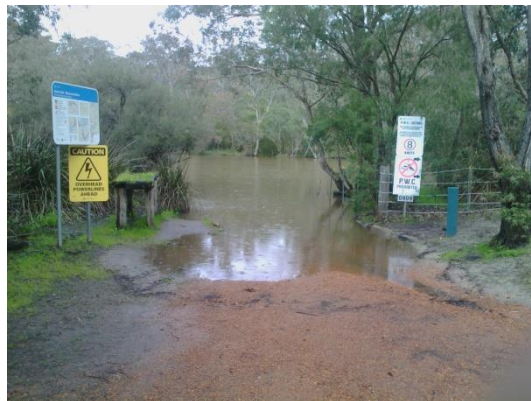
Post the site inspection VWA sourced photos of 2016 river flood levels (see below). This flood covered all the logs and other uneven stabilising structures leaving only the timber framed steps, which could result in visitors/boat users not realising there were hazards along the water's edge just under the water.

L and R: 2016 floods

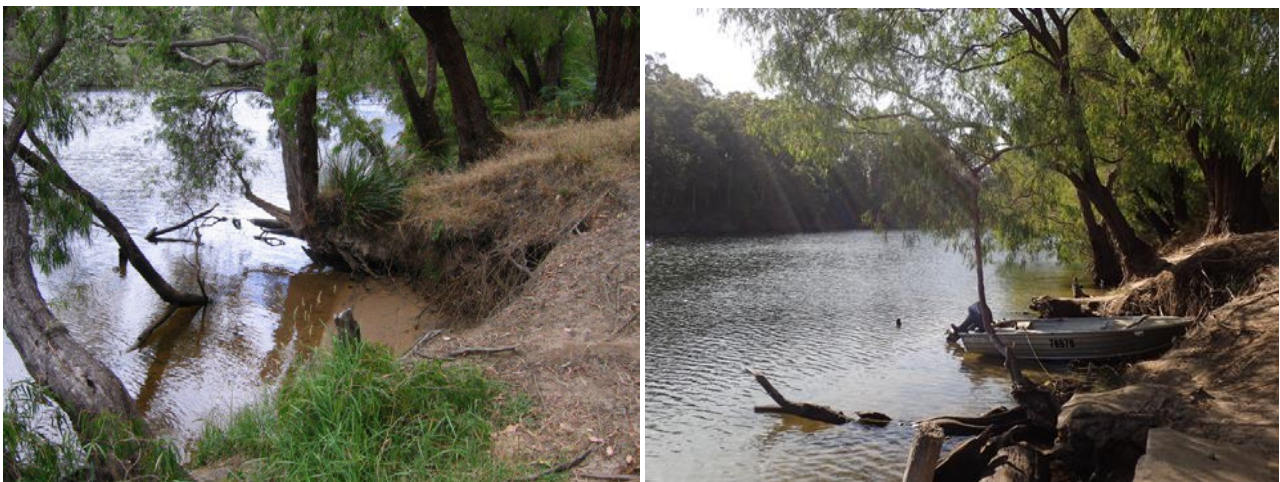
L: Looking north of the rocked (north) access point (west of boat trailer parking) 2009 R: Same location 2020

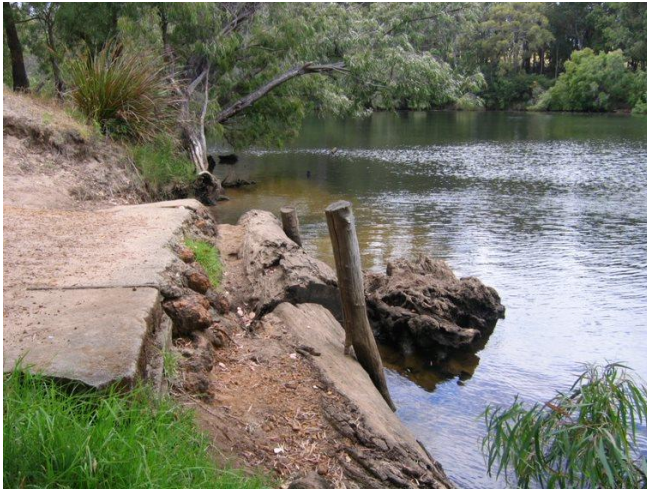
L: Looking south from rocked (north) access, in 2009 and **R: Looking south in 2020**

The above photos illustrate how the fill behind the logs has washed out over time. Inspection indicated fill had also washed out from behind the rock work. The photos below are of the southern end of this rockwork.

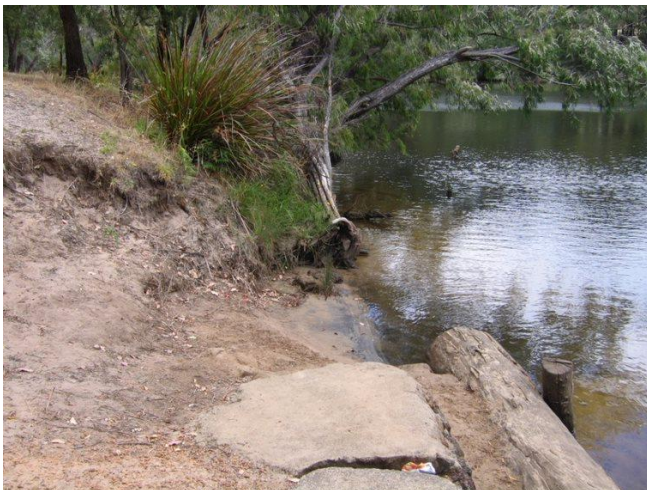
L: Southern end of above access point 2009

From the photos above it looks as though the bank has continued to erode a little and the clump of sedges has been trampled and is possibly falling into the water. The logs are holding back the bank to a degree but foot traffic is causing erosion and preventing revegetation despite the area being fenced off.

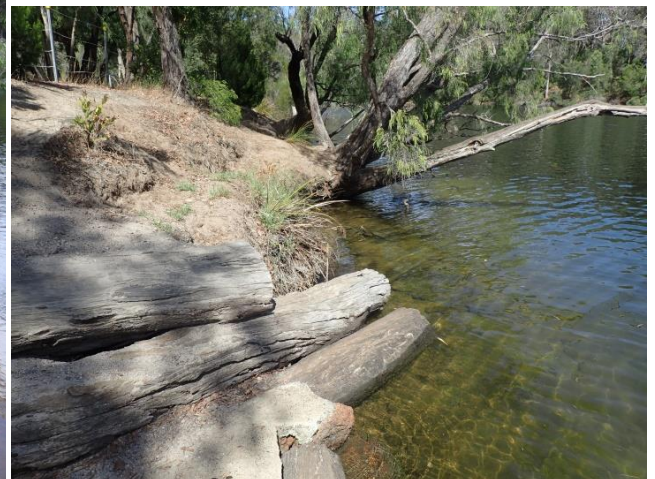
R: Same location in 2020

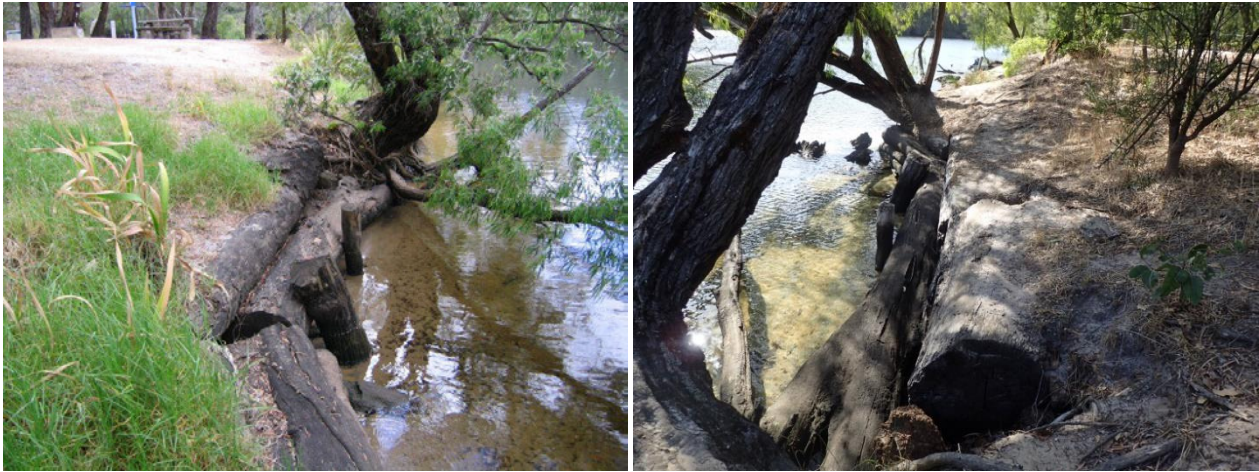
L: Looking south from south of the previous access point 2009 R: Looking north at same location 2020

The photos above are thought to be of a location south of the above access point, viewed from different ends due to the supporting posts looking like the same posts in each picture. The 2009 photo has a relatively stable sloping bank behind lower logs. Additional logs have been added in the 2020 photo to give a leveller area behind the logs, and there is fencing to restrict foot access. Although there is erosion occurring in the gap between the large logs the remainder of the bank behind the logs is stable.

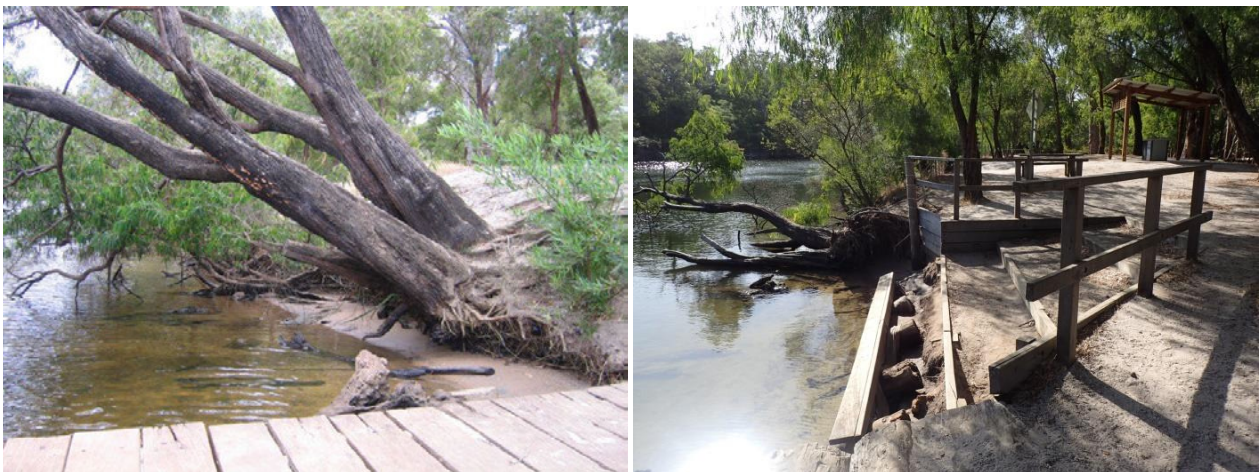
L: Main swimming access (jetty now removed) looking north in 2009 R: Note fallen tree in 2020

The above photos show the bank around the tree (that has now fallen in the water) continuing to erode and recede. Installing the retaining wall has not protected the tree roots (and may even have caused more scour at its base). Access is not controlled and the tree is actually used by swimmers who climb out on it to jump in the water. Below the large logs appear to have stabilised the bank south of the previous jetty.

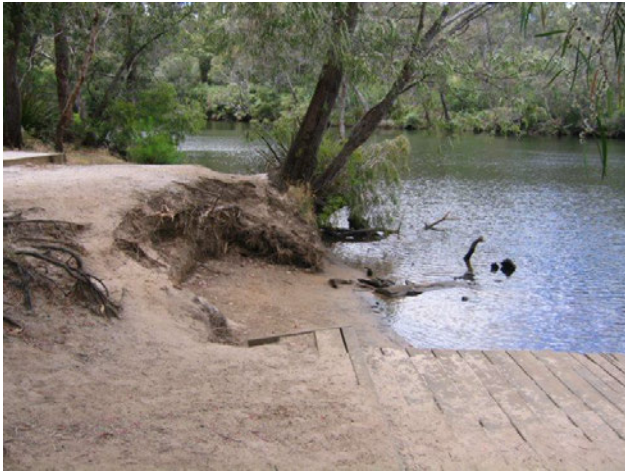
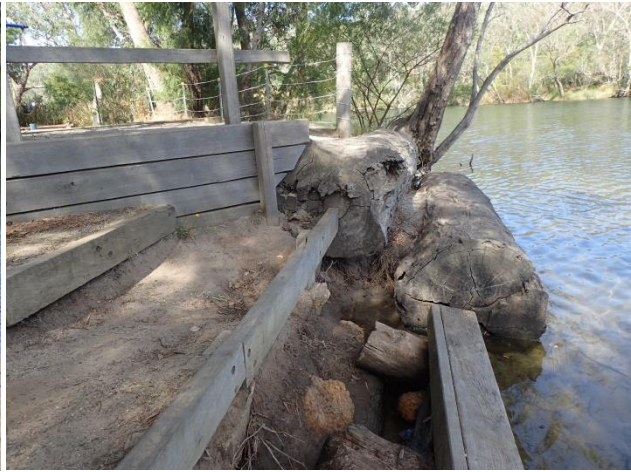
L: Main swimming access (jetty now removed) looking south in 2009

R: Same view in 2020

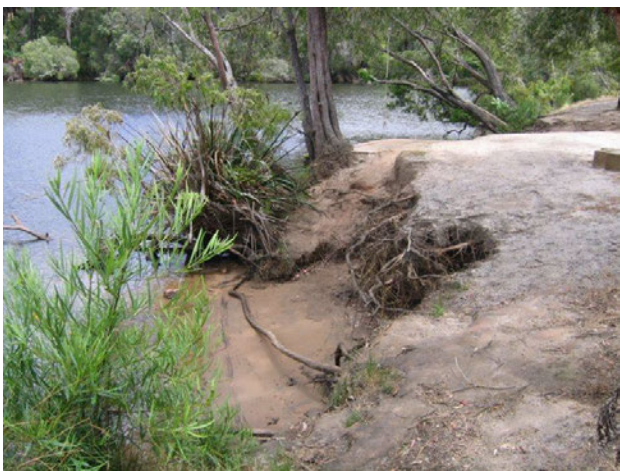
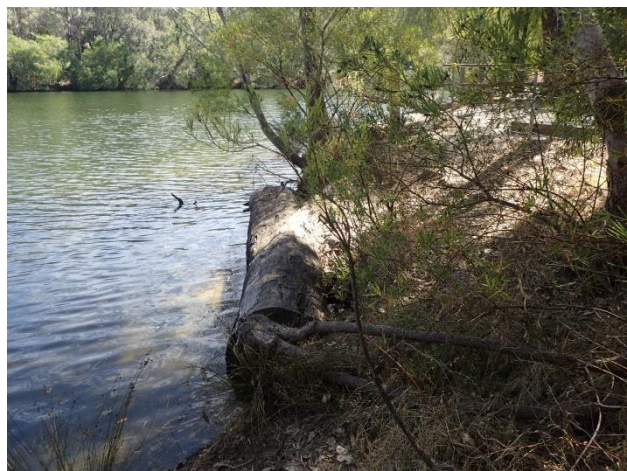
L: South of the old jetty, west of the boat ramp 2009

R: Same view in 2020

The above photos show how the combination of the log and excluding people with fencing has halted the bank erosion. However this section of bank has a different aspect to the above sections of bank and so may also have different erosion forces occurring. The sedges in the 2009 photo have gone in the 2020 photo; possibly because they had gone before the log was installed.

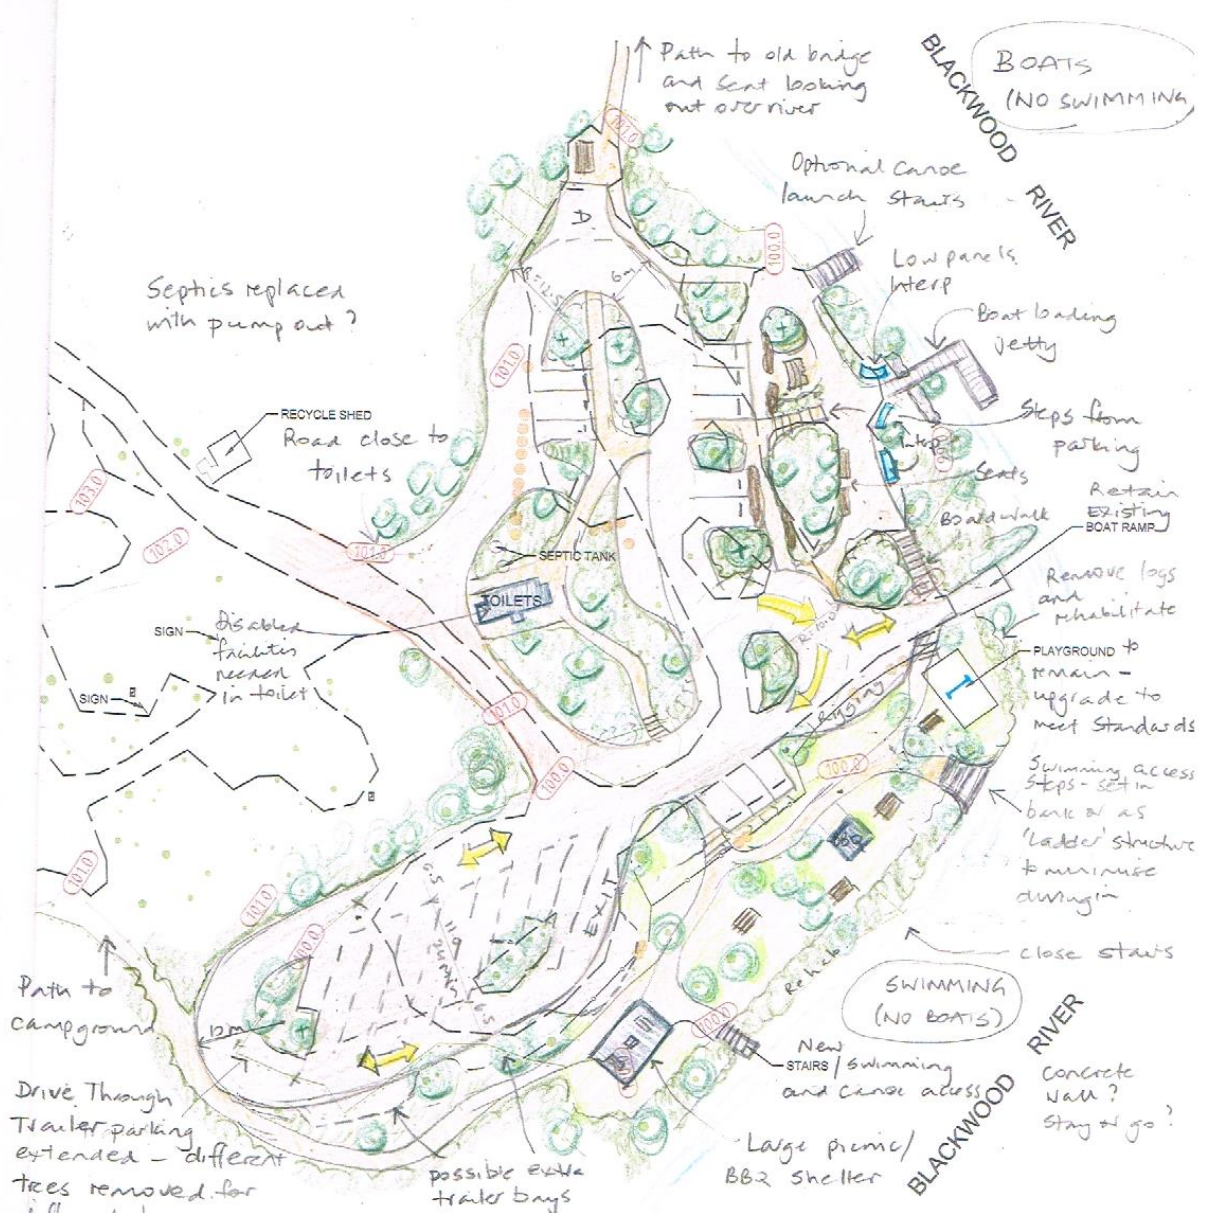
- OPTION 1 - Conceptual Layout**
- 1 long bay?
 - 16 Car bays
 - + 2? 6 Trailer bays
 - 1 Rigging bay
- keep ramp as is
 - Eastern shore - boats
 - Western shore - swimming (No motor boats)
- + All swimming subject to underwater hazard checks

- Loop circulation with 6 long bays and 3 car bays,
- 3 trees removed and 2 tree islands created one with existing trees the other with new trees.

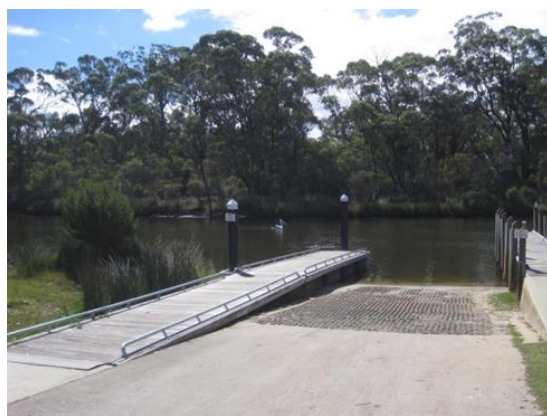
R: Denmark floating jetty Launch

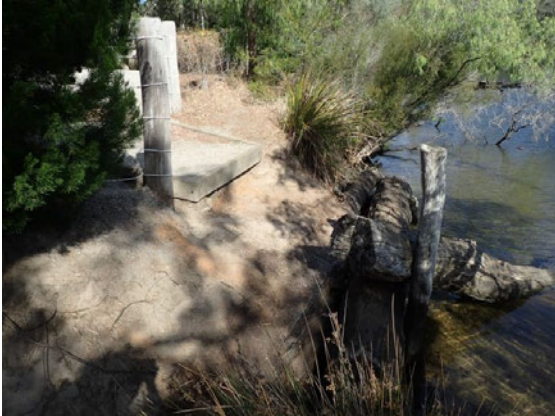
L: River Access 2 - to be closed

- Remove loose logs and pole and place rocks, rubble or coir log at toe of remaining log.
- Remove timber steps and reshape bank so that erosion does not occur down the bank.
- Relocate fence back from foreshore and close access to the river.
- Lay jute mesh on bank, secure and plant through mesh on bare areas.
- Lay brushing/branches along the edge of the bank to restrict pedestrian access.

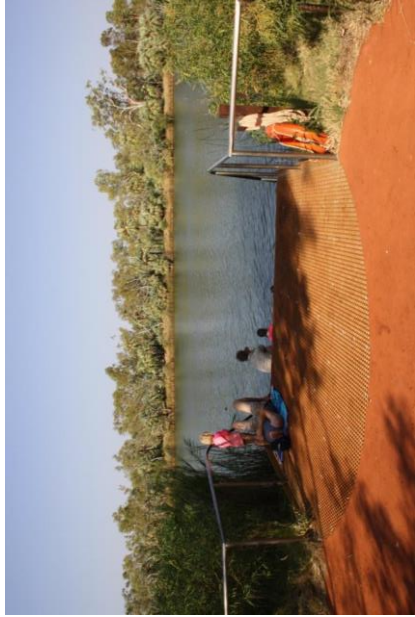
L and R: Deep Reach swimming access – similar proposed for Alexandra Bridge swimming access but with timber decking

- The big log along the water line should stabilise the bank under the stairs (with geofabric behind, and rubble at toe) but this may give issues for driving the post into the banks, so a small log and toe reinforcement may suit better (will need securing) with jute above it or a coir log to hold the bank in place while it revegetates (sufficient light should come through the fibre reinforced plastic to enable plant growth).
- There will be more space at the upper level which will be mostly decked with the stairs (4m wide) taking off at the water line extending out into the river (accessing deeper water if feasible).
- Logs south of this will be retained (see photo above), but toe scouring may need addressing and visitor access excluded to the top of the logs (new steps to be used for sitting on, not these logs).

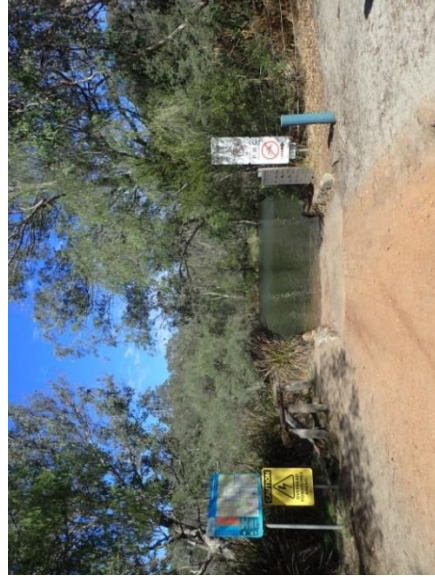
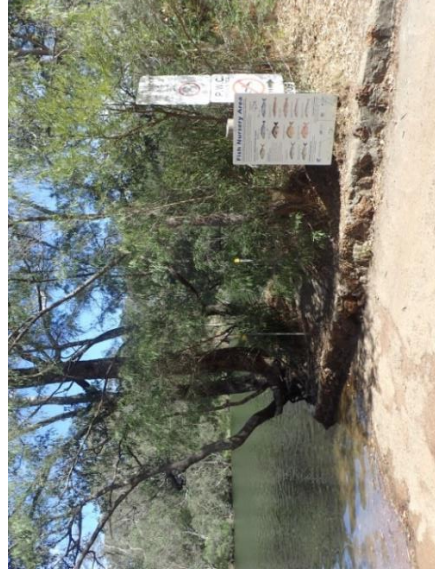
- The ramp may need resurfacing (to be advised by marine engineer) but essentially the ramp will be retained as it is. Rubber or a softer material could be considered, but providing there is a grass rigging area nearby the existing hard surface should be acceptable.
- The worn banks either side will be revegetated, protective fencing may be needed in the short term and jute logs or similar may be needed to stabilise the trees either side of the ramp until new vegetation establishes.
- A map of the river showing where canoes can pull up for a picnic rest has been suggested by canoeists.

L: Existing boat ramp to be widened and straightened R: West wall

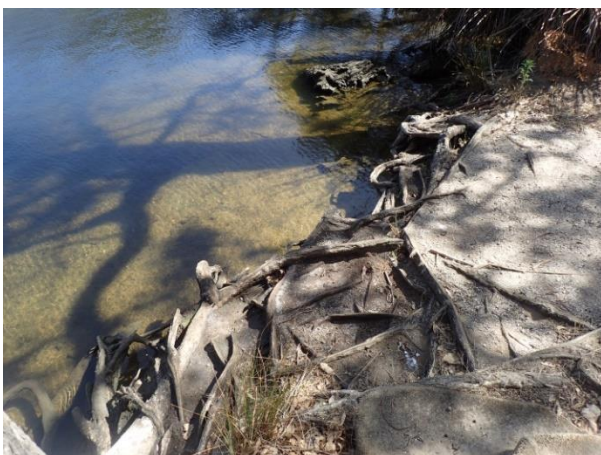
L: Exposed roots to be protected and revegetated

- If the area is to be rehabilitated it requires coir logs set out from the existing root zone, secured and backfilled with granular material (shale) this should have jute matting laid, secured and planted to hold it in place. Levels, locations and quantities of coir logs will depend on low water and flood levels as will plant species selected and where they are planted. This coir log structure should continue along the eastern shore to stabilise River Access points 6, 7 and 8 and finish at the stable banks east of River Access 8. Logs may be required as well where the bank is over 500mm high, see section 6.2.3.

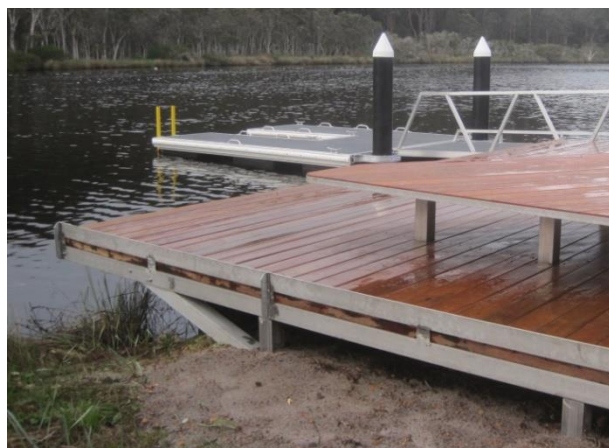
R: Low cantilevered deck at Nornalup

- If a disabled fishing deck is proposed this is to be approx. 3m by 2m steel framed cantilevered structure, probably with fibre reinforced plastic deck but could have a timber deck. Structure would need confirming with Fishability. Coir logs etc. will be needed as in the point above, to stabilise the foreshore.

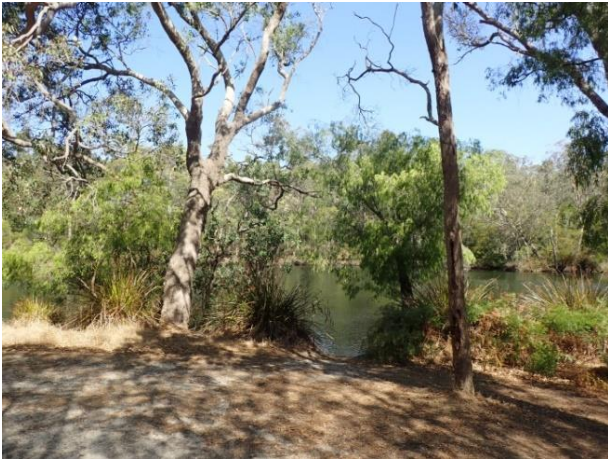
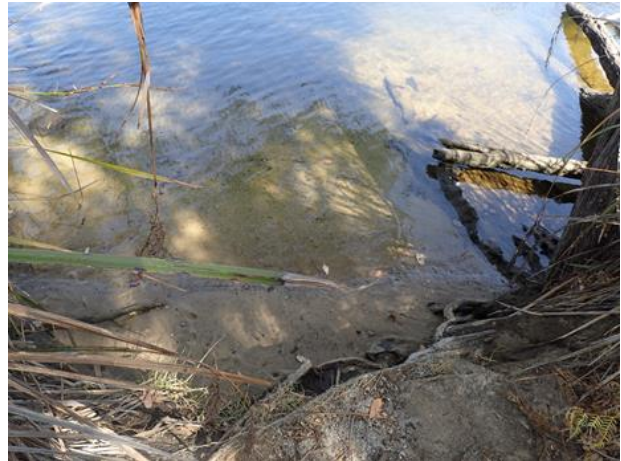
L and R: River Access 6 to be closed and rehabilitated

As River Access 5 may remain an access point and River Access 8 is proposed to have swimming stairs, River Access 6 and 7 are both proposed to be closed and rehabilitated. The coir logs are to form a continuous structure from River Access 5, past River Access 8 to stable banks associated with the rock outcrop in the river. The technique is to be the same as is described for rehabilitating River Access 5 above, but due to the steeper slope, brush and branches may also need to be laid over the area to be rehabilitated. If the banks are too steep to only use coir logs, timber logs with geofabric behind and rubble at the toe can be used to achieve the required height. The continuous line of coir logs will follow the original river edge and additional logs may be needed within the embayments at the toe of the bank. The area will be closed to visitors with fencing and additional planting.

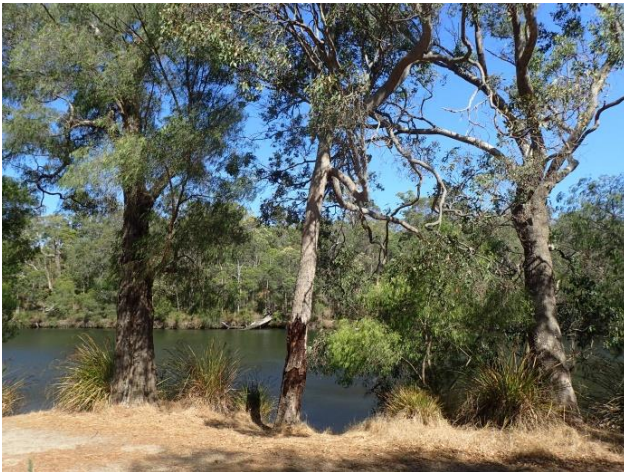
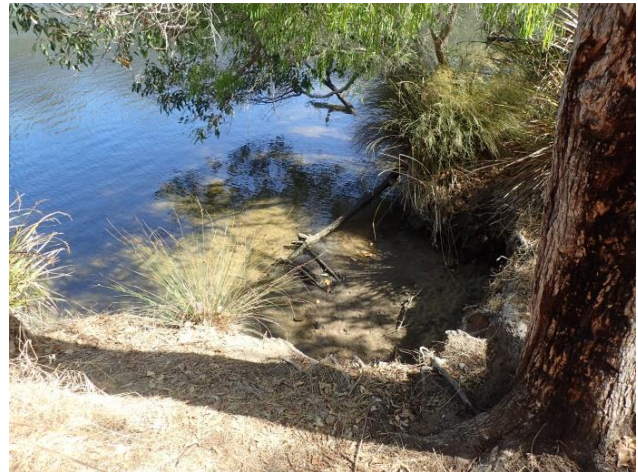
L and R: River Access 7 to be closed and rehabilitated

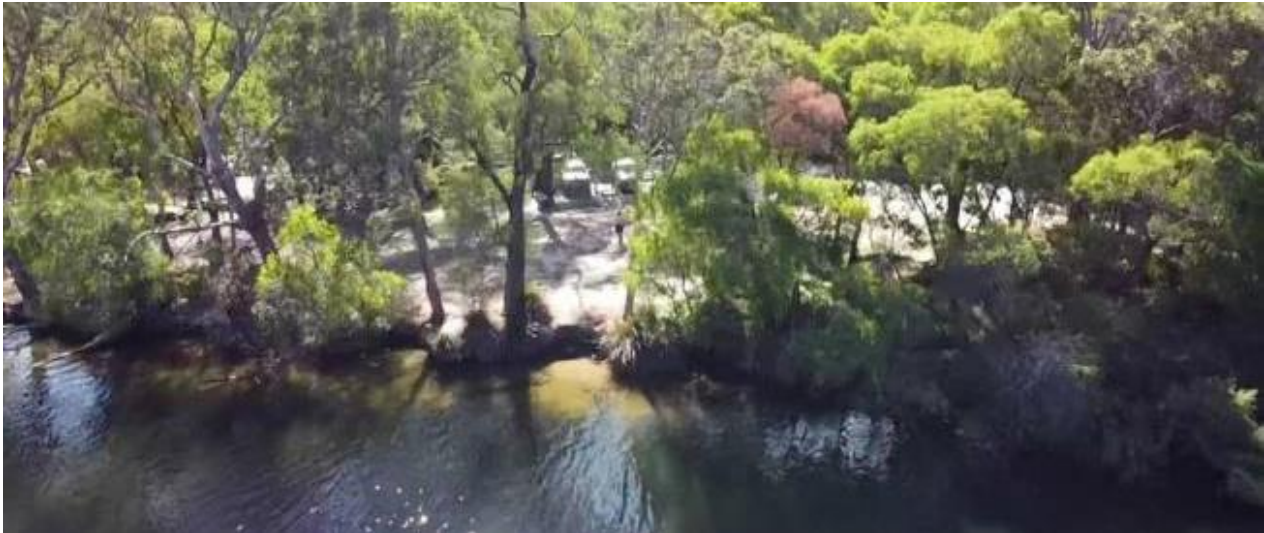
Eastern Shore - Rock outcrop on right, River Access 8 adjacent and centre

The land has started to rise from the river and the bank here has a drop of about 1.5m, giving a steep slope down to the river that is currently eroding and it is proposed to formalise this access to provide an access point for those picnicking on the eastern foreshore. It is possible the eastern shore will become the focus for day use once the new boat ramp is installed and so these steps should be as wide as is feasible.

- The old shoreline will be re-established and the river’s edge will be stabilised with coir logs and fill supplemented with jute matting, planting and brushing as described above.
- A gathering and sitting deck or open area is to be provided at the higher level.
- Safety of overhead trees to be checked and if any trees are to be removed a wider set of stairs may be feasible.
- River depths associated with the rock outcrop to be inspected.
- Swimming access / sitting stairs (with hand rail) to be provided from the deck to the water using the same design (but narrower unless trees are removed) as is used for the main swimming access location.

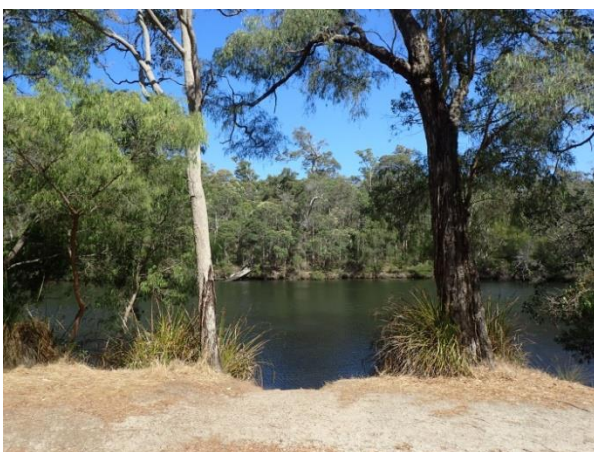
L: River Access 8 proposed sitting area

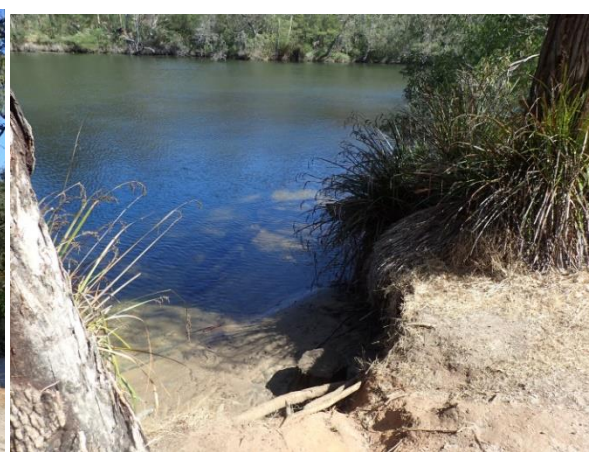
R: Existing access requiring stairs over.

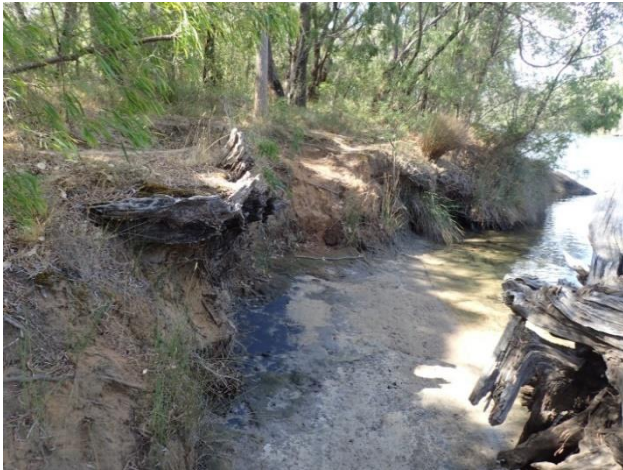
East of River Access 9 is a stretch of foreshore that is not readily accessed by visitors which may be quite stable (due to the rock outcrop shown on aerial photos). This section of foreshore needs further investigation, probably from the water as the bank is so steep. Further east again is an eroded embayment, with undercutting on the headlands and a drop of 1.5 – 2.0m with the path close to the edge and access to the water.

L: Undercut foreshore

As this is some distance from the main use area no additional river access structures are proposed, though a viewing deck could be considered long term (but would need a geotechnical report). Instead it is proposed to align the path away from the bank edge and place a seat north of the path with views to the river, and if feasible to the old bridge. Some pruning or thinning of vegetation may be required to achieve the view.

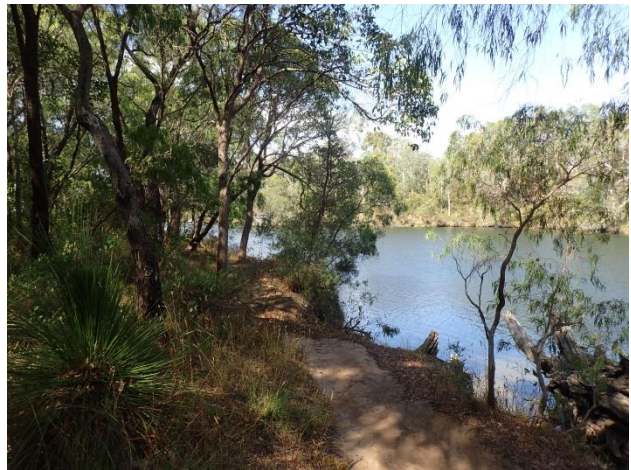
R: Existing track very close to edge of bank

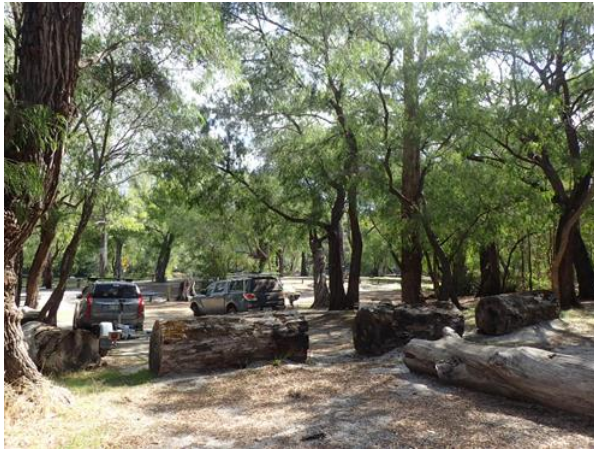
L: Existing Large logs dominating the site

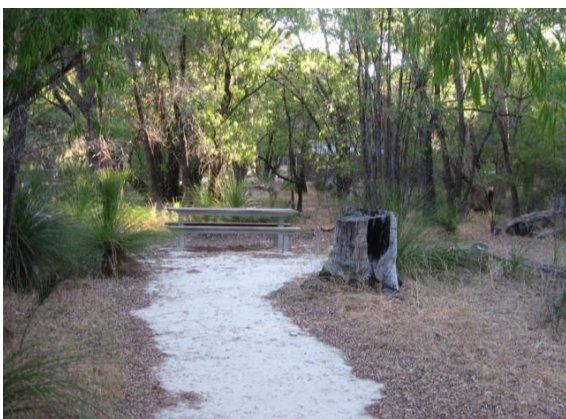
- Totally accessible walk – wider paths (1.5 m) with a firm even surface (of compacted, crushed limestone, concrete or asphalt) will be provided to link key facilities so there are opportunities for less able persons to use the site.

L: Limestone path at Martin's Tank

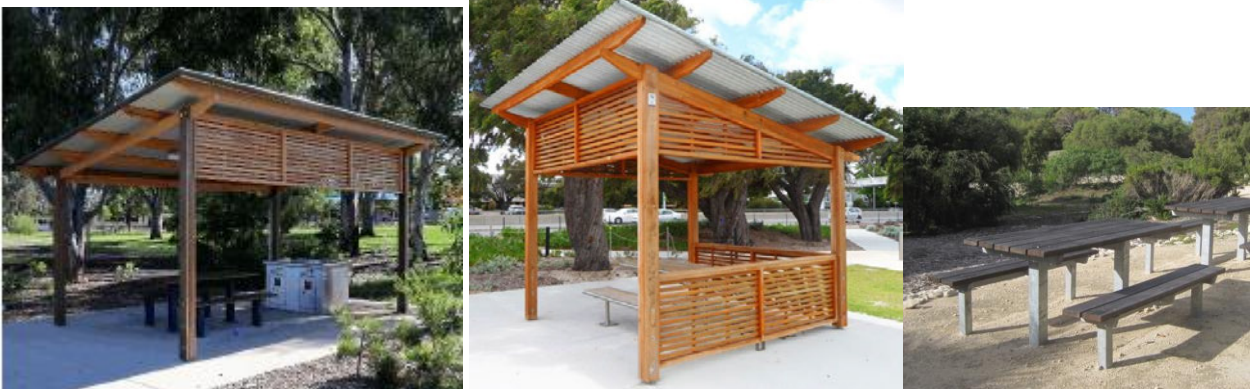
Shelters are proposed to be of a design that matches the existing foreshore and fee collection shelters, which is a Landmark Peninsula skillion shelter, with a skillion roof in colourbond Woodland Grey colour with timber posts and trims, and a concrete floor. A larger shelter (6m x 4m) is proposed for an elevated position (and views to the river) near the day use car park that will have a picnic table and BBQ (this could be relocated from the foreshore) or 2 picnic tables. This table should be suitable for wheelchair use and be free standing so it is easier to access (DBCA Conto's table may be suitable, steel frames can be made in Collie and timber sourced locally).

L: New larger landmark shelter C: Shelter only to have one fence at front R: Contos picnic table for shelter

An additional smaller shelter (4m x 4m) may be located near the new boat ramp, with a picnic setting and a railing at the front so people can lean on it and look over the river and they are discouraged from walking from the shelter down the bank. The existing shelter will be retained, though the BBQ may be replaced with a picnic setting.

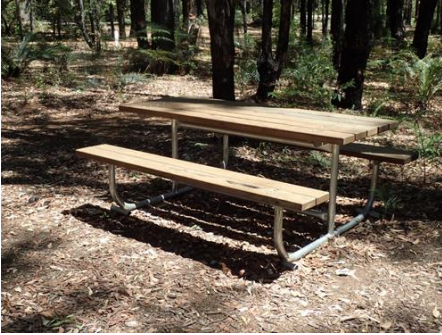
L: DBCA standard table

It is proposed that DBCA standard picnic tables are used (see photo below) providing the SoAMR can source the timber (the metal frames are made by the Bunbury Prison). If these tables are not a practical option there are commercially available alternatives such as the ones from Exteria and Landmark shown above and below. If stainless steel is required for the metal work, this needs advising by the SoAMR. Individual tables and bench seats as shown for Contos above will be used in the picnic shelter(s) and the combination table and bench unit shown below will be used elsewhere. There will be concrete floors in the shelters but concrete pads will not be supplied under individual tables enabling them to be more easily repositioned

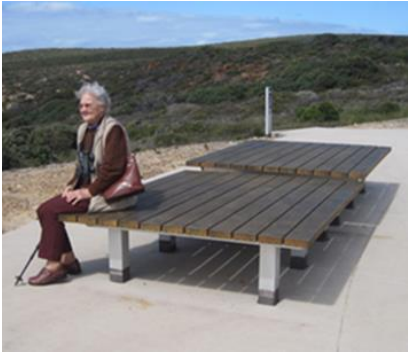
L: Platform bench for swimming platforms

A platform bench is proposed for the information node as it can have a variety of uses such as waiting, viewing, picnicking etc. This will be detailed as part of the information node and again the need for stainless steel metal work needs confirming.

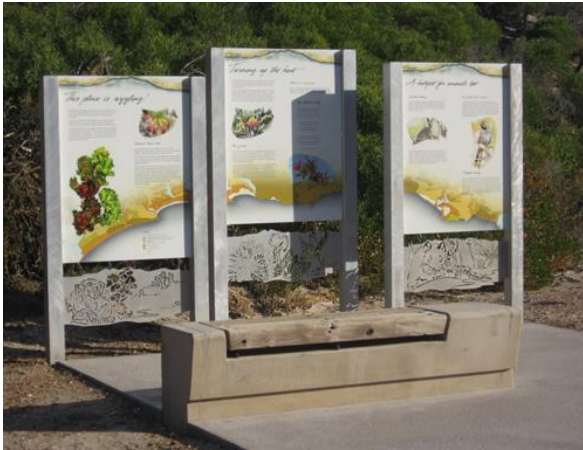
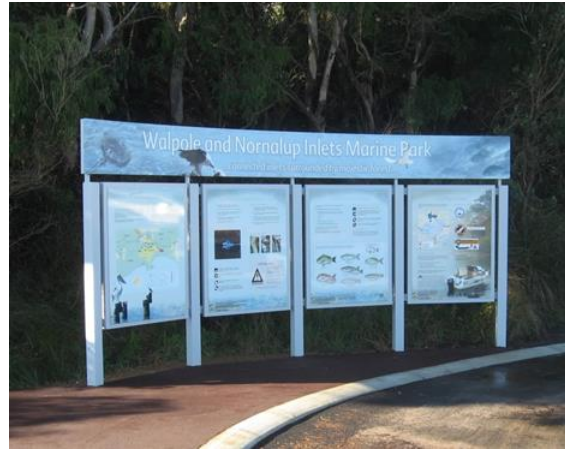
Free standing panels are proposed as shelters are already proposed / existing near both locations and so are not considered necessary. These panels could also have art works integrated with the information panels. The panels will have trees behind them so they are not obtrusive and will not be blocking any views.

L: Standalone panels and seats in Fitzgerald River National Park R: Multi agency structure at Coalmine

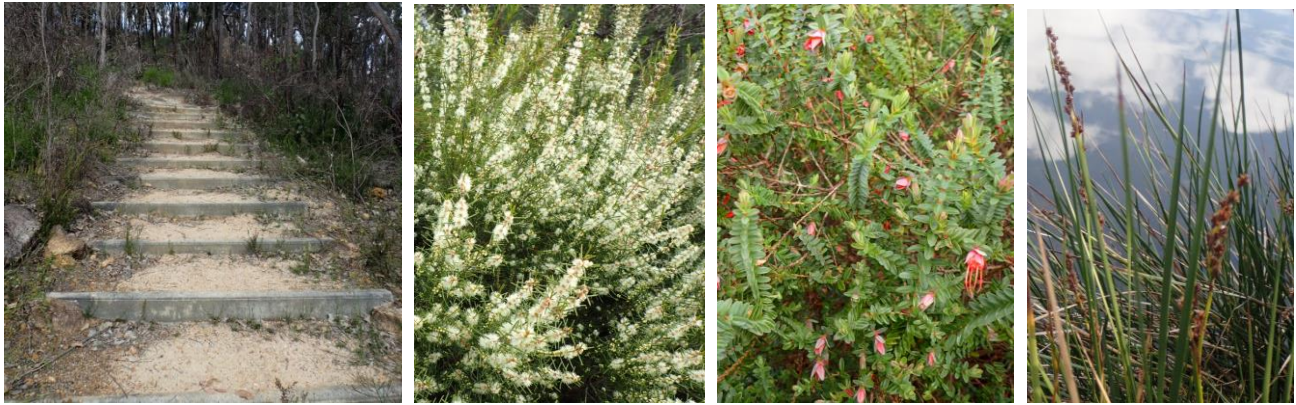
L: Steps with concrete risers at Mt. Lindesay C – R: Hypocalyma sp. Darwinia sp. and rushes / sedges

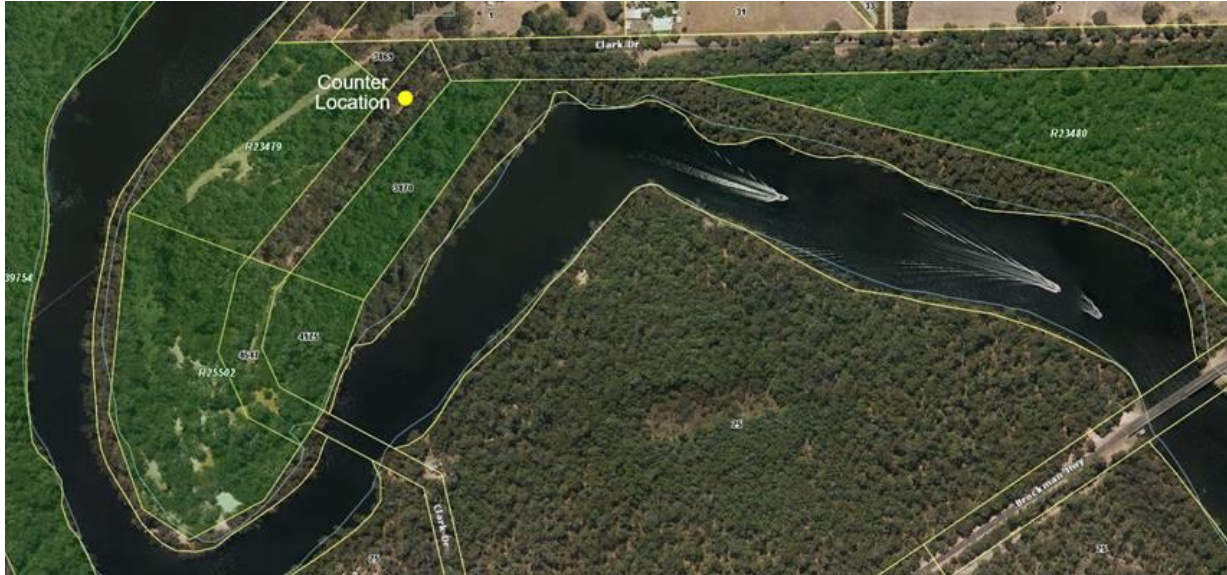
Traffic Counter Location

Weekly Vehicle Counts (Virtual Week)
